Heritage Conservation Management Plan
Derry House, 875 Enola Avenue, Mississauga

March 4th, 2021

Heritage Conservation Management Plan – Roof assembly / Soffit / Fascia / Eaves troughs / Rain Water Leaders / Wall Siding / Storm Window and Foundation Wall at Derry House, 875 Enola Avenue, Mississauga Ontario

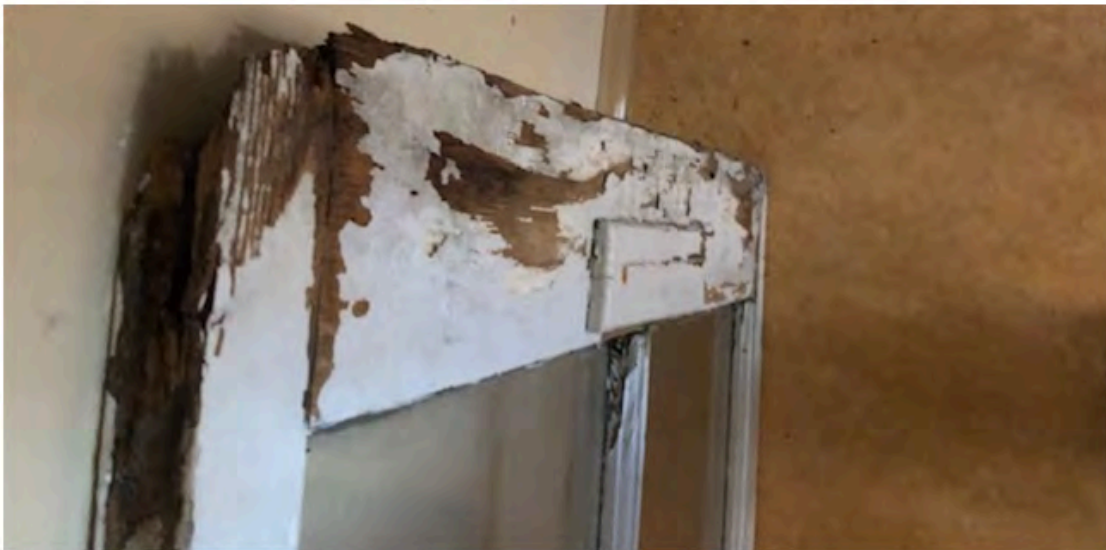
Storm window - Deteriorated bottom rail - south elevation

All deteriorated parts of the storm windows must be replaced with new to match existing profiles.

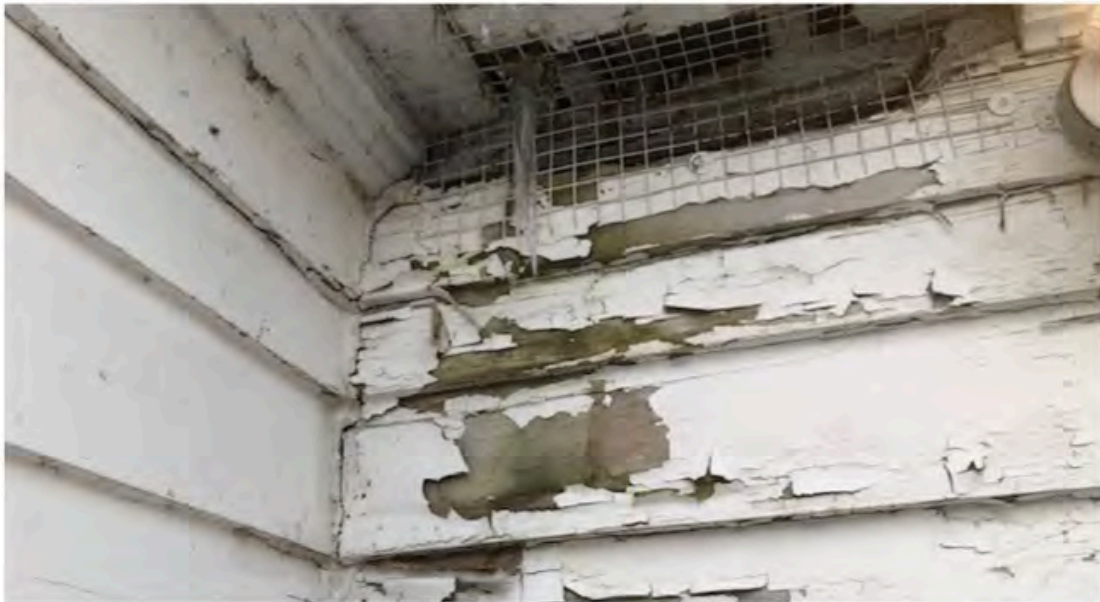
Deteriorated soffit, siding & foundation wall - West wing north elevation

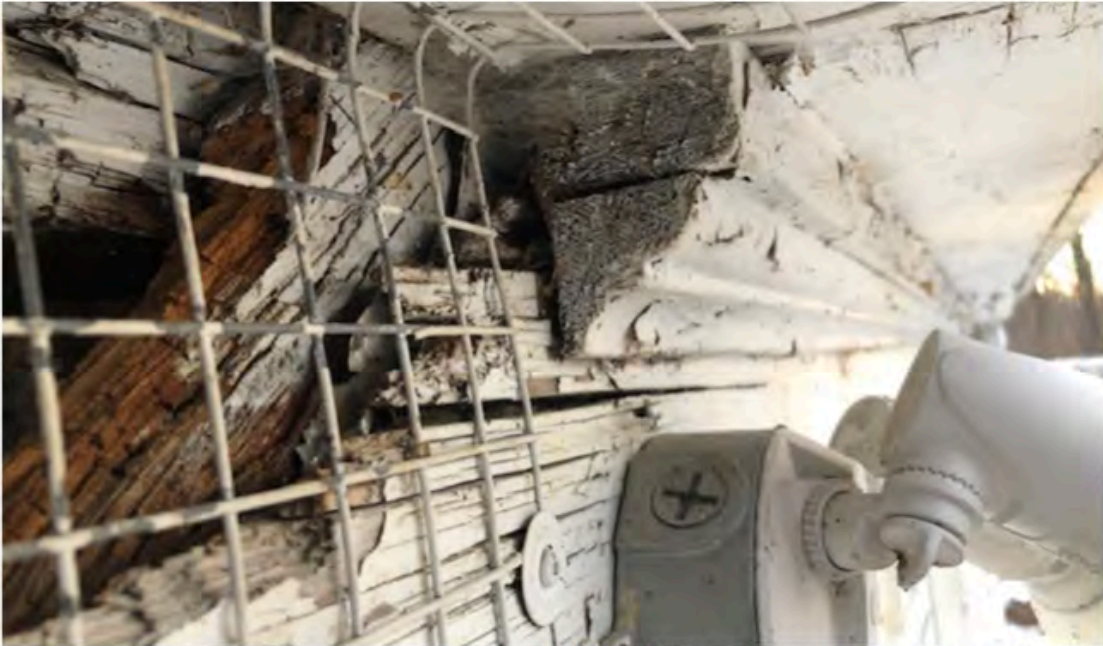
Deteriorated soffit, frieze and siding - West wing north elevation

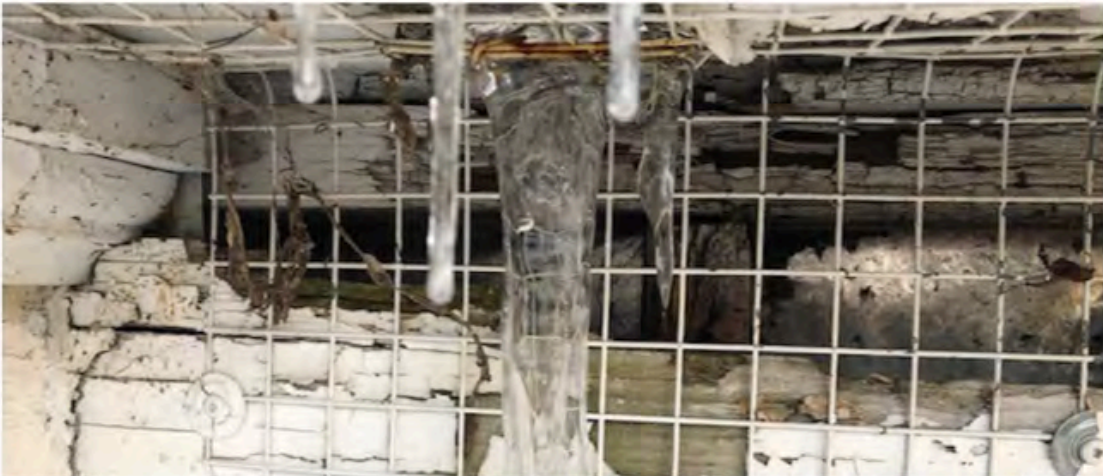
Deteriorated soffit, frieze and siding - West wing north elevation

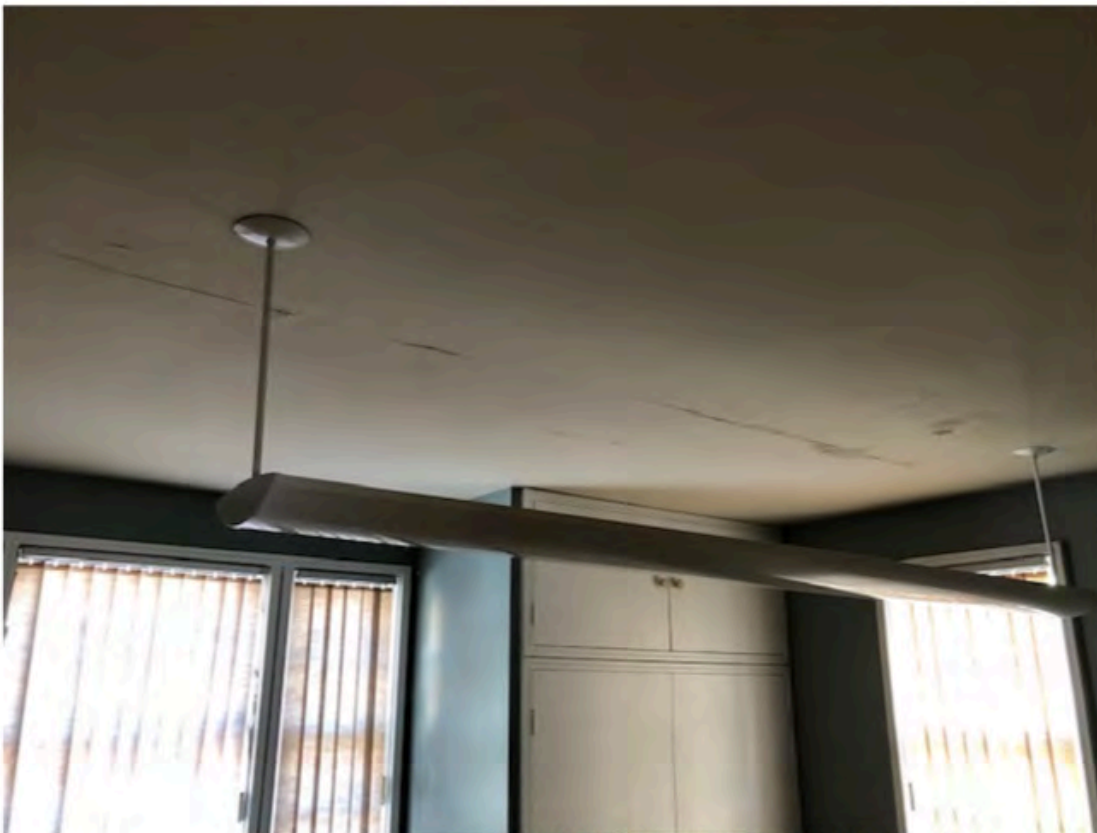
Ceiling damaged due to roof leaks - West wing office

Remove all deteriorated and delaminated plaster ceiling. Supply all required materials and install new plaster ceiling to match existing. Paint ceilings in the vestibule and offices.

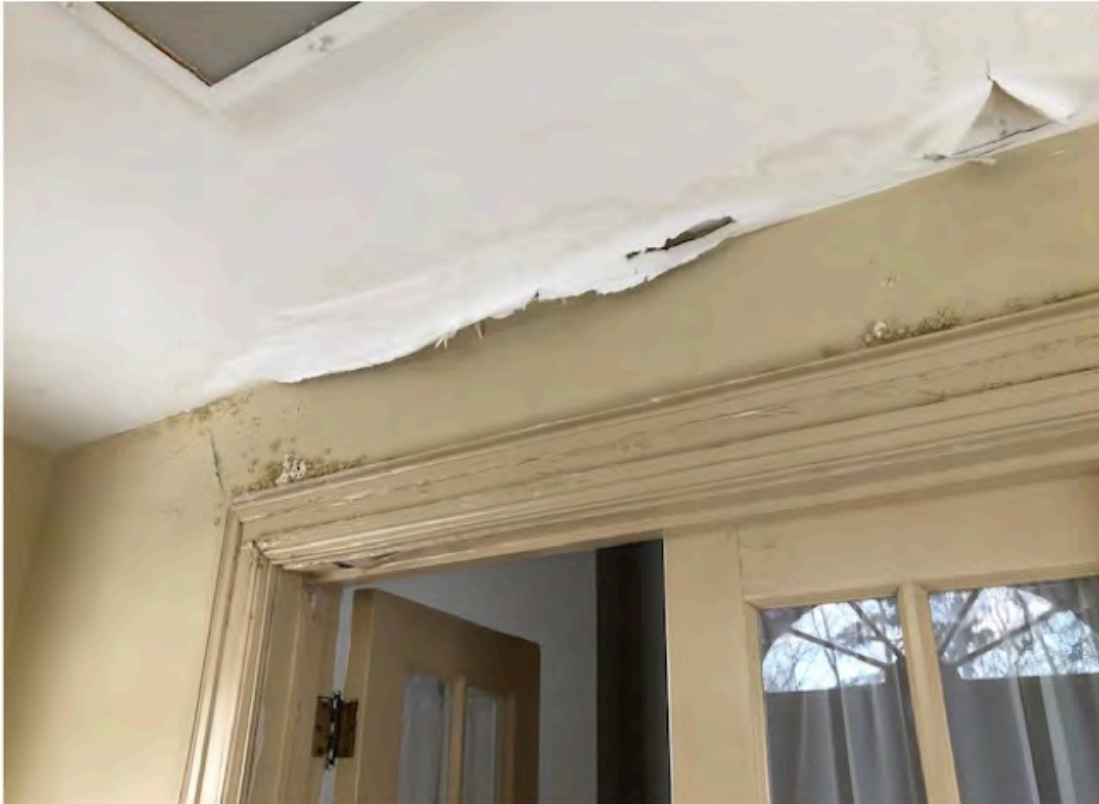
Ceiling damaged due to roof leaks - West wing office

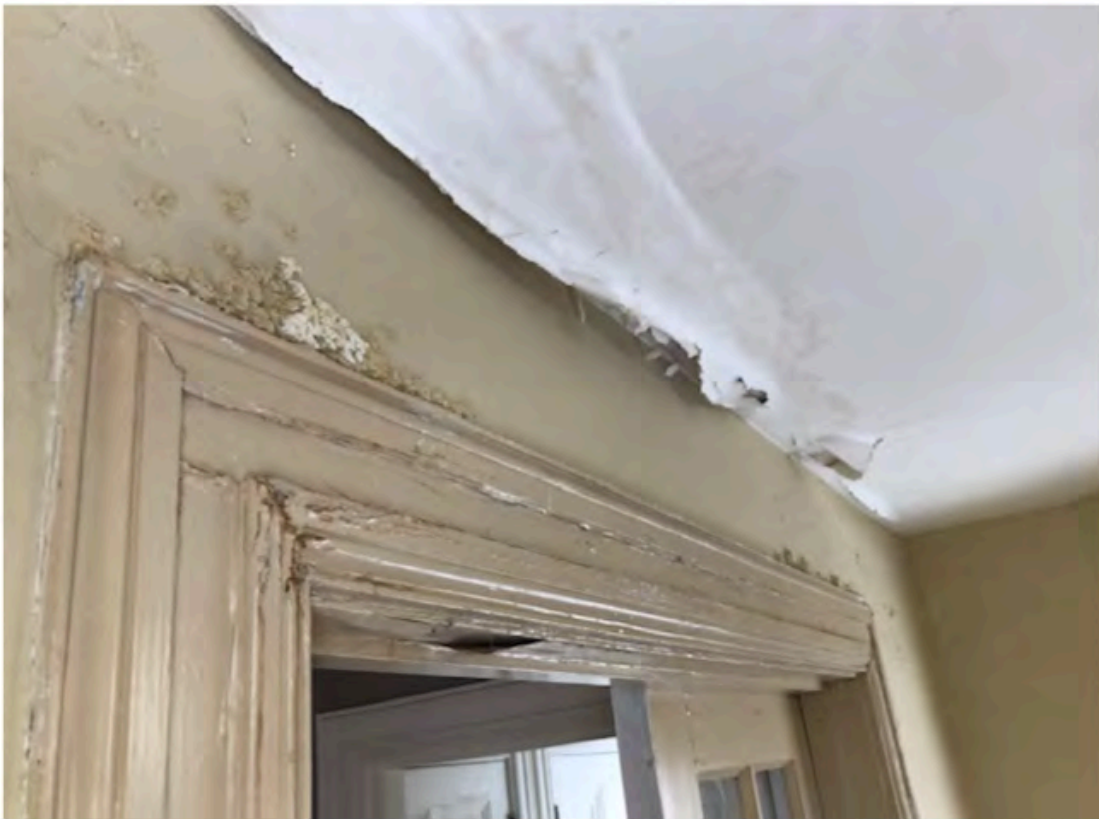
Ceiling damaged due to roof leaks - Main entrance vestibule

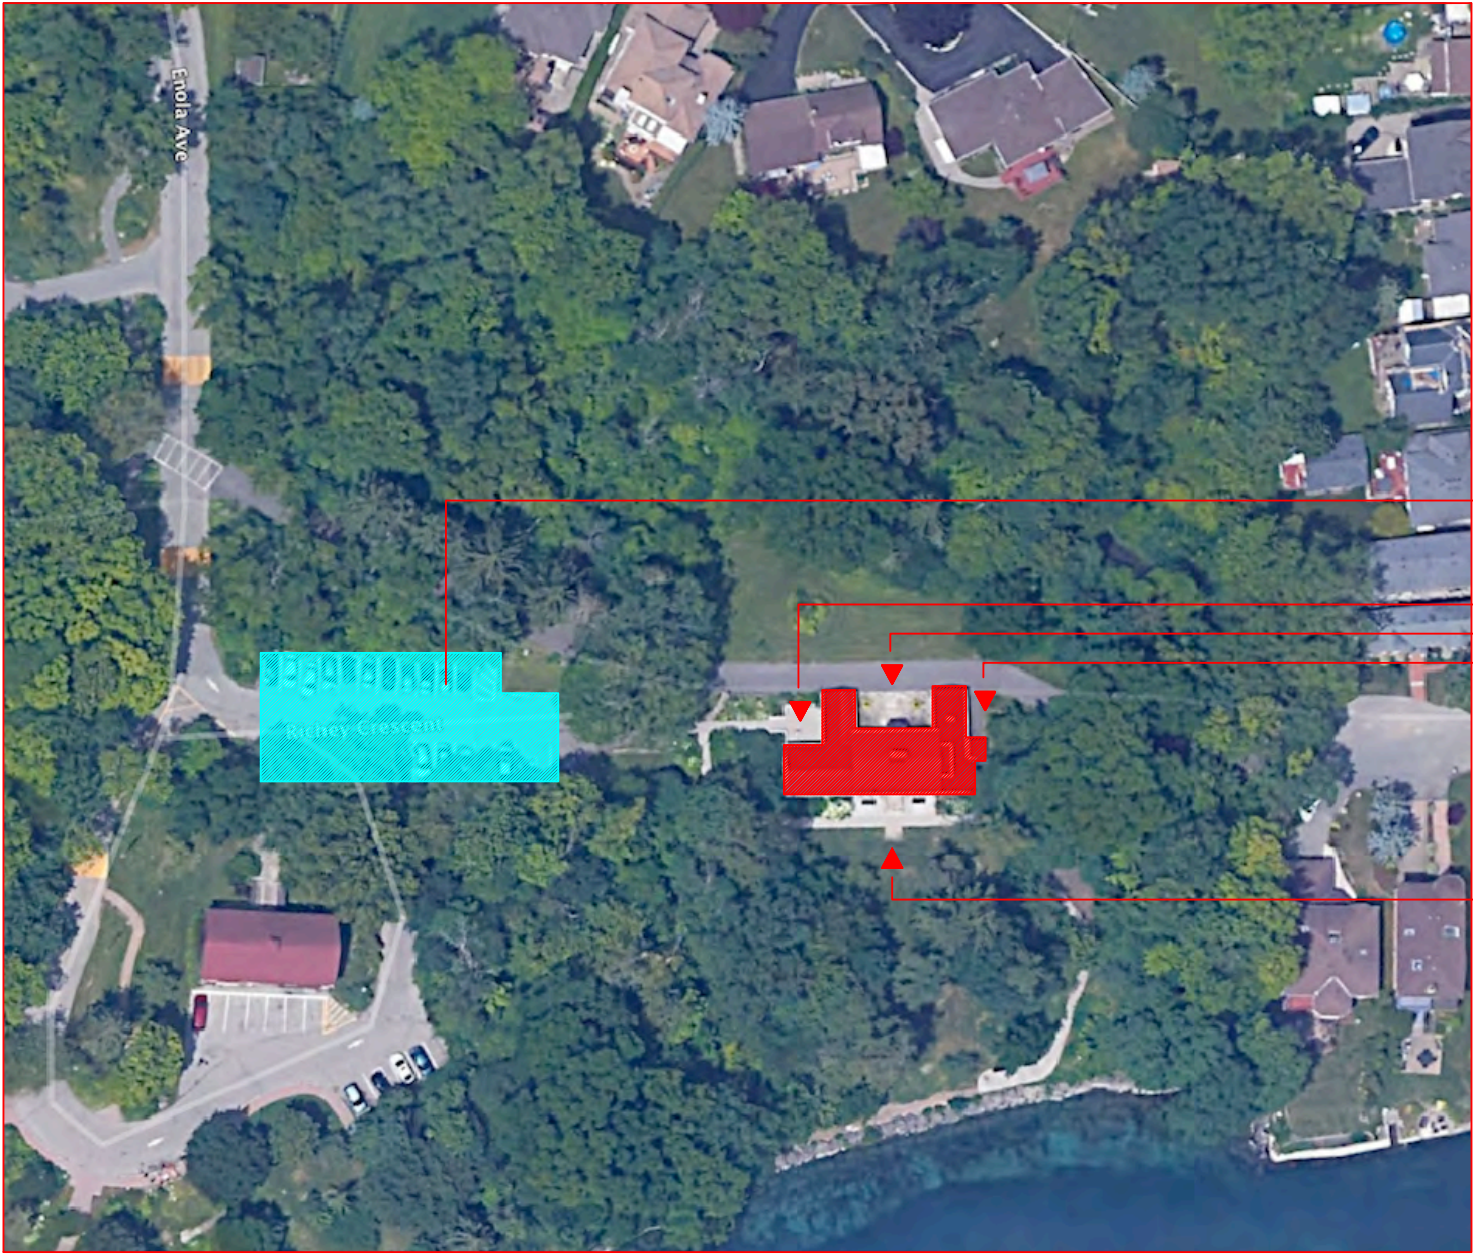
Deteriorated steel frame and door - West entrance

The hollow metal frames and doors located at the north elevation of the building were found in poor condition and require replacement. Existing hardware will be removed and reused and H.M. doors and frames will be replaced with new to match existing. Those two doors and frames as well as H.M frame and door located at the south elevation of the building will be painted to match existing.
