SUBJECT: Permit to change outer cladding and the front door

This refers to the property located at 1133 Willow Lane, Mississauga ON L5W1A1. The main house located at this property is categorized as a Heritage Property. On the same property there is an old art studio/converted barn. This application is to request further work to change the outer cladding of the entire structure and change the front door.

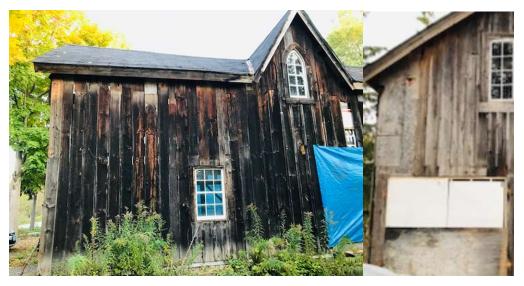
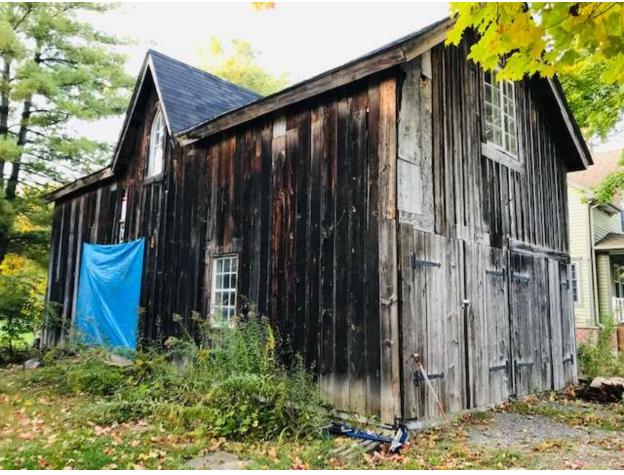
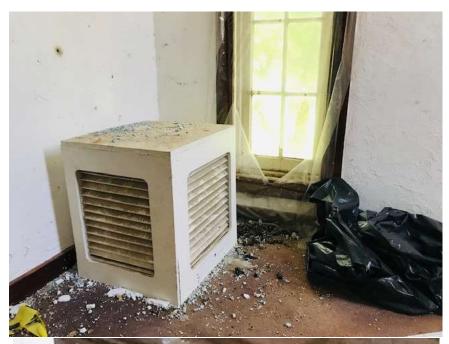
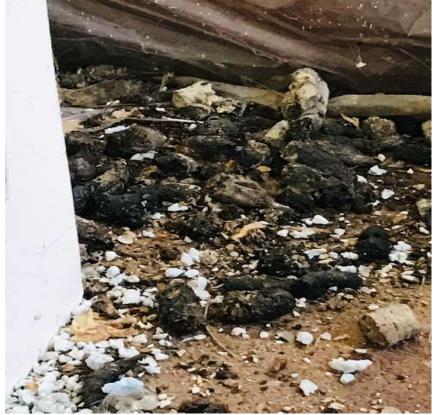
Before

During the last three years we have seen a significant decaying of the outer wooden cladding. The barn boards have rotten in several places and this has allowed squirrels and raccoons to get multiple accesses to the inside space. Though we tried to do some repair work to block a few passages the animals are able to quickly create new holes. This place has been mainly used so far to store furniture, unused electronics and tools. We even had a few incidences of thefts.

In addition to the above mentioned problem we had some serious challenges with the two large front doors. The doors were supported on two side wooden poles and over the years that support had rotten and displaced due to exposure to water and extreme temperatures. The doors were very heavy and had rotten outer layers due to weathering and lack of maintenance over the past several years.

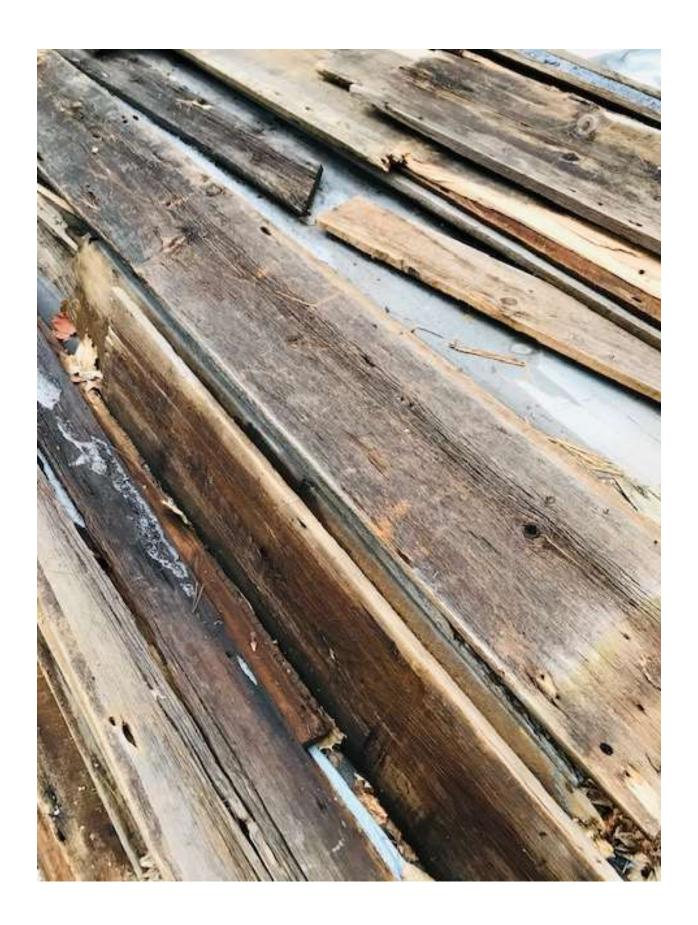
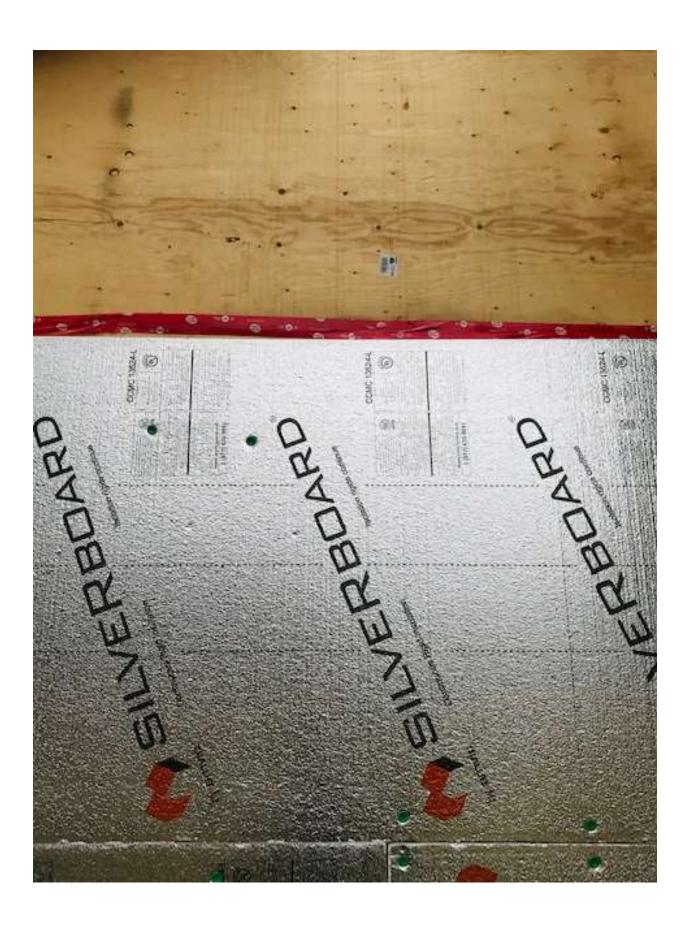
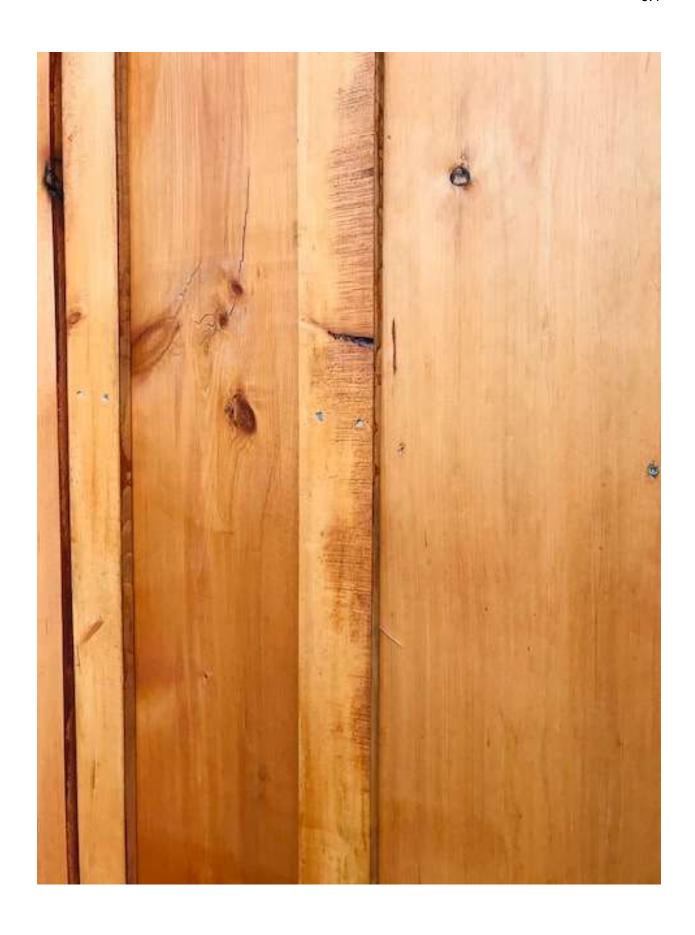
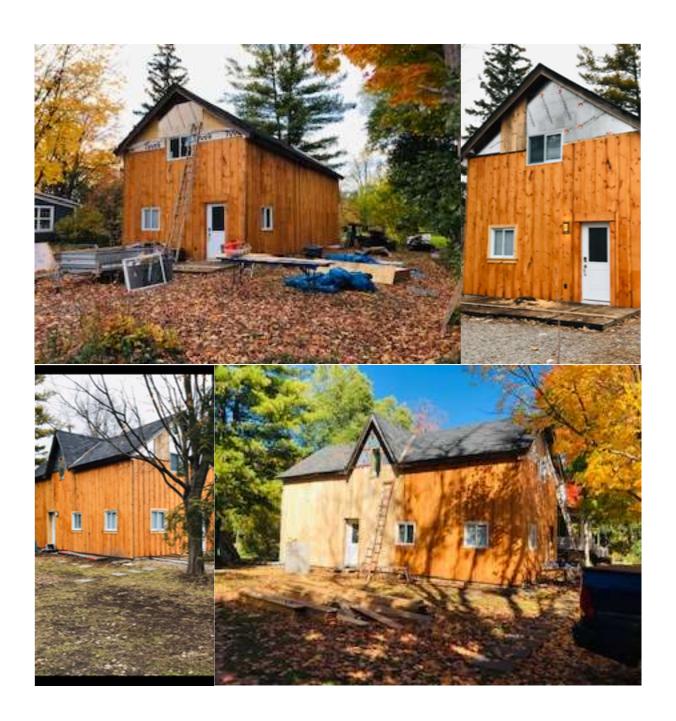
Most of the outer layer has been upgraded and the new look helps to maintain the character of the structure while improving the look of the neighborhood. I have attached a few pictures for your reference.

We had a few options to replace the barn boards with materials outlined in the Heritage guidelines. Since we wanted to make sure the guidelines are followed we opted to go ahead with the maple barn boards in sizes of 12inces and 10 inches. This is by far the most expensive option to address the problem considering the cost of barn boards, need for stronger nailing surface, labor and long term maintenance.

We opted to remove the doors and replace them with smaller openings for easier access and maintenance. The door is a standard metal entrance door and if required will be covered with wooden barn boards. The window is vinyl and will be covered with wooden outer cover, if required.
