Heritage Conservation Management Plan  
Adamson Estate Barn, 875 Enola Avenue, Mississauga

**Heritage Conservation Management Plan – Roof assembly, Second Floor Exterior Wall and Ground Floor Exterior Wall repairs at the Adamson Estate Barn located at 875 Enola Avenue, Mississauga Ontario**

Building structural review

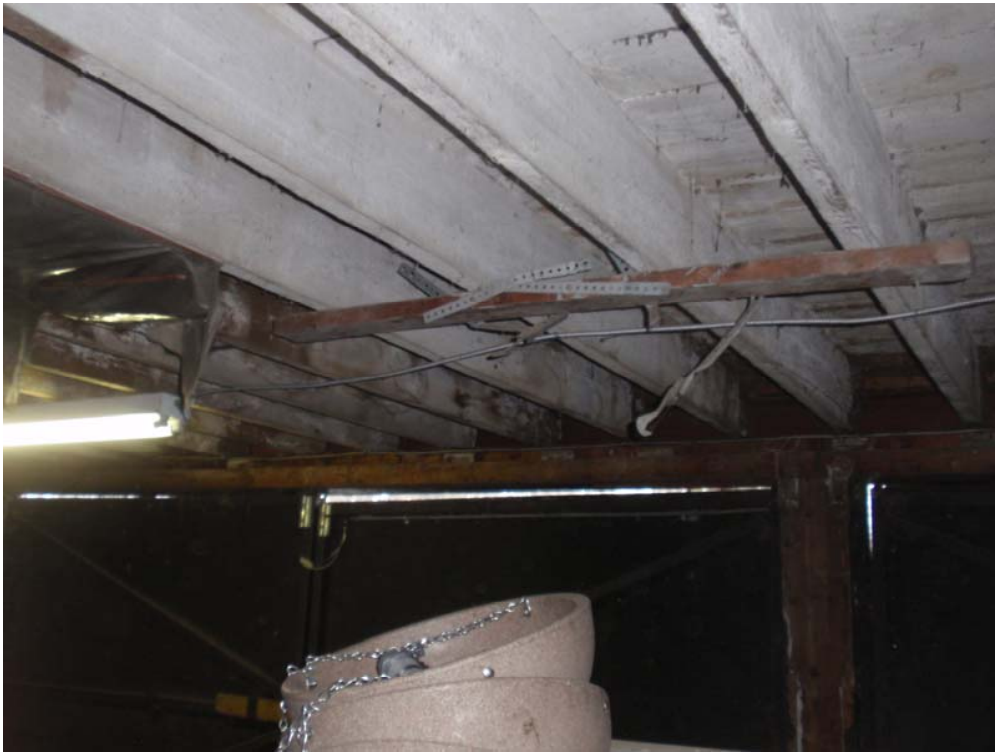
The floor joists, in our opinion, are in acceptable condition, though there was a noticeable deflection at the north bay. We checked the existing joists with mechanical equipment occupancy load of 75psf (3.6 KPa), and in our opinion, the south bay of joists is acceptable, and the north bay joists require reinforcement.

**South Bay of Ground Floor Framing (2x10)**

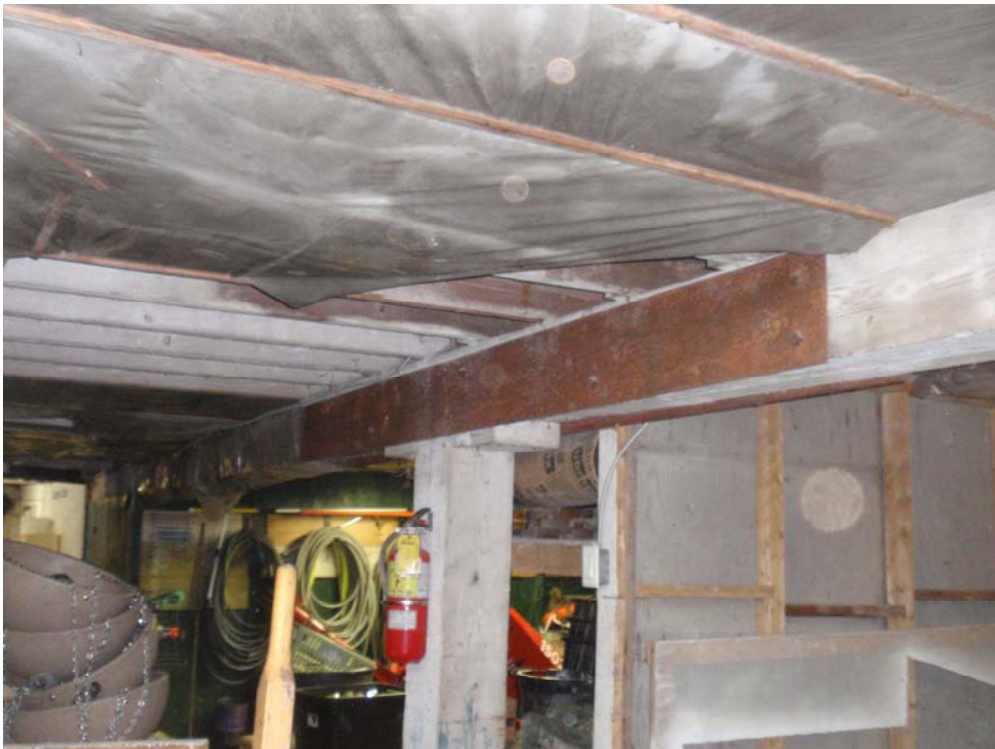
The wood beam shows significant deflection. We also found at least one area of decay and crack that suggest the beam failure.

**Reinforced Beam of Ground Floor Framing**

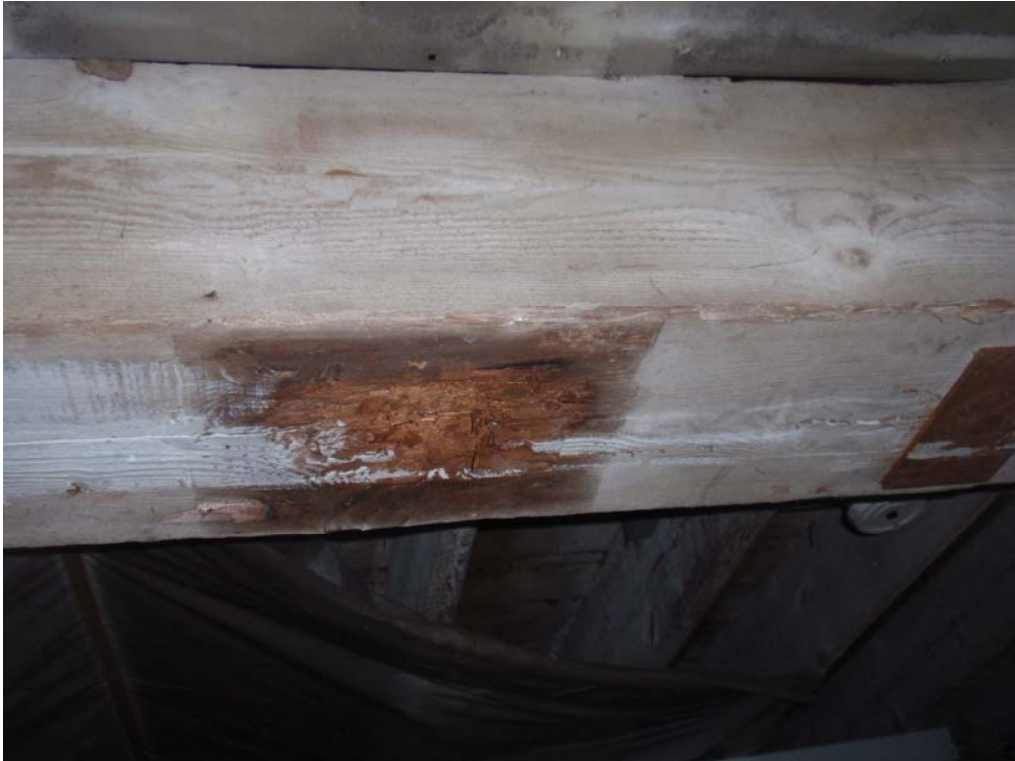
We checked the existing beam with mechanical equipment occupancy load of 75psf (3.6 KPa), and in our opinion, the beam fails. **In our opinion, the existing condition is not safe! We recommend installing temporary shoring immediately.**

**Decayed Area of Ground Floor Framing Beam**

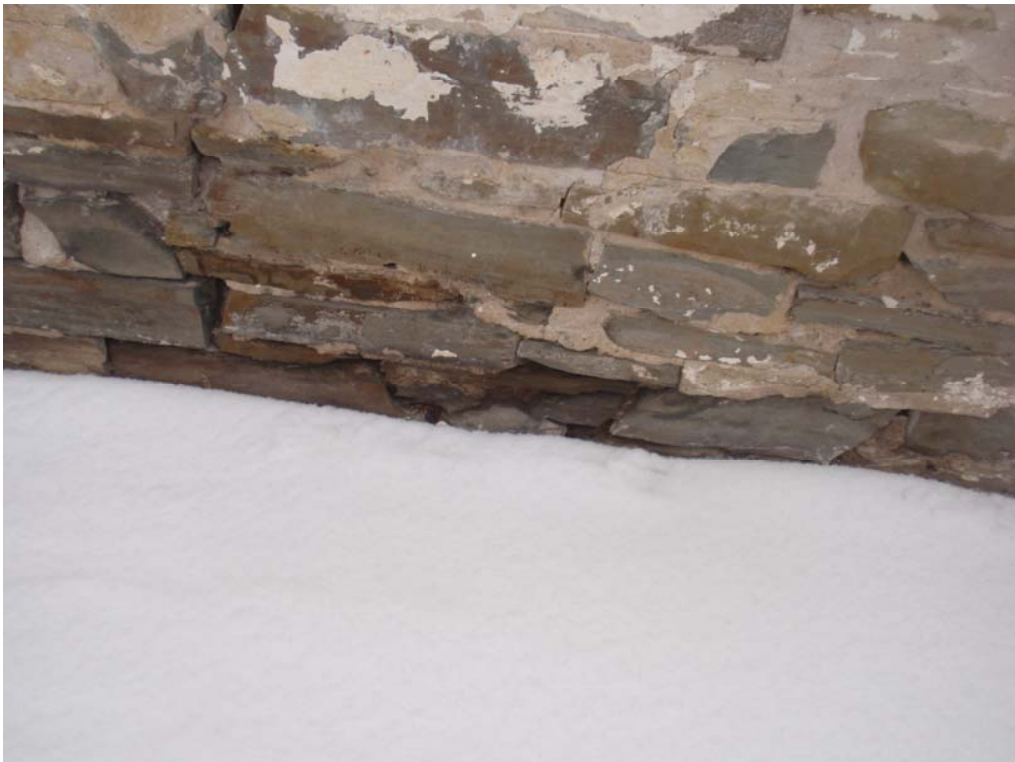
We noted many areas of empty, loose or cracked mortar joints in the rubble stone walls. In our opinion, they require re-pointing.

**Exterior Wall To Be Re-pointed**

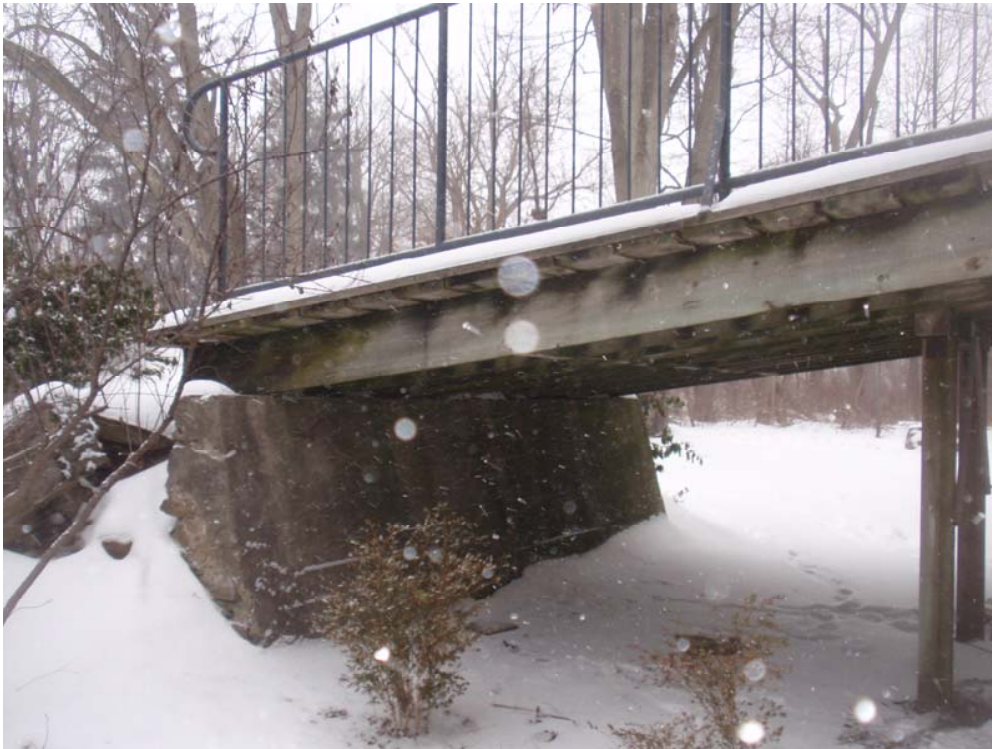
We checked the existing ramp with exit bridge load of 100psf (4.8 KPa), and in our opinion, it is not adequate and requires reinforcement or replacement.

**North Portion of the Ramp**

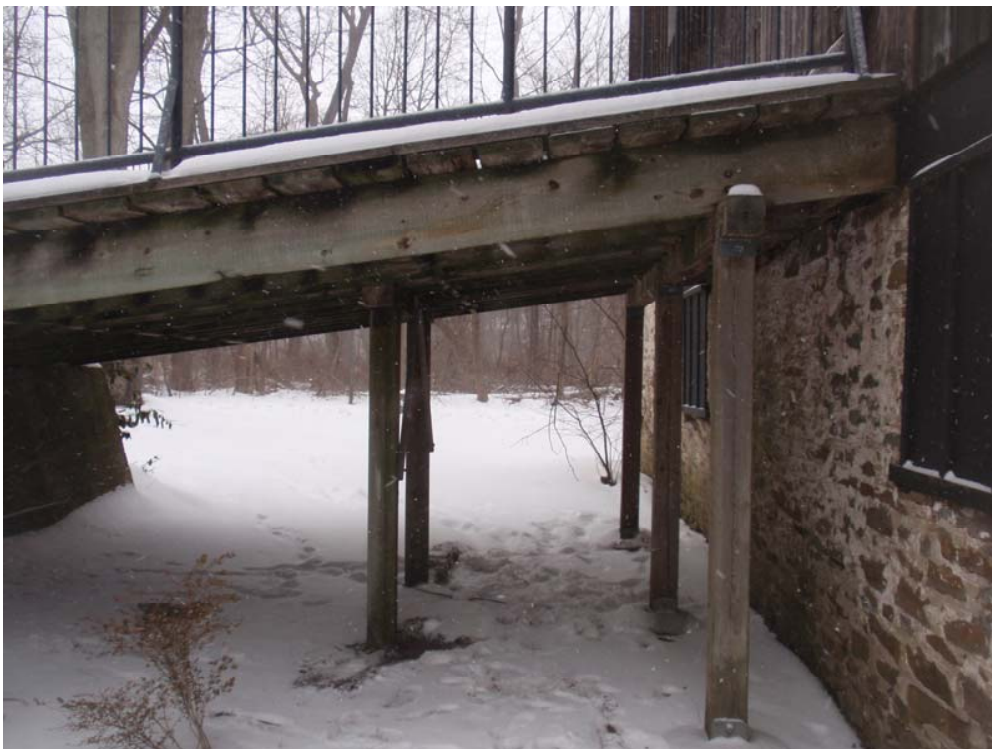
**South Portion of the Ramp**

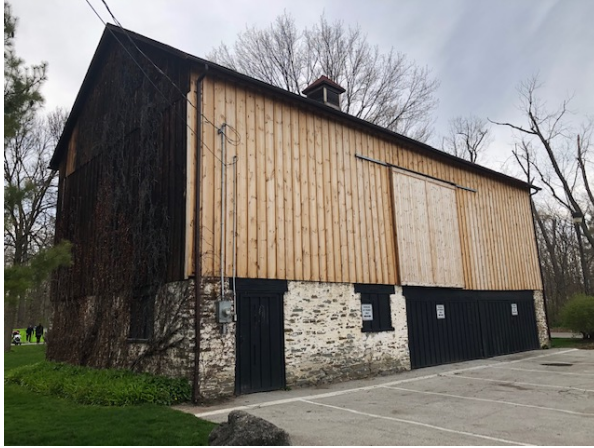
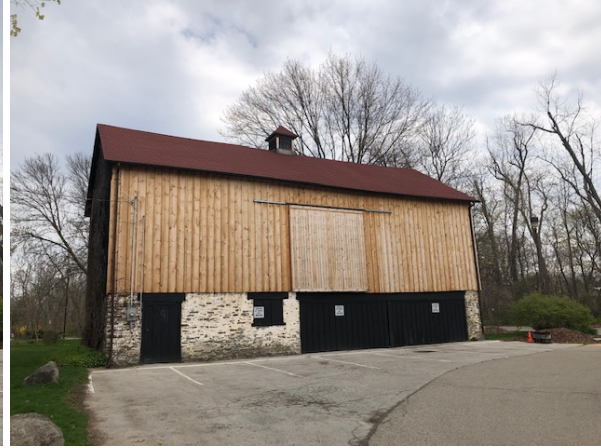
Images of southwest & south elevation – previously replaced boards and battens at south elevation

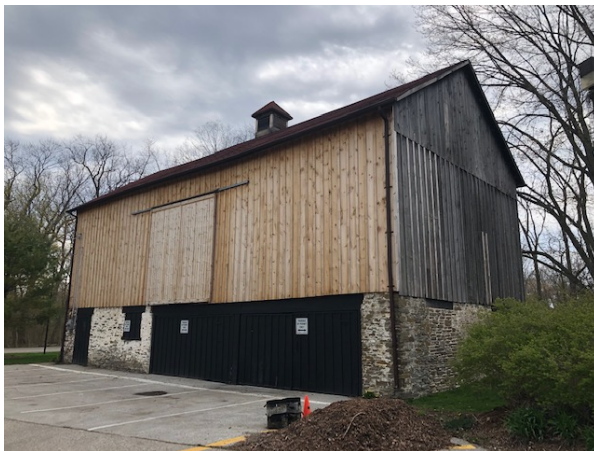
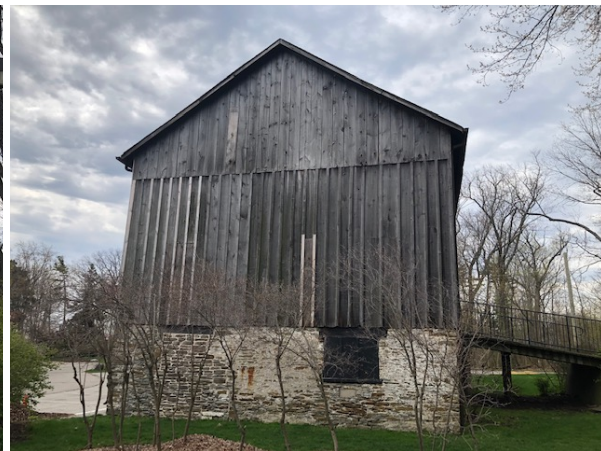
Images of southeast & east elevation – previously replaced boards and battens at south elevation

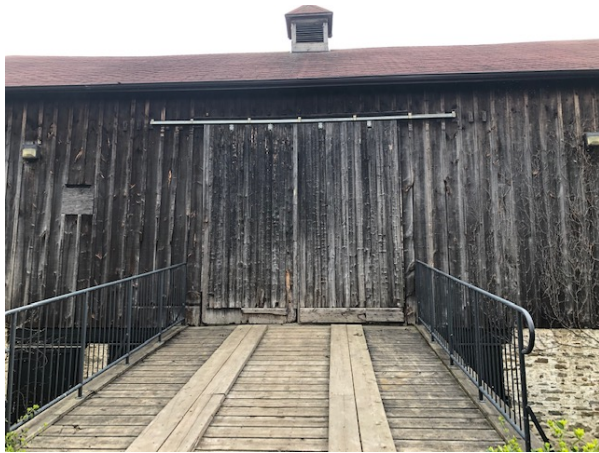
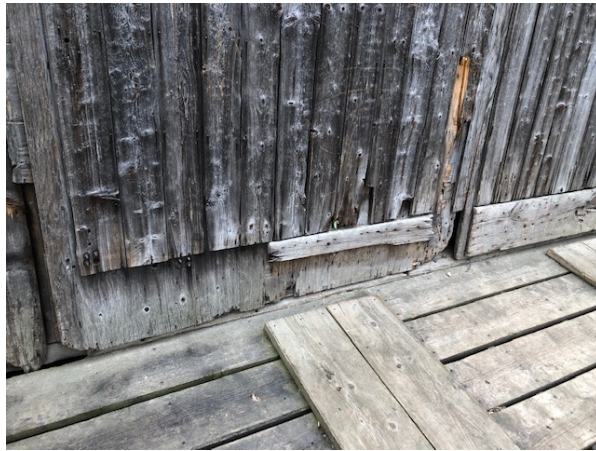
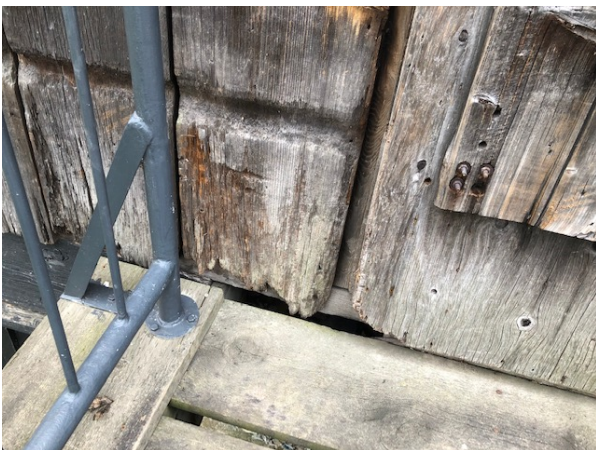
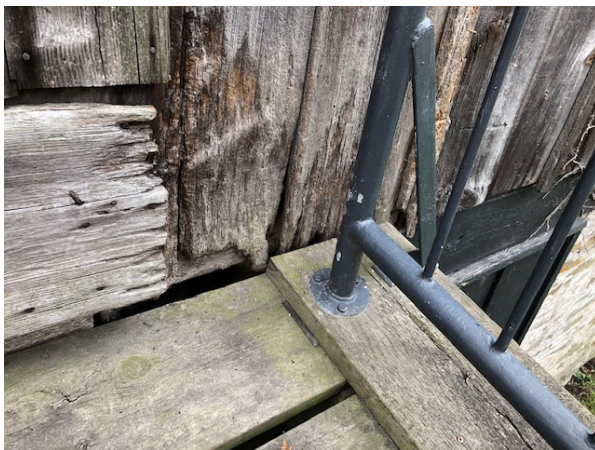
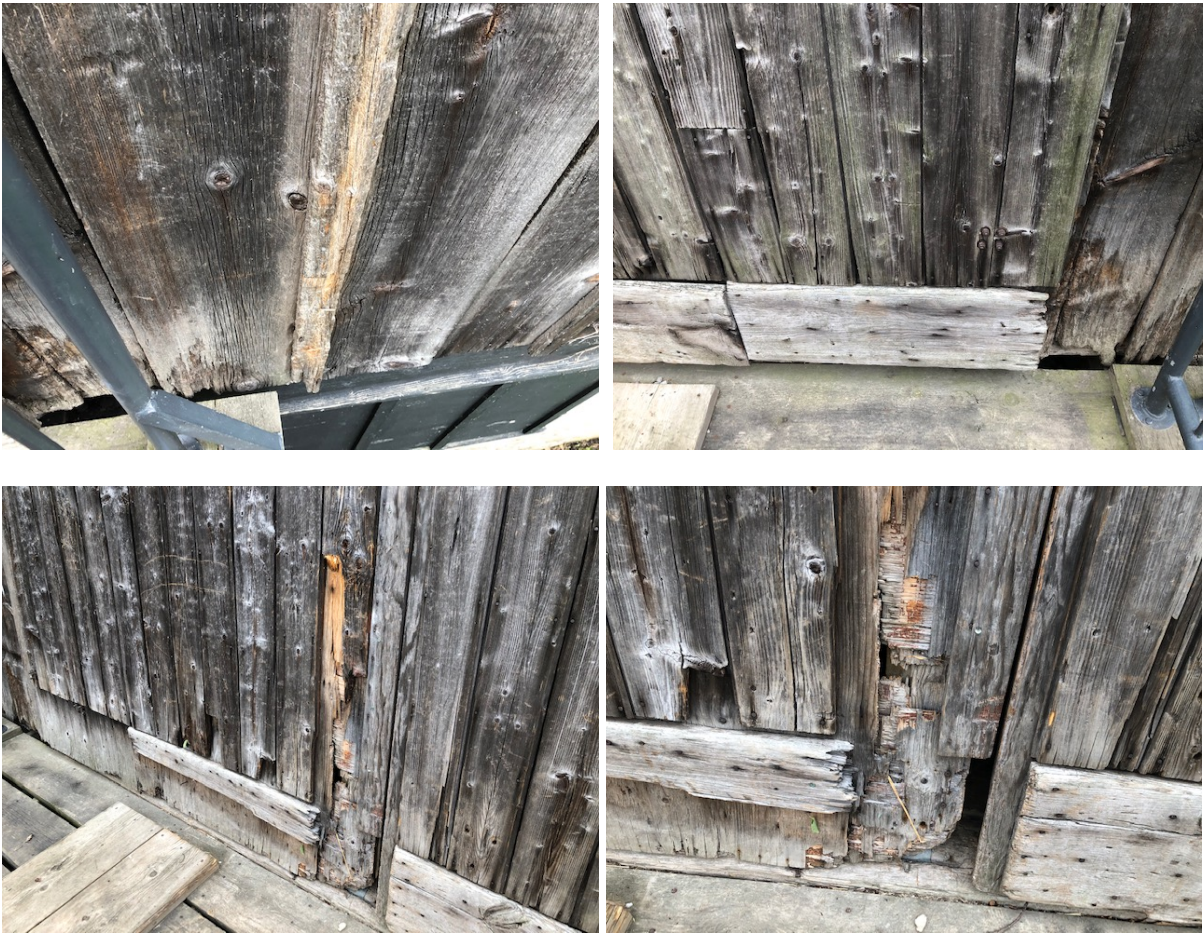
Images of typical deterioration found at the barn door located at the north elevation

Existing wood door will be repaired. All rotten boards will be removed and replaced with new. Door structural components that are found in fair or good condition would remain. Existing hardware will be reused and missing components replaced with new to match existing and those used at the new south elevation door.

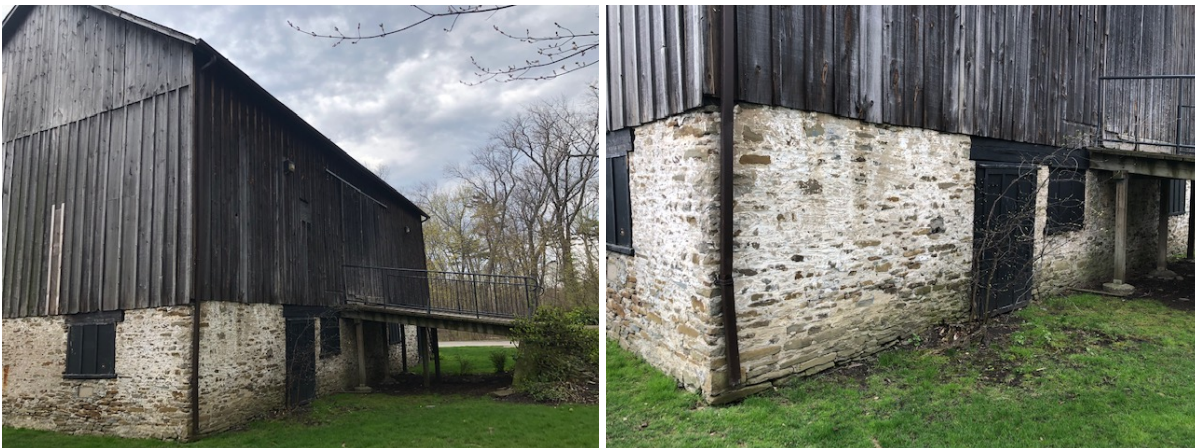
Wall siding has deteriorated beyond repairs at the east, north and west elevations. We propose to replace the deteriorated wood boards and battens with new to match south elevation boards and battens previously replaced.

Images of typical board and batten deterioration found

Upper floor exterior wall wood frame structure will remain. Existing deteriorated boards and battens would be replaced with new to match existing and those previously replaced at the south elevation.

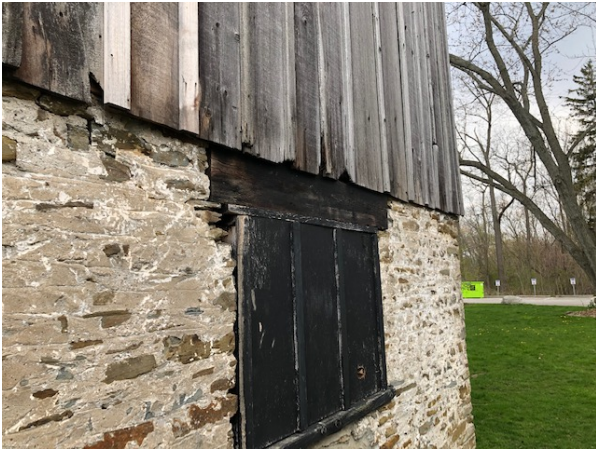
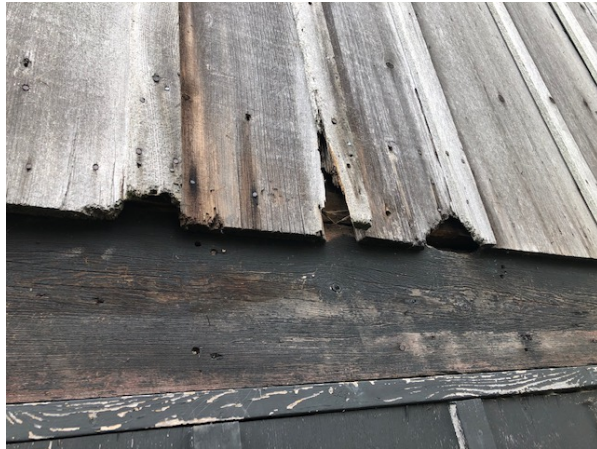
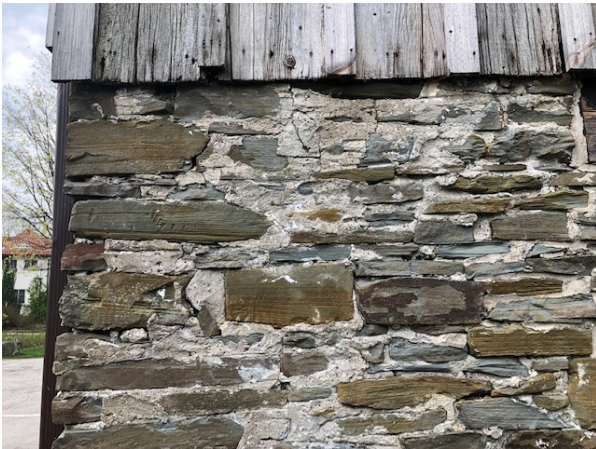
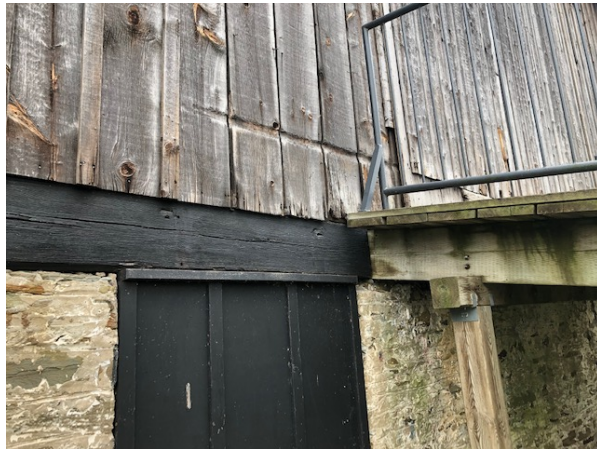
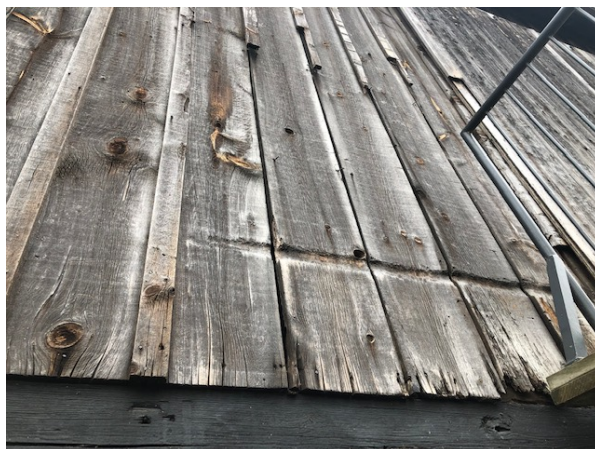
Images of typical board and batten deterioration found

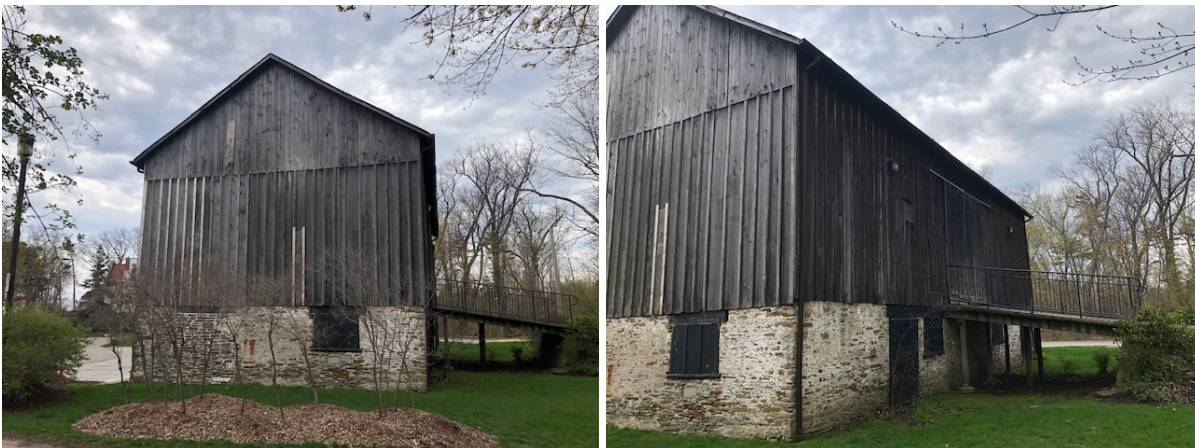
Mortar joints at the exterior side of the ground floor rubble walls were found in poor condition where joints were empty, loose or cracked.

Images of typical mortar joints deterioration found

Area where the mortar joints are deteriorated and damaged will be removed. New mortar joints will match existing. The surface of the exterior wall will be painted to match existing.

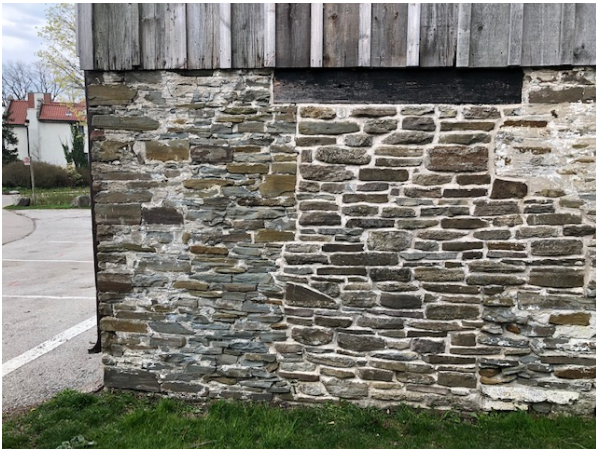
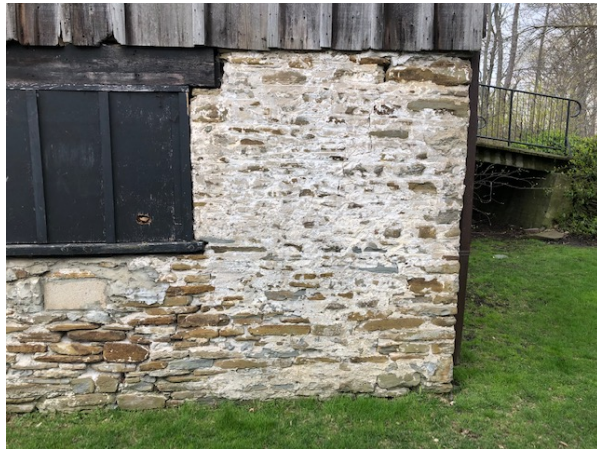
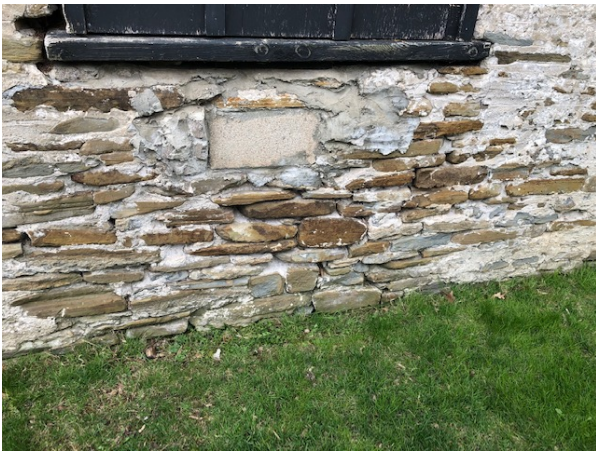
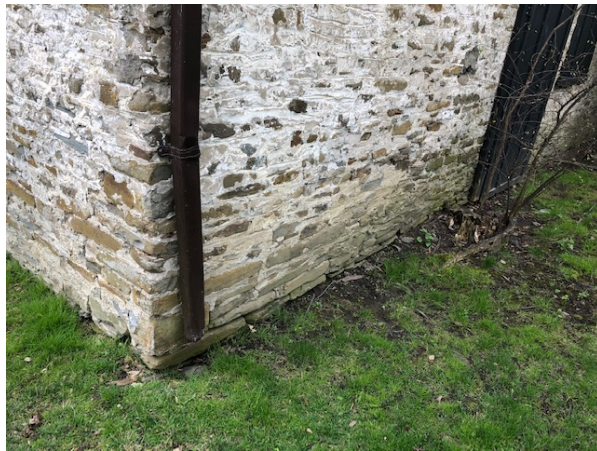
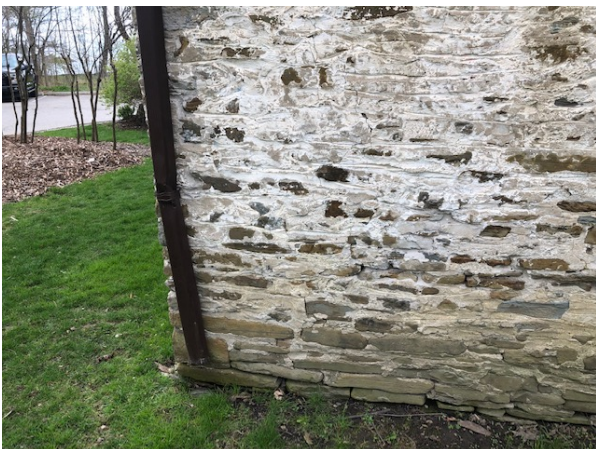
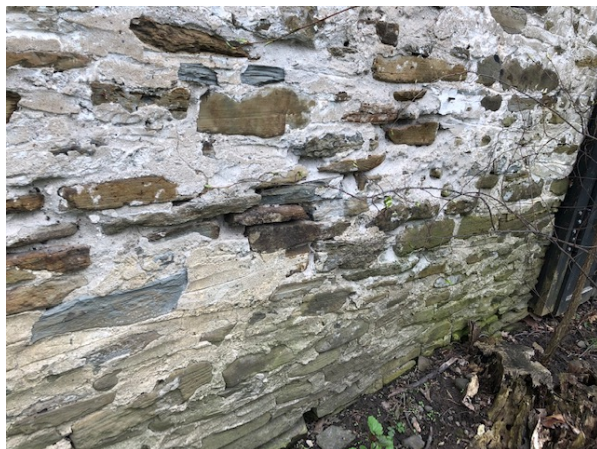
Images of typical mortar joints deterioration found at the east and north elevation

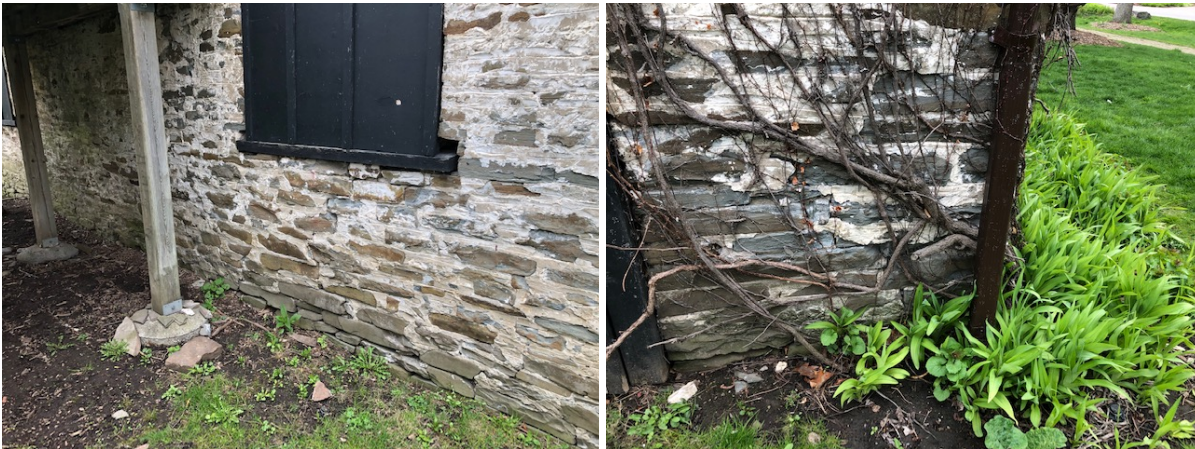
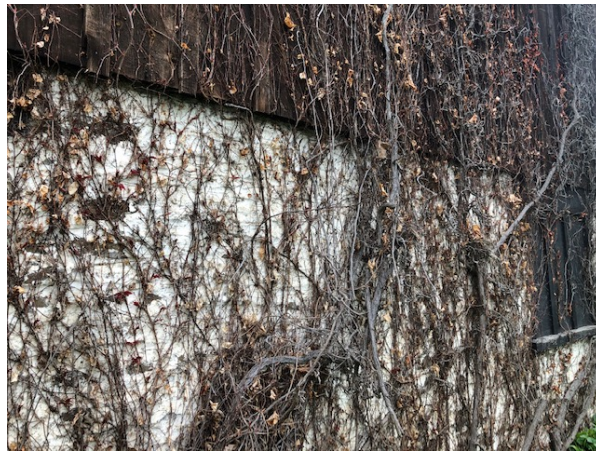
Images of typical mortar joints deterioration found at the north and west elevation

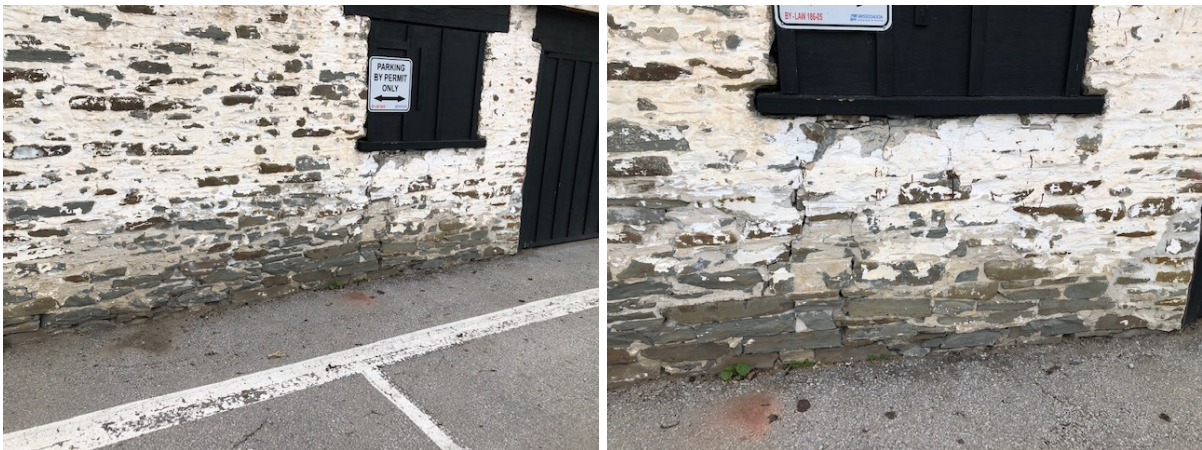
Images of typical mortar joints deterioration found at the south elevation

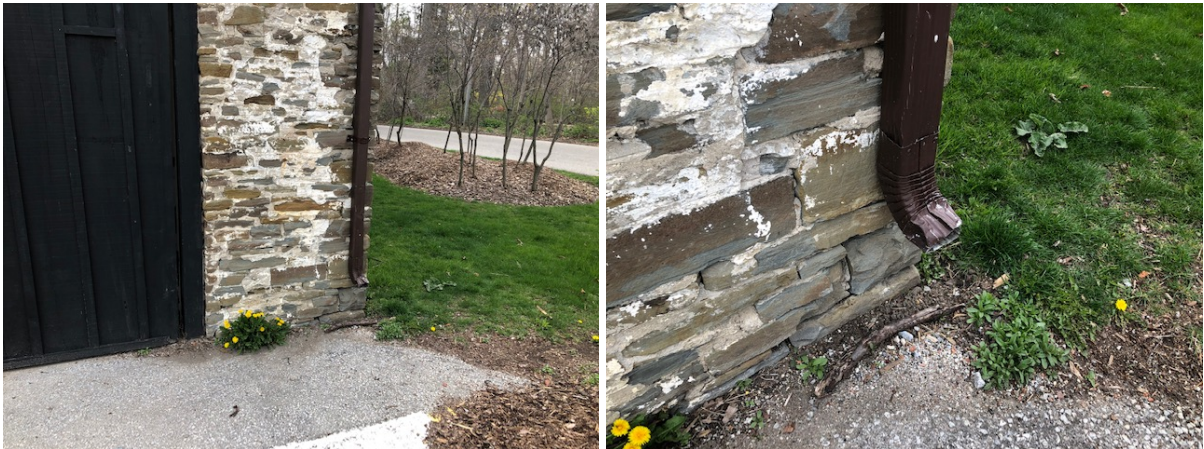
Images of typical mortar joints deterioration found at the south elevation
