Re: **Engineering Inspection of Fire Damage to a Residential Structure**

Date of Loss: December 29, 2020

Loss Location: 40 Peter St. S., Mississauga, ON

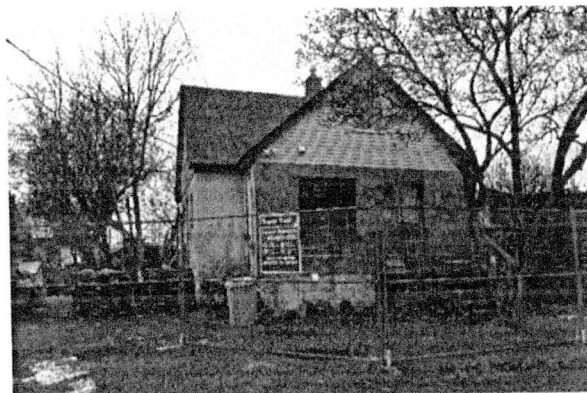
Based on our evaluation conducted to date, the subject fire loss occurrence resulted in localized fire loss related structural damage to the second level floor system and the staircase service this space, as well as at interior and exterior wall framing components. The roof system above the direct area of the fire and heat penetration / break through (i.e., from the first level washroom situated within the middle third of the residence, adjacent the rear / south exterior wall system) has also sustained structural damage. Evidence of smoke migration and deposition at several locations throughout (and within) the building enclosure was confirmed. Moisture related damage to the interior finish and underlying building materials were also observed within the residence.

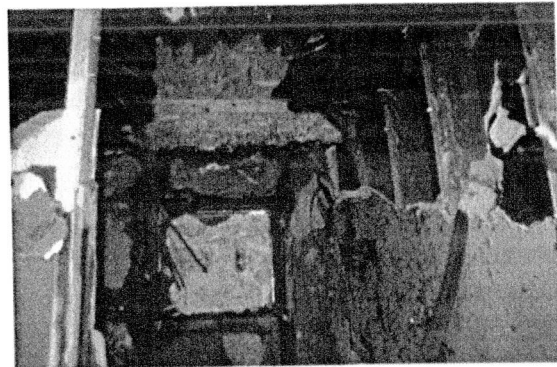
1. Fire loss related structural damages were primarily concentrated to the southern extents of the building and within the middle third of the residence, at framing members exposed to fire and heat migration. Interior and exterior wall framing items, and the second floor frame (as well as the stairs) sustained the majority of damages. The roof may have suffered some minor structural impairment.

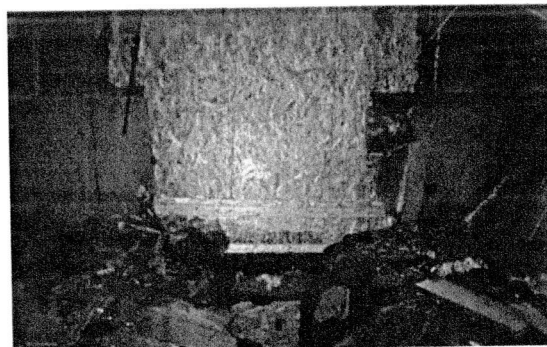
2. To date, structural impairment caused by the subject fire loss occurrence was noted at roughly ten (10) 2x8" second floor joists running the full depth of the building (i.e. within the north / front and south / rear spans); the underlying load bearing and non-load bearing interior partition wall frames; the staircase serving the second level; the rear / south exterior wall system at the second level; and the sill plate at the first level two wythe solid masonry exterior wall assembly;
