Heritage Property Application

Heritage Management Conservation Plan

Baird Sampson Neuert Architects (BSN) was engaged by the City of Mississauga to provide complete consulting and design services for Streetsville Kinsmen Hall, located at 327 Queen Street South, Mississauga, ON. The focus of BSN's services includes the conservation and repair of the deteriorated brick masonry on all building elevations, wood soffit refurbishment and repair, refurbishment of wood windows and doors, replacement of deteriorated hollow metal doors, asphalt roof replacement, removal of visible conduits and mechanical penetrations on the façades. Other work includes the replacement of a canopy and deteriorated ramp/stair system, all related to the rear entry (facing the parking lot), and the provision/upgrade of exterior lighting.

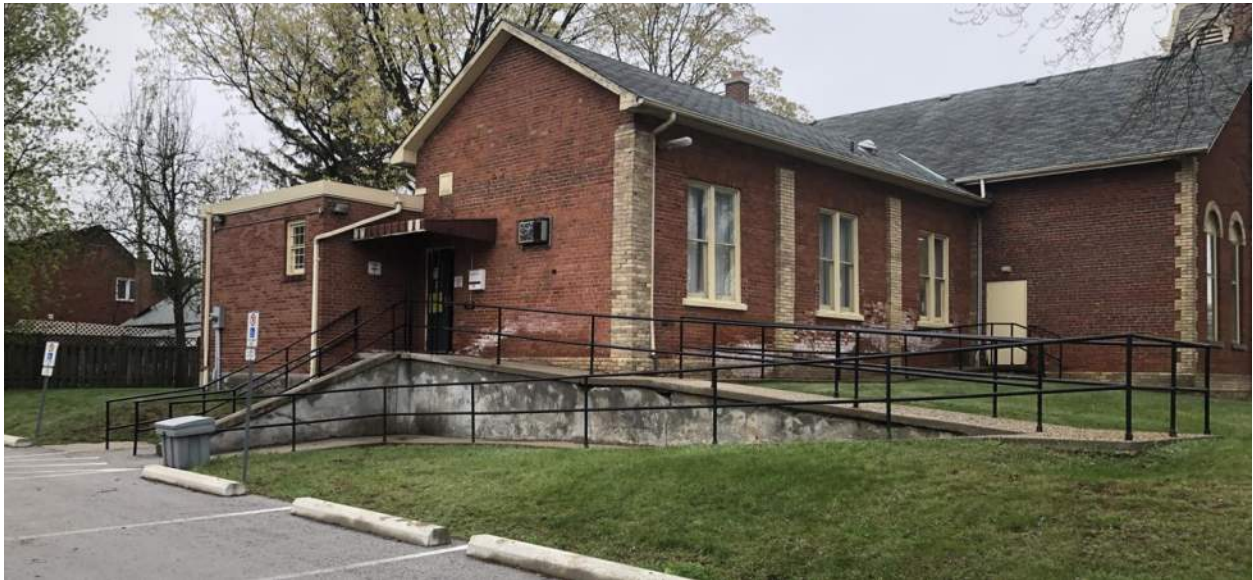
Existing ramp conditions

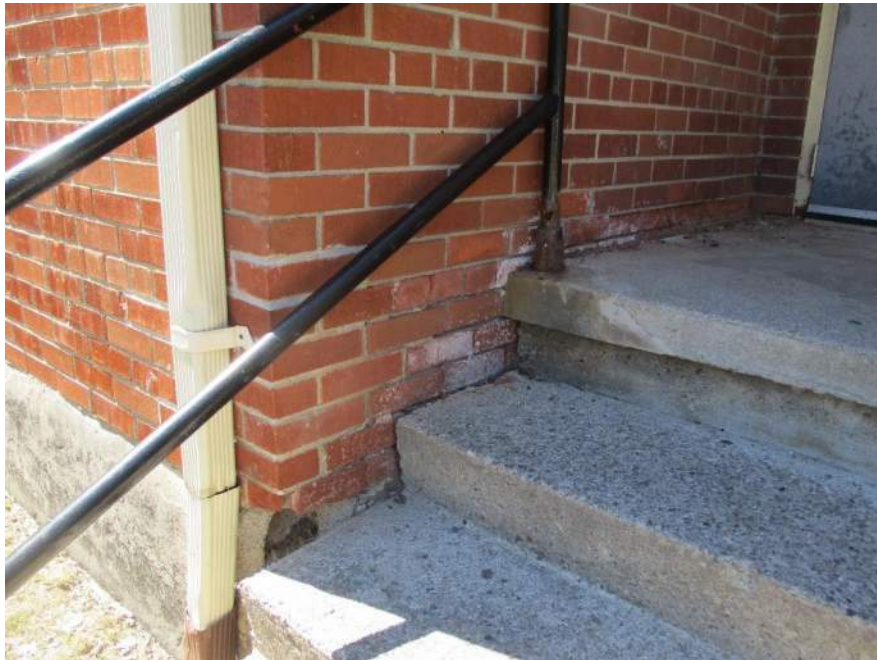
Photo # 6: Typical Masonry Brick and mortar deterioration at the eastern staircase.

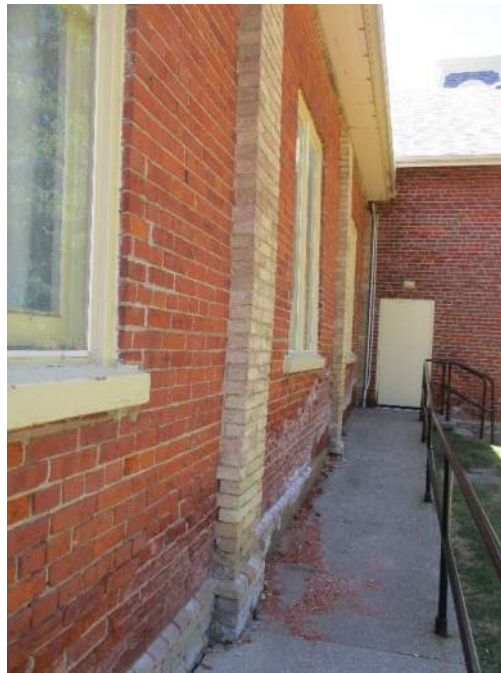
Photo # 7: Overview of spalling brick and efflorescence at the north elevation (original building, facing west).

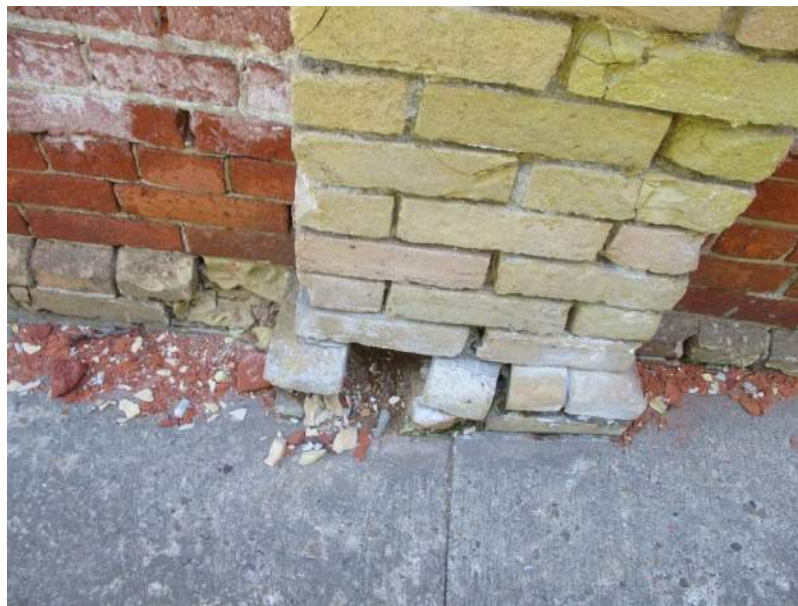
Photo # 8: Close up view of masonry and mortar deterioration at a column at the north elevation (original building).

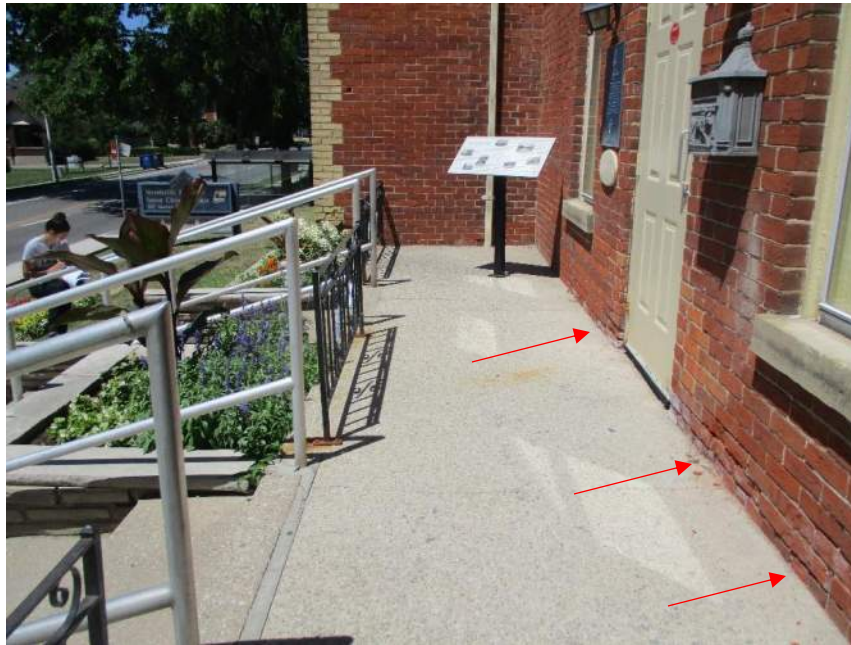
Photo # 9: View of mortar deterioration at the grade level of the west elevation (west addition).

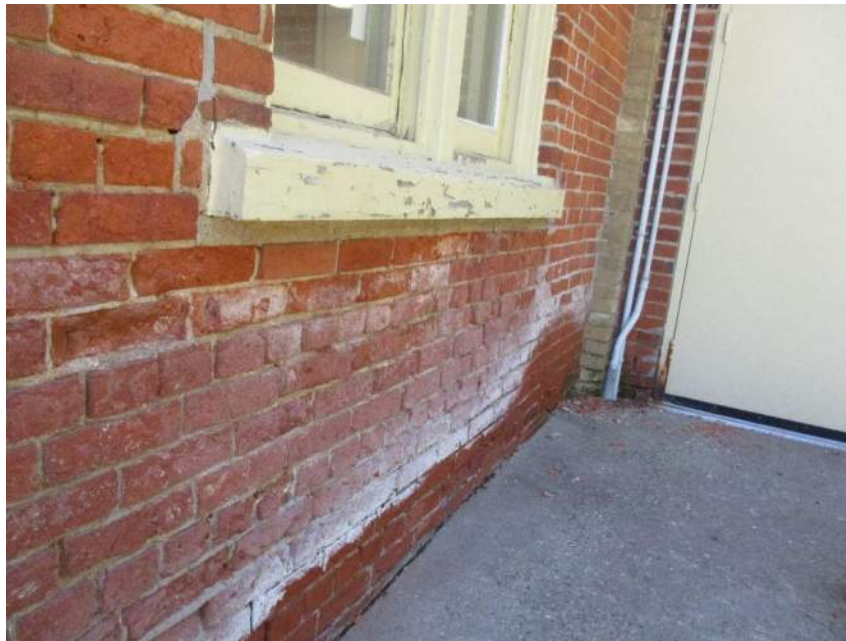
Photo # 10: White staining (efflorescence) was observed to be concentrated approximately 12 inches above grade level at the north and east elevations (original building).

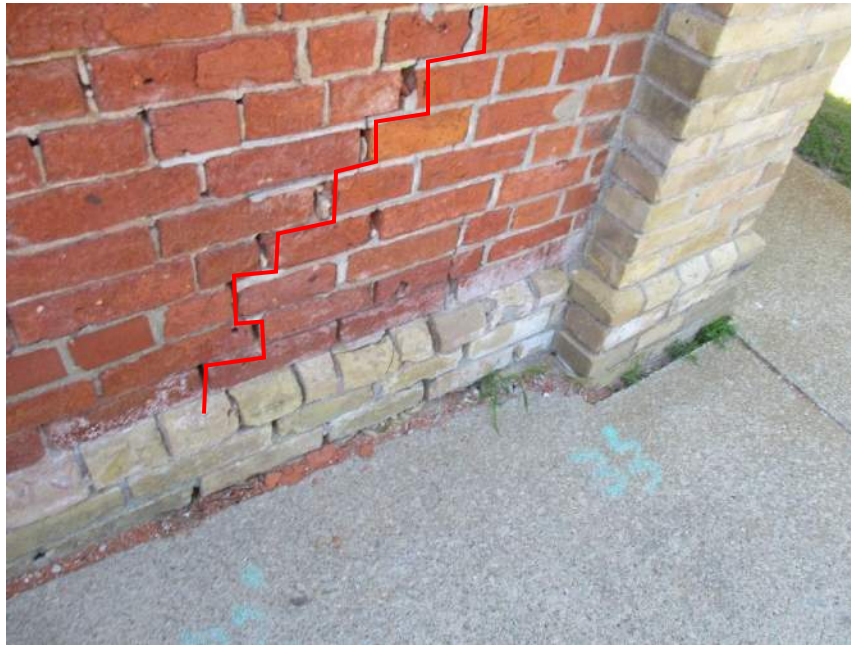
Photo # 13: View of step crack continuing through masonry brick at east elevation and mortar deterioration.

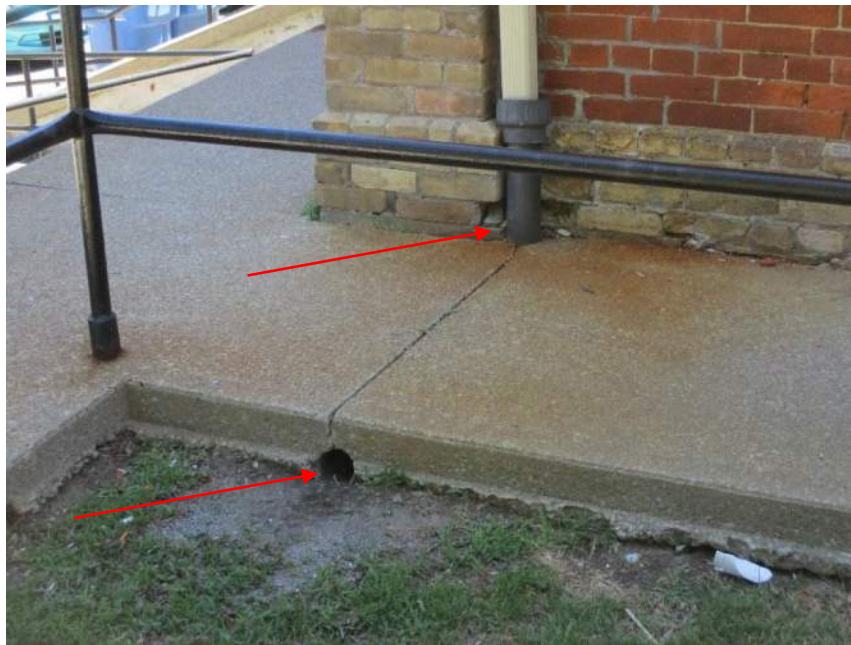
Photo # 14: A rain water leader was observed to be present next to the north-east corner pilaster at the north elevation and appeared to run underneath the access ramp.

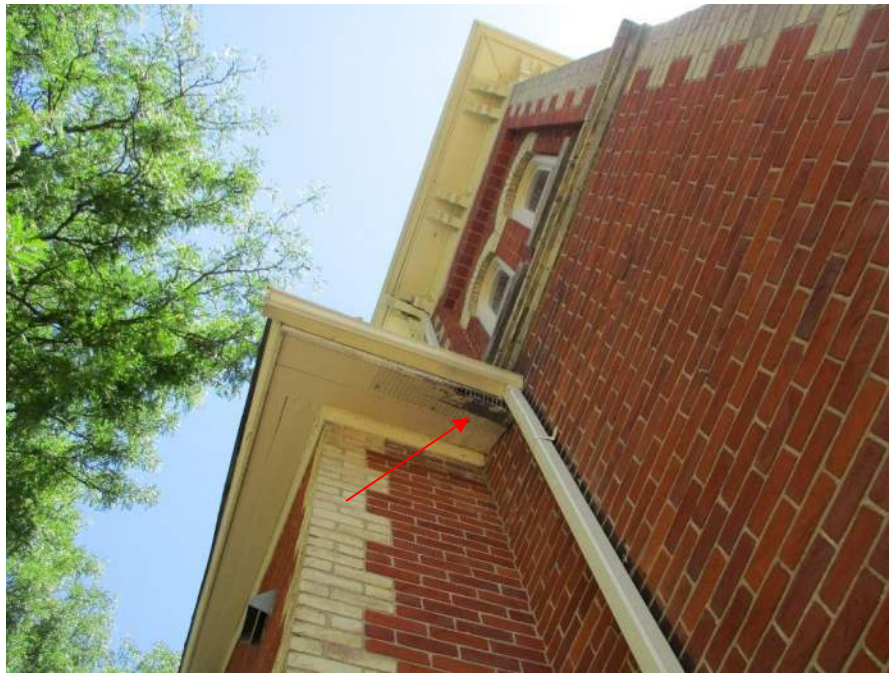
Photo #15: Typical view of localized area of soffit deterioration at the north elevation (west addition).

The soffit work will be localized and will focus on the repair of areas that have been damaged by rodents and weather decay. Once the damaged boards are replaced, all soffits and fascia boards will be refurbished and repainted to match existing.

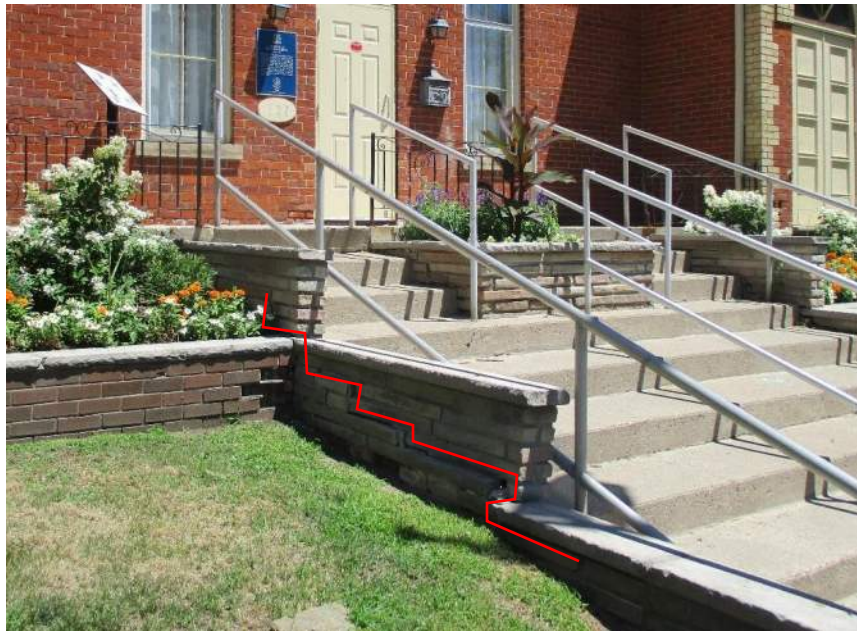
Photo # 16: View of displaced/cracking northern brick masonry low landscaping wall at the west elevation main entrance.

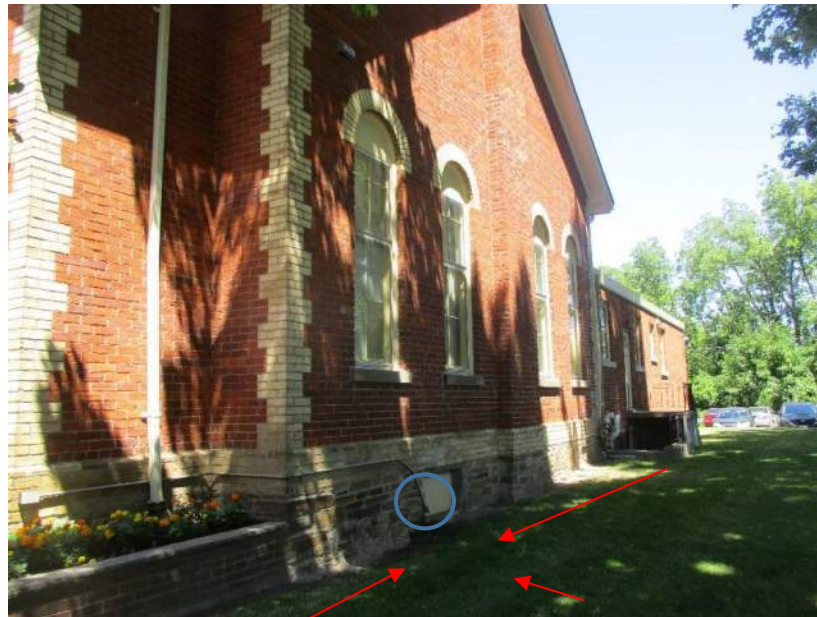
Photo # 17: View of a potential negative drainage at the west end of the south elevation. The direction of the approximate ground slope is shown with a red arrow, and the location of a leaking water tap is shown in blue.

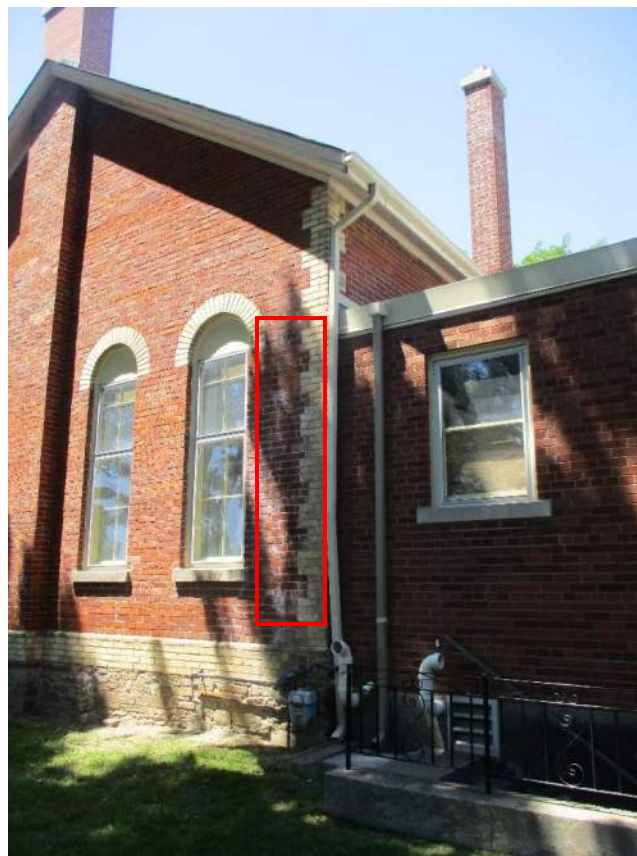
Photo # 18: View of efflorescence observed on the south elevation (west addition).

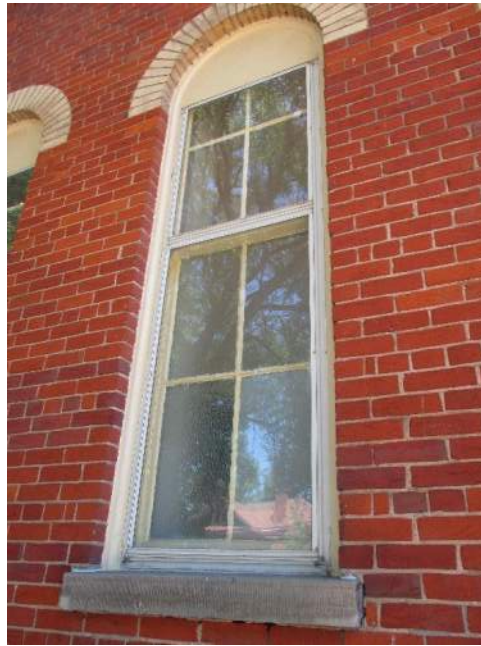
Photo # 19: View of typical single hung wood framed window with masonry arches and exterior aluminum framed storm windows at the exterior (south elevation of west addition).

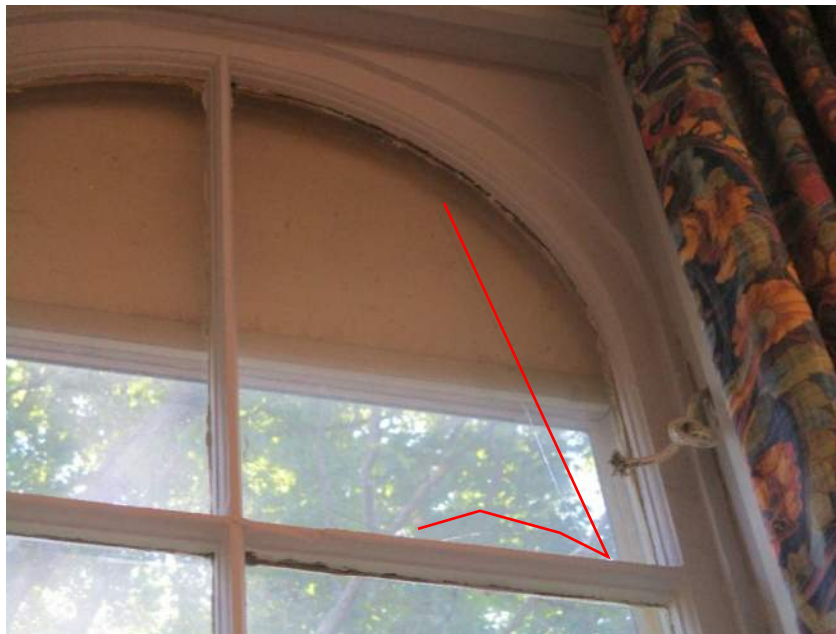
Photo # 20: View of crack in glass pane at wood framed window (south elevation, west addition).

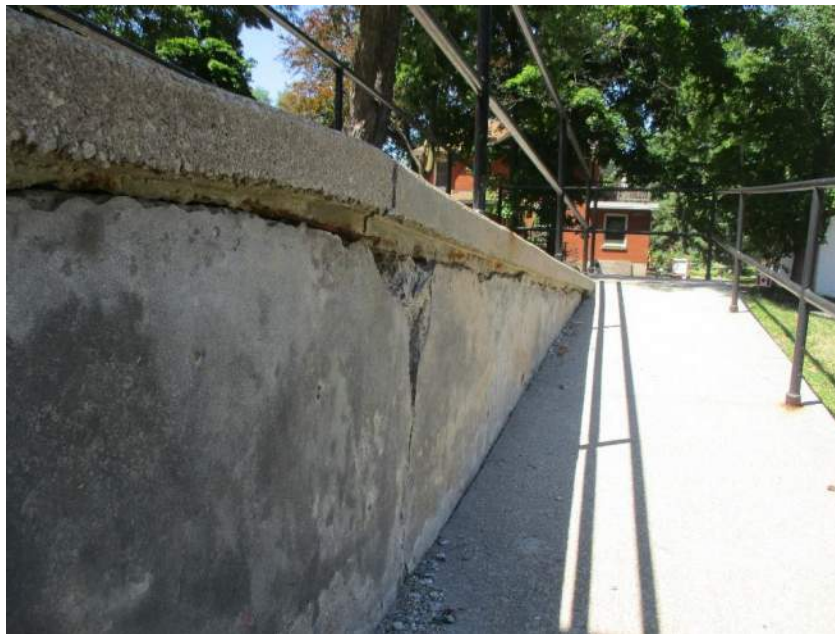
Photo # 21: View of typical deterioration at the access ramp on the northeast elevations of the building adjacent the northeast pilaster (original building and south addition, facing north).

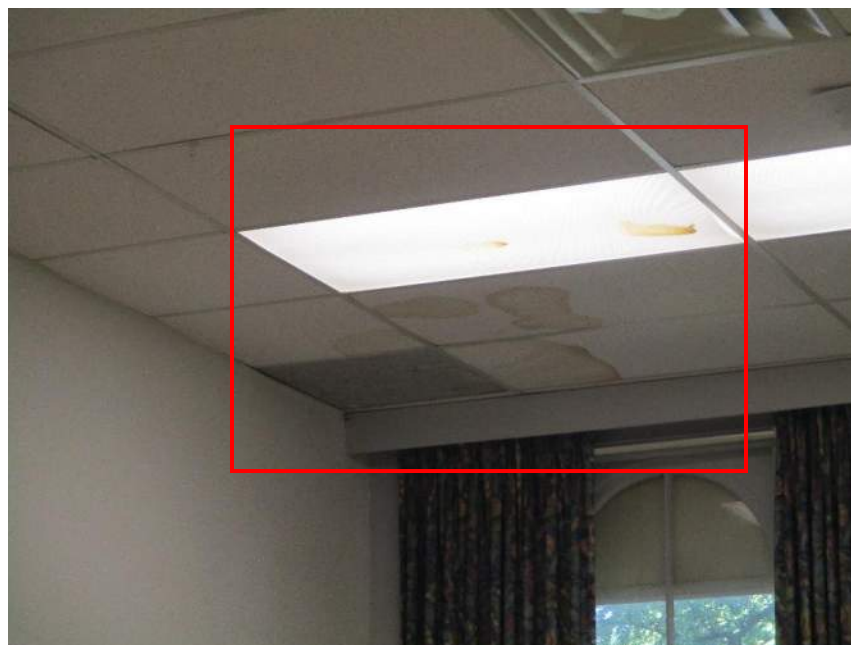
Photo # 22: View of typical stained ceiling tiles in the main hall reportedly related to roof leaks (west addition).

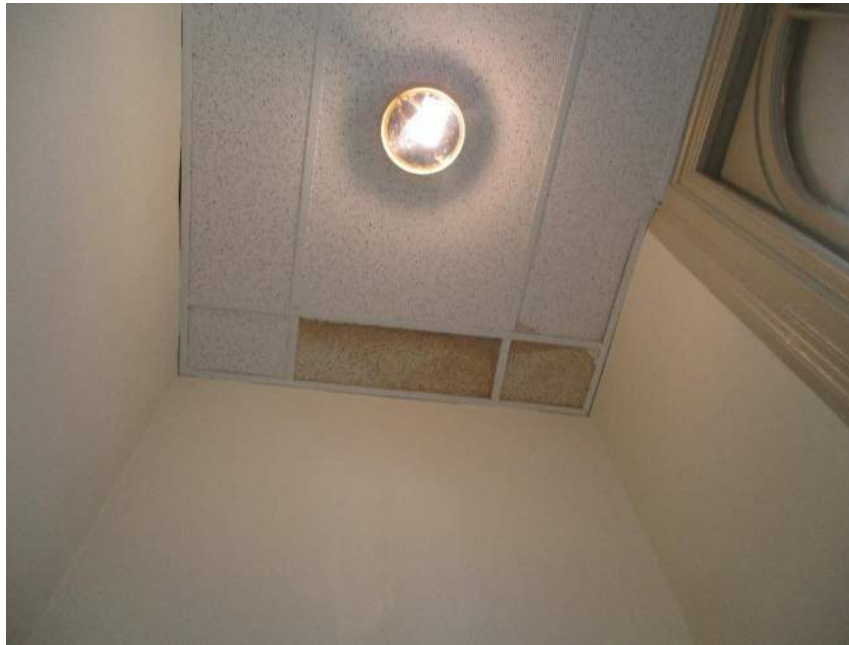
Photo # 23: View of stained ceiling tile in the women's washroom (north elevation, west addition).

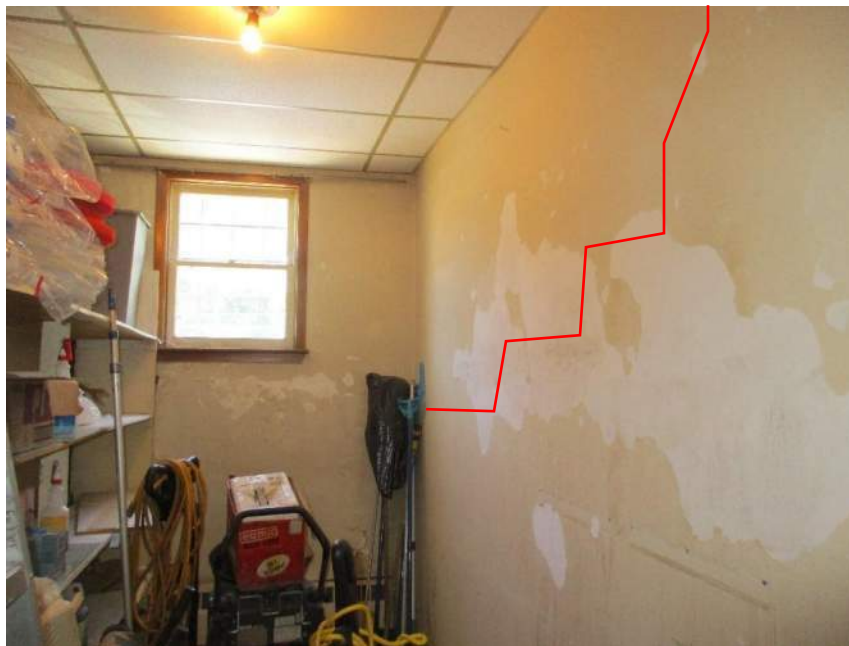
Photo # 24: Paint peeling was observed in jail cell 1 at the west elevation and a step crack was observed on the interior wall in between jail cells 1 and 2

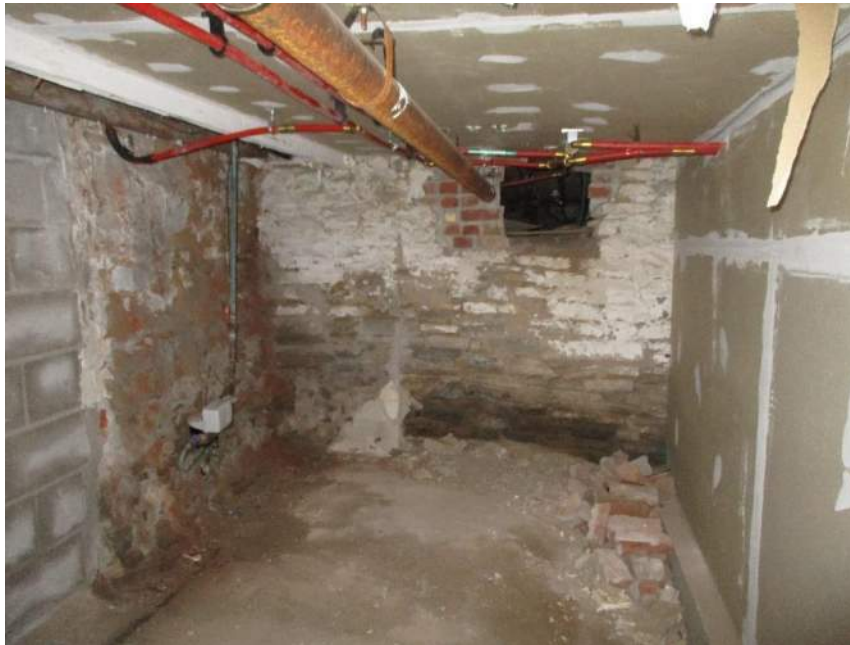
Photo # 25: View of rubble wall foundation. Moisture infiltration is visible at the base of the wall (north elevation, west addition).

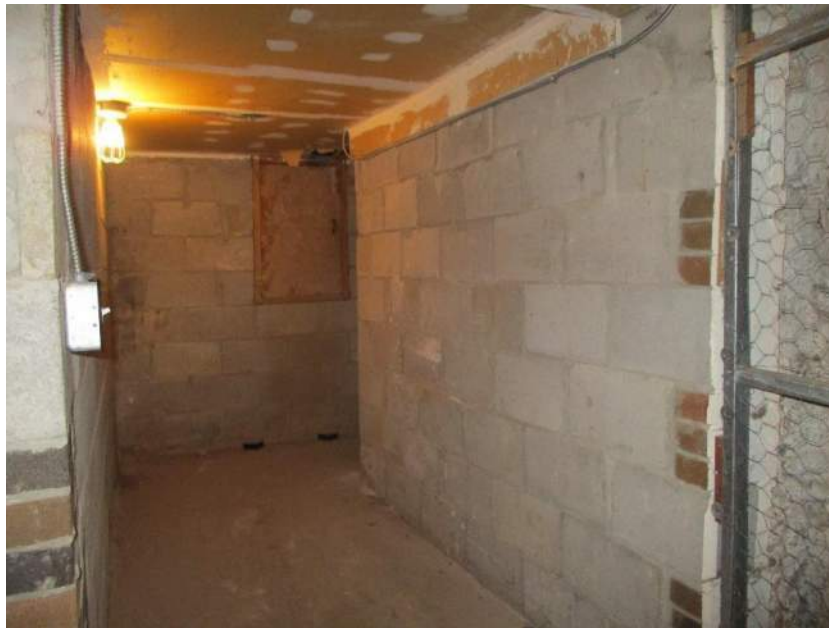
Photo # 26: View of typical concrete masonry unit foundation in the newer addition to the building (interior hallway, south addition).

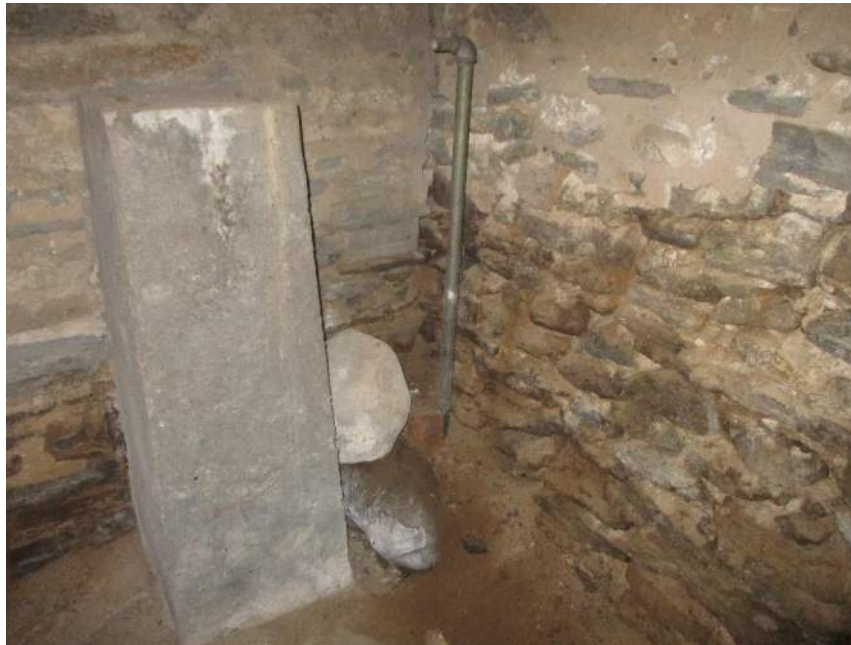
Photo # 27: View of typical deteriorated/lost limestone mortar at the base of the rubble wall foundation.

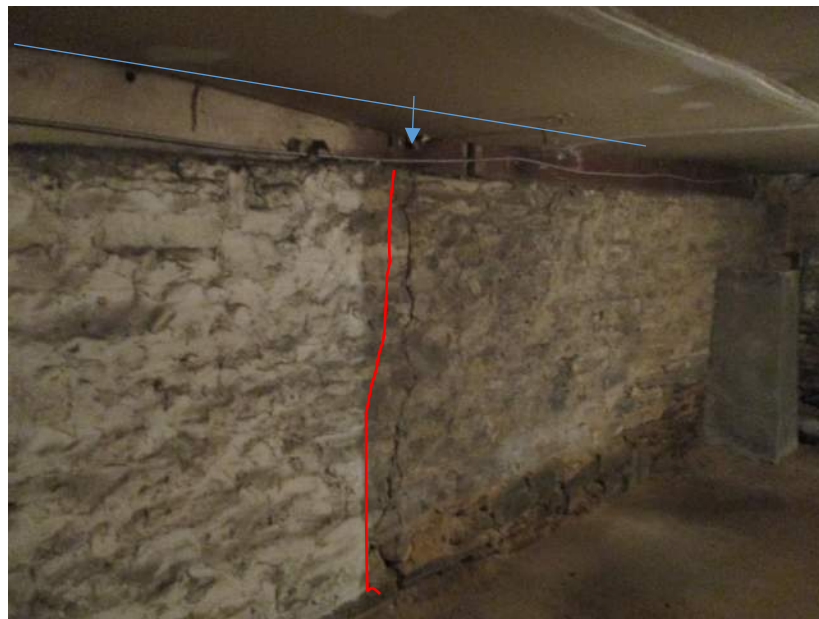
Photo # 28: The floor in the south kitchenette was observed to be bowing. View from below is shown with displacement in blue. A vertical crack in the rubble foundation wall below the bowed floor is shown in red.
