Heritage Property Application

1- Introduction

Baird Sampson Neuert Architects (BSN) was engaged by the City of Mississauga to provide complete consulting and design services for Streetsville Kinsmen Hall, located at 327 Queen Street South, Mississauga, ON. The focus of BSN's services includes the conservation and repair of the deteriorated brick masonry on all building elevations, wood soffit refurbishment and repair, refurbishment of wood windows and doors, replacement of deteriorated hollow metal doors, asphalt roof replacement, removal of visible conduits and mechanical penetrations on the façades. Other work includes the replacement of a canopy and deteriorated ramp/stair system, all related to the rear entry (facing the parking lot), and the provision/upgrade of exterior lighting.

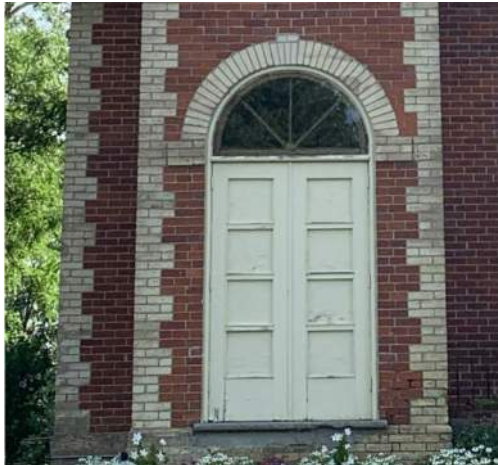
Left: Existing Wood Doors to be replaced

Due to the deterioration of the two wooden doors facing Queen Street, BSN was tasked with replacing them with wooden doors that match the appearance of the original wood doors that existed at those two locations before their removal. To design the new wooden doors, BSN will reference the historical images of the building in order to design doors that are as historically accurate as possible. The design team will work to match the trim styles and colors of the doors as a first step to set the tone for any future repair work on the building.

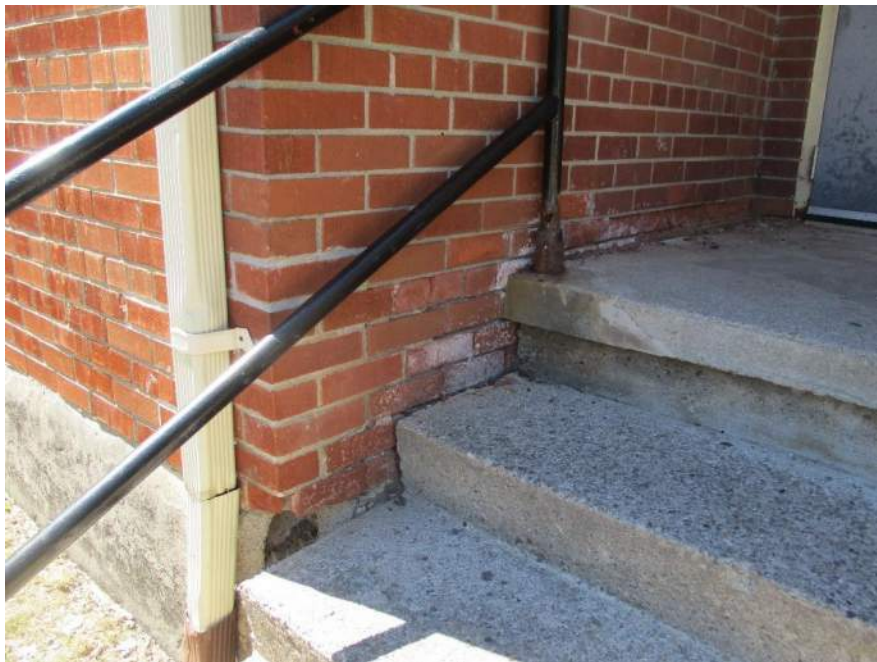
Photo # 6: Typical Masonry Brick and mortar deterioration at the eastern staircase.

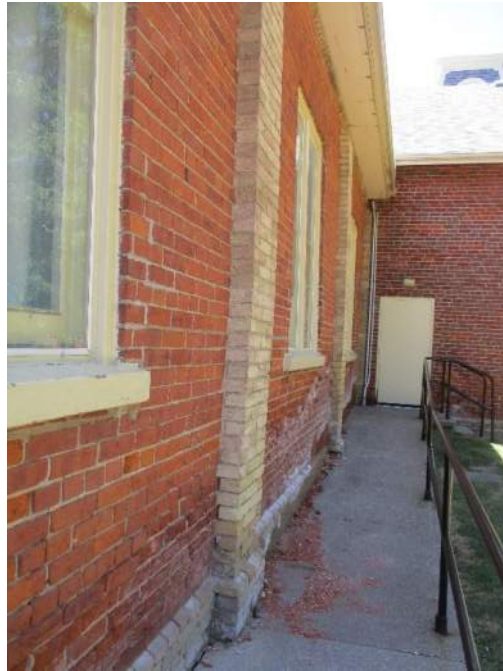
Photo # 7: Overview of spalling brick and efflorescence at the north elevation (original building, facing west).

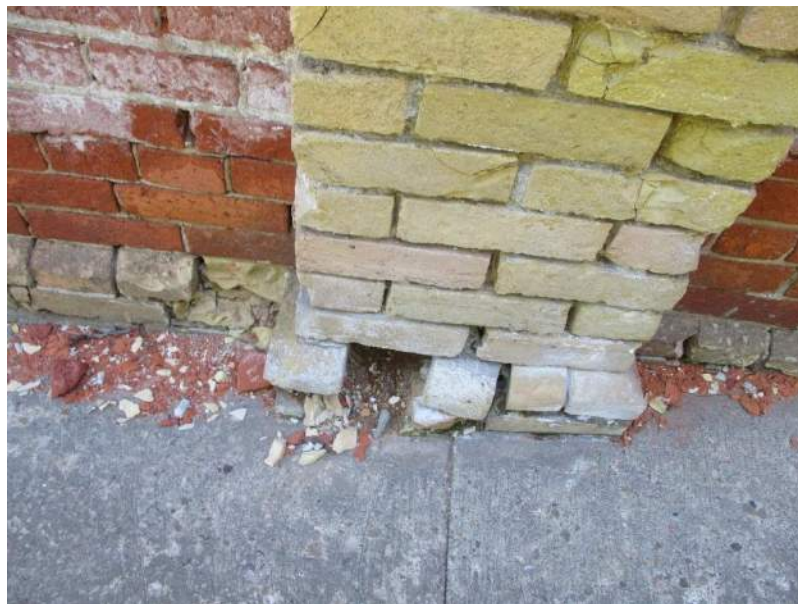
Photo # 8: Close up view of masonry and mortar deterioration at a column at the north elevation (original building).

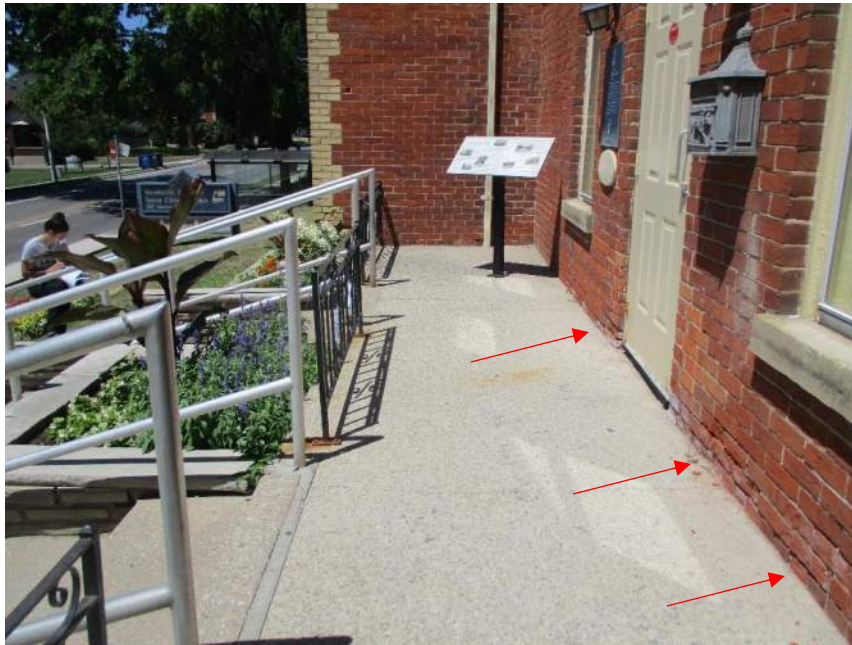
Photo # 9: View of mortar deterioration at the grade level of the west elevation (west addition).

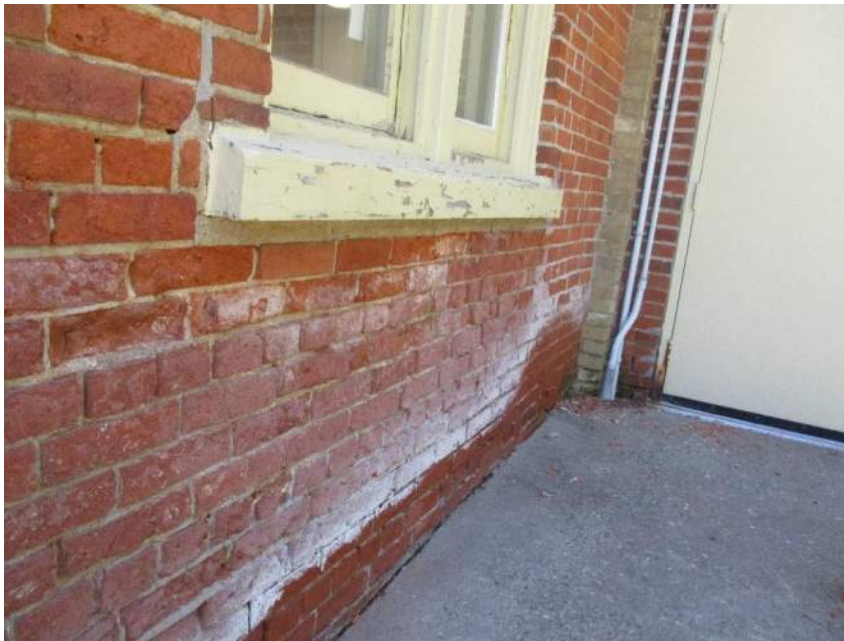
Photo # 10: White staining (efflorescence) was observed to be concentrated approximately 12 inches above grade level at the north and east elevations (original building).

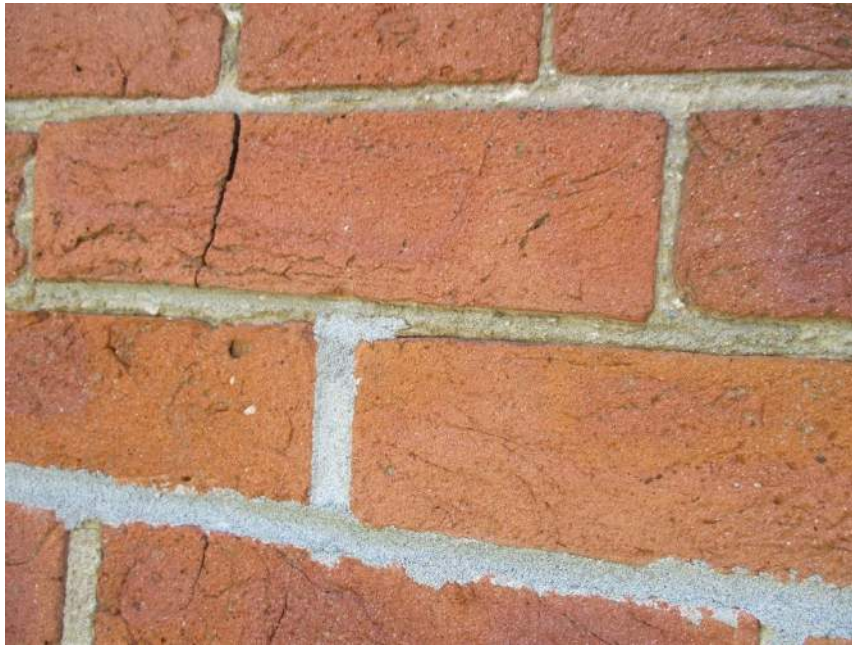
Photo # 11: View of the brick masonry at the east elevation. The masonry was observed to have a rough texture that appeared to be the result of sandblasting (original building).

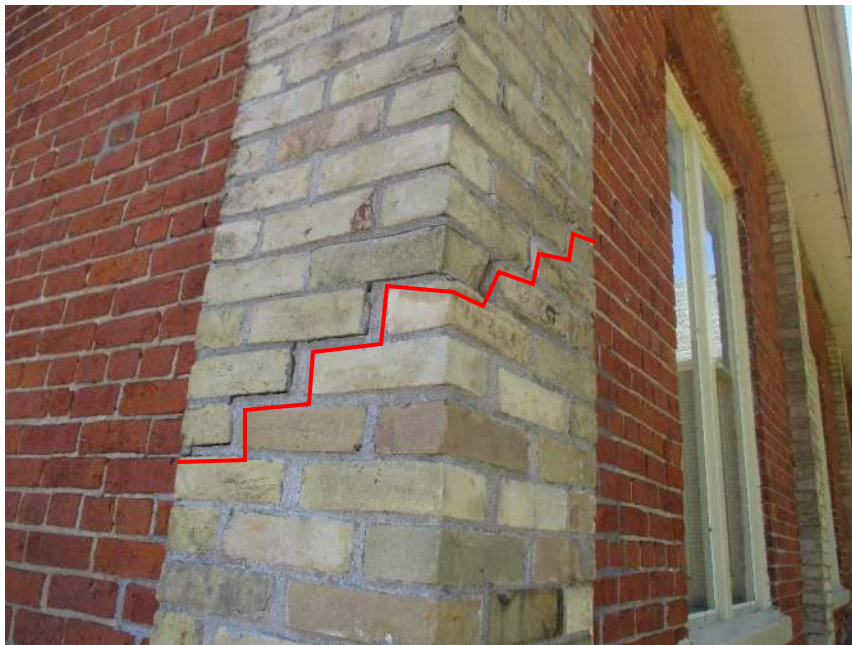
Photo # 12: View of step crack in the northeast corner pilaster at the east elevation (original building).

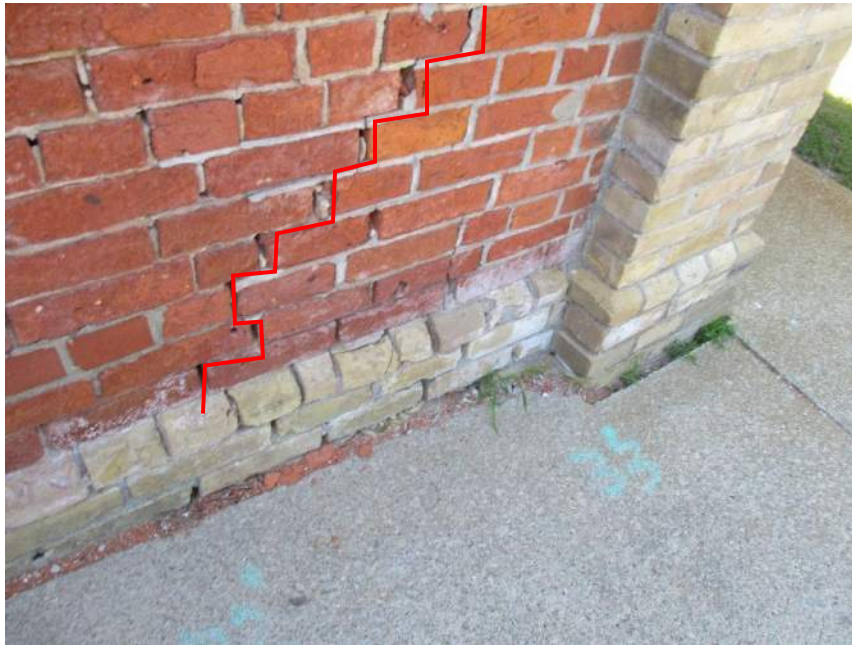
Photo # 13: View of step crack continuing through masonry brick at east elevation and mortar deterioration.

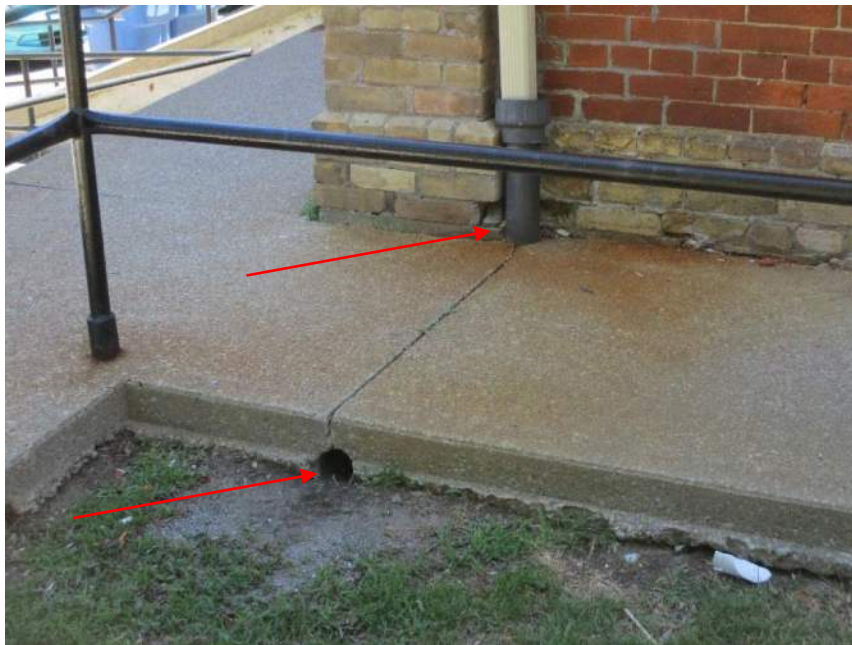
Photo # 14: A rain water leader was observed to be present next to the north-east corner pilaster at the north elevation and appeared to run underneath the access ramp.

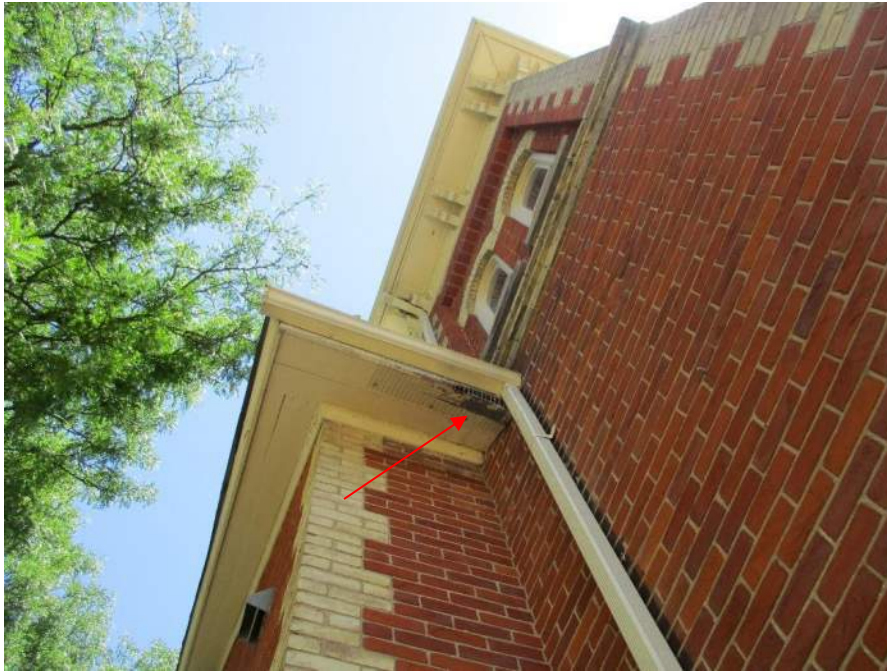
Photo #15: Typical view of localized area of soffit deterioration at the north elevation (west addition).

The soffit work will be localized and will focus on the repair of areas that have been damaged by rodents and weather decay. Once the damaged boards are replaced, all soffits and fascia boards will be refurbished and repainted to match existing.

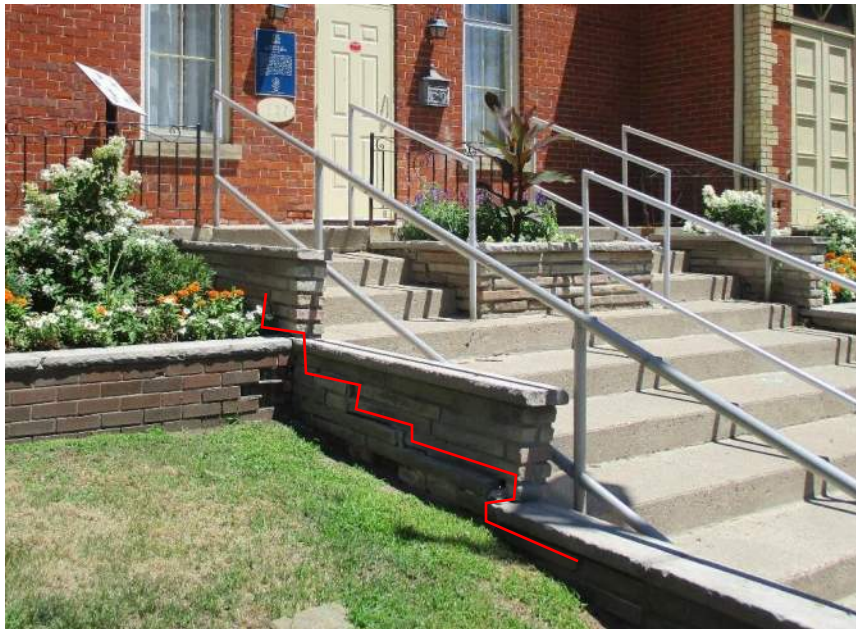
Photo # 16: View of displaced/cracking northern brick masonry low landscaping wall at the west elevation main entrance.

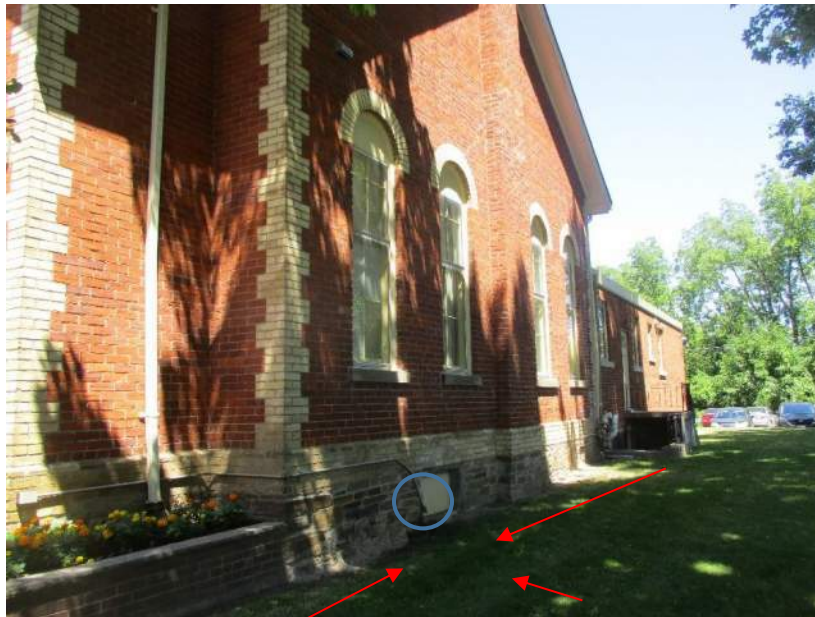
Photo # 17: View of a potential negative drainage at the west end of the south elevation. The direction of the approximate ground slope is shown with a red arrow, and the location of a leaking water tap is shown in blue.

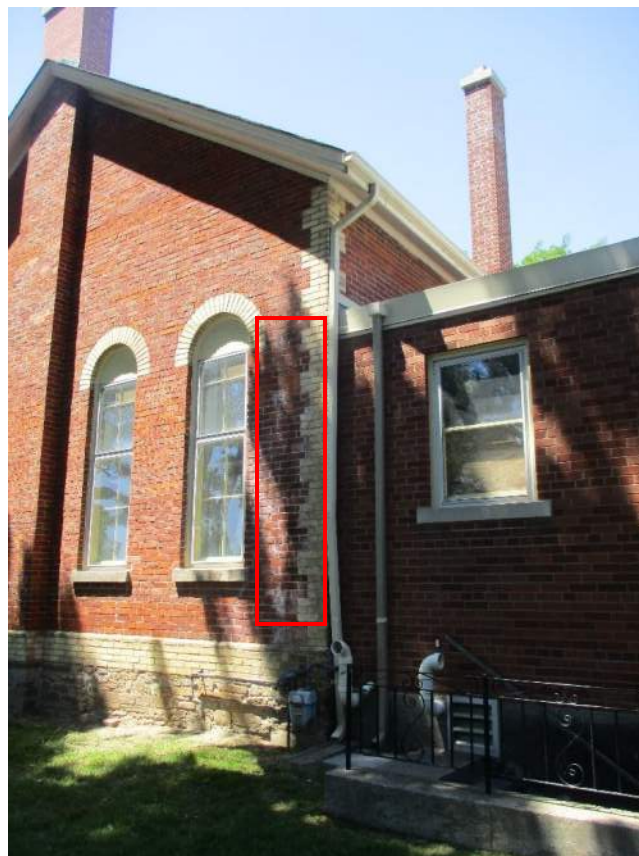
Photo # 18: View of efflorescence observed on the south elevation (west addition).

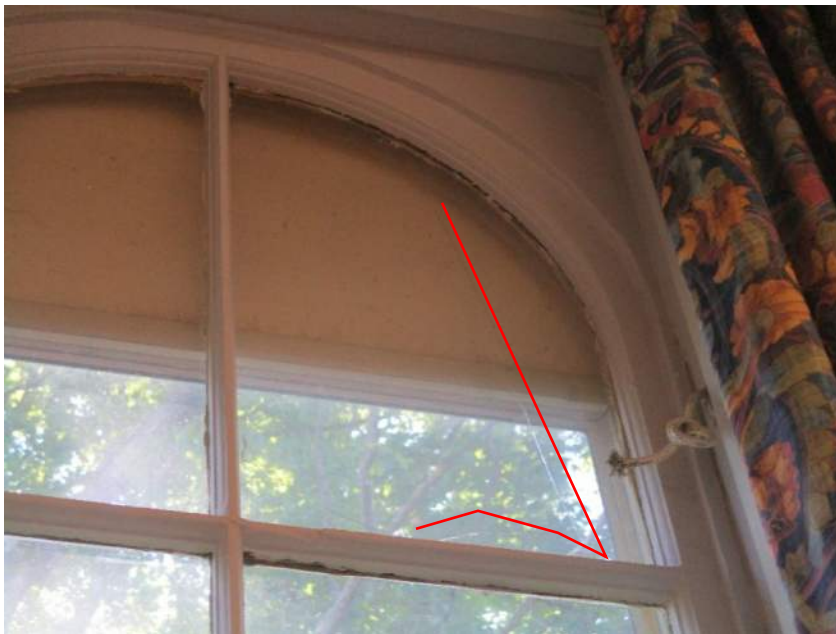
Photo # 20: View of crack in glass pane at wood framed window (south elevation, west addition).

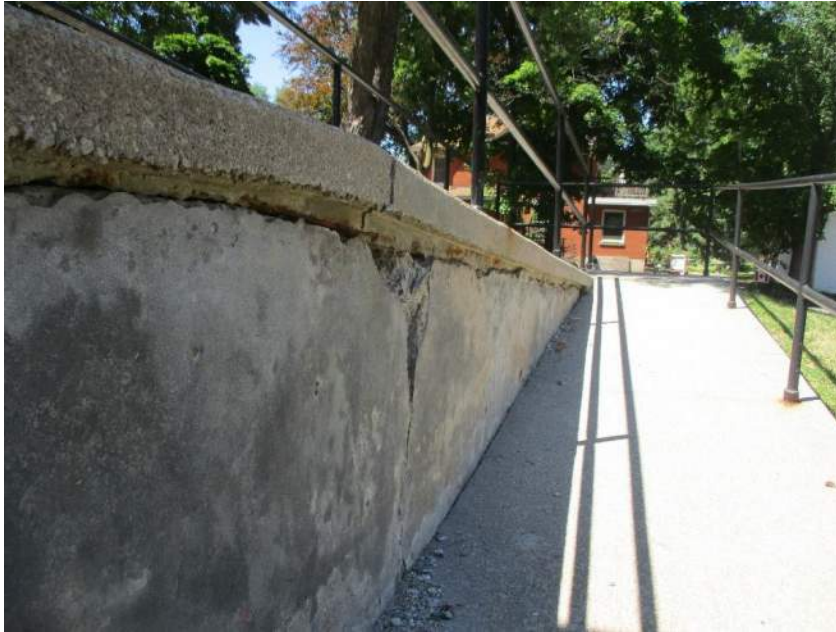
Photo # 21: View of typical deterioration at the access ramp on the northeast elevations of the building adjacent the northeast pilaster (original building and south addition, facing north).

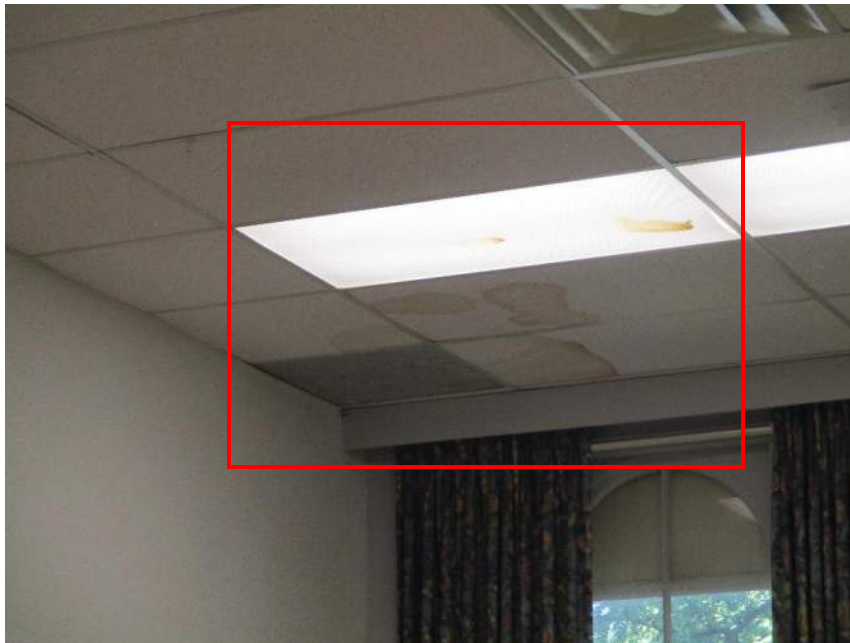
Photo # 22: View of typical stained ceiling tiles in the main hall reportedly related to roof leaks (west addition).

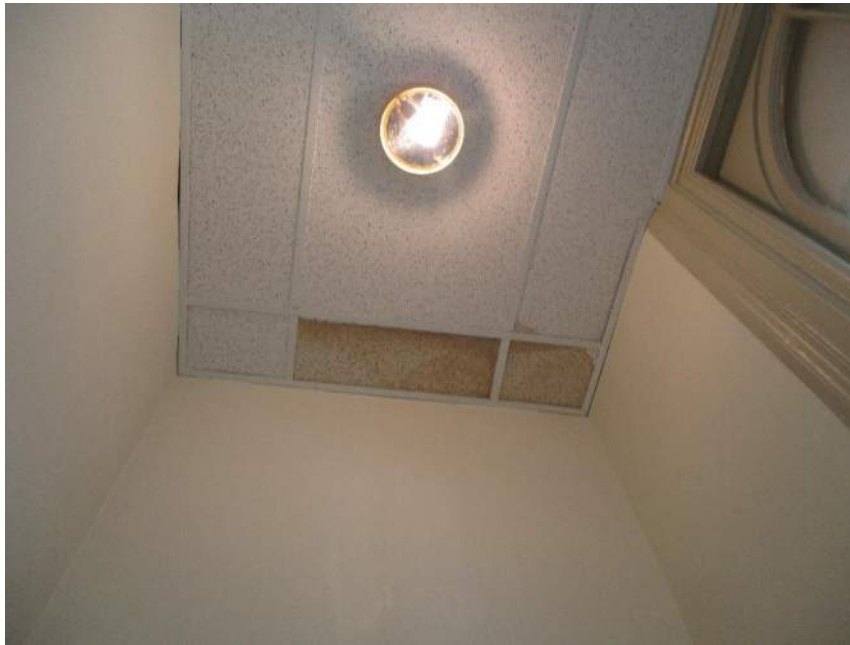
Photo # 23: View of stained ceiling tile in the women's washroom (north elevation, west addition).

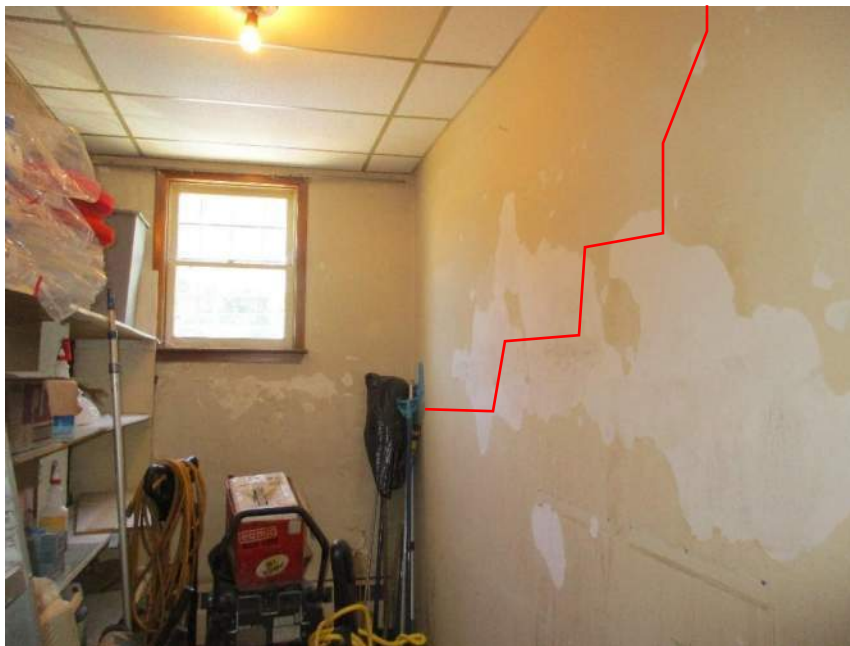
Photo # 24: Paint peeling was observed in jail cell 1 at the west elevation and a step crack was observed on the interior wall in between jail cells 1 and 2

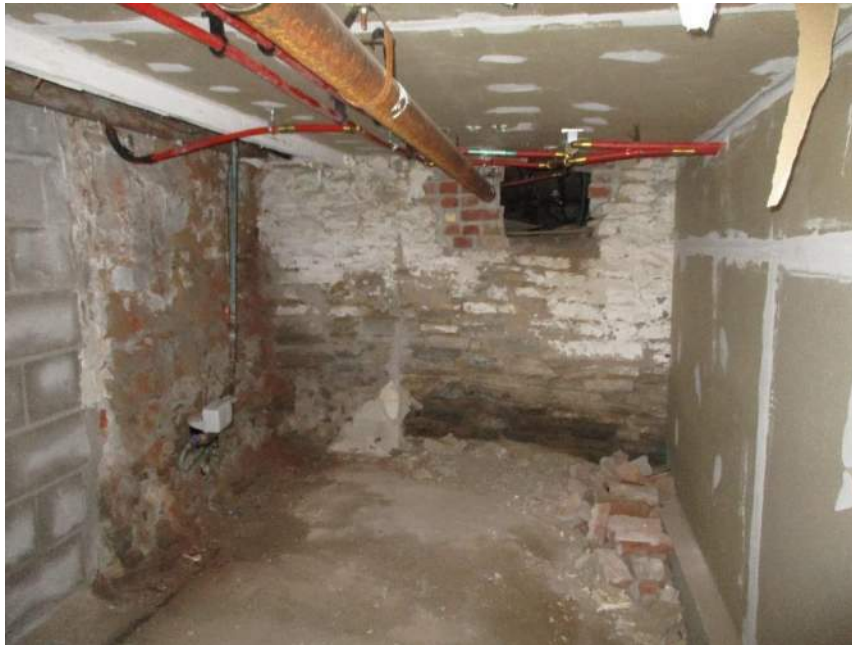
Photo # 25: View of rubble wall foundation. Moisture infiltration is visible at the base of the wall (north elevation, west addition).

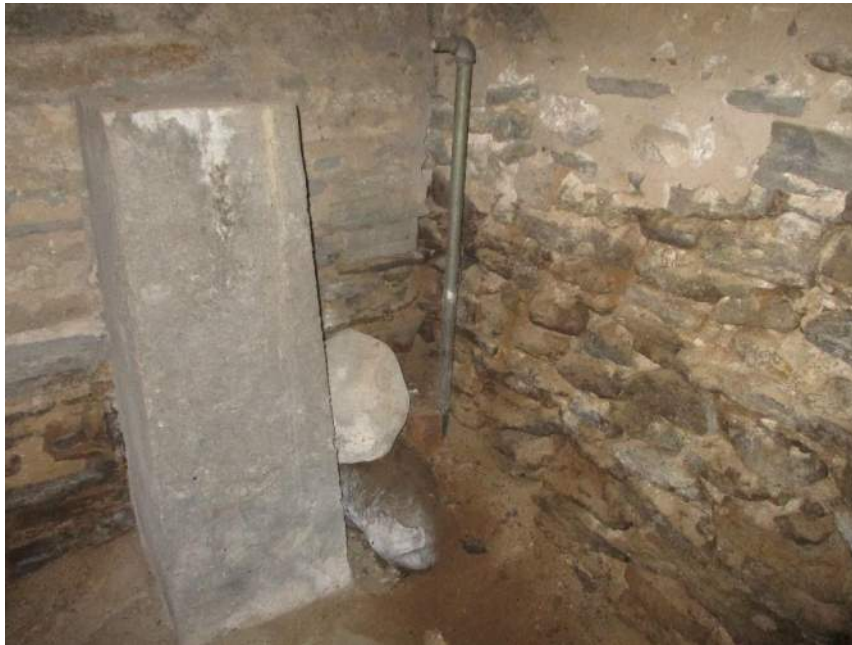
Photo # 27: View of typical deteriorated/lost limestone mortar at the base of the rubble wall foundation.

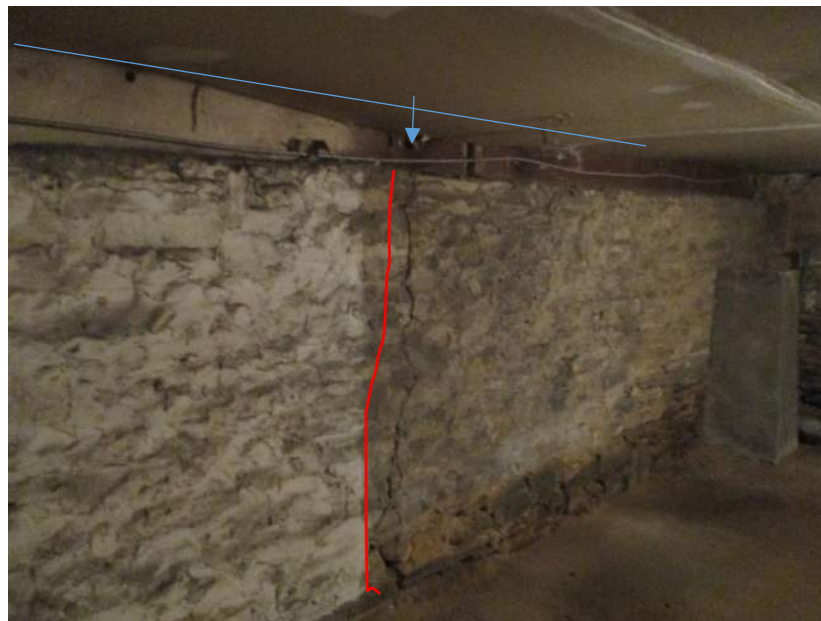
Photo # 28: The floor in the south kitchenette was observed to be bowing. View from below is shown with displacement in blue. A vertical crack in the rubble foundation wall below the bowed floor is shown in red.

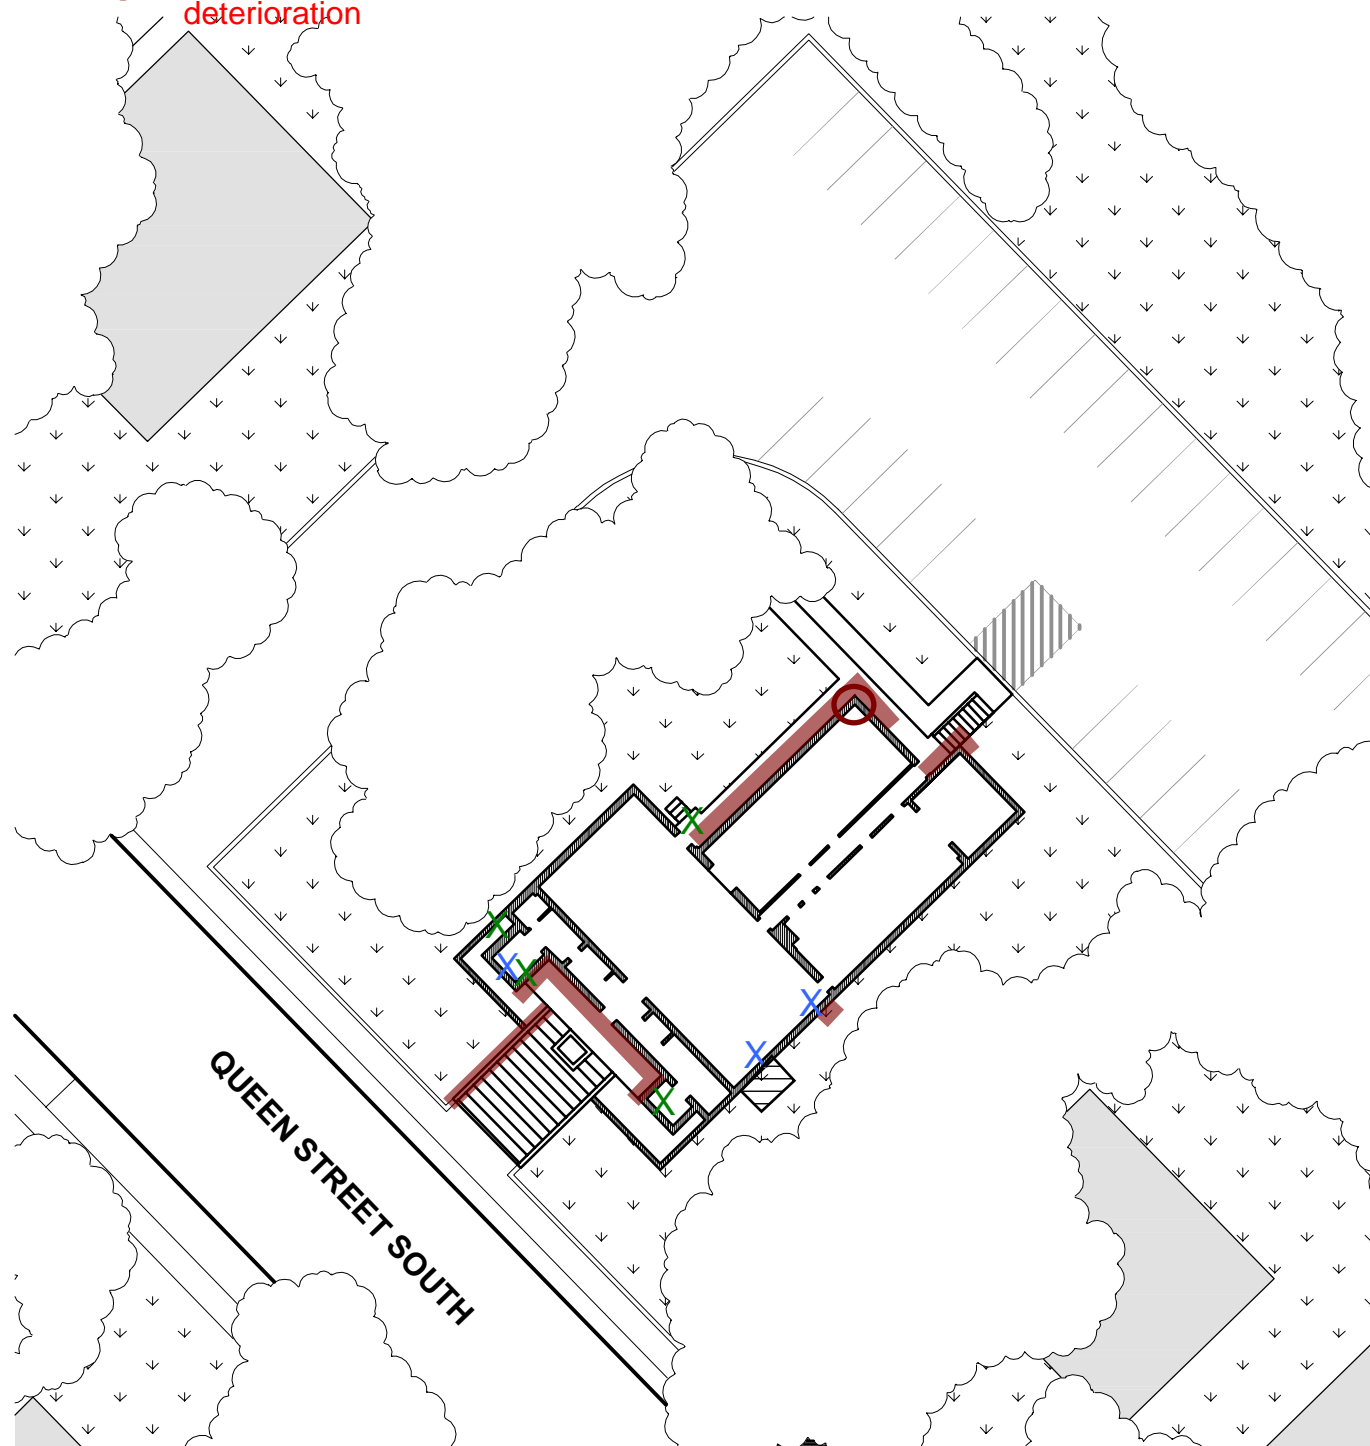
Figure 2.0 - Key observations - Ground floor

- Masonry deterioration
- Negative Drainage
- X Cracked Glass
- X Soffit deterioration
- O Northeast pilaster deterioration
