VIMY PARK ENHANCEMENT | CITY OF MISSISSAUGA

EXISTING CONDITIONS REPORT AND SCHEMATIC DESIGN BRIEF

Cenotaph Condition Report

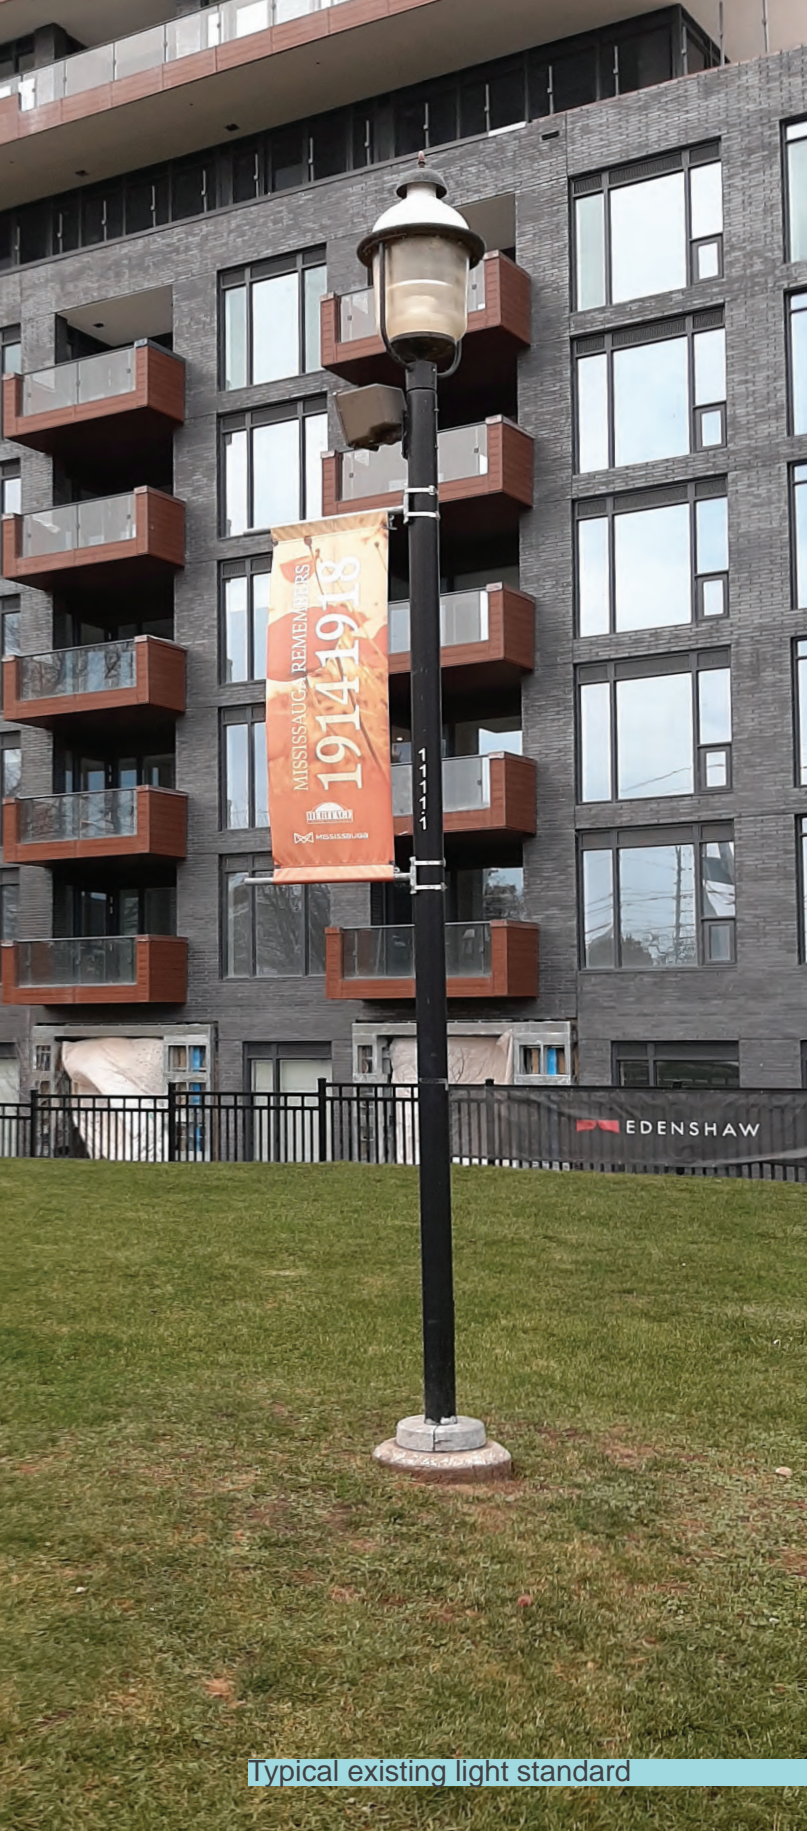
Vimy Park contains three pedestrian light posts along the existing pathways. The poles were manufactured in 1992, by Powco Inc. The light fixtures are acorn-style luminaires with a white cap and black accents. Two of the poles contain additional flood light fixtures to illuminate the Cenotaph. The equipment appears to be in moderate condition.

Typical existing light standard

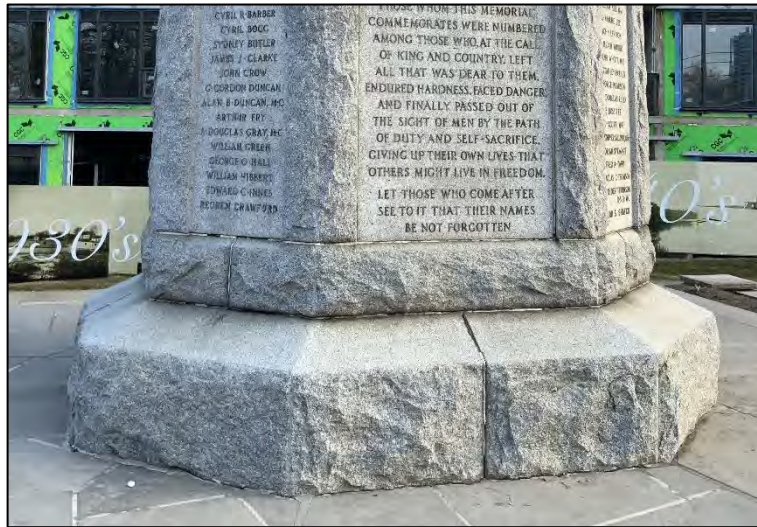
The cenotaph monument and base appears to generally be in **fair condition**. Note that a visual review of the joints above the top of the base must be completed prior to completion of comprehensive repair construction documents.

- i. Full repointing of all vertical and horizontal joints on the base is recommended.
- ii. The horizontal joint between the base of the cenotaph and the terrace pavers is in poor condition and has been observed to be increasing in size since it was originally noted in 2019.

It is recommended that this repair work is prioritized as ongoing weathering of these joints and exposure to moisture has been observed to accelerate the deterioration. This deterioration will continue until the joints have been closed.

Photograph 1: Open joints in cenotaph base (Photo taken Jan. 2020)

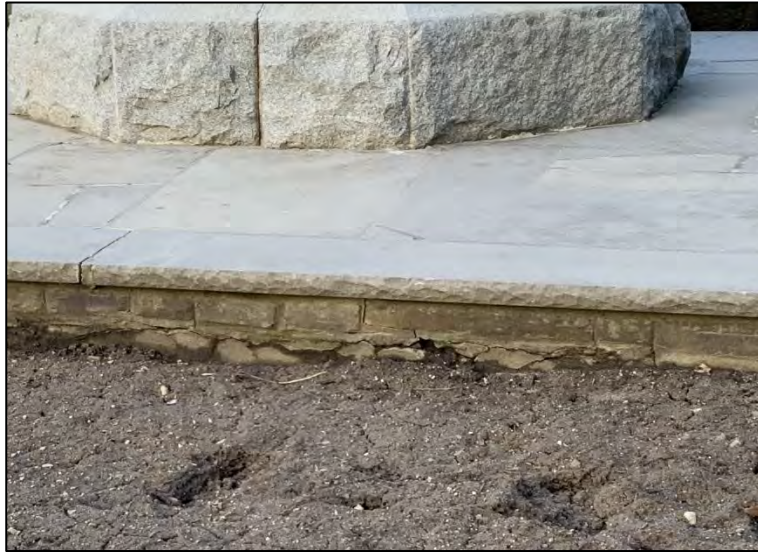
The retaining walls appear to generally be in **fair condition**.

- i. Open joints were noted within the retaining walls around the upper terrace as well as the lower planter walls. Specifically, the horizontal joint where the retaining walls meet grade is generally in poor condition around much of the perimeter.
- ii. Repointing is recommended for 100% of the upper and lower retaining walls.
- iii. Cleaning of the stones is recommended with special attention to shaded areas and areas near grade.

Photograph 2: Deteriorated horizontal joint at grade (Photo taken Jan. 2020)

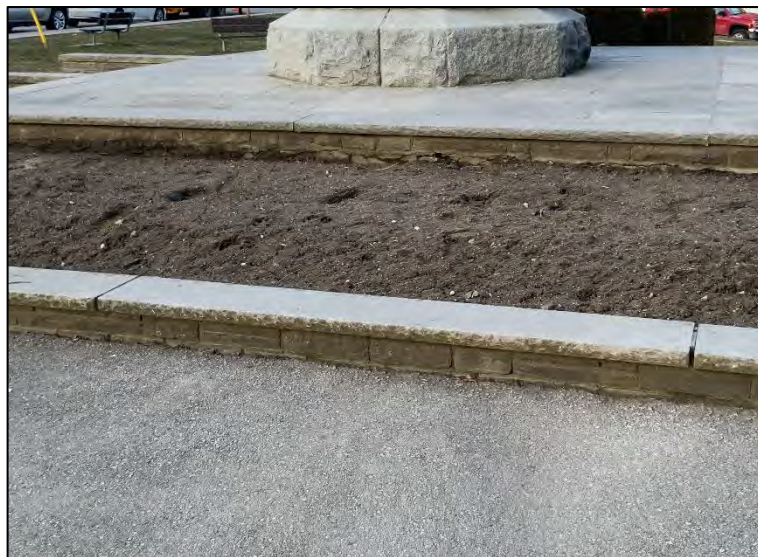
- iv. Approximately 50% of upward facing capstone joints in the lower planter walls were previously noted to have failed and require repair with a compatible material.

Photograph 3: Failed joints between capstones (Photo taken Jan. 2020)
