HERITAGE IMPACT ASSESSMENT

**36 BAY STREET**  
MISSISSAUGA, ONTARIO

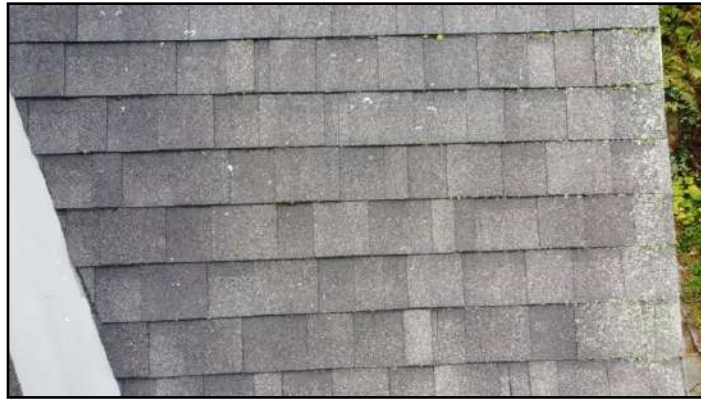
Roof inspection limited/prevented by: • Slope - too steep to walk

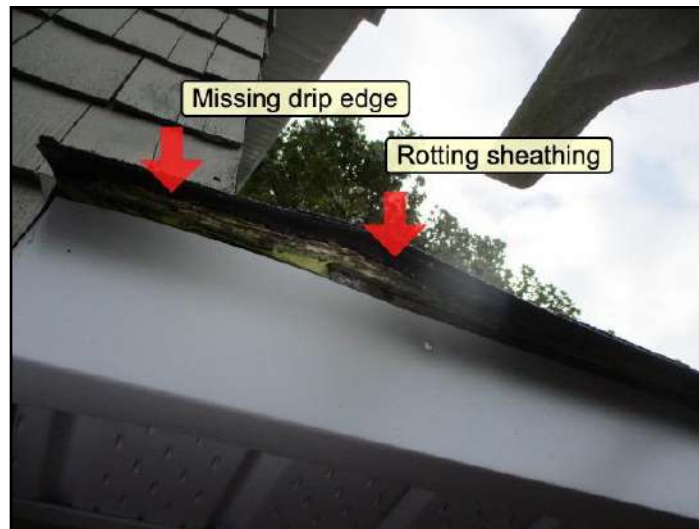
## FLASHINGS - DRIP EDGE \ 2.11

**Condition:** • [Missing](#)

**Task:** Provide

**Time:** Less than 1 year

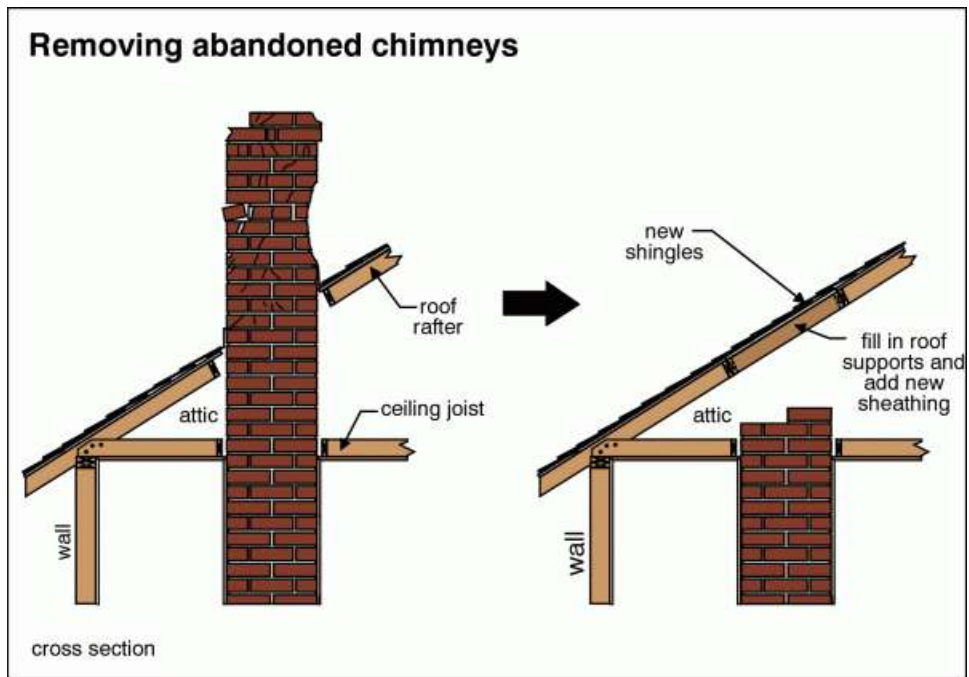
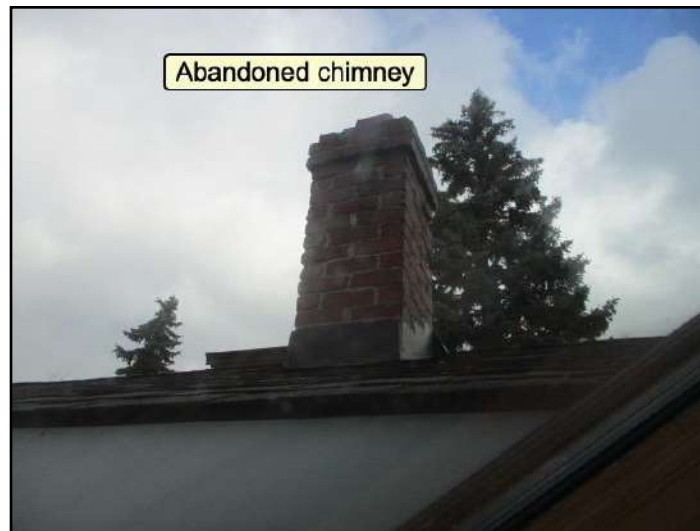
## CHIMNEY(S) \ 3.0

**Condition:** • [Abandoned - vulnerable area for roof leak](#)

**Task:** Remove

**Time:** When remodelling

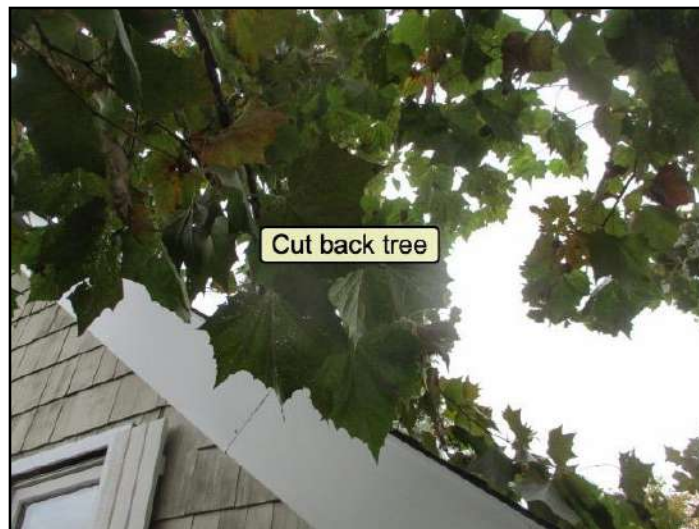
**Condition:** • [Tree branches rubbing against roof cause wear \(1.15\)](#)

**Task:** Remove

**Time:** As soon as practical

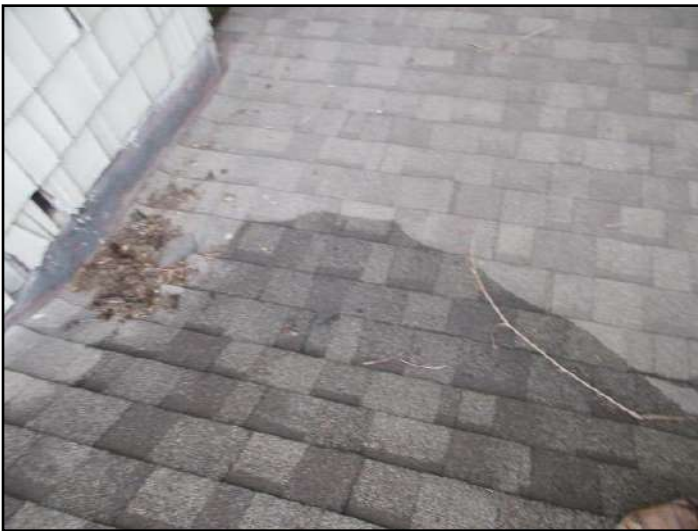
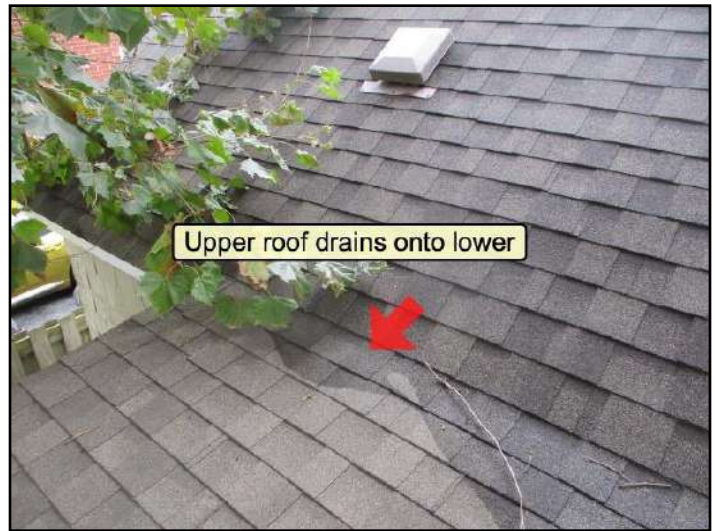
**Condition:** • [Upper roof draining onto lower roof causes wear](#)

**Task:** Monitor over time

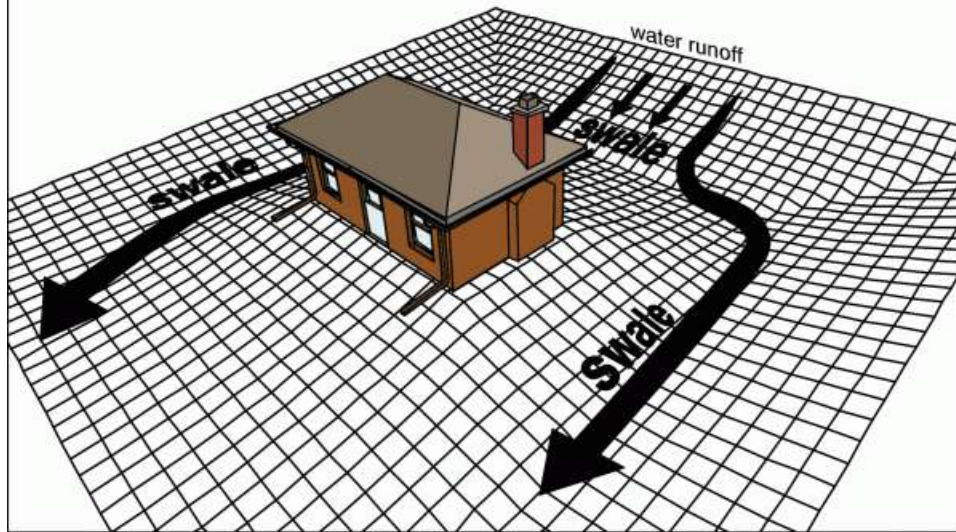
Condition: • Low areas

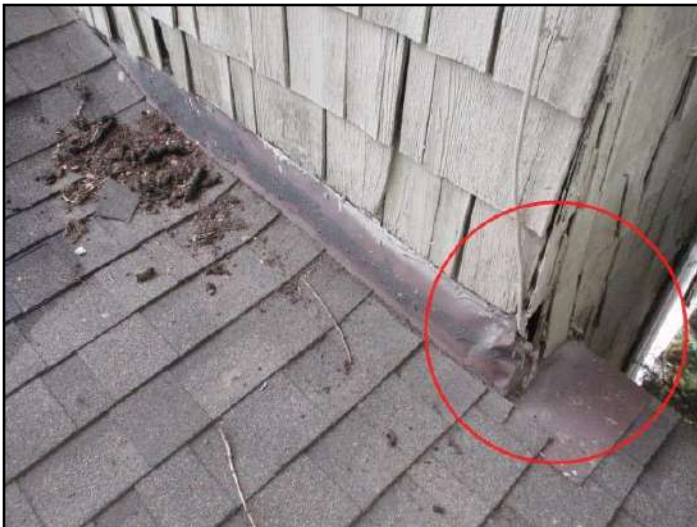
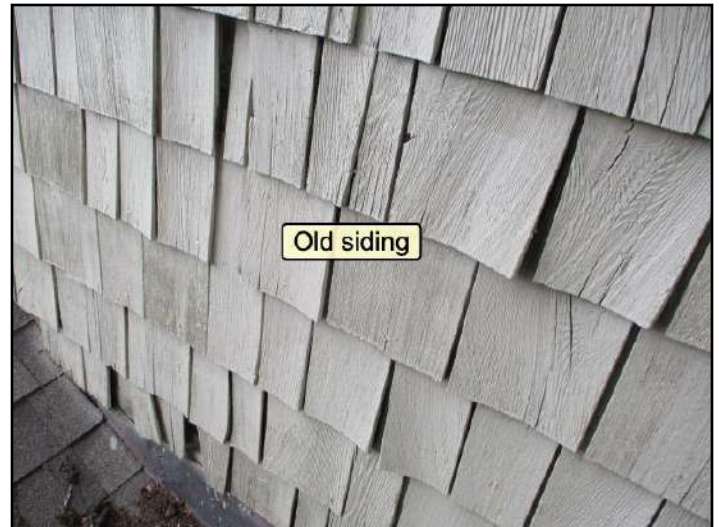
## WALL SURFACES \ 4.0

**Condition:** • [Deteriorated](#)

**Task:** Replace

**Time:** As required

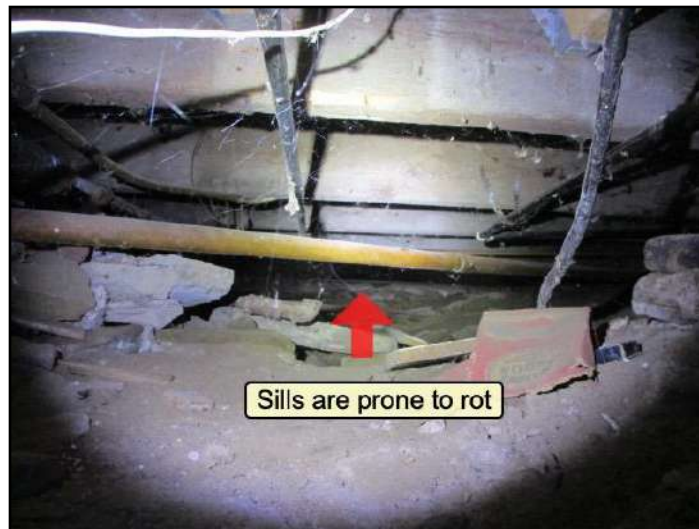
## SILLS \ 5.1

Condition: • [Suspect](#)

Location: Crawl Space

Task: Further evaluation

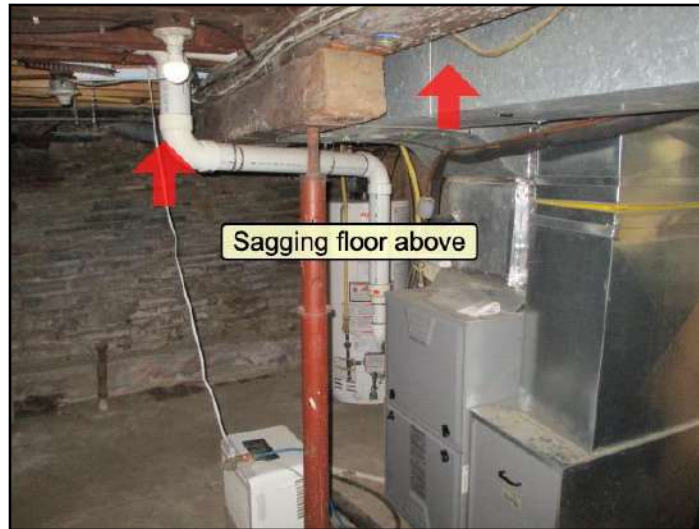
## BEAMS \ 5.2

Condition: • [End bearing inadequate](#)

**Task:** Repair or replace

**Time:** Less than 1 year

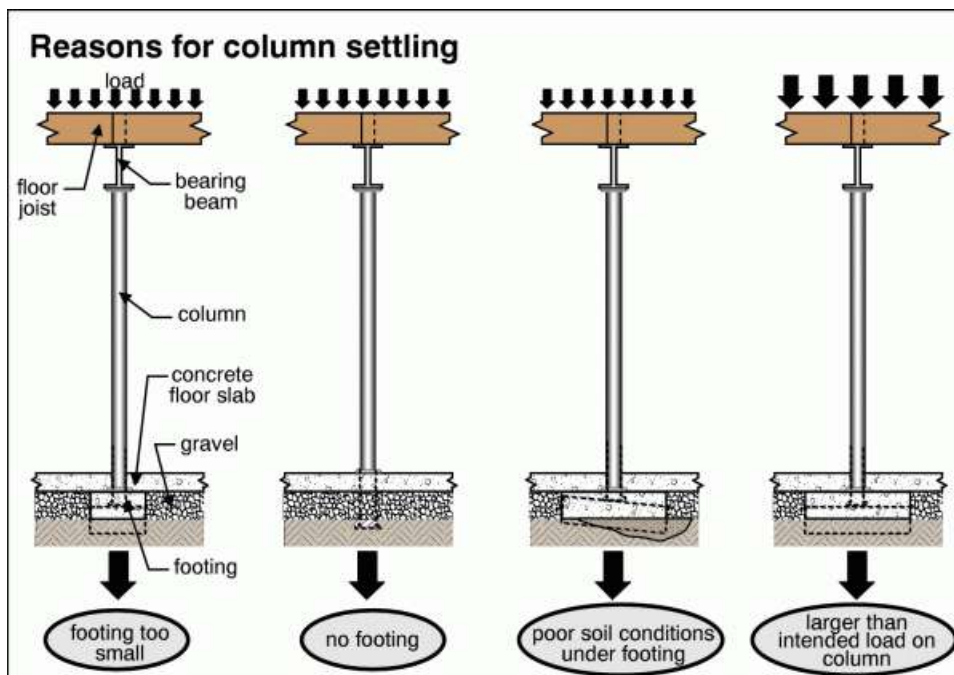
## POSTS/COLUMNS \ 5.3

**Condition:** • [Footing missing?](#)

**Task:** Provide

**Time:** As required

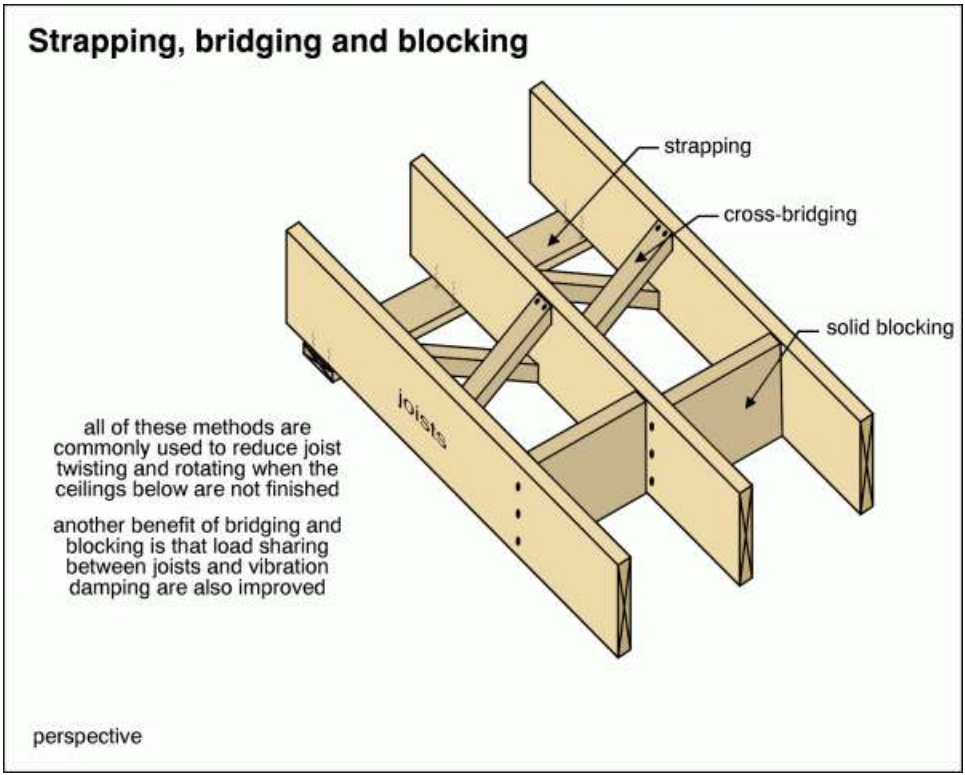
## JOISTS \ 5.4

**Condition:** • [Bridging, blocking or strapping missing \(5.6\)](#)

Task: Repair or replace

Time: Less than 1 year

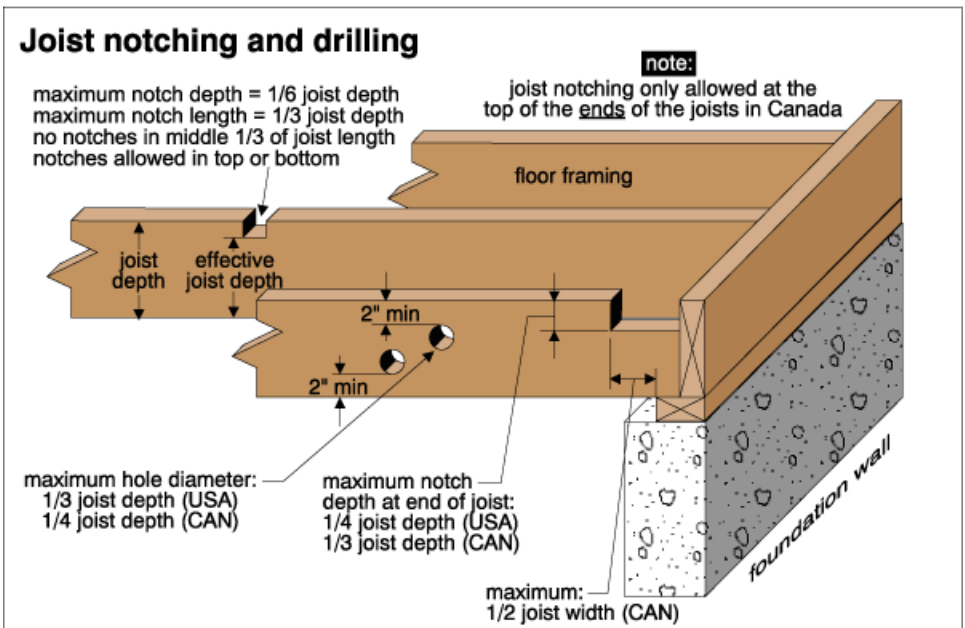
Condition: • [Notches - excessive](#)

Location: Various

Task: Repair or replace

Time: Less than 1 year

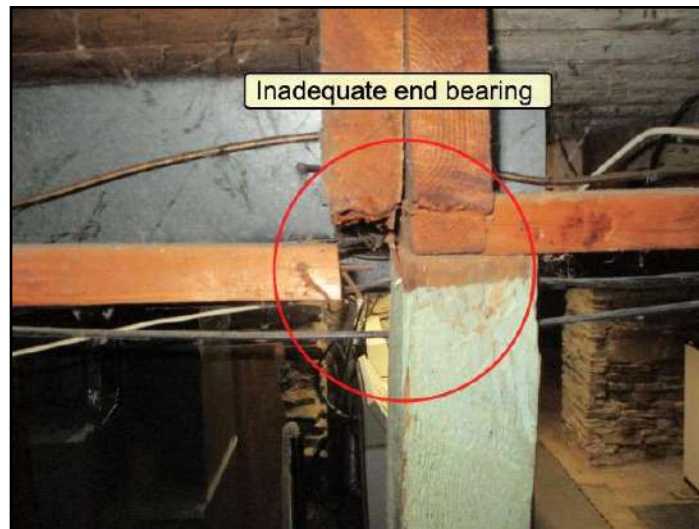
**Condition:** • [Rot](#)

**Location:** Various Crawl Space Basement

**Task:** Repair or replace

**Time:** Less than 1 year

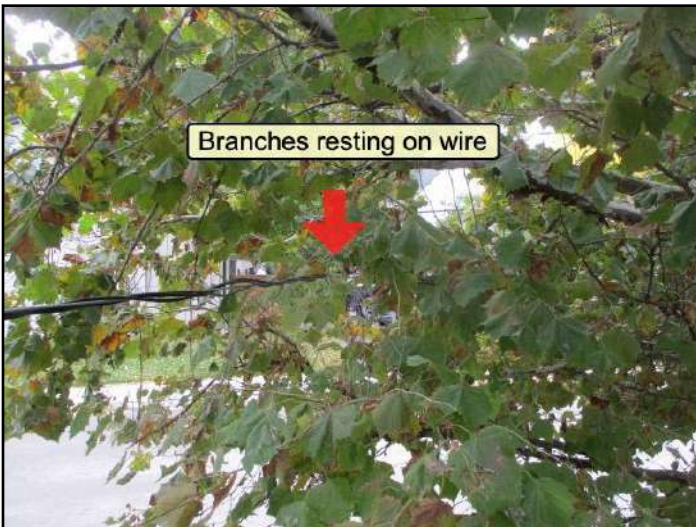
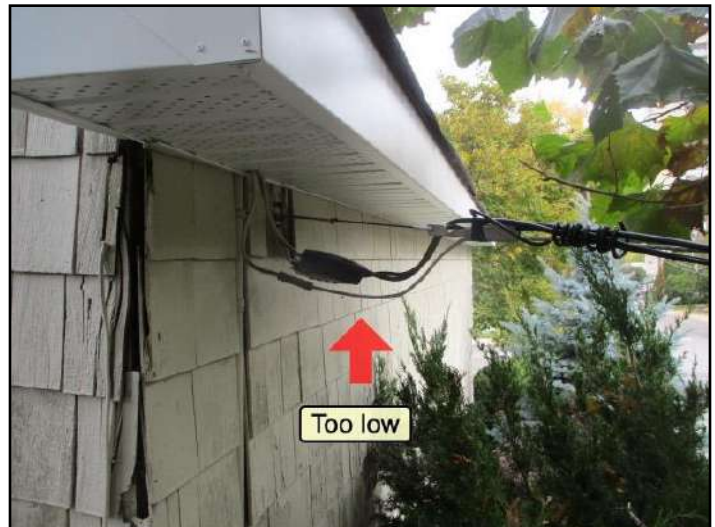
### **SERVICE ENTRANCE \ 2.1, 2.2 and 2.3**

**Condition:** • [Clearance inadequate](#)

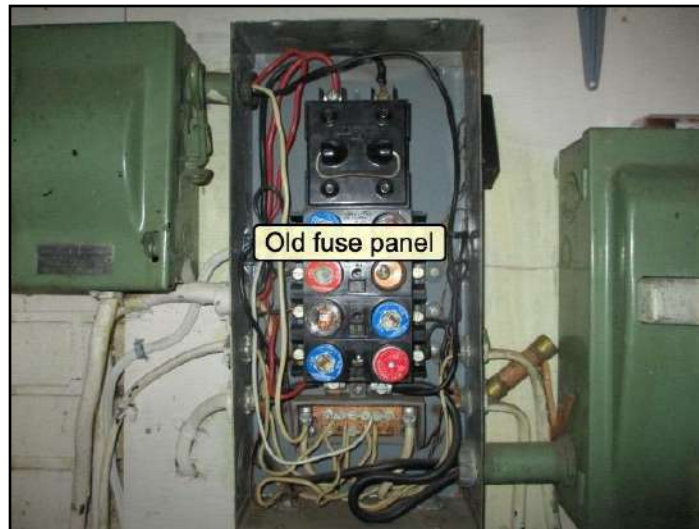
### MAIN PANEL - GENERAL \ 3.0

Condition: • [Obsolete](#)

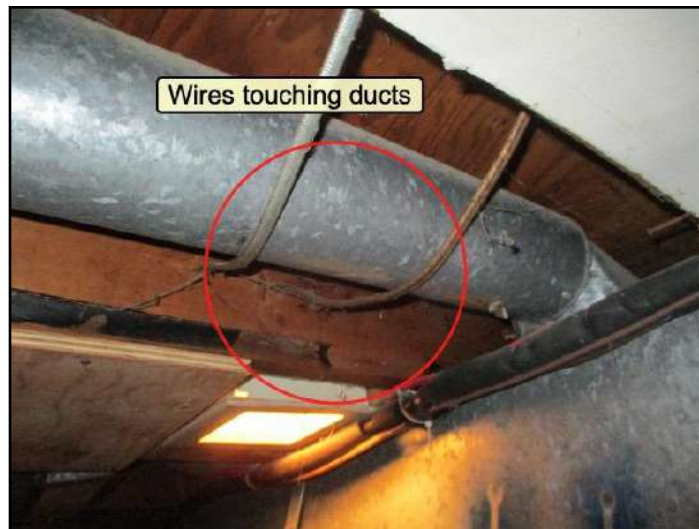
Condition: • [Surface mounted wiring – unprotected](#)

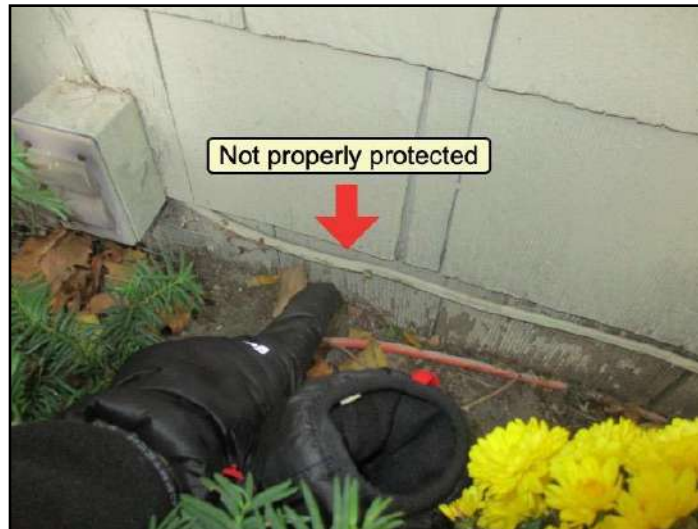
### HOUSE WIRING - EXTERIOR \ 4.1

Condition: • [Not intended for exterior use](#)

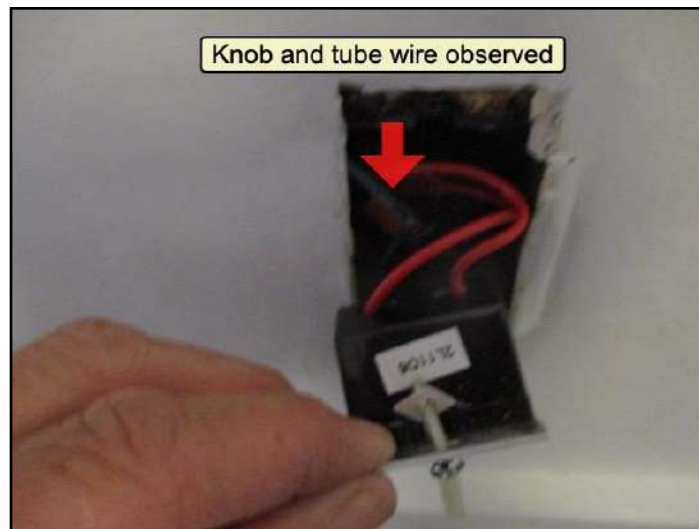
## HOUSE WIRING - KNOB-AND-TUBE \ 4.4

**Condition:** • Knob-and-tube wiring was noted in the home.

**Condition:** • As discussed, bringing the house up to current electrical standards is recommended for convenience and safety. The cost to do so will depend on the approach and the extent of work required. Consultation with a qualified electrical contractor is recommended.

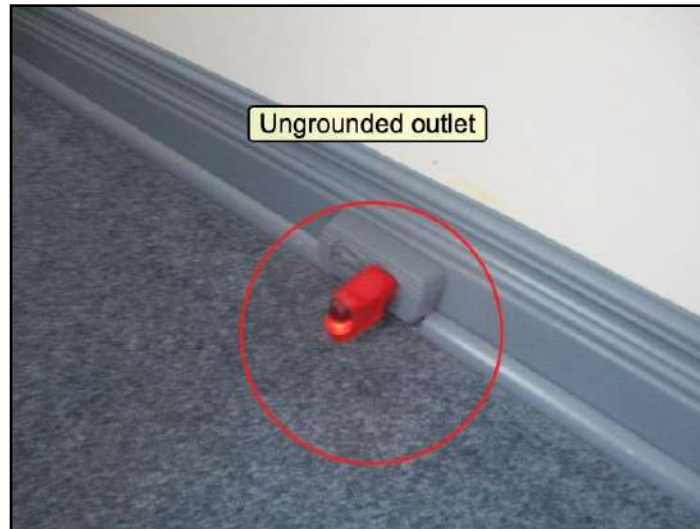
**Condition:** • [Ungrounded - ground fault interrupter \(GFI\) not provided \(5.2.2\)](#)

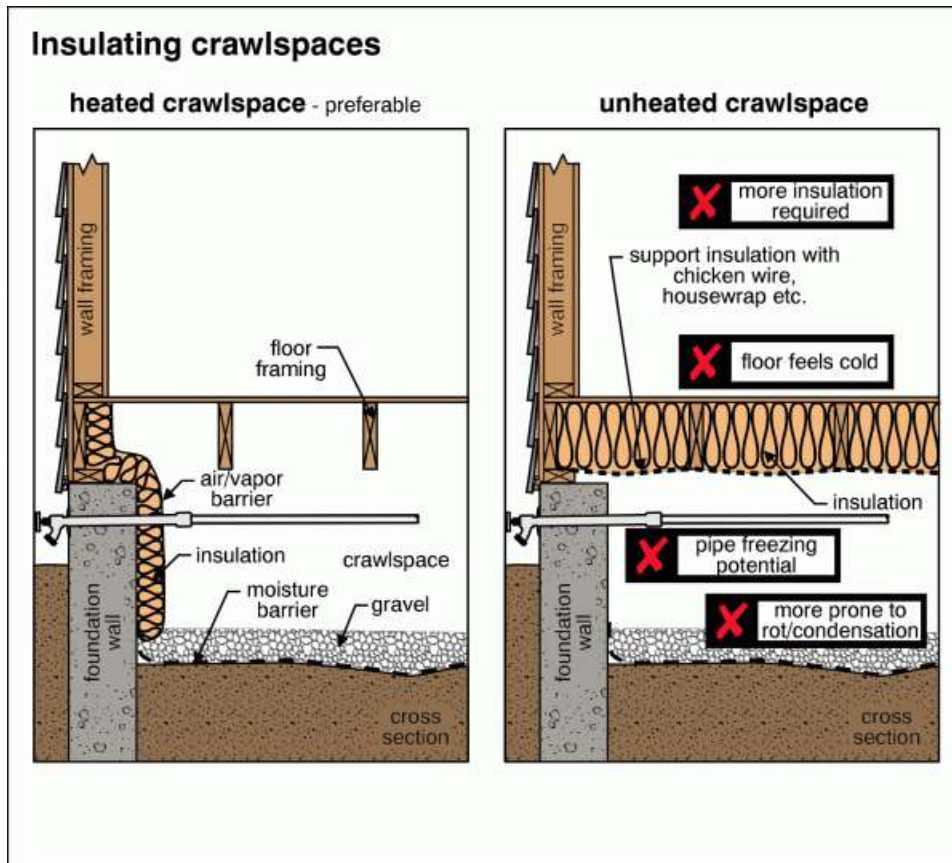
## WALLS - CRAWLSPACE \ K

Condition: • [Insulation amount - less than current standards \(R12\)](#)

**Task:** Repair

**Time:** Less than 1 year

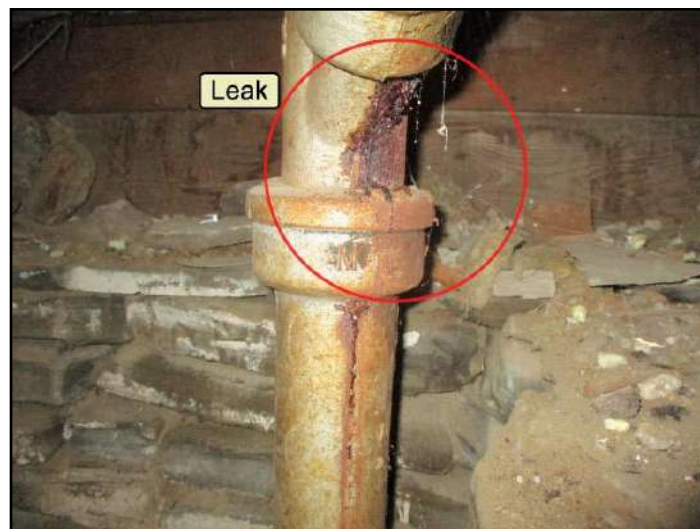
**Condition:** • [Leak \(2.3.1\)](#)

**Location:** Basement

**Task:** Repair or replace

**Time:** As soon as possible

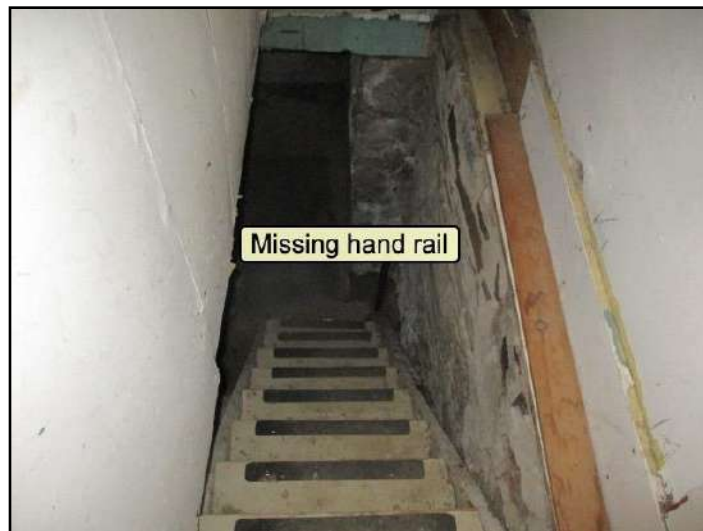
**STAIRS \ 5.0**

**Condition:** • [Headroom marginal](#)

Task: Provide

Time: Less than 1 year
