Scoped Heritage Impact Assessment for the Reroofing of Cherry Hill House
Unit 18 – 680 Silver Creek Boulevard, Mississauga, Ontario

by Francine Antoniou Architect
and Paul Dilse, Heritage Planning Consultant

for the Property Owner and the City of Mississauga

on March 28, 2023

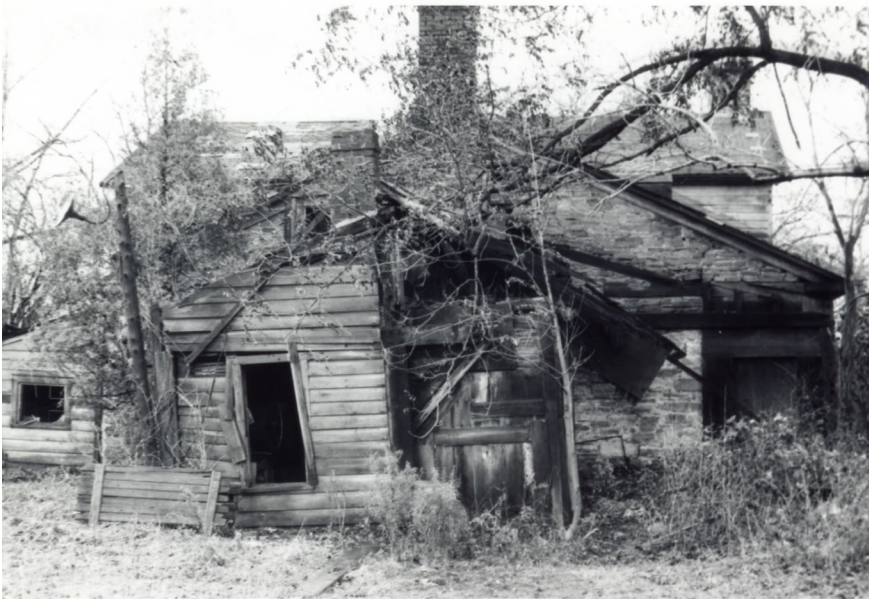
Fig. 10 Joseph De Rijck, "Cherry Hill House, Dixie," 1972, Mississauga Library System, I.D. MC0500. The rear view shows a collapsed frame wing attached to the house's stone back wing.

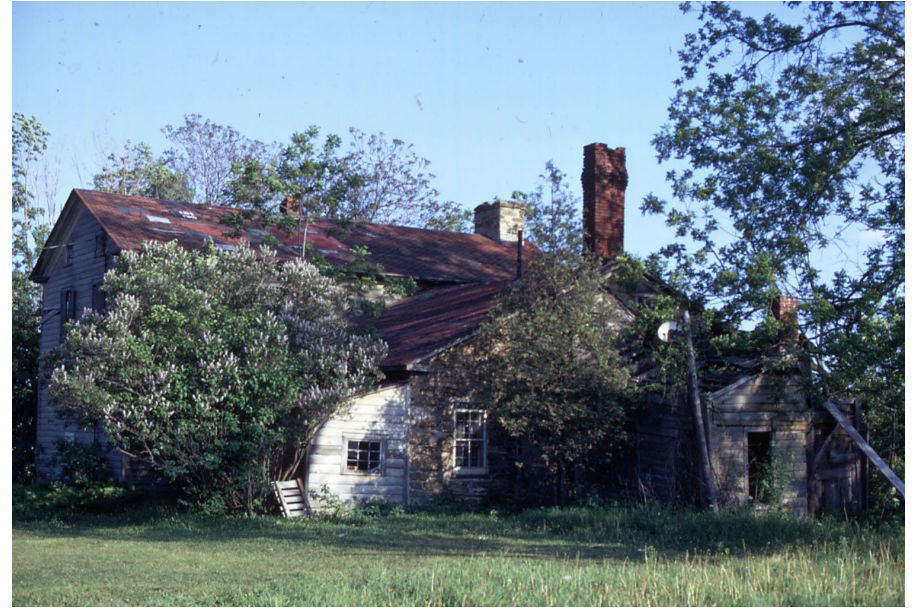
Fig. 11 Joseph De Rijck, "Cherry Hill House, Dixie," 1972, Mississauga Library System, I.D. MC0483. The corner view shows a reddish asphalt shingle roof over both the front part and stone back wing. Patches over the asphalt shingle are also evident.

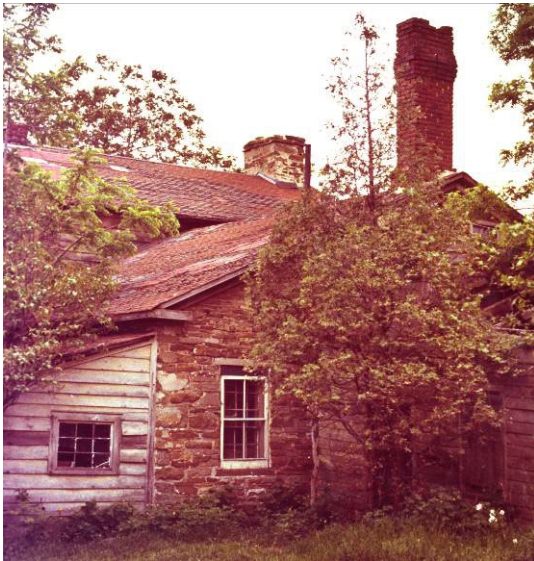
Fig. 12 Joseph De Rijck, "Cherry Hill House, Dixie," 1972, Mississauga Library System, I.D. MC0497. This detail from Fig. 11 shows the asphalt shingle roof in very poor condition.

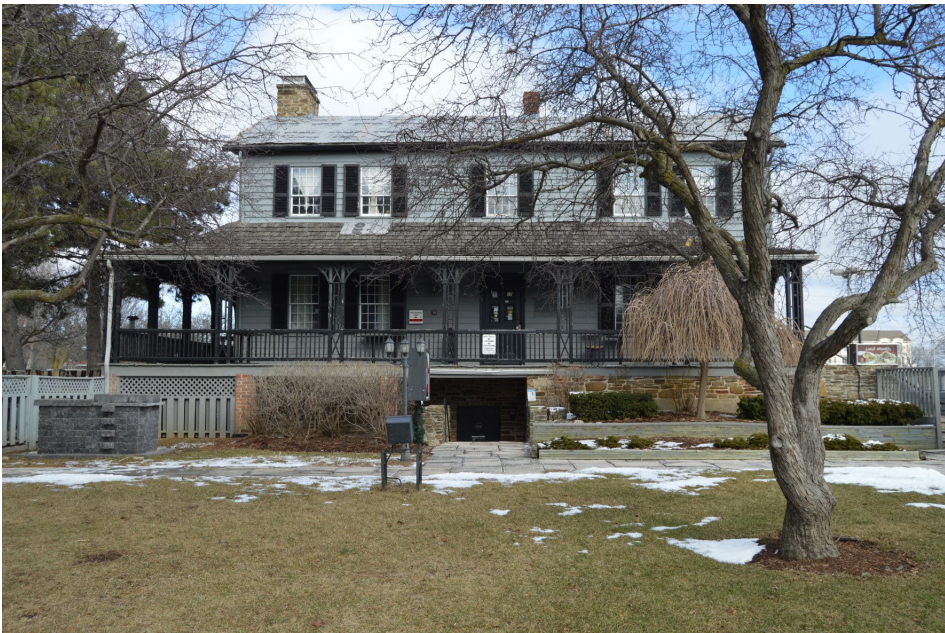
Fig. 18 Front facade (west elevation) of Cherry Hill House in 2023. Note the wood shingle cladding over the awning-form verandah roof and patches atop the wood shingle. The gable roof over the house's front part is shrouded with a tarpaulin.

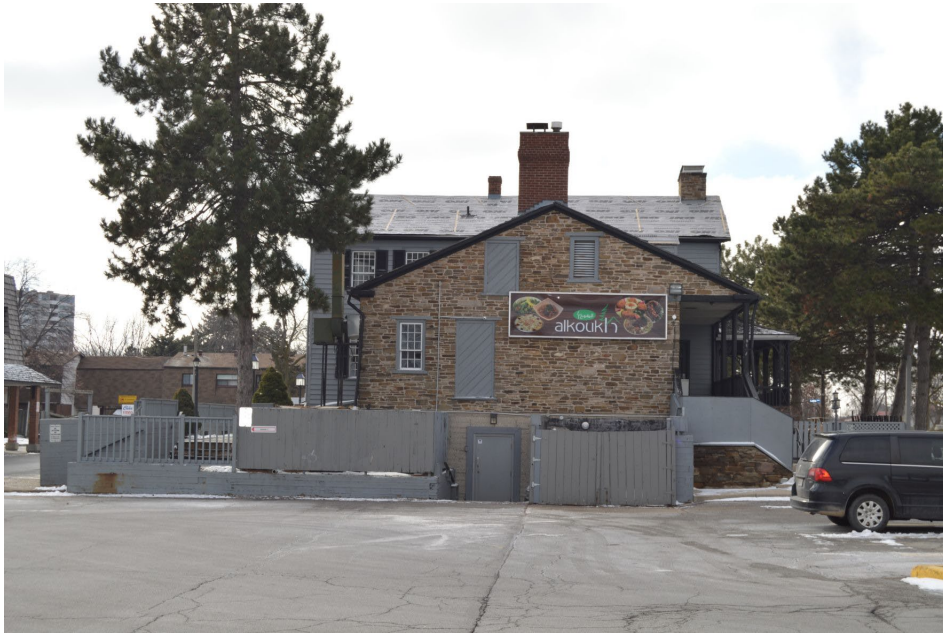
Fig. 22 East elevation facing the Silver Creek Plaza parking lot. Detracting from the elevation's visual appeal are the wood screen enclosures around the garbage collection area and mechanical equipment area, the solid balustrade along the stairs to the back wing's verandah and the large wall sign for the defunct restaurant.

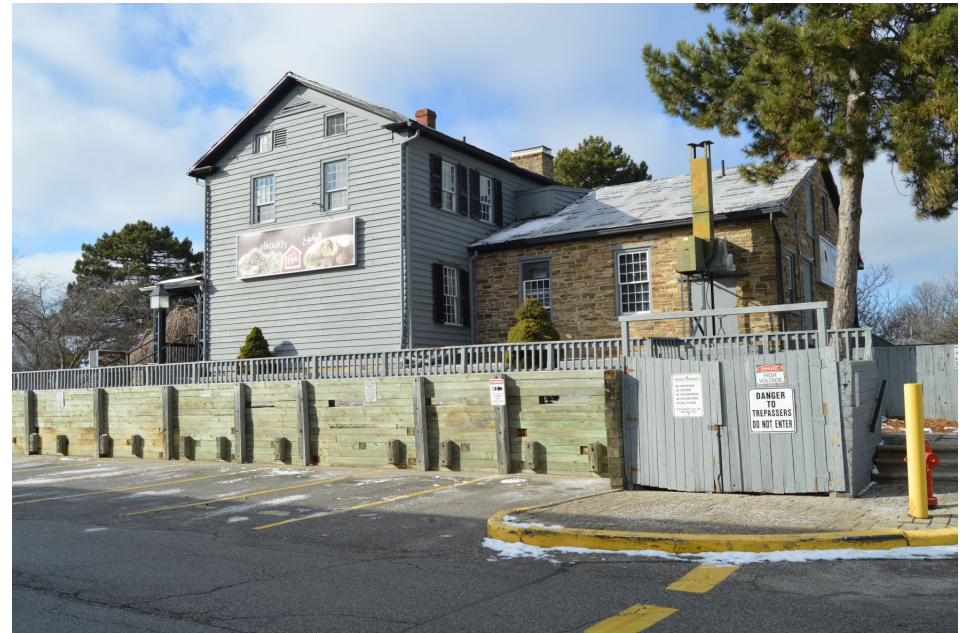
Fig. 23 Corner view, showing the south and rear elevations. The tarpaulin fitted over the back wing's gable roof is clearly shown. Note the unattractive wood screen enclosure for the mechanical equipment, the prominent metal vent on the back wing and another restaurant sign tacked onto the wall.

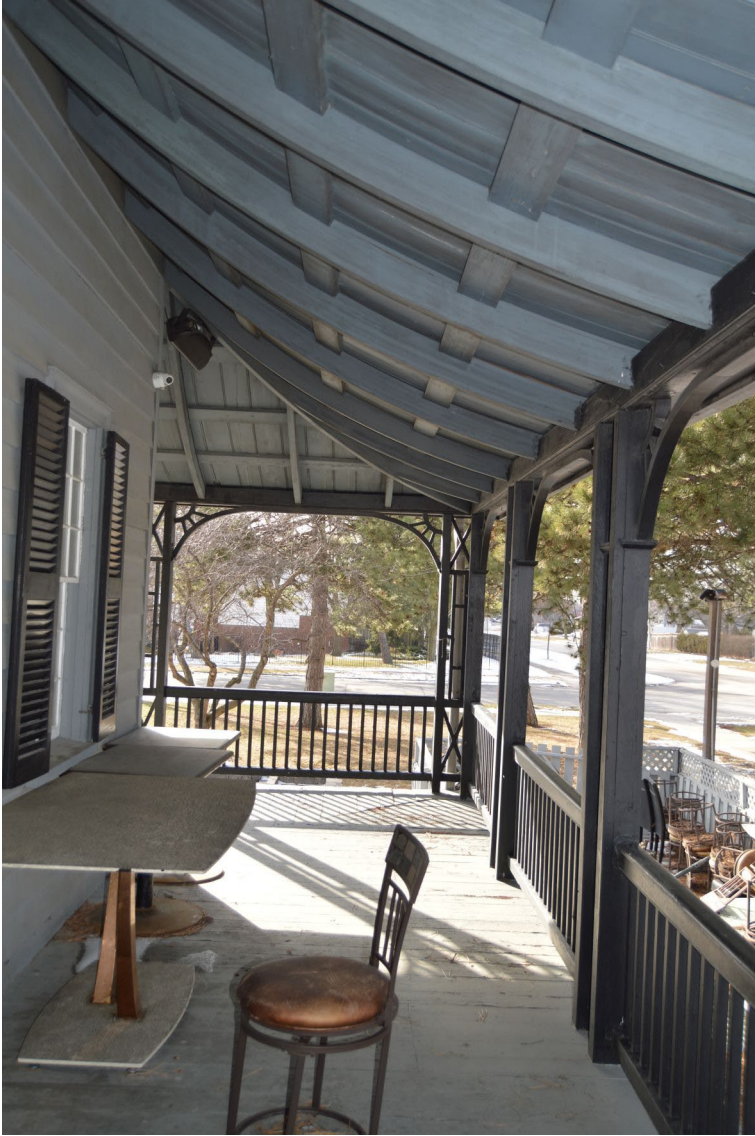
Fig. 26 Detail showing the verandah roof's wood framing in good condition. The view near the house's northwest corner looks west.

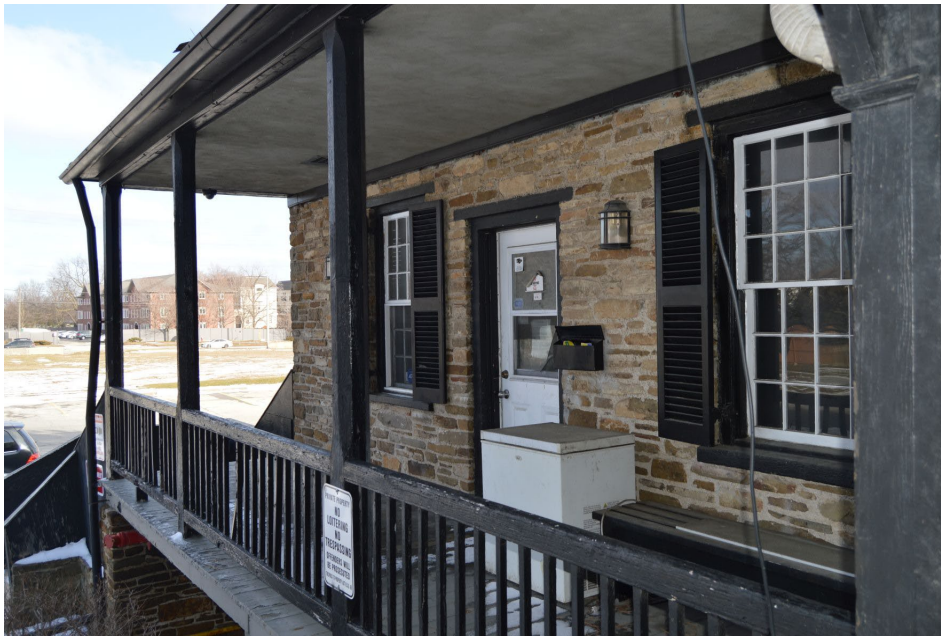
Fig. 28 View of the back wing's verandah in apparently good condition

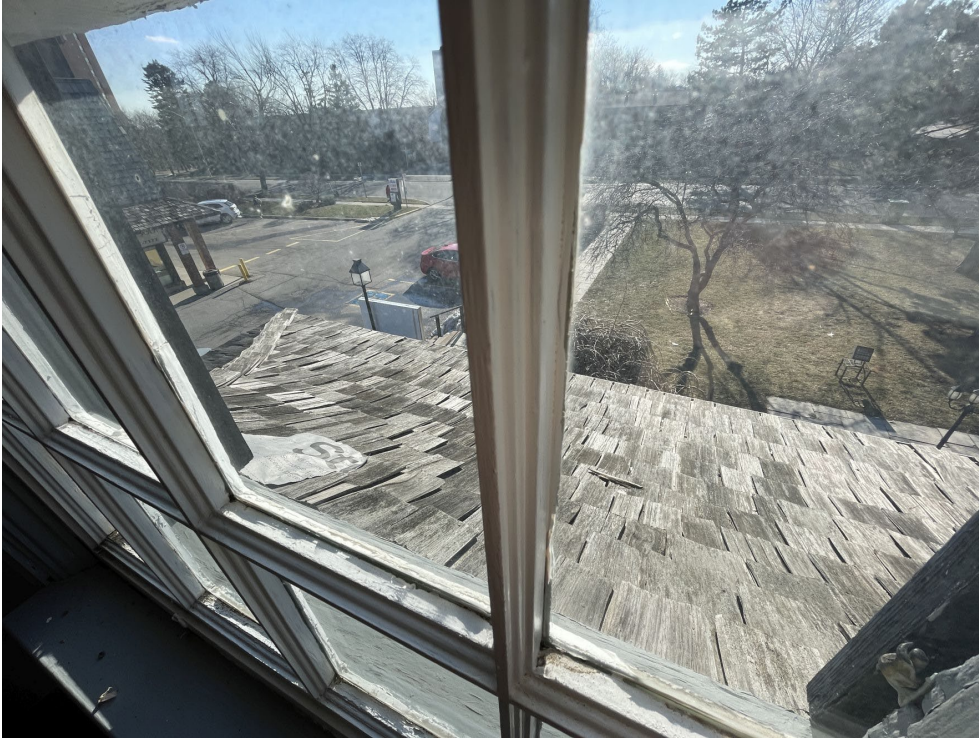
Inside the house, the verandah roof clad in weathered silvery-grey wood shingle can be better seen (Fig. 32). A hole in the upper floor's ceiling located near the building's west-facing front facade has likely been caused by raccoons (Fig. 33 and 34). The reconstructed A-frame attic over the house's front part is full of duct work (Fig. 35 to 38). The asbestos sheet specified in the engineers' drawings from the 1970s shows between boards in the attic ceiling (Fig. 39). Some of the asbestos is intact, and some is damaged (Fig. 40). Loose asbestos is also evident around what appears to be the stove pipe hole for the small brick chimney (Fig. 41). Like the front part's attic, the back wing's attic dates from the 1970s (Fig. 42).

Fig. 32 View from inside the building, looking west over the verandah roof with its weathered silvery-grey wood shingle cladding

The verandah roof is a 1970s recreation of the bent board-and-batten verandah seen in the 1877 lithograph. At some point in time, the deteriorated pine sheathing was overlain with cedar shingle; and it too is not performing. The existing cedar shingle is not attractive nor would its replacement with asphalt shingle complement the special awning-form roof. Reconstruction of the bent board-and-batten sheathing, while authentic, has the disadvantage of requiring high maintenance. The appearance of durable and long-lasting standing-seam steel roofing recommends it as a suitable replacement for the bent board-and-batten.

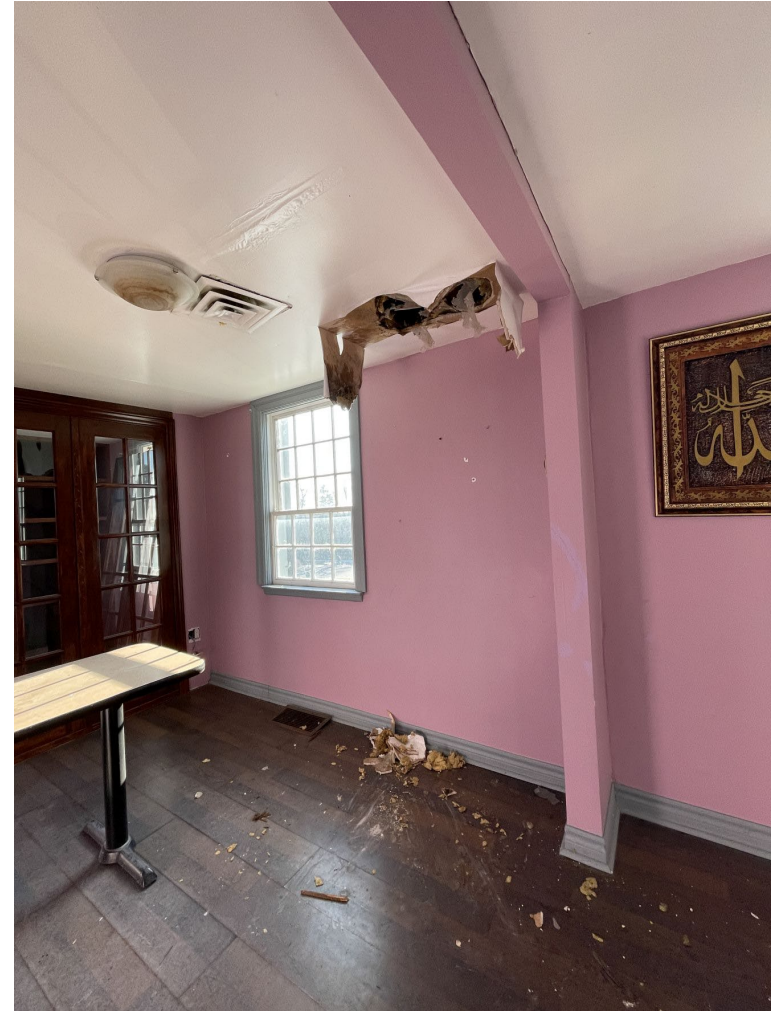
Fig. 33 Hole in the upper floor's ceiling near the building's west-facing front facade

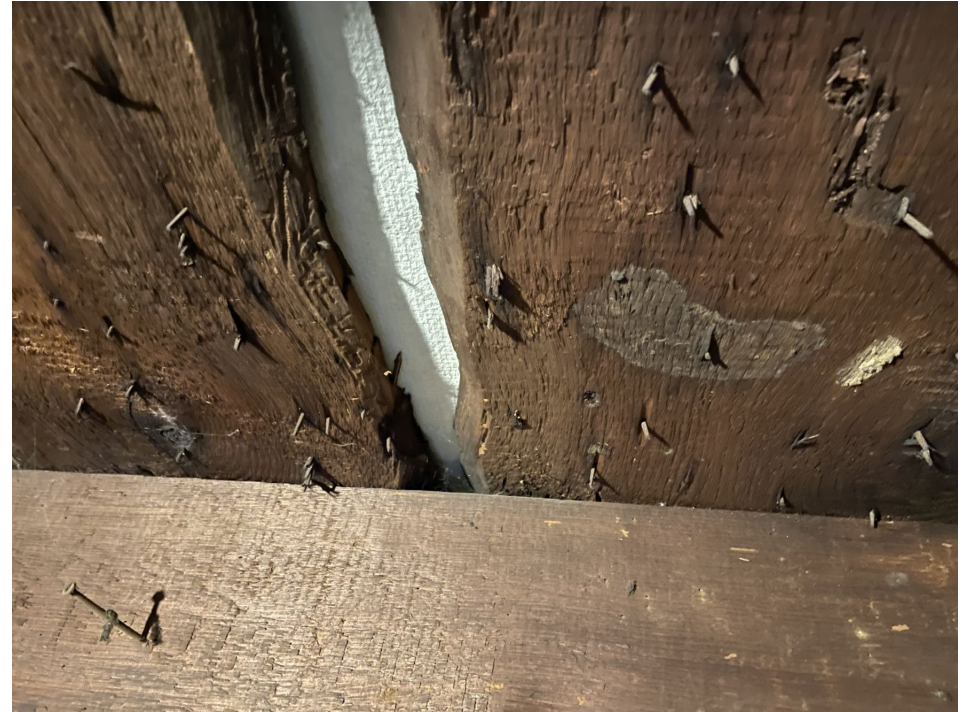
The main roofs have been laid in wood shingle (probably pine) as depicted in a lithograph from 1877, in asphalt shingle as shown in photographs from about 1930 and in cedar shingle when the house was rehabilitated in the 1970s. Unfortunately, as was common practice, the engineers who designed the house for its use as a restaurant specified a layer of asbestos sheet beneath asphalt felt and a covering of cedar shingles. Some of the asbestos sheeting is damaged, and all of it is a hazardous material.

Fig. 39 Detail of the same attic's ceiling, showing an intact sheet of asbestos between boards. Note the many nail punctures in the wood.

- BEFORE REMOVAL, CONTRACTOR IS TO GET INSTRUCTIONS TO PROPERLY REMOVE AND DISPOSE OF ASBESTOS SHEATHING UNDER THE EXISTING SHINGLES.
- REMOVE AND DISPOSE ALL EXISTING CEDAR SHINGLES ON DECKS ALONG WITH ALL METAL FLASHING AND EAVESTROUGHS AND DOWNSPOUTS. REPLACE ANY ROTTEN BOARDS AND CLEAN DECK THROUGHOUT.

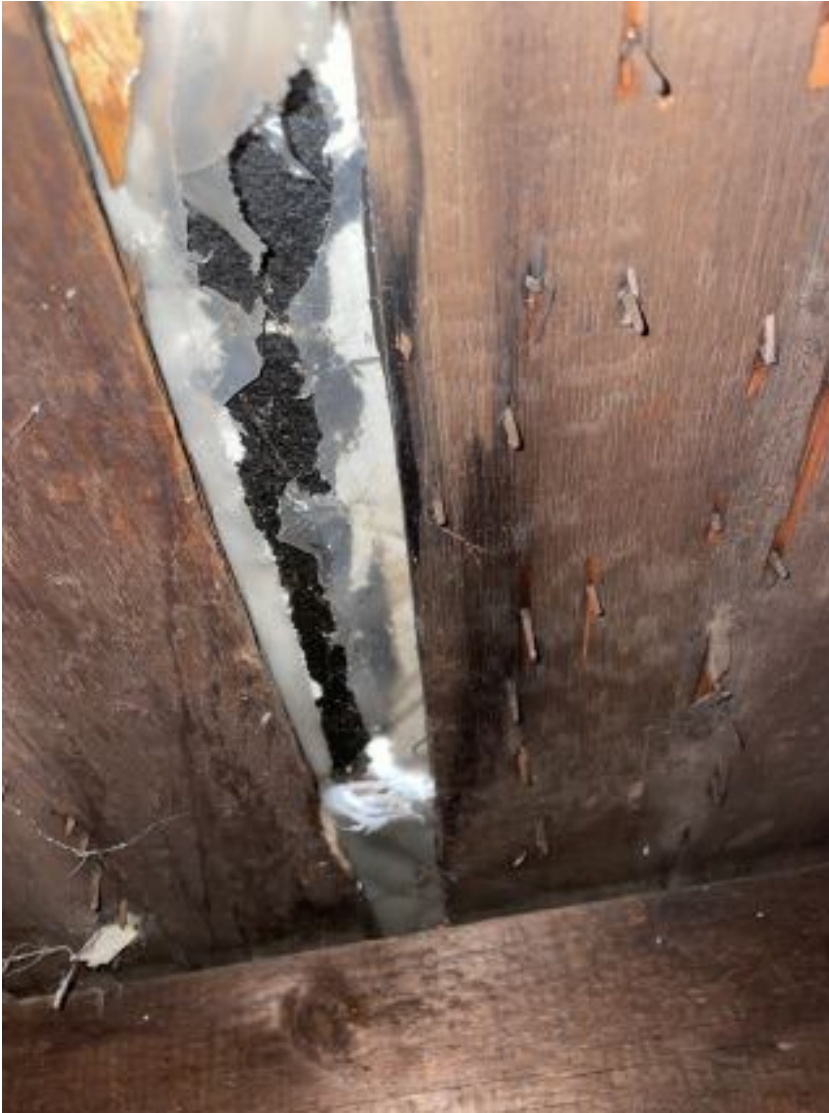
Fig. 40 Detail of the same attic's ceiling, showing a damaged asbestos sheet

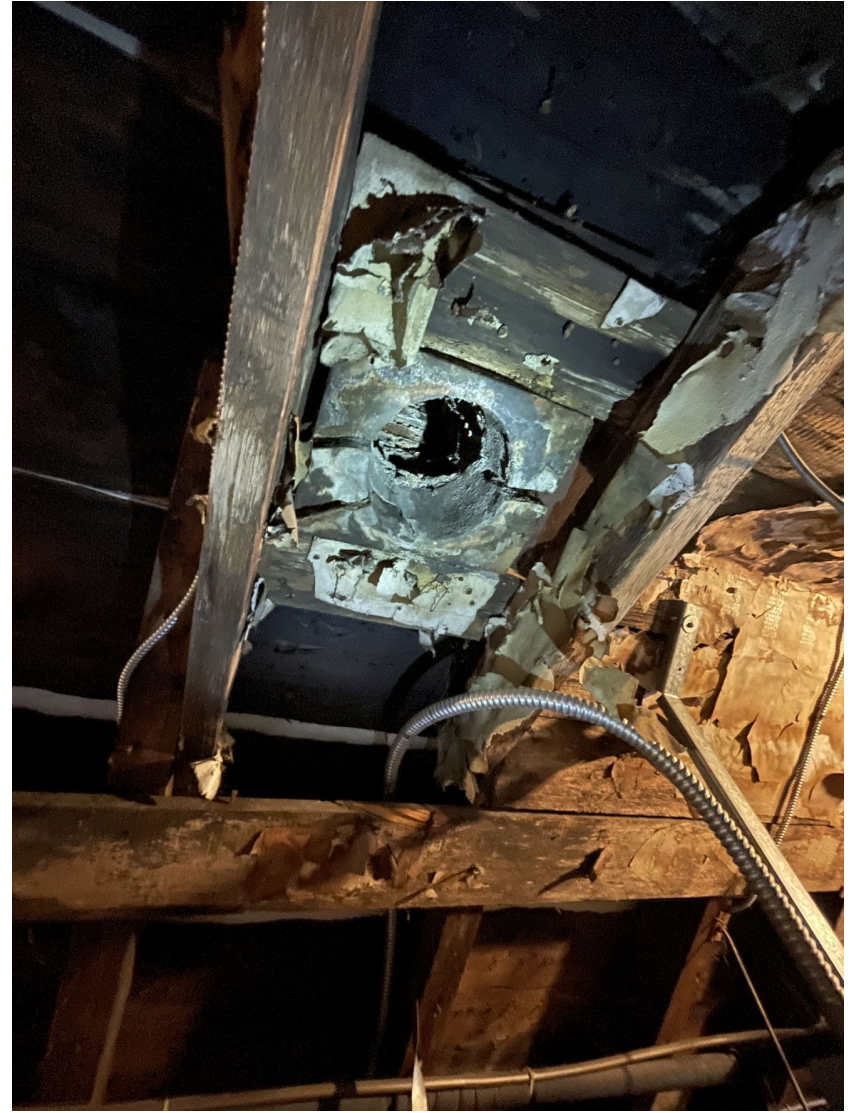
Fig. 41 Detail of the same attic's ceiling, showing loose asbestos around the stove pipe hole for the small brick chimney
