Britannia Church and Cemetery-5961 Hurontario Street

Security Services - Review and Recommendations

Date: May 20, 2020

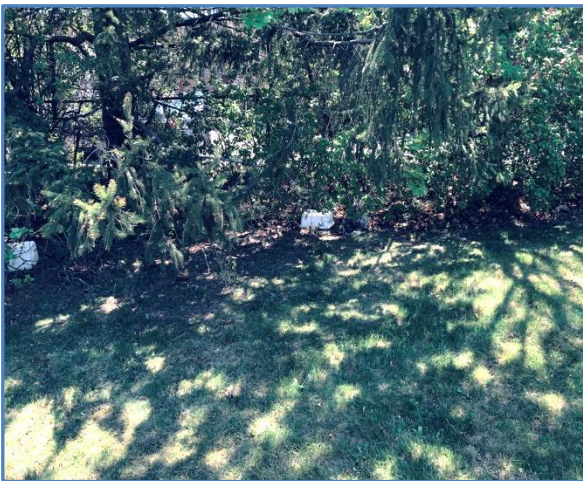
Debris and overgrown foliage found on the exterior of the property.

3. It is recommended that all overgrown foliage around the perimeter of the facility be trimmed or removed to accommodate better sight lines into the property from the neighbouring streets or

4. It is recommended that the debris/garbage scattered around the property be picked up and then properly maintained going forward.
5. It is recommended that the property fence line be inspected and repaired in areas where damage has occurred or possible entry points have been created.
6. It is recommended that the entry points to the property be secured with a lock during times when the facility is closed to the public.
7. It is recommended that exterior light fixtures be installed at the entrance to the property as well as exterior perimeter of the church.

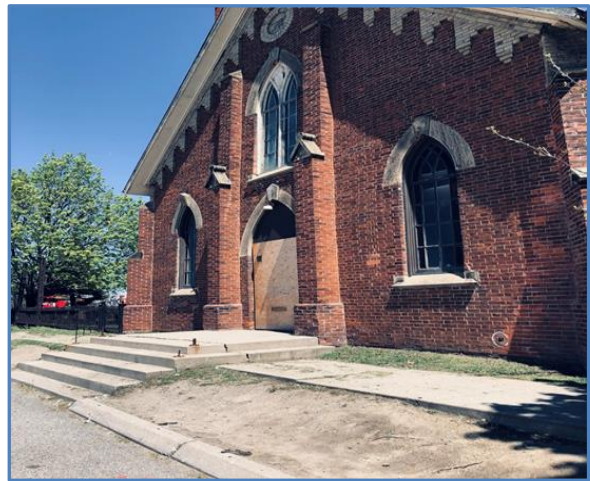
closed. The main entry into the church is blocked off by plywood and the main entry stairs are in need of repair. Appropriate signage indicating the closure of this property may provide the required notice and discourage inappropriate usage off the space. The gates remain open and there are no locking mechanism installed. On the exterior of the property, there are areas that will require some attention in order to enhance the space management principal, including; overgrown foliage, repair work to a number of sections in the perimeter fence, clean up of debris and garbage.

Front entry point to the church in need of repair or maintenance.
