## **Dixie Union Chapel and Cemetery**

**707 Dundas Street East, Mississauga Ontario**

## **Security Services - Review and Recommendations**

**Date: May 20, 2020**

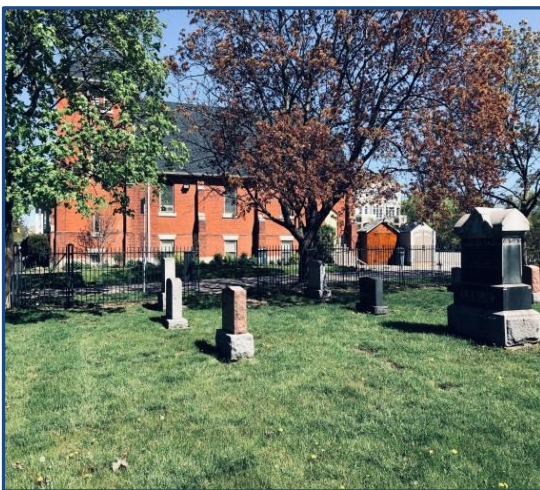
NW area of the cemetery

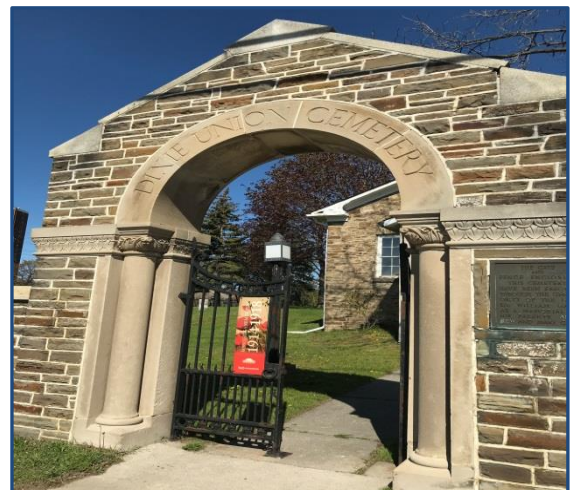
Main Entry gate to property off Dixie Rd.

2. It is recommended that the main access gate off of Dundas Street be secured with a lock during times when the facility is closed to the public.
3. It is recommended that a wireless intrusion detection system consisting of door contacts, motion sensors and glass break sensors be installed in the chapel structure in areas with accessible entry points such as doors and windows to provide a layered intrusion detection system at this facility. The recommended wireless intrusion detection system will consist of the following;

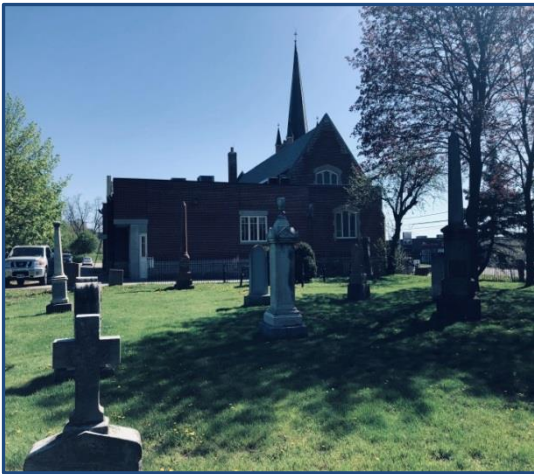
NE area of the cemetery

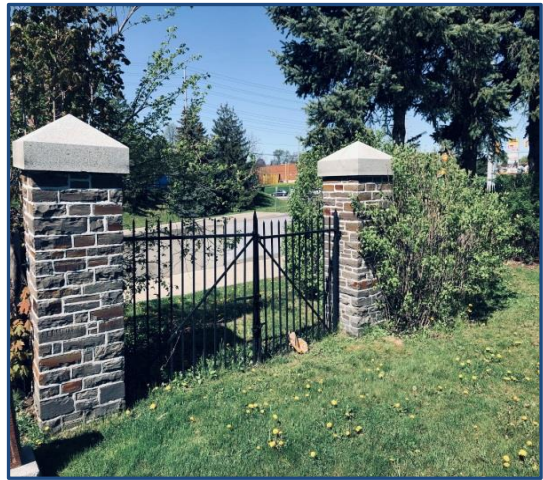
West access gate of off Cawthra

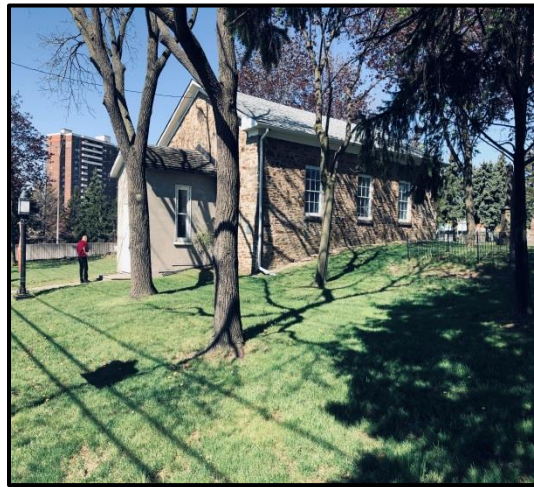
West side of Dixie Chapel

The area at the back of the chapel and the west perimeter is more secluded and there is very minimal natural surveillance into these areas. The west perimeter has some overgrown foliage which further reduces the natural surveillance prospect into the property.

4. It is recommended that all overgrown foliage around the perimeter of the facility be trimmed or removed to accommodate better sight lines into the property from the neighbouring streets and properties.
5. It is recommended that the property fence line be inspected and repaired in areas with damage or possible entry points.

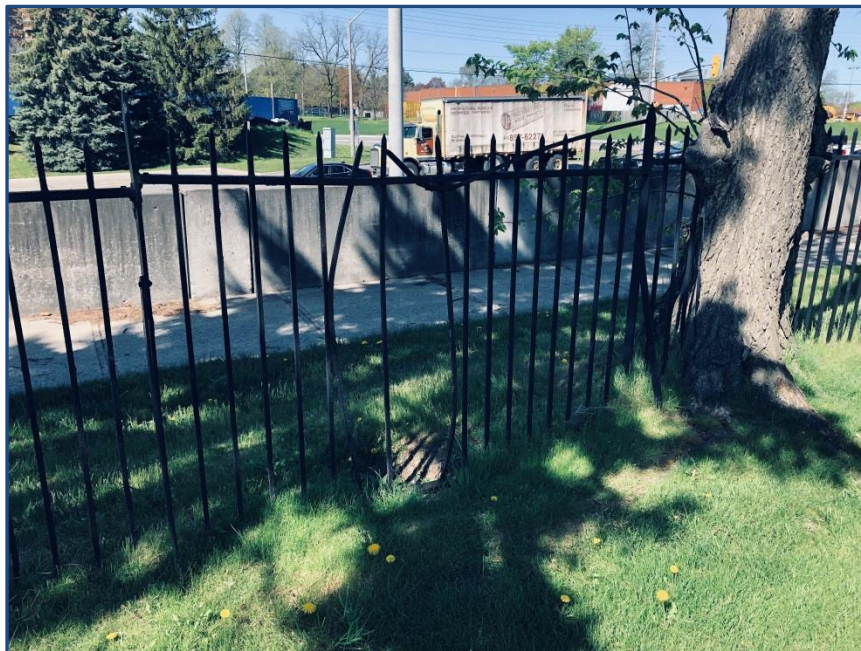
Damage in the perimeter fence line providing a vulnerable access point onto the property

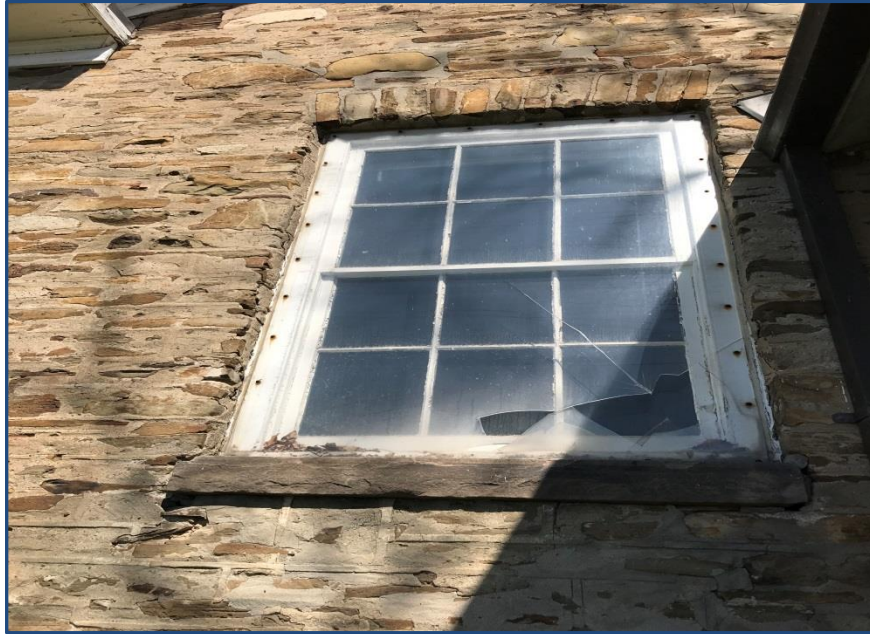
Damaged Plexi window pane recommended for replacement

6. It is recommended that exterior light fixtures be reinstated at the entrance to the property as well as exterior perimeter of the chapel.
7. It is recommended that the exterior Plexi window pane that was found broken during the site visit be replaced or repaired.
