**Subject:** Vehicle Impact to a Residential Building – Structural Assessment  
**Your File:** R1032796  
**Loss Date:** April 07, 2024  
**Location:** 18 John Street South, Mississauga, Ontario  
**Reference:** Ryan McDonough & Paula Galli  
**Our File:** AC40404

**Report Date:** April 18, 2024  
**Prepared by:** Mr. Gustavo Estrada

## Structural Assessment Report

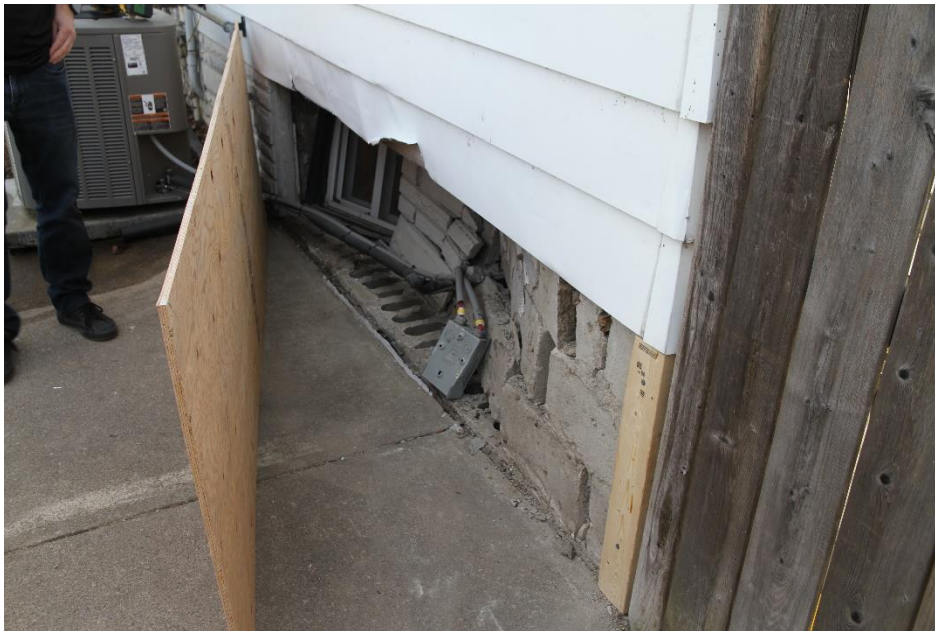
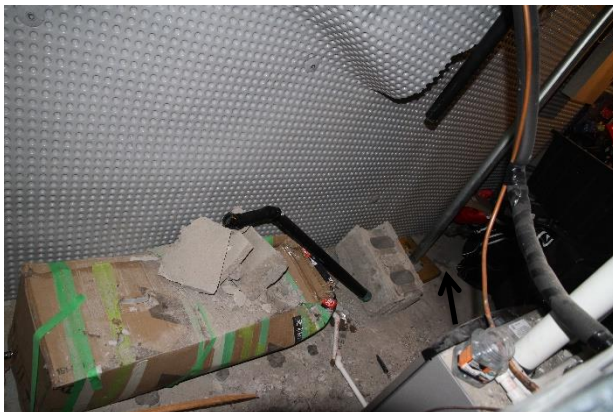
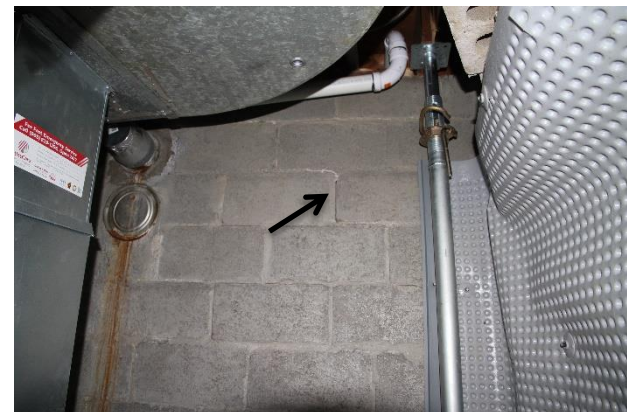
The impact-related structural damage was localized at the west foundation wall, near the southwest corner of the basement. An approximately 8-foot-long section of the south foundation wall, comprising the above-grade top 3 concrete block masonry courses and a window assembly, had been dislodged and displaced several inches eastward (into the basement). Several masonry units, including fractured sections, were also laying on the basement floor adjacent to the affected area. Some of the mortar joints at a section of the south foundation wall adjacent to the affected area were cracked.

**Figure 1 – Exterior view of the affected area, debris in the basement, and mortar cracks at the south wall.**

2. Any damaged concrete block masonry units in the affected area that still form part of the wall shall be removed, along with any displaced, undamaged units. Undamaged concrete block masonry units and new units of equal dimensions shall be used to reconstruct the damaged section of the foundation wall, matching the existing course pattern;

3. Any mortar cracking surrounding the affected area shall be repaired as required. The affected foundation area shall be provided with new thin stone veneer to match existing conditions prior to the vehicle impact;

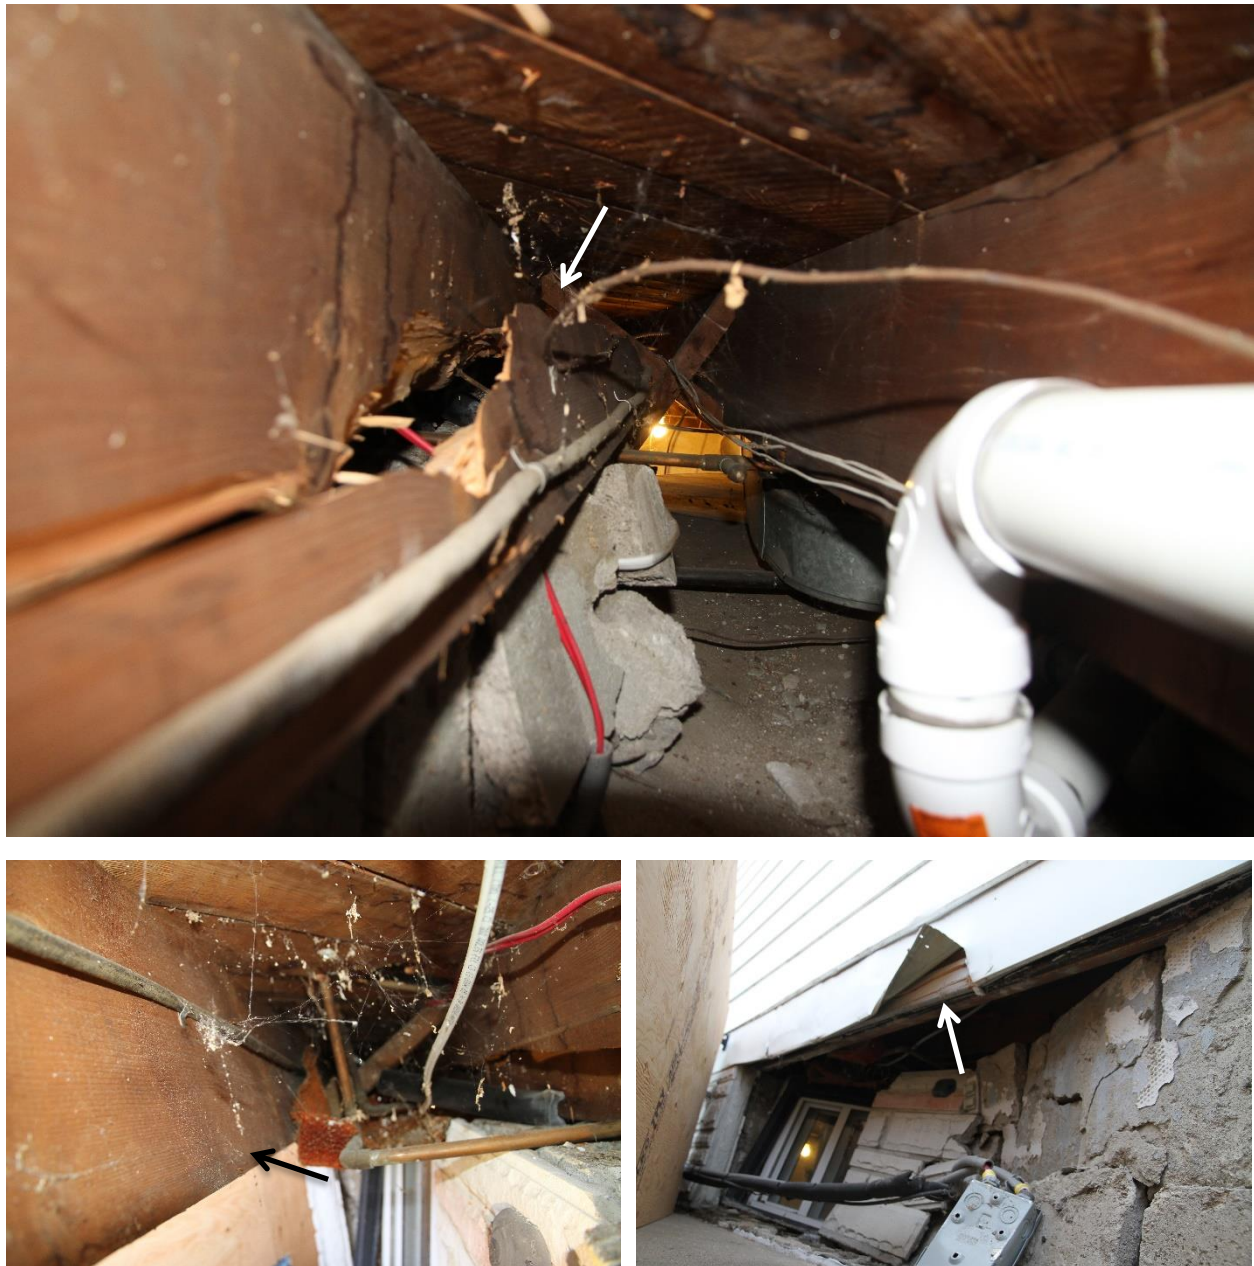
In addition to the damage to the foundation wall, the floor joist adjacent to the rim joist above the affected west foundation was split and fractured. The bottom portion of the noted rim joist had been slightly displaced eastward, and an attached wood nailer for the aluminum siding was split. The bottom piece of aluminum siding was dented above this area; however, the Contractor tore and lifted this portion to access the framing behind. We could not confirm the condition of the wall sheathing above the affected area.

**Figure 2 – Views of damaged floor joist, slightly displaced rim board, and split wood nailer on the rim board.**

4. The split and fractured floor joist shall be removed and replaced with either a new 2x12 wood member of equal length, ripped to match the original joist depth, or with a new 2x10 wood member of equal length, complete with wood blocking/shimming at the bearing points to ensure a tight fit;

5. The slightly displaced section of the rim board shall be re-aligned as required. New solid wood blocking at mid-span shall be installed between the rim board and the new adjacent floor joist;

6. The Contractor shall confirm the condition of the wall sheathing and air barrier above the affected area and repair or replace as required with new materials matching the existing performance level;

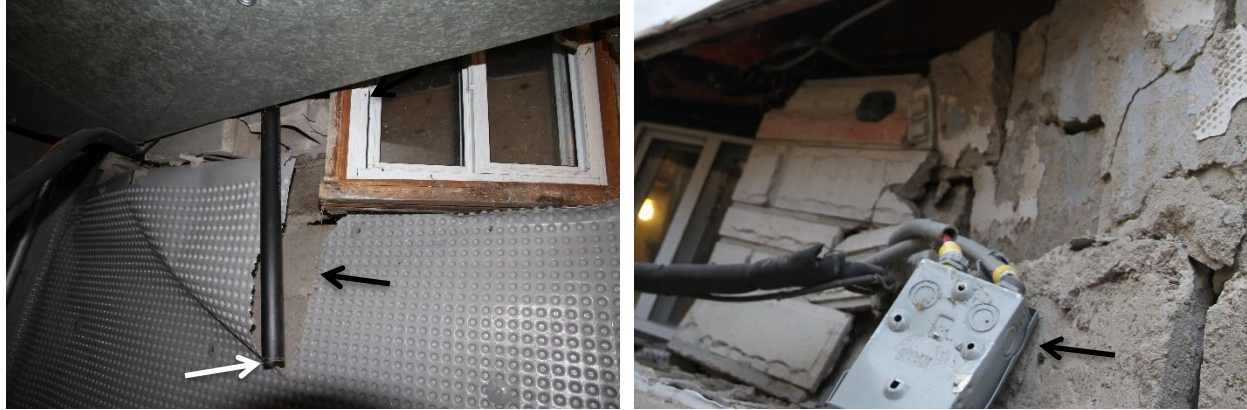
The interior side of the involved foundation wall was covered from grade-height down to the floor with a dimpled plastic moisture barrier. A section of the noted barrier was ripped within the affected area. Other

non-structural elements of the building included severed sections of plumbing pipes, and damaged exterior electrical outlets/connectors.

**Figure 3 – Views of some of the non-structural damage observed within the affected area.**

7. Any damaged or removed exterior and interior finishes within or surrounding the affected area shall be restored to their original condition prior to the vehicle impact incident.
