HIA ADDENDUM

1141 CLARKSON ROAD NORTH
City of Mississauga

30 APRIL 2024

**RE: 1141 Clarkson Rd N, Mississauga
 Structural Condition Assessment & Moving Feasibility Study**

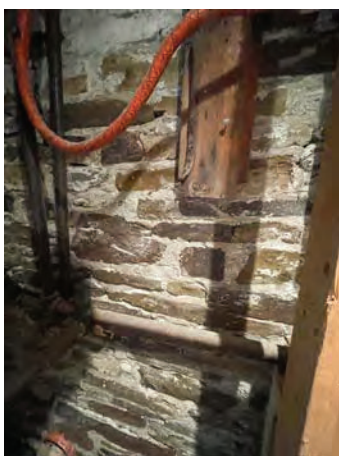
Recent site investigation undertaken by Jonathan Dee and Sarah Francisca of John G. Cooke & Associates has revealed that the historic portion of the building is 'rammed earth' construction with a stone foundation and stucco exterior. Previous information, including the 1936 *Fire Insurance Plan* indicated that the building was wood frame with a stucco exterior. Selective openings were made in the exterior walls to confirm the assembly. The Engineer's Report outlining their findings is included in the appendix of this report.

stone foundation

Rammed earth construction was not uncommon in rural Ontario but few examples have survived or have been identified, making this an interesting and rare example of this type of construction in the City of Mississauga. The walls of the historic portion are monolithic and approximately 10 inches thick. They appear to have been formed using a mix of earth, sand and gravel with lime and natural cement used as a binder. A number of locations in the walls and ceilings were opened to confirm the assembly and the condition of the exterior load bearing walls was generally found to be good. Therefore, the structural engineer is confident that the proposed relocation is feasible but has noted that it will require careful removal of the 20th century additions and installation of temporary supports during relocation. It is critical that the wall assembly remains dry and protected from the elements. This protection is currently provided by the exterior stucco and the overhanging roof but areas exposed when the additions are removed will need to be temporarily protected and then patched with compatible lime stucco.

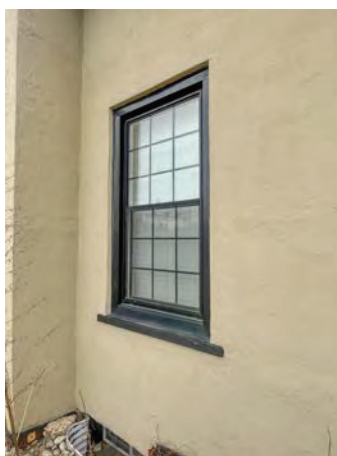
stucco exterior

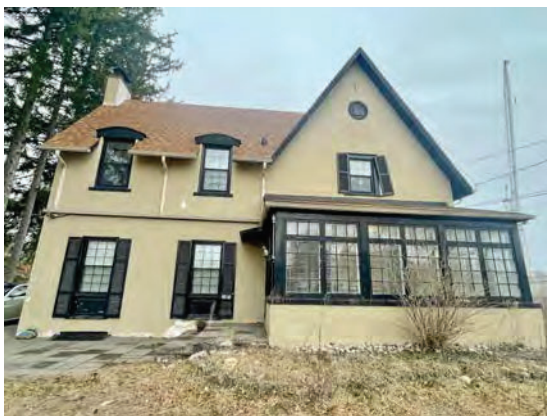
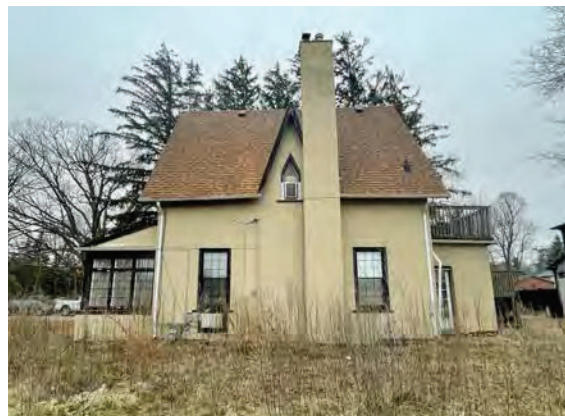
CURRENT CONDITIONS - the front and south side elevations of the vacant heritage building

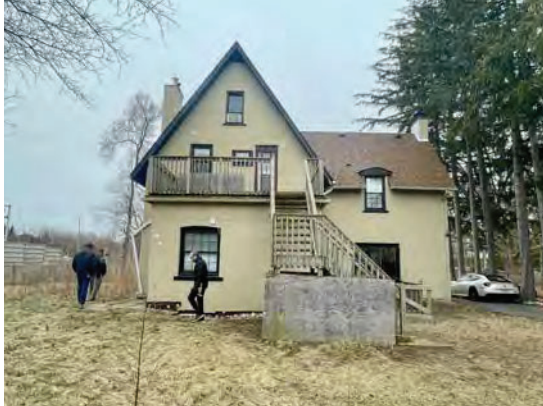
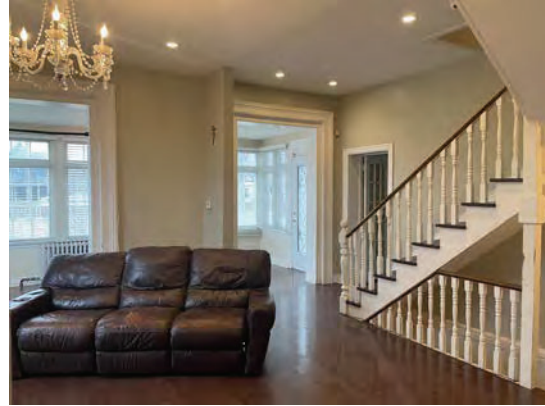
CURRENT CONDITIONS – rear elevation and interior

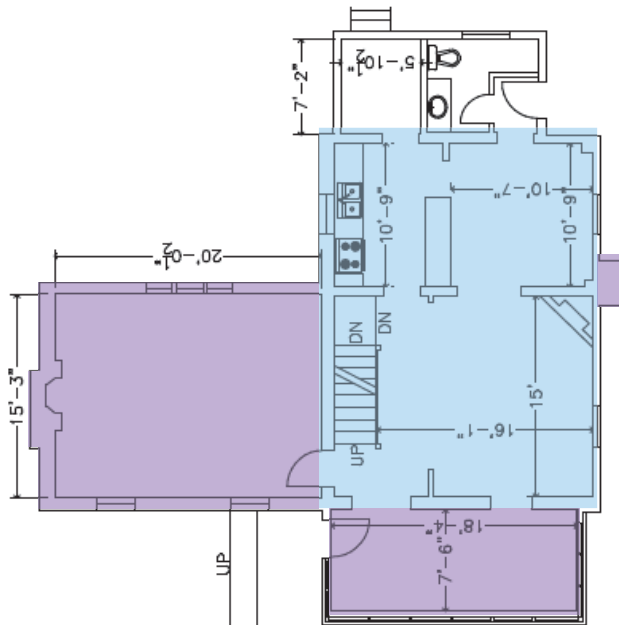
EXISTING 1ST FLOOR PLAN

- Clarkson portion, c.1860s - to be retained & relocated
- Paisley additions, c.1930s – to be removed
- Modern addition – to be removed

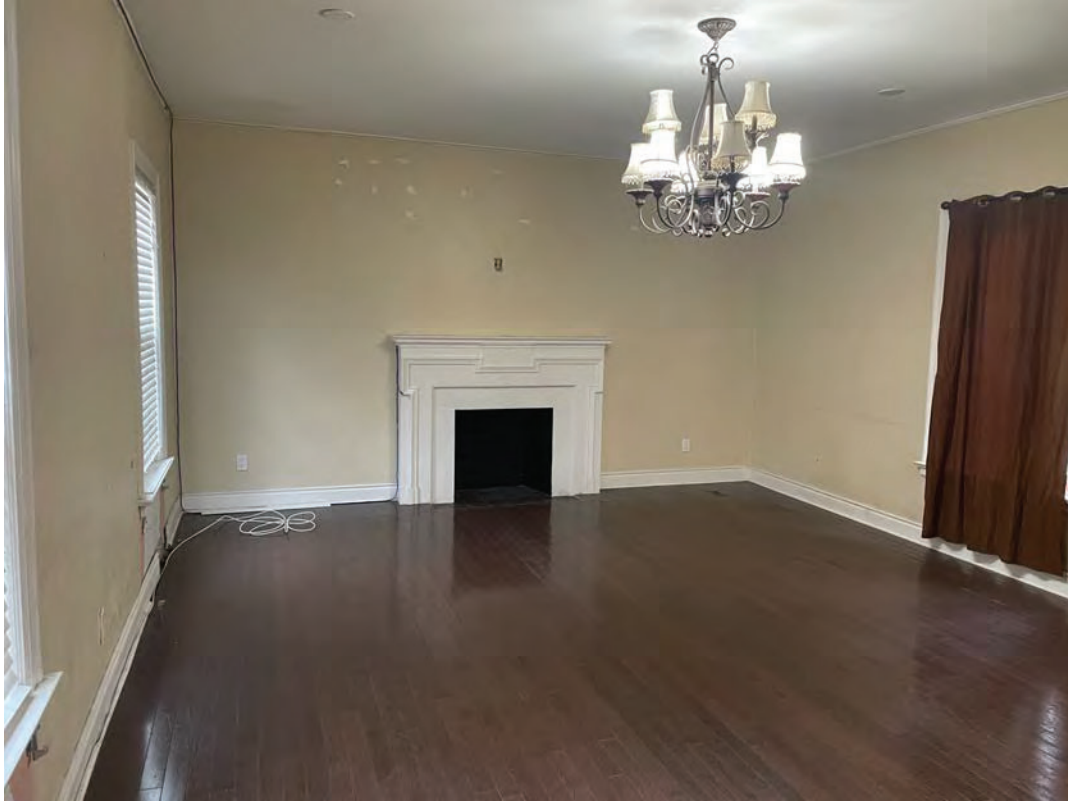
INTERIOR – 1ST FLOOR – ADDITION TO BE REMOVED – FIREPLACE WITH STONE OR CONCRETE SURROUND

The removal of the 20th century additions is not reversible but, as already noted, these additions are not protected under the *Designation By-law*. Retention of the round window in the gable on the front elevation is intended to preserve an element of the Paisley layer that is being removed and the two stone fireplaces in the c.1937 Paisley addition will be salvaged.

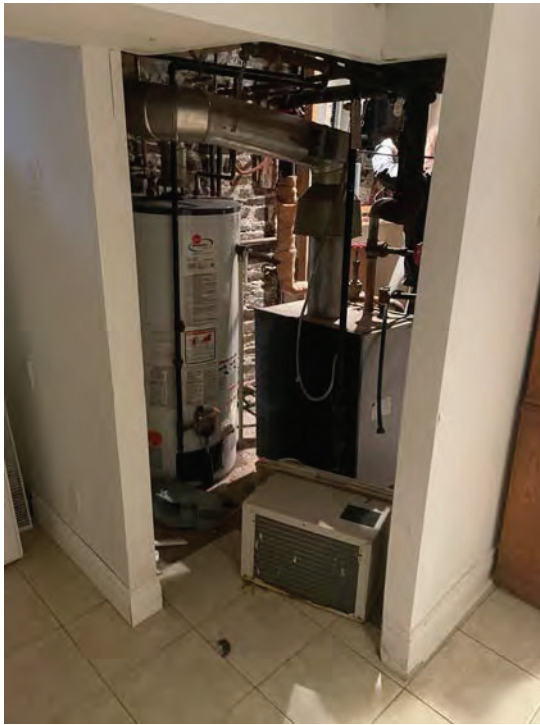
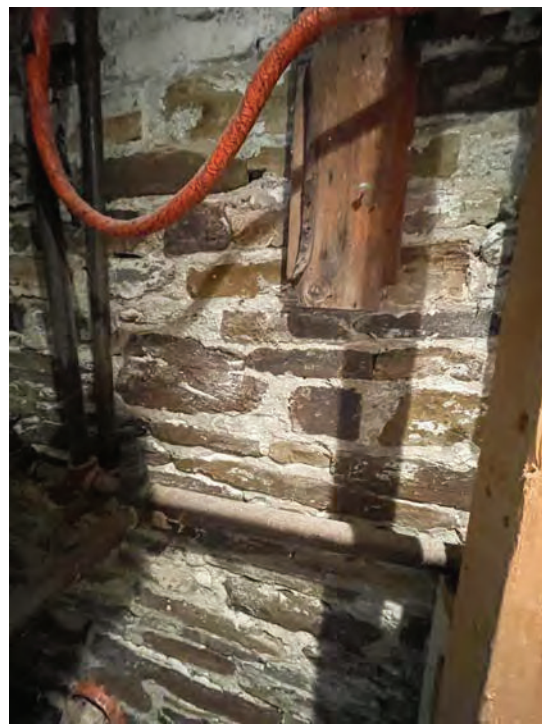
BASEMENT – FURNACE – IRREGULARLY COURSED STONE FOUNDATION WALL VISIBLE IN THIS AREA

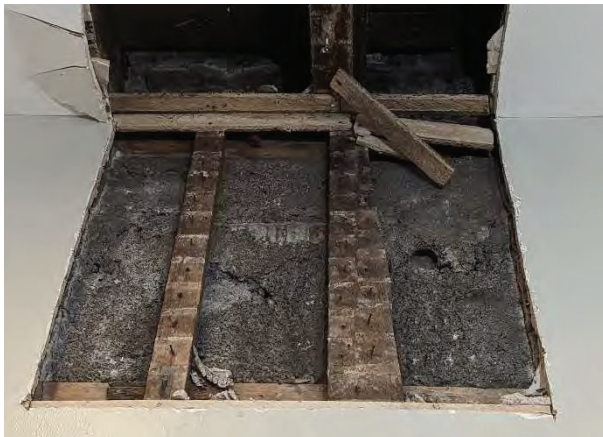
Photo #5: East exterior wall at the underside of the second floor as exposed from the interior face [JCAL 2024]

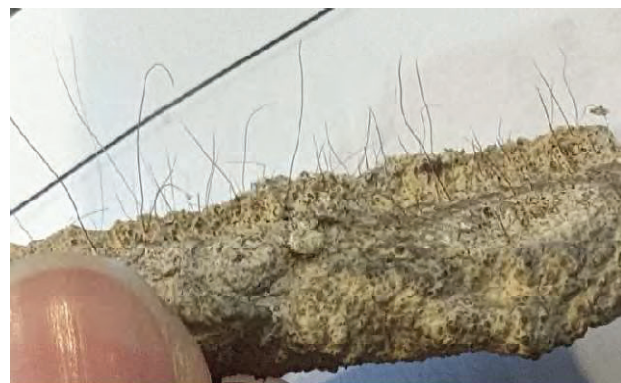
Photo #8: Animal hair observed in interior wall plaster, typical [JCAL 2024]

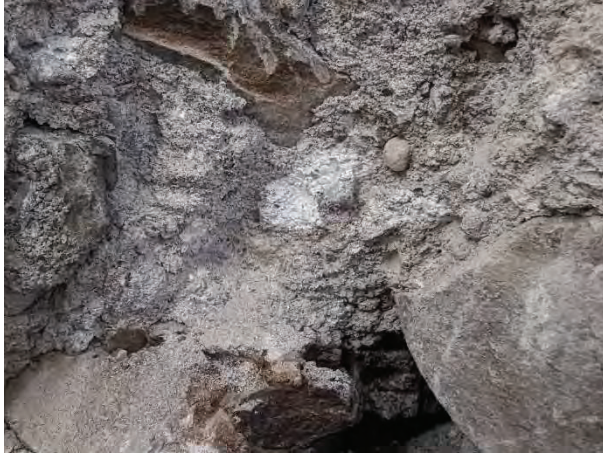
Photo #9: Typical area of concrete-masonry wall showing localized stones embedded randomly in a cementitious matrix [JCAL 2024]

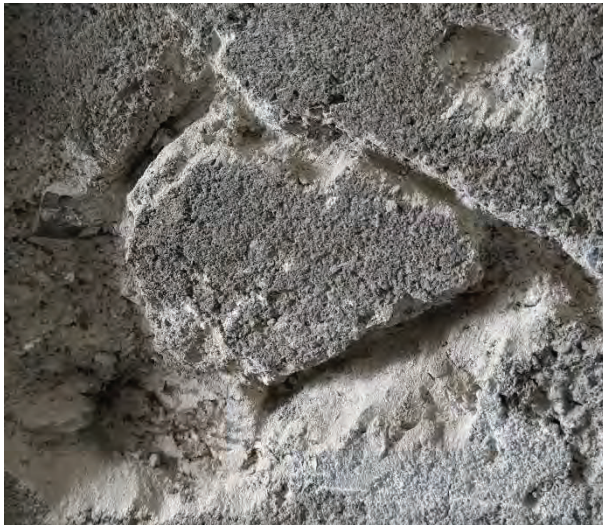
In general, the exterior walls appeared to be in overall fair-to-good condition; however, the lack of homogeneity and softness of the walls will pose a challenge during any move. It is also evident that the exterior walls have been exposed to significant levels of moisture over the years, as indicated by a rotted joist end embedded into the exterior walls (see Section 3.2 below) and areas of past parging repairs, moisture staining, peeling paint and cracking in the exterior finishes (see Photos #13-14). It should be kept in mind that the parging, and especially previous repairs, may be hiding issues with the underlying wall.

Photo #11: Easily damaged concrete-masonry wall with hand tools, typical [JCAL 2024]

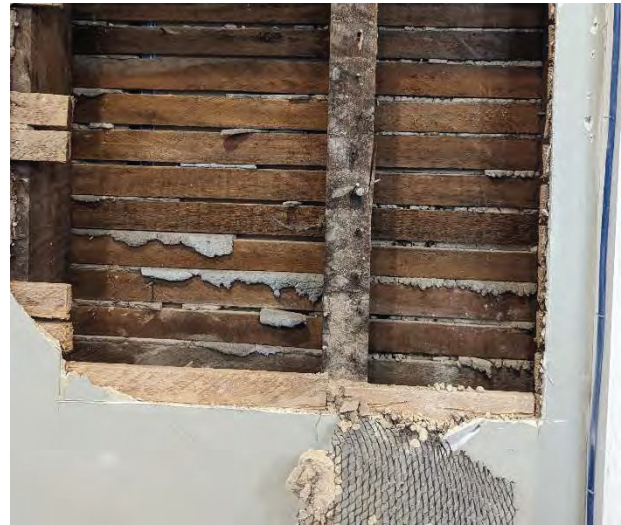
The interior partition walls were wood-framed, comprised of $\pm 2"$ x $\pm 4\text{-}1/4"$ rough-cut wood studs spaced at approximately 16 inches on center, with horizontal wood lath nailed to the studs with round headed nails, and covered with plaster reinforced with animal hair and/or wire mesh (see Photo #12). In general, the interior partition walls appeared to be in overall good condition for their age with no signs of structural distress.

Photo #12: Interior partition wall construction between kitchen and living room [JCAL 2024]

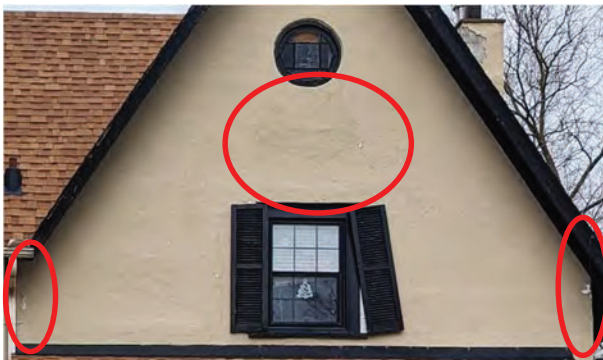
Photo #13: Previous parging repairs, and cracked/peeling parging/paint on the West Elevation [JCAL 2024]

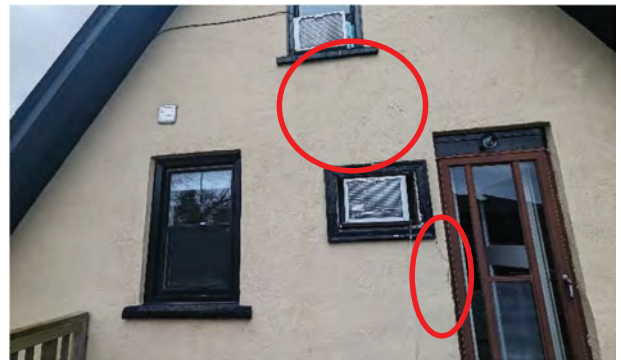
Photo #14: Cracked parging and moisture staining on the East Elevation [JCAL 2024]

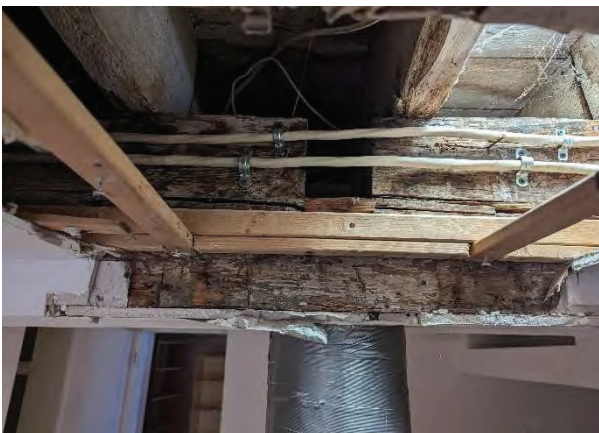
- The first-floor framing appears to be comprised of $\pm 2\text{-}\frac{1}{2}$ " x ± 10 " wood joists running in the east-west direction, spaced at approximately 16 inches on center, and supported by the exterior walls on one end (not observed) and a ± 10 " wide by $\pm 11\text{-}\frac{1}{2}$ " deep wood beam supported by an $\pm 8\text{-}\frac{1}{2}$ " diameter wood column with unknown footing at mid span (see Photo #15). The joists were observed to be butt-jointed over the beam, and the beam had a large ± 4 " wide by $\pm 6\text{-}\frac{1}{4}$ " deep notch in its top face, directly above the column (see Photo #16). It is suspected that the beam and joist ends are embedded into and supported by the stone foundation walls. The joists span between approximately $\pm 10\text{'-}9$ " to $\pm 15\text{'-}3$ ", and the beam spans approximately 8 feet.

Photo #15: First-floor framing showing the wood joists supported by a notched wood beam and a circular wood column [JCAL 2024]

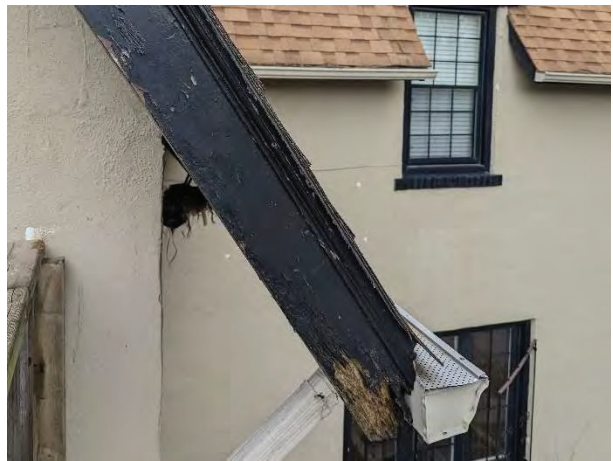
Photo #20: Rotted rafter ends [JCAL 2024]

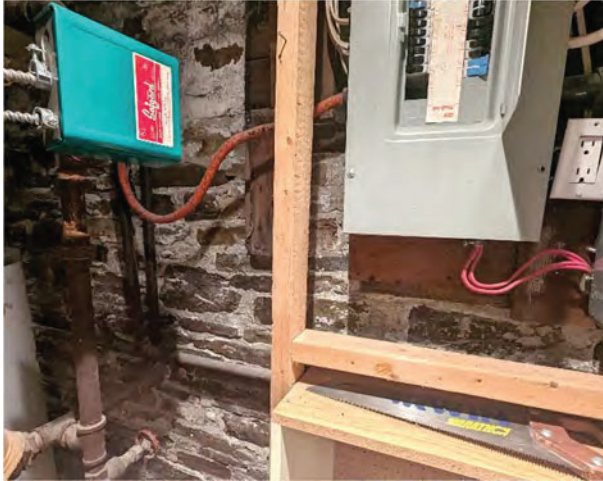
The foundation walls were observed to be constructed of multi-wythe rubble stone masonry, measuring approximately 20 to 24 inches thick (see Photo #21 as observed in the water heater room). We did not identify any obvious concerns with the foundations, however, since the building is intended to be moved to new reinforced concrete foundations, we did not review them in detail. The construction and condition of the observed walls is otherwise typical of foundation walls built in this period, and masonry conservation would be required if they were to remain in use (i.e. repointing of failed mortar joints, local rebuilding, and consolidation of the wall core).

Photo #21: Original stone foundation wall [JCAL 2024]
