Project:
Exterior Maintenance Alumni House
 1550 The Collegeway
 Mississauga, ON

Sheet Title:
WEST ELEVATION NORTH ELEVATION CONSERVATION NOTES

Drawing No:
 A1.1

Project: **Exterior Conservation Alumni House**
1550 The Collegeway
Mississauga, ON

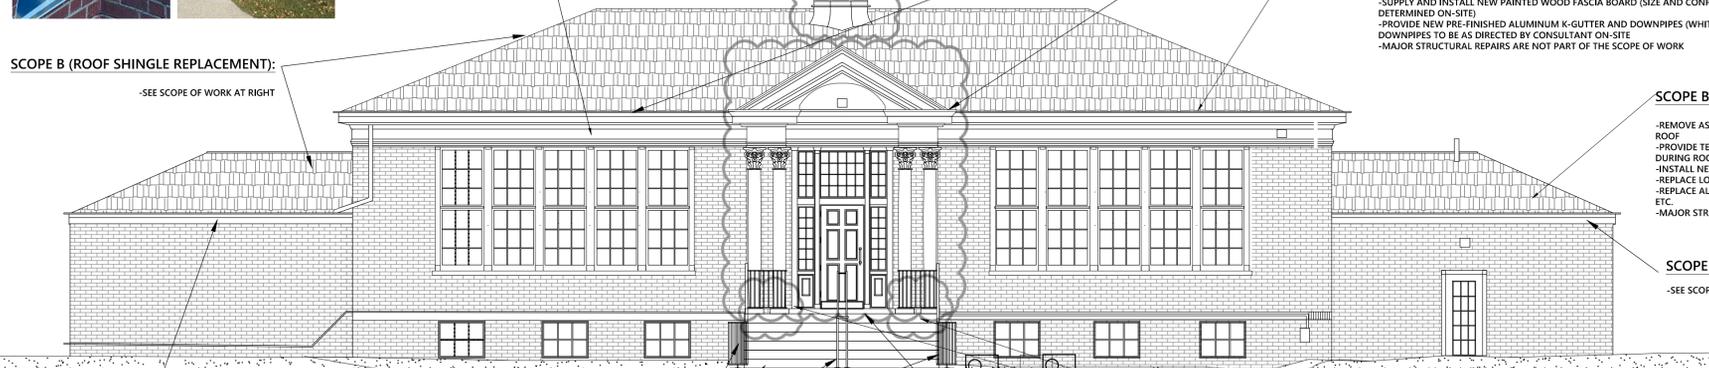
WEST ELEVATION
 SCALE: 1:100

SCOPE F (REFINISHING OF WOOD TRIMS @ ROOF):
 -WOOD TRIMS AT UPPER CORNICE, SOFFIT AND CUPOLA SHOW OBVIOUS SIGNS OF DETERIORATION, GAPPING, OPEN MITERS AT CORNERS, ETC. PREVIOUS PAINT REPAIRS ARE PEELING AND FLAKING OFF. DETERIORATION OF SOFFIT BOARDS IS VISIBLE AT VARIOUS AREAS AT UPPER ROOF. CONTRACTOR TO INSPECT, SCRAPE, REPAIR AND RE-FINISH PER CONSERVATION PLAN.
 -SCOPE OF WORK IS EXPECTED TO INVOLVE SCRAPING, PAINTING AND CAULKING OF CUPOLA AND TRIMS AROUND THE UPPER ROOF. REMOVAL AND REPLACEMENT OF UP TO 50% OF THE SOFFIT AND TRIMS ALONG THE WEST SIDE OF THE BUILDING. REMOVAL AND REPLACEMENT OF MINOR QUANTITIES (NOT MORE THAN 10% OF OVERALL) OF DETERIORATED SOFFIT AND TRIMS ELSEWHERE ON THE UPPER ROOF. AND NECESSARY REPAIRS TO THE BUILDING FRAMING TO EFFECT THE REPAIR AND REPLACEMENT DESCRIBED ABOVE
 -NO REPLACEMENT OF MATERIALS IS EXPECTED ON THE CUPOLA
 -MATCH ALL REPLACEMENT TRIMS AND OTHER MATERIALS TO EXISTING

-LEAKING AND DETERIORATION VISIBLE AT SOFFIT AT VARIOUS AREAS AT UPPER ROOF INCLUDING AROUND FRONT PORTICO. LEAKAGE APPEARS TO BE COMING FROM CONCEALED GUTTER DETAIL ABOVE.
 -CONTRACTOR TO MODIFY PERIMETER OF ROOF TO ABANDON CONCEALED GUTTER DETAIL AND TO CREATE NEW EXPOSED GUTTER DETAIL PER DRAWING
 -REMOVE PERIMETER WOOD TRIM AT EDGE OF ROOF AND AS MUCH AS OF THE CONCEALED GUTTER ASSEMBLY AS NECESSARY TO EXPOSE STRUCTURALLY SOUND FRAMING MEMBERS
 -REPLACE SMALL AREAS OF DETERIORATED MATERIAL (AFFECTING NOT MORE THAN 10% OF THE LINEAR LENGTH OF GUTTER TO BE REPLACED)
 -REMOVE 1/2" OF ASPHALT SHINGLES AROUND PERIMETER OF ROOF TO EXPOSE EXISTING SHEATHING
 -REMOVE AS MUCH EXISTING SHEATHING AS REQUIRED TO ALLOW NEW SHEATHING TO BE BLENDED SEAMLESSLY TO OLD
 -TYPICAL CONCEALED GUTTER DETAIL IS PROVIDED FOR REFERENCE. ACTUAL CONDITION MAY DIFFER
 -SUPPLY AND INSTALL NEW BLOCKING, PLYWOOD SHEATHING, ETC. ALONG EDGE OF ROOF AS PER DETAIL

NOTE DETERIORATED AND LEAKING SOFFIT. THIS IS EXPECTED TO BE CAUSED BY LEAKAGE IN THE CONCEALED GUTTER ABOVE

NOTE DETERIORATED SHINGLES AT LOWER ROOF

-SUPPLY AND INSTALL NEW PAINTED WOOD FASCIA BOARD (SIZE AND CONFIGURATION TO BE DETERMINED ON-SITE)
 -PROVIDE NEW PRE-FINISHED ALUMINUM K-GUTTER AND DOWNPIPES (WHITE COLOUR). LOCATION OF DOWNPIPES TO BE AS DIRECTED BY CONSULTANT ON-SITE
 -MAJOR STRUCTURAL REPAIRS ARE NOT PART OF THE SCOPE OF WORK

-REMOVE ASPHALT SHINGLES AND ANY EXISTING UNDERLAYMENT FROM SLOPED ROOF
 -PROVIDE TEMPORARY COVER TO PREVENT INGRESS OF WATER INTO BUILDING DURING ROOF REPLACEMENT
 -INSTALL NEW UNDERLAYMENT AND ASPHALT SHINGLES PER SPECIFICATION
 -REPLACE LOCAL AREAS OF DETERIORATED SHEATHING (MAX 10% OF ROOF AREA)
 -REPLACE ALL STARTER STRIPS, FLASHINGS, GASKETS AROUND ROOF PENETRATIONS, ETC.
 -MAJOR STRUCTURAL REPAIRS ARE NOT PART OF THE SCOPE OF WORK

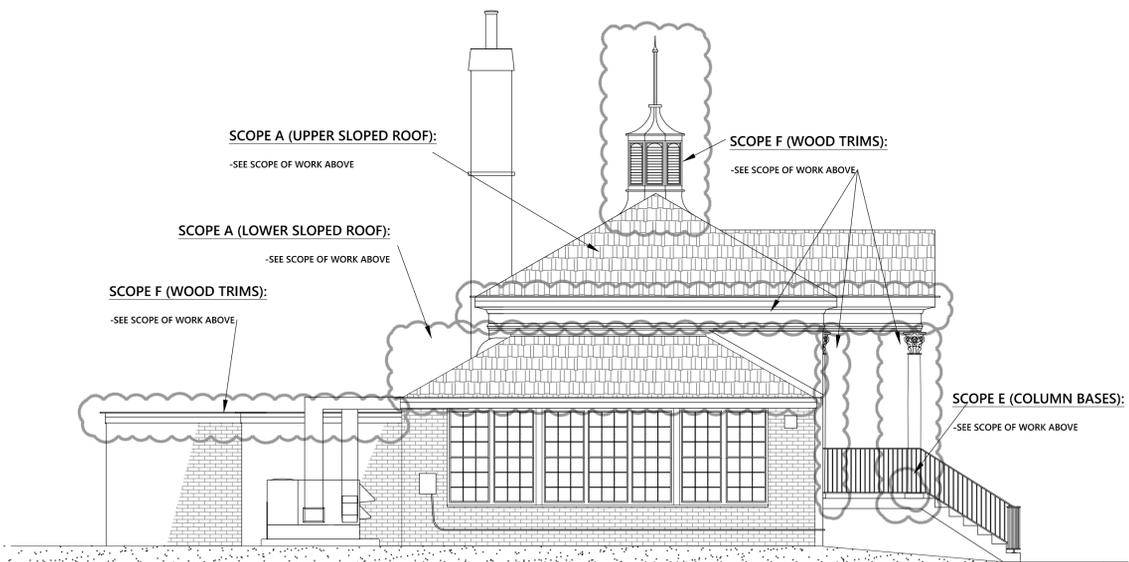
NORTH ELEVATION
 SCALE: 1:100

-FRONT POURED CONCRETE STEPS, RISERS AND EDGES HAVE BEEN PREVIOUSLY COVERED WITH A THIN CEMENTITIOUS FINISHING LAYER SIMILAR TO RUSTOLEUM "STONE EFFECTS"
 -FINISHING LAYER IS NOW CHIPPED AND LIFTING IN AREAS AND PRESENTS A TRIPPING HAZARD IF NOT REPAIRED
 -SCOPE OF WORK INCLUDES MANUALLY CHIPPING AND REMOVING ANY LOOSE AREAS OF FINISHING MATERIAL. LOCALLY CLEANING AREA AND PATCHING WITH RUSTOLEUM "STONE EFFECTS"
 -ASSUME MAX. 20% OF SURFACE AREA OF STEPS, RISERS AND EDGES WILL REQUIRE PATCHING. IF INVESTIGATION REVEALS GREATER THAN 20% LOOSE MATERIAL DISCUSS WITH CONSULTANT
 -STEEL HANDRAILS AND GUARDS AT FRONT STEPS SHOW SIGNS OF LOCAL CORROSION AND DETERIORATION. SCRAPE AND SAND ALL AREAS OF LOOSE PAINT AND ALL RUSTED AREAS AND RE-FINISH STEEL HANDRAILS AND GUARDS WITH TWO COATS EXTERIOR RUST PAINT, COLOUR BLACK

-WOOD COLUMNS SHOW SIGNS OF DETERIORATION AT BASES. IT APPEARS THAT A PREVIOUS REPAIR REMOVED THE COLUMN PEDIMENT AND REPLACED IT WITH A CONCRETE REPLICA. THE COLUMNS HAVE CONTINUED TO DETERIORATE. SEE CONSERVATION PLAN FOR DETAILED INFORMATION REGARDING CONSERVATION
 -NOTE: CONTACT CONSULTANT IMMEDIATELY IF IT APPEARS THAT STRUCTURAL INTEGRITY OF COLUMNS IS COMPROMISED

NOTE CHIPPING OF STAIR FINISH MATERIAL

COLUMN BASE. NOTE EXISTING CONCRETE LIKELY NOT ORIGINAL

-WOOD TRIMS AT FRONT ENTRY INCLUDING CORNICE, PILASTERS, WINDOW AND DOOR TRIMS, PORCH SOFFIT SHOW OBVIOUS SIGNS OF DETERIORATION, GAPPING, OPEN MITERS AT CORNERS, ETC. PREVIOUS PAINT REPAIRS ARE PEELING AND FLAKING OFF. CONTRACTOR TO INSPECT, SCRAPE, REPAIR AND RE-FINISH PER CONSERVATION PLAN.
 -SCOPE OF WORK IS EXPECTED TO INVOLVE REPLACEMENT OF MINOR QUANTITIES (NOT MORE THAN 10% OF OVERALL) OF DETERIORATED MATERIAL
 -NOTE: DETERIORATED WOOD COLUMNS BASES ARE TO BE REPAIRED AS PART OF SCOPE "E" BUT OTHER PAINTING AND REPAIR OF COLUMNS IS BY THIS SECTION.
 -NOTE IT MAY BE NECESSARY TO CUSTOM MILL TRIMS TO MATCH EXISTING
 -MAJOR STRUCTURAL REPAIRS ARE NOT PART OF THE SCOPE OF WORK

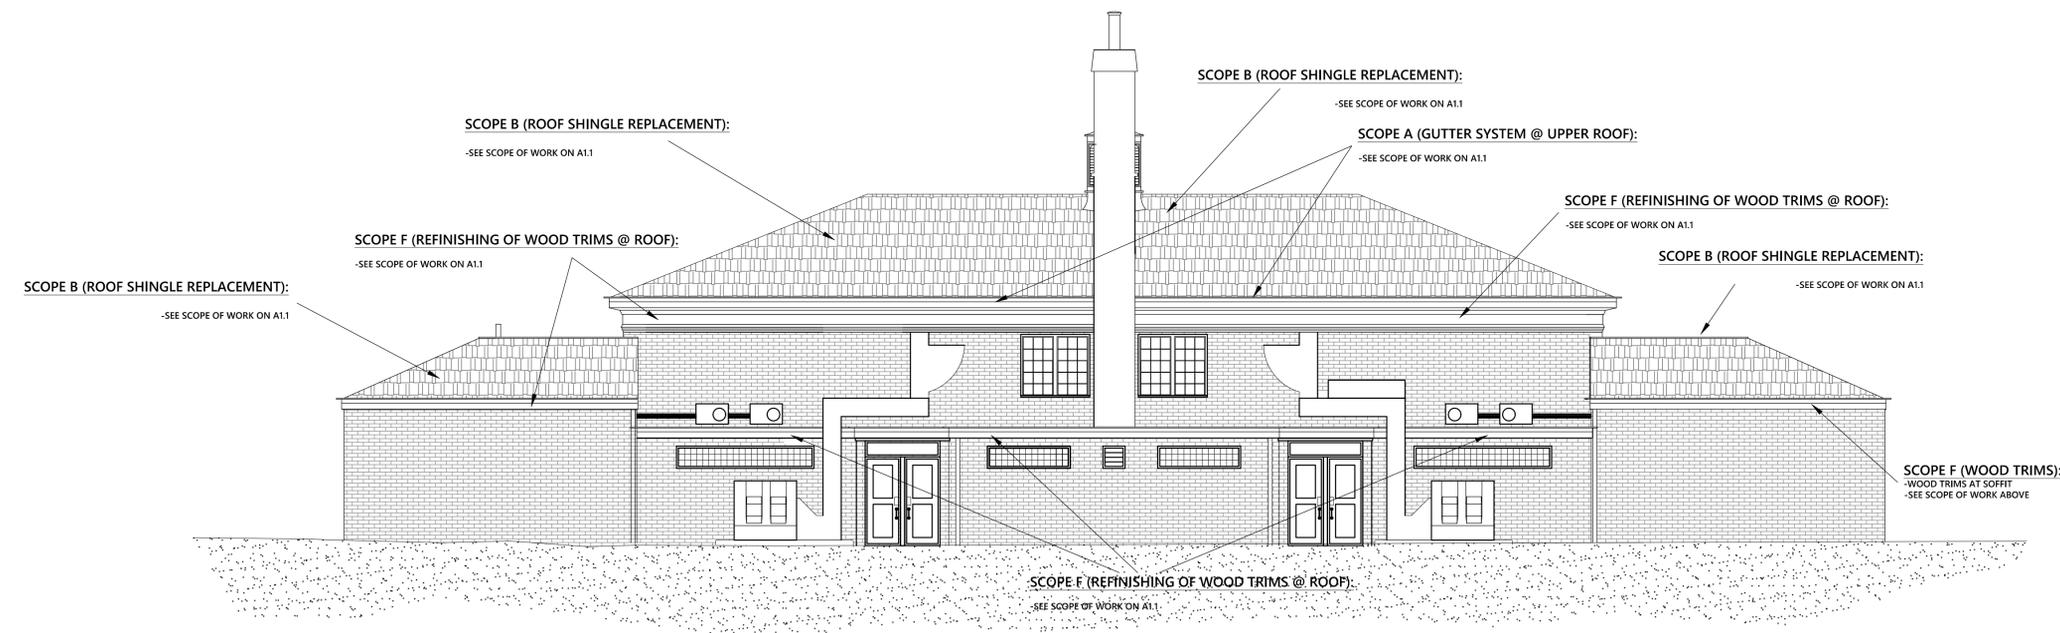
1 EAST ELEVATION
SCALE: 1:100

NOTE DETERIORATED SOFFIT AT ENTRY PORTICO. THIS IS LIKELY CAUSED BY LEAKING OF CONCEALED GUTTER ABOVE

- REMOVE EXISTING ROOF MEMBRANE AND ANY EXISTING UNDERLAYMENT FROM FLAT ROOF AREA. NOTE HVAC DUCTS AND MECHANICAL UNITS THAT WILL REQUIRE TEMPORARY SUPPORT OR REMOVAL DURING THIS PROCEDURE. NOTE TEMPORARY DE-CONNECTION OF POWER, WATER AND GAS SERVICES MAY BE REQUIRED DURING THIS PROCEDURE.

- PROVIDE TEMPORARY COVER TO PREVENT INGRESS OF WATER INTO BUILDING DURING ROOF REPLACEMENT
- REPLACE LOCAL AREAS OF DETERIORATED SHEATHING (MAX 10% OF ROOF AREA) WITH NEW MATERIAL TO MATCH EXISTING

- ENSURE POSITIVE SLOPE TO DRAIN OF ALL FLAT ROOFS BY PROVIDING SLOPING WOOD SLEEPERS @ 16" O.C. AND 1/2" PLYWOOD SHEATHING ON TOP OF THE STRUCTURAL SHEATHING OR CONTRACTOR MAY PROPOSE SLOPED INSULATION PANELS IF DESIRED. CONSULT WITH UTM REPRESENTATIVE AND CONSULTANT.
