The Personal Insurance Company of Canada  
3 Robert Speck Parkway  
Mississauga, Ontario L4Z 3Z9

**Attention:** Mr. Matthew Szuty

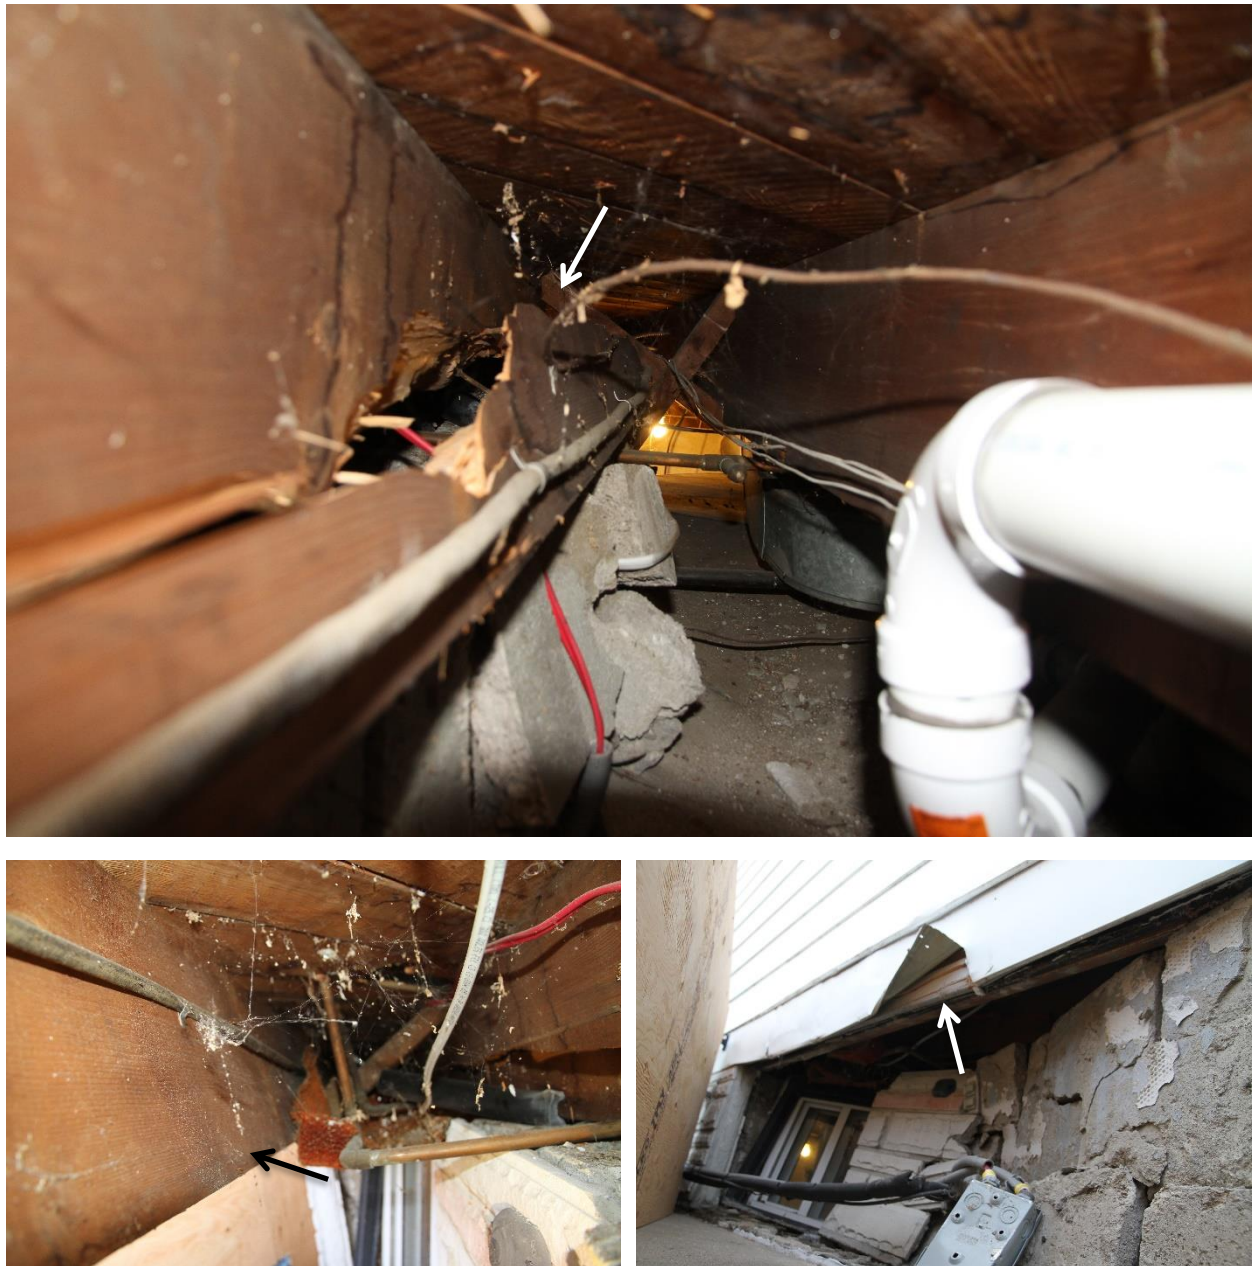
**Figure 2 – Views of damaged floor joist, slightly displaced rim board, and split wood nailer on the rim board.**

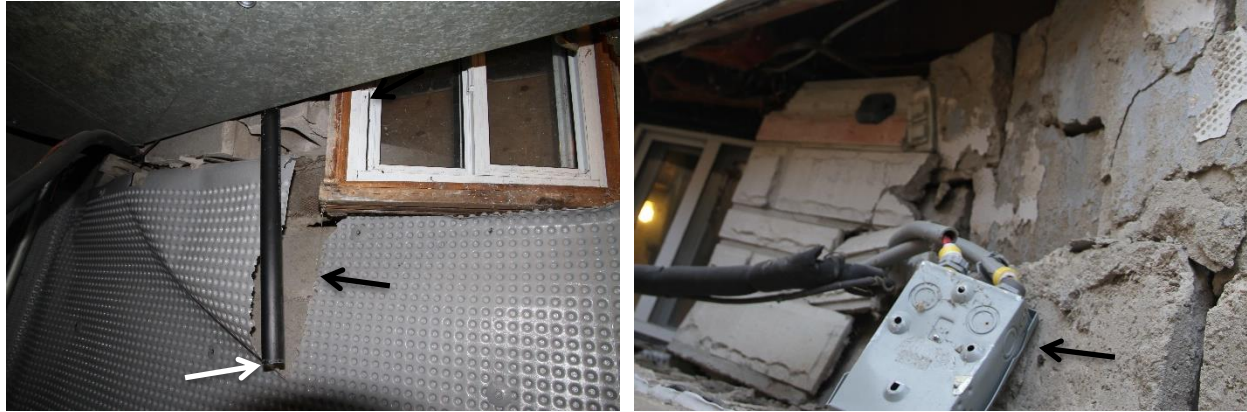
**Figure 3 – Views of some of the non-structural damage observed within the affected area.**

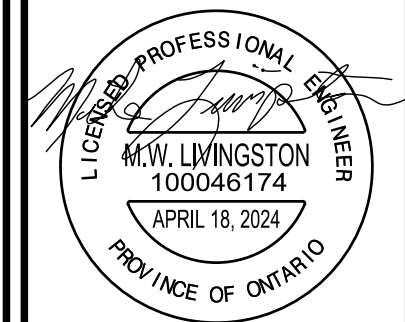
**ARCON**  
**FORENSIC ENGINEERS**  
ARCON ENGINEERING CONSULTANTS LIMITED  
9033 LESLIE STREET, UNITS 18 & 19  
RICHMOND HILL, ONTARIO. L4B 4K3  
TEL. 416-491-2525 FAX 416-491-2696  
WWW.ARCONFORENSICS.COM

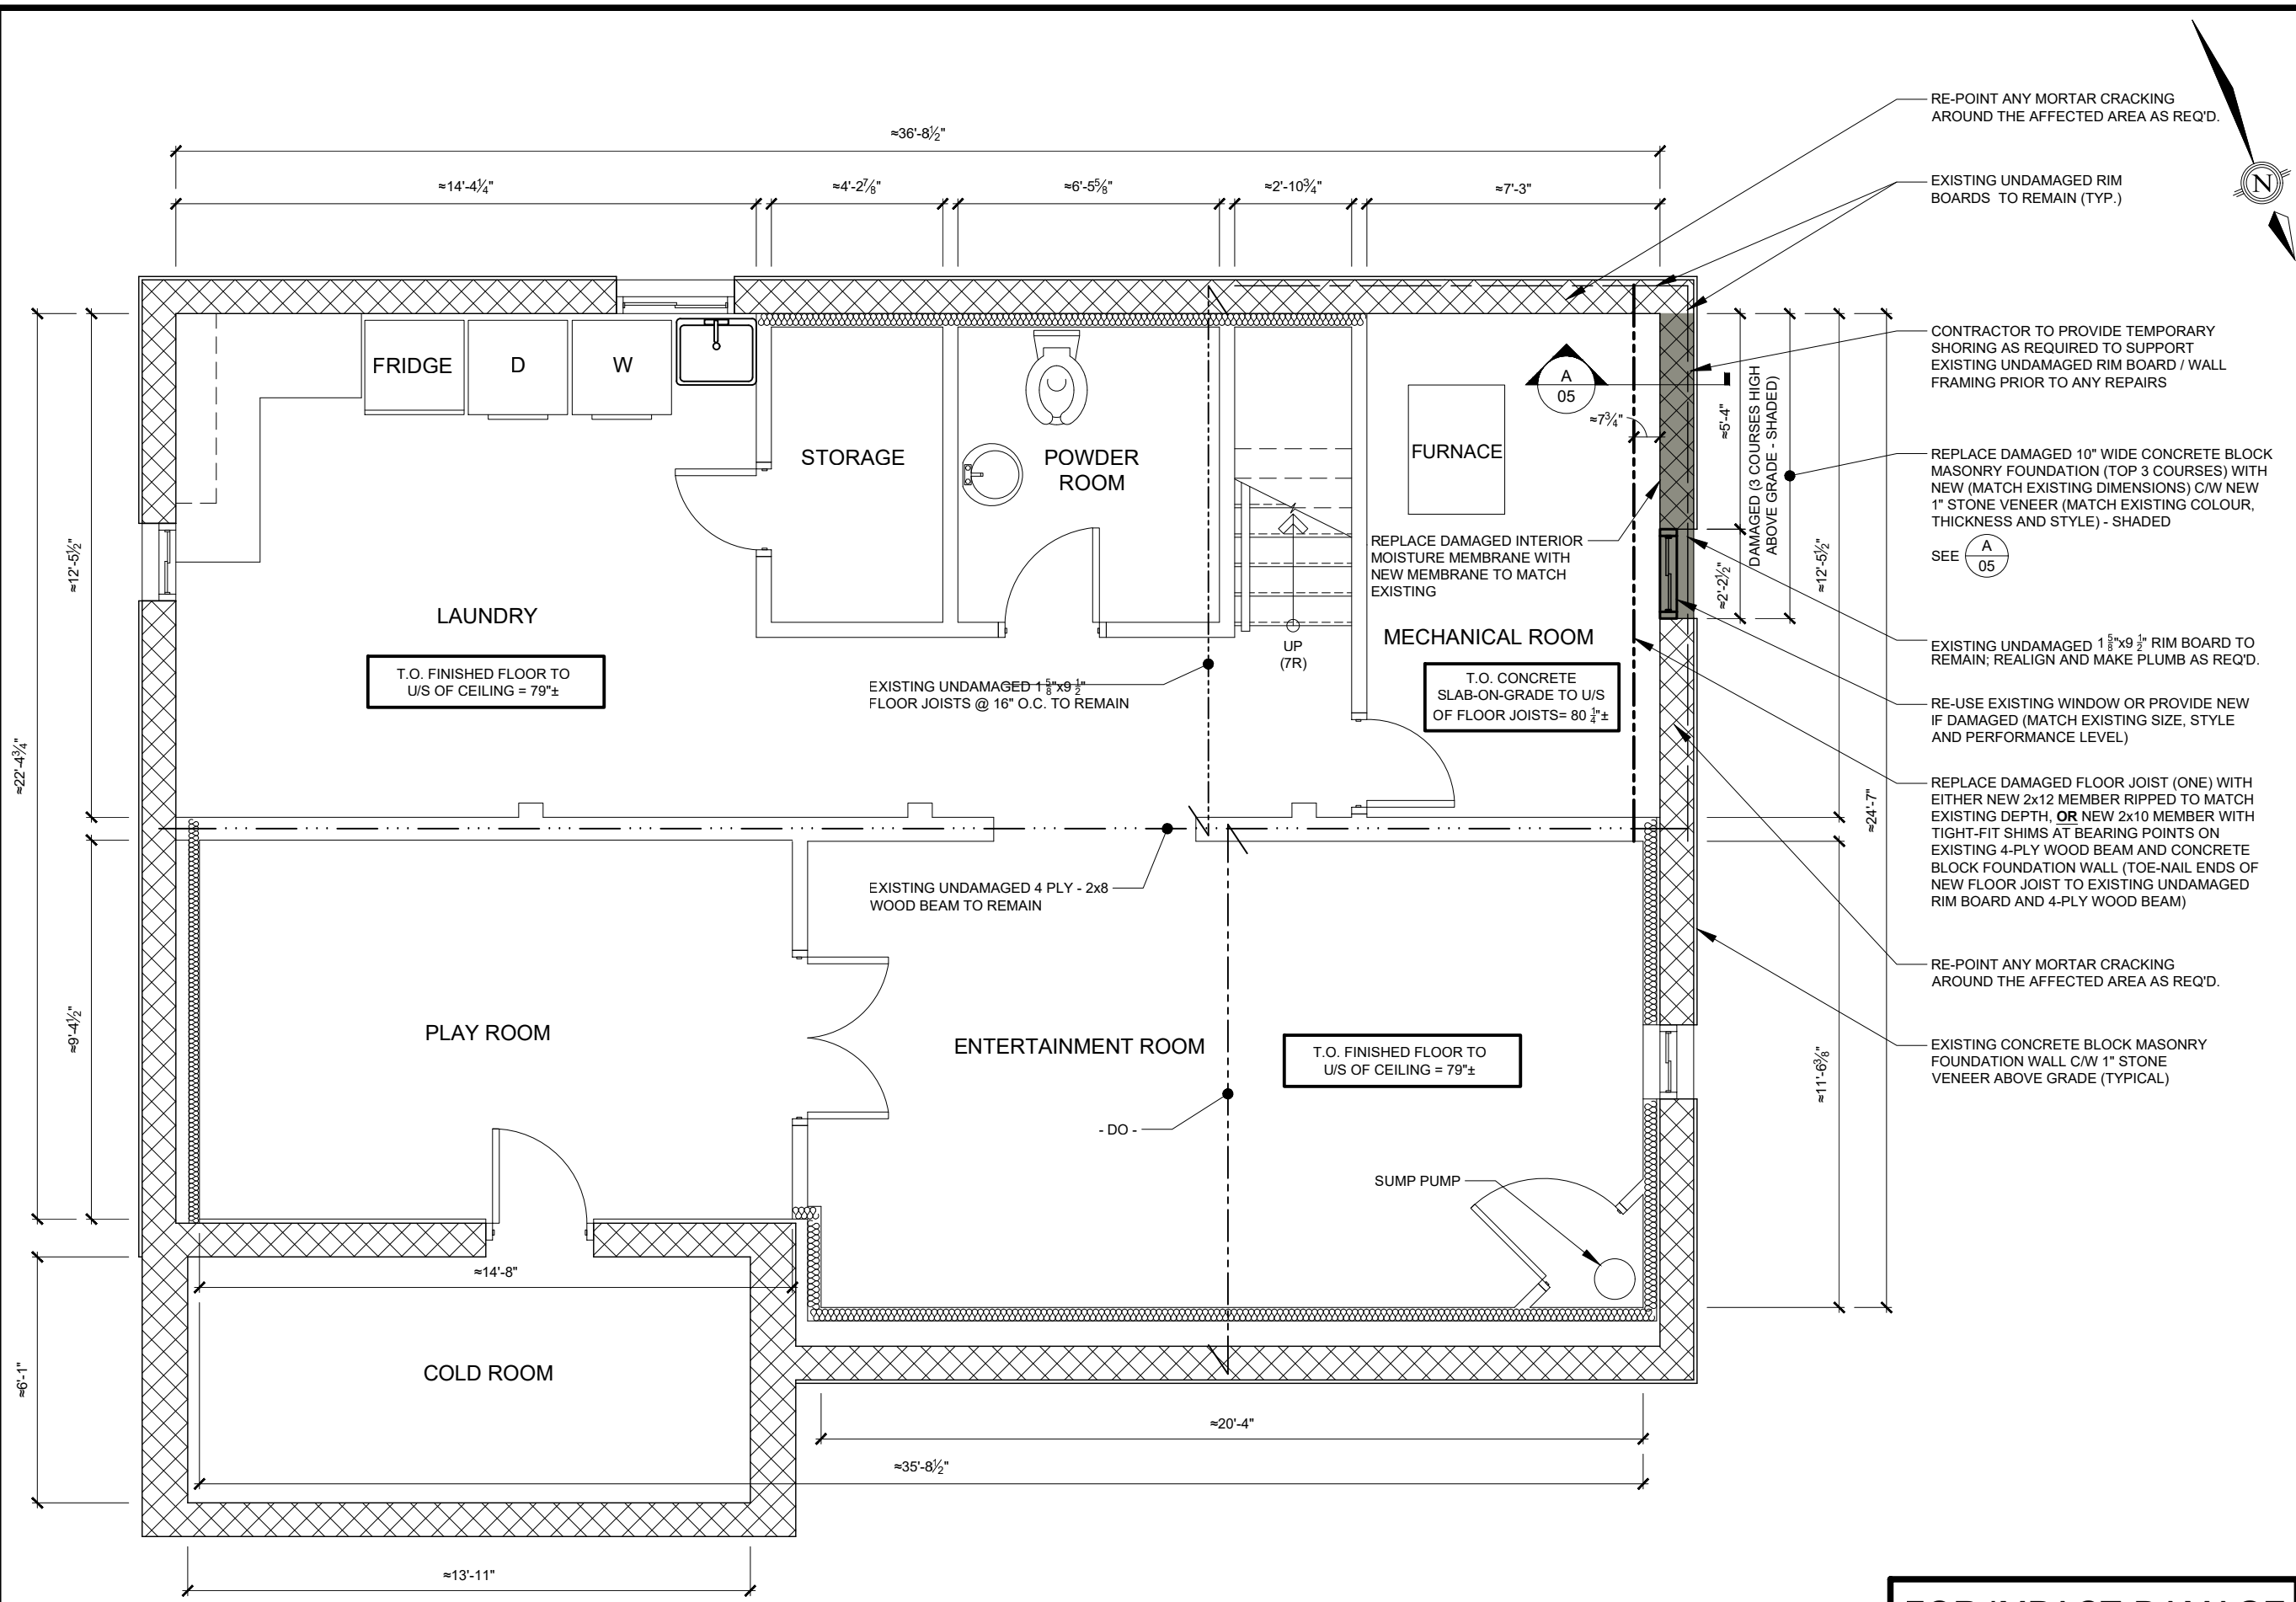
RE-POINT ANY MORTAR CRACKING AROUND THE AFFECTED AREA AS REQ'D.

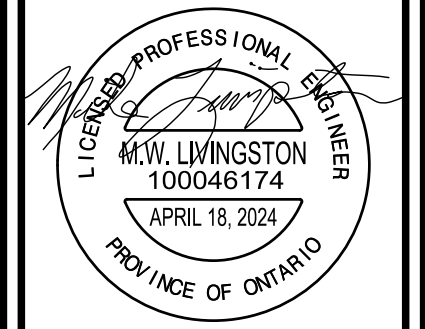
**ARCON**  
**FORENSIC ENGINEERS**  
ARCON ENGINEERING CONSULTANTS LIMITED  
9033 LESLIE STREET, UNITS 18 & 19  
RICHMOND HILL, ONTARIO. L4B 4K3  
TEL. 416-491-2525 FAX 416-491-2696  
WWW.ARCONFORENSICS.COM

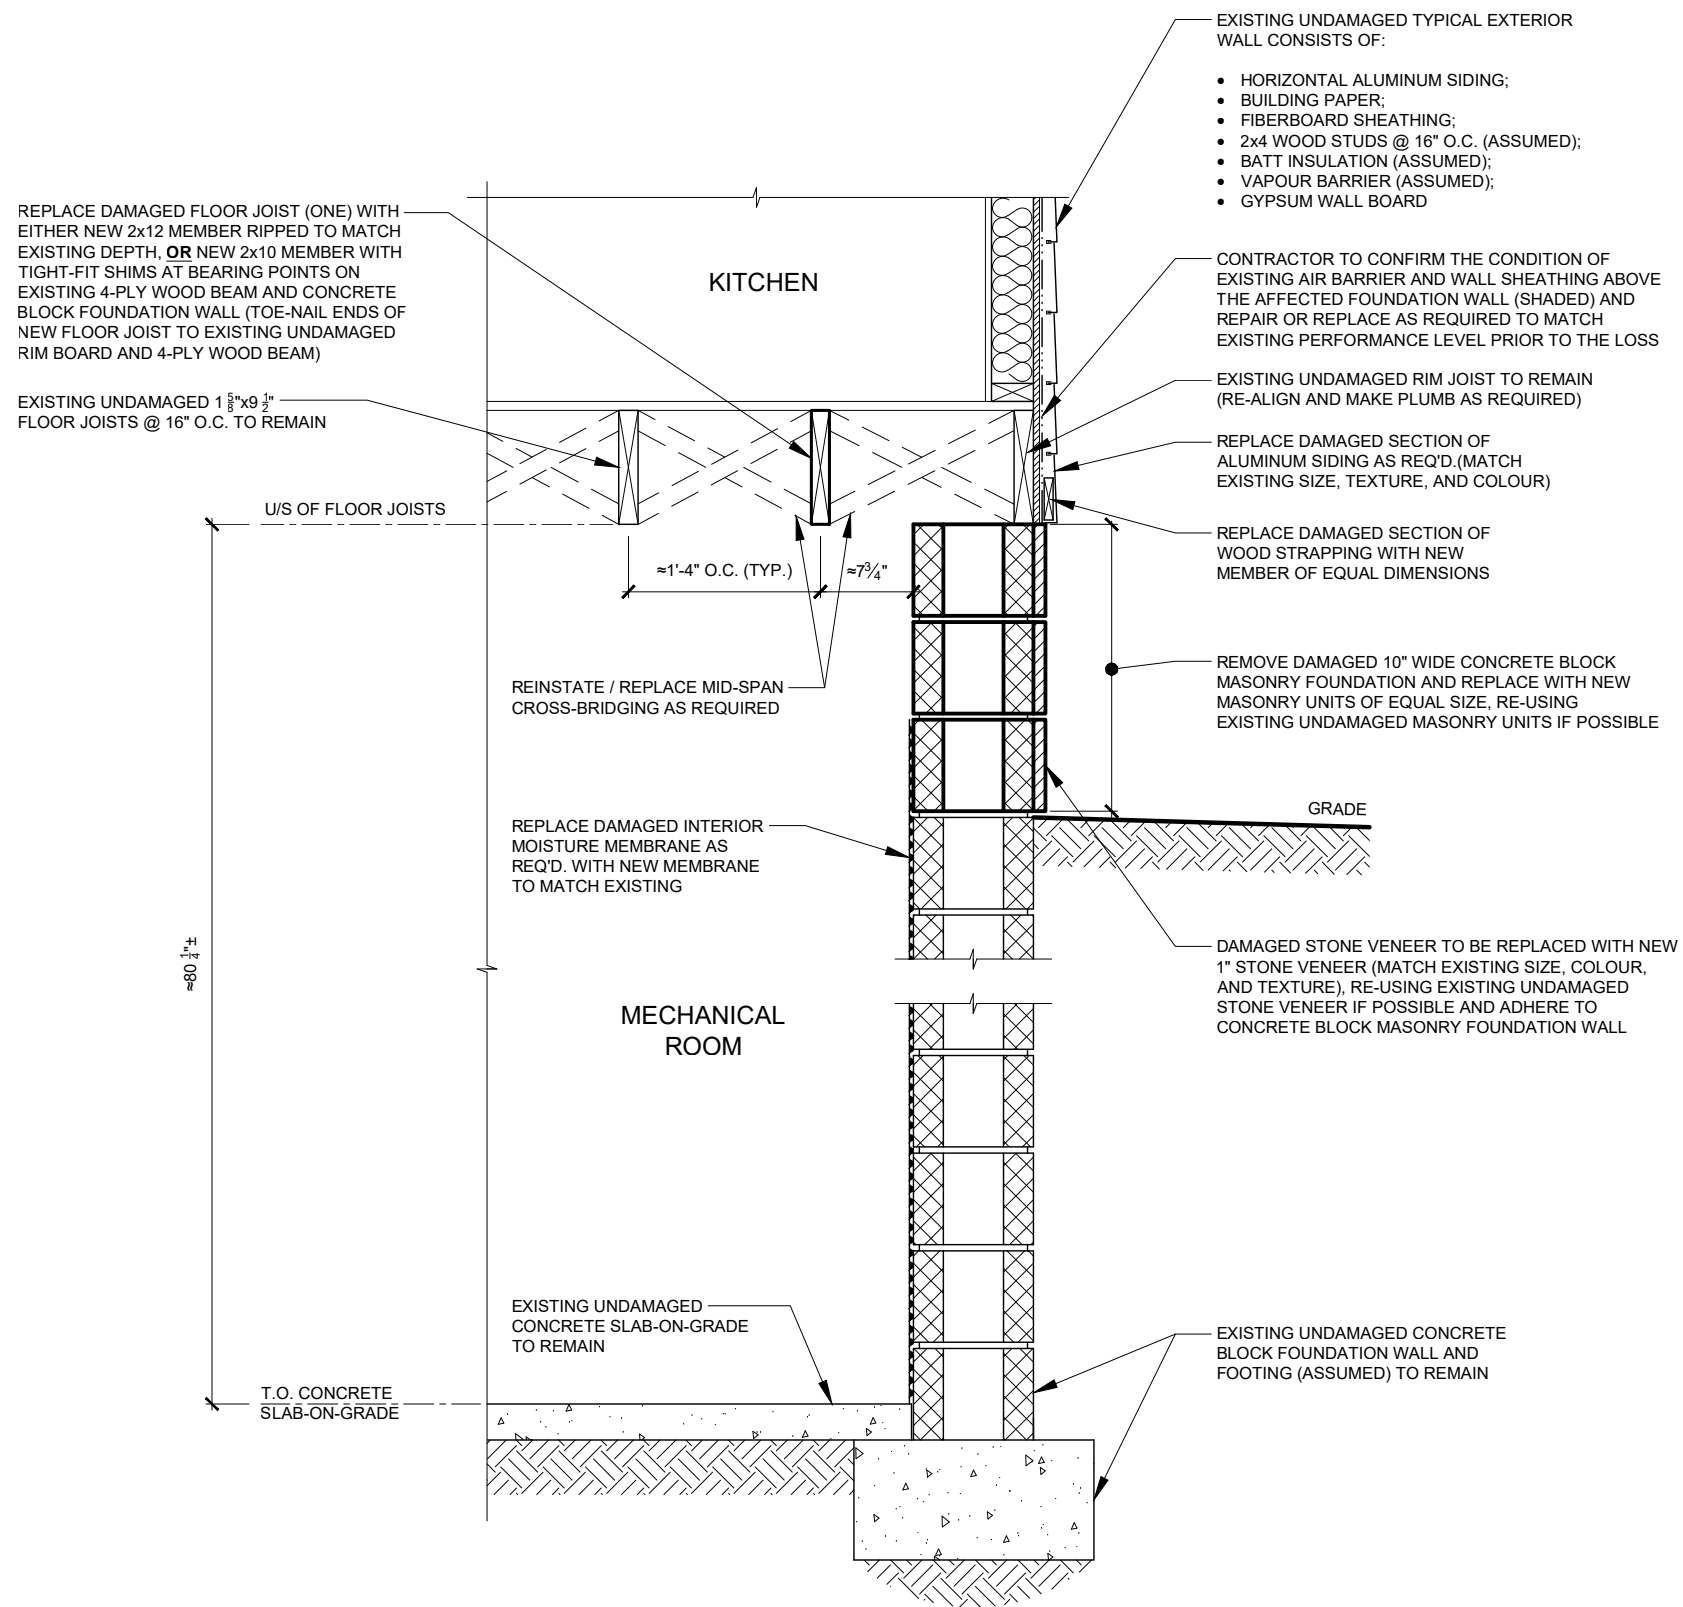
- EXISTING UNDAMAGED TYPICAL EXTERIOR WALL CONSISTS OF:
- HORIZONTAL ALUMINUM SIDING;
  - BUILDING PAPER;
  - FIBERBOARD SHEATHING;
  - 2x4 WOOD STUDS @ 16" O.C. (ASSUMED);
  - BATT INSULATION (ASSUMED);
  - VAPOUR BARRIER (ASSUMED);
  - GYPSUM WALL BOARD

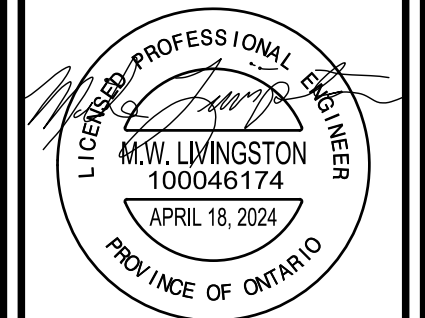
**ARCON**  
**FORENSIC ENGINEERS**  
ARCON ENGINEERING CONSULTANTS LIMITED  
9033 LESLIE STREET, UNITS 18 & 19  
RICHMOND HILL, ONTARIO, L4B 4K3  
TEL. 416-491-2525 FAX 416-491-2696  
WWW.ARCONFORENSICS.COM
