Bradley House

1620 Orr Rd  
Mississauga, ON

Sheet Title:  
Elevations

A001.0

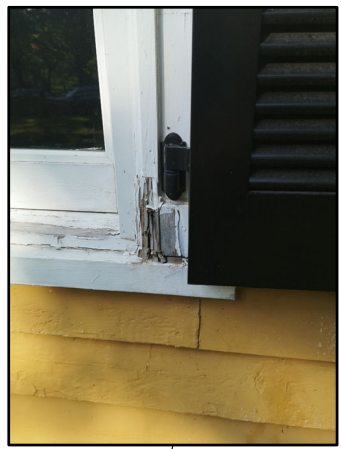
NOTE DETERIORATED WINDOW TRIM. INSPECT ALL TRIMS FOR DAMAGE OR DETERIORATION. CUT OUT AFFECTED AREAS. REPAIR SMALL AREAS (UNDER 2" THICK) WITH WOOD FILLER. REPAIR LARGER AREAS WITH NEW WOOD CUT AND TIGHTLY FITTED TO SUIT.

**Windows, Doors, Trims, Soffits, Fascia, Corner Boards, Misc. Wood Trims:** These must be hand scraped and sanded to a smooth finish. Rotted or badly damaged areas must be replaced. Smaller damage areas may be repaired with wood filler. Areas of bare wood must be treated with one coat primer. Complete removal of the existing paint finish is not anticipated. Loose boards must be re-attached. Nails holes must be filled.

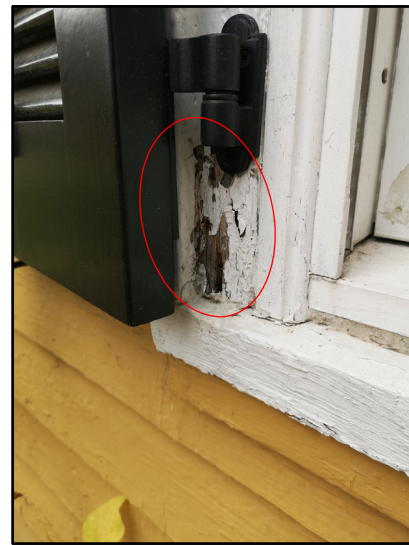
DAMAGED/ROTTED AREAS FROM PREVIOUS NON-PROFESSIONAL INSTALLATION OF NEW SHUTTERS. INSPECT ALL WINDOWS FOR DAMAGE. CUT OUT AFFECTED AREAS. REPAIR SMALL AREAS (UNDER 2" THICK) WITH WOOD FILLER. REPAIR LARGER AREAS WITH NEW WOOD CUT AND TIGHTLY FITTED TO SUIT.

**Windows:** extant windows are a mix of newer wood replacements (sash kits) in older wood frames & trims and older wood sash, frames & trims. All window sash, frames & trims must be inspected on all elevations. Generally they appear to be in good condition, however note damage caused to many window trims from previous non-professional installation of shutters. Report significant deterioration, if found, to consultant.

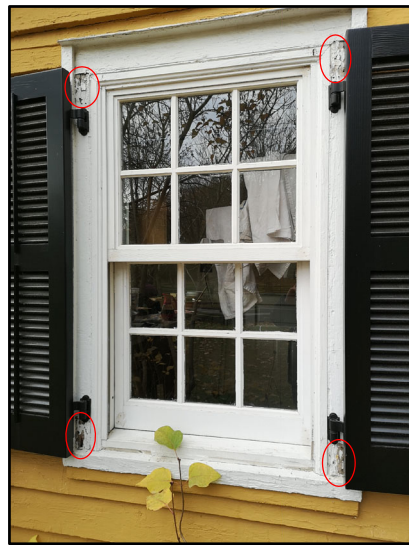
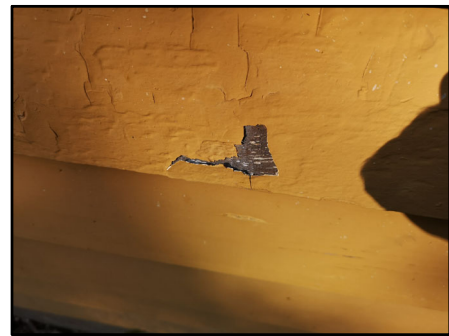
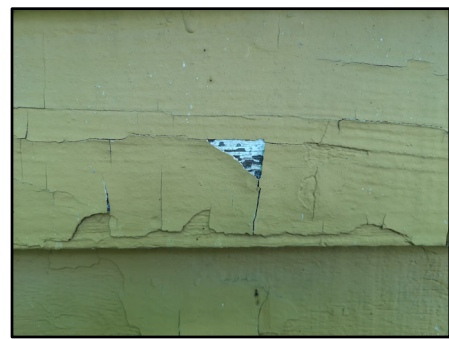
TYPICAL PEELING PAINT DETAIL

**Wood Siding:** the horizontal siding on all elevations shows signs of extensive peeling paint. Some siding boards are split, twisted or have pieces missing. Deteriorated areas of siding should be cut out for replacement. Do not cut out sections of board if the result would be to leave a remnant less than 0.9m long. The entire board should be removed in this case. The removed board material should be inspected and if serviceable portions (generally 1.2m long or longer) from these removed boards can be recovered they should be cut out and saved for potential re-use or repair elsewhere. See drawings for expectation of location and amount of siding to be replaced. Consultant and/or City representative on-site may direct additional removals and replacement. Actual quantity to be replaced may vary from assumed quantities. Assume overall that approx. 30% of the siding boards will require replacement.

**Paint Removal:** the siding is presently painted in a dark yellow colour and chipping areas indicate a layer of older, white paint below. Extant photographs indicate that the yellow paint was applied approximately 15-20 years ago. The lead content is likely associated with the white paint below. Various options are available for chemical paint removal including solvent, caustic, biochemical and low-VOC products. Some paint strippers come in gel or paste form to trap lead particles and keep them airborne. This is preferred here. The contractor will need to prepare at least three test patches experimenting with different products to see which is most effective in this instance. The contractor, in consultation with the consultant and City of Mississauga representative will then determine which product/method to use.

Chemical paint removal will be followed by mechanical scraping and sanding of the siding boards to achieve a smooth finish. The majority of the paint removal must be by scraping, with a light, vibrating sander used to remove residue left from the scraping and to feather edges of remaining paint. CIRCULAR OR BELT SANDERS ARE NOT ALLOWED UNDER ANY CIRCUMSTANCES. Note that some minimal residue of paint may remain embedded in the wood grains if well adhered.

**Siding repair:** Very small (less than 25mm) imperfections should be filled with epoxy filler. Larger imperfections and local deterioration should be cut out and replaced with new or salvaged material. Boards that have been removed due to deterioration should be replaced with new material. Existing boards should be checked for firm attachment and nailed as required.

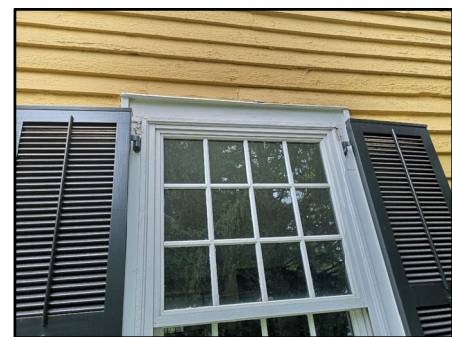
TYPICAL PEELING PAINT, SIDING DETERIORATION

**Siding:** new horizontal wood siding should be installed to match that removed. Boards must be tightly fitted. This siding should replicate in size, shape and dimension the existing size and profile. Nailing pattern should be as per existing or min. 1 row of nails @ 0.6m on center. Maintain even, consistent pattern when face nailing. NOTE THAT CUSTOM MILLING OF SIDING BOARDS MAY BE NECESSARY TO ACHIEVE CORRECT MATCH TO EXISTING BOARDS. All siding boards to be clear pine without knots or sap areas. Re-fasten any existing boards loosened by the removal of adjacent boards.

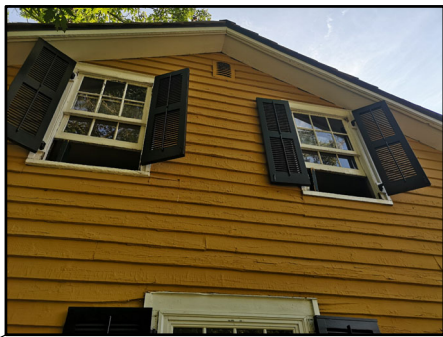
TYPICAL PEELING PAINT, SIDING DETERIORATION

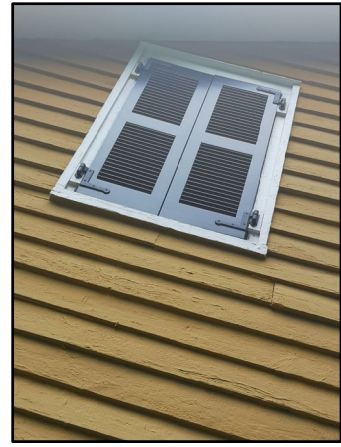
TYPICAL PEELING PAINT, SIDING DETERIORATION

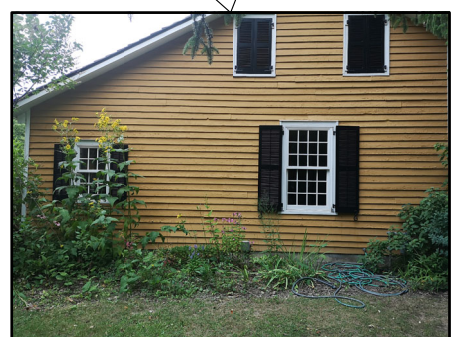
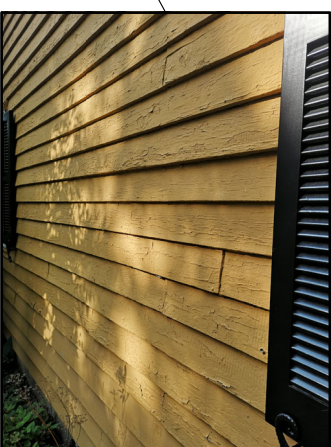
TYPICAL PEELING PAINT, SIDING DETERIORATION

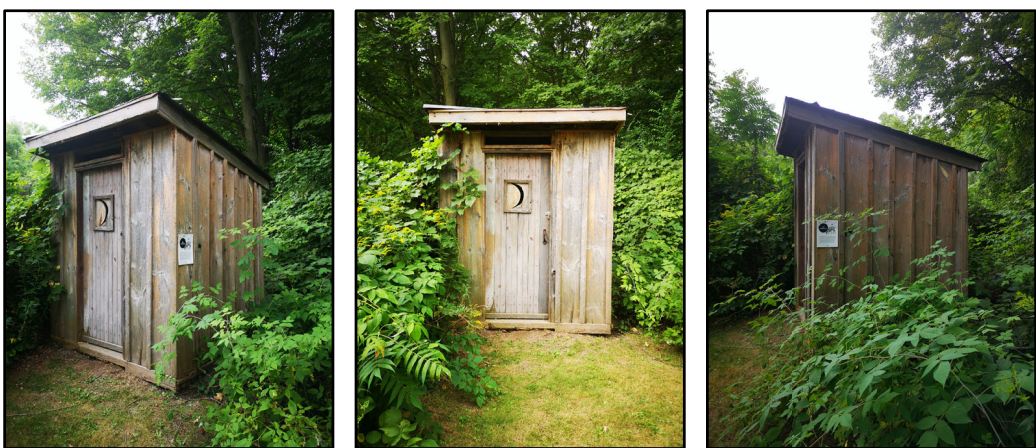
EXISTING OUTHOUSE ELEVATIONS

**All Elevations:** The existing outhouse is believed to be a replica of a previous building constructed of salvaged materials. The building should be carefully demolished to retain for re-use the extant door, toilet seat and any other material as directed on-site by the consultant or City of Mississauga representative. Remaining materials may be discarded.

**All Elevations:** Outhouse is to re-built on a "like for like" basis with the following considerations:

- exposed framing material should be rough-cut true dimension material, not typical lumberyard dressed material. This will involve purchasing direct from a mill source
- all fasteners should be hot dipped galvanized, hand driven. Pneumatic nailing is not allowed.
- ground contact: sill beam and other wood with ground contact must be treated to meet the standards of the American Wood Protection Association UC4B or similar
- building is not to be painted but allowed to weather naturally
- siding material to be vertical board & batten per existing
- roofing material to be galvanized metal sheet
