Project Title
10 WEST GO GP INC.
17 & 19 Ann St.; 84 & 90 High St.
Mississauga, ON

TREE INVENTORY & PRESERVATION PLAN

Sheet Number File Number
TS.1

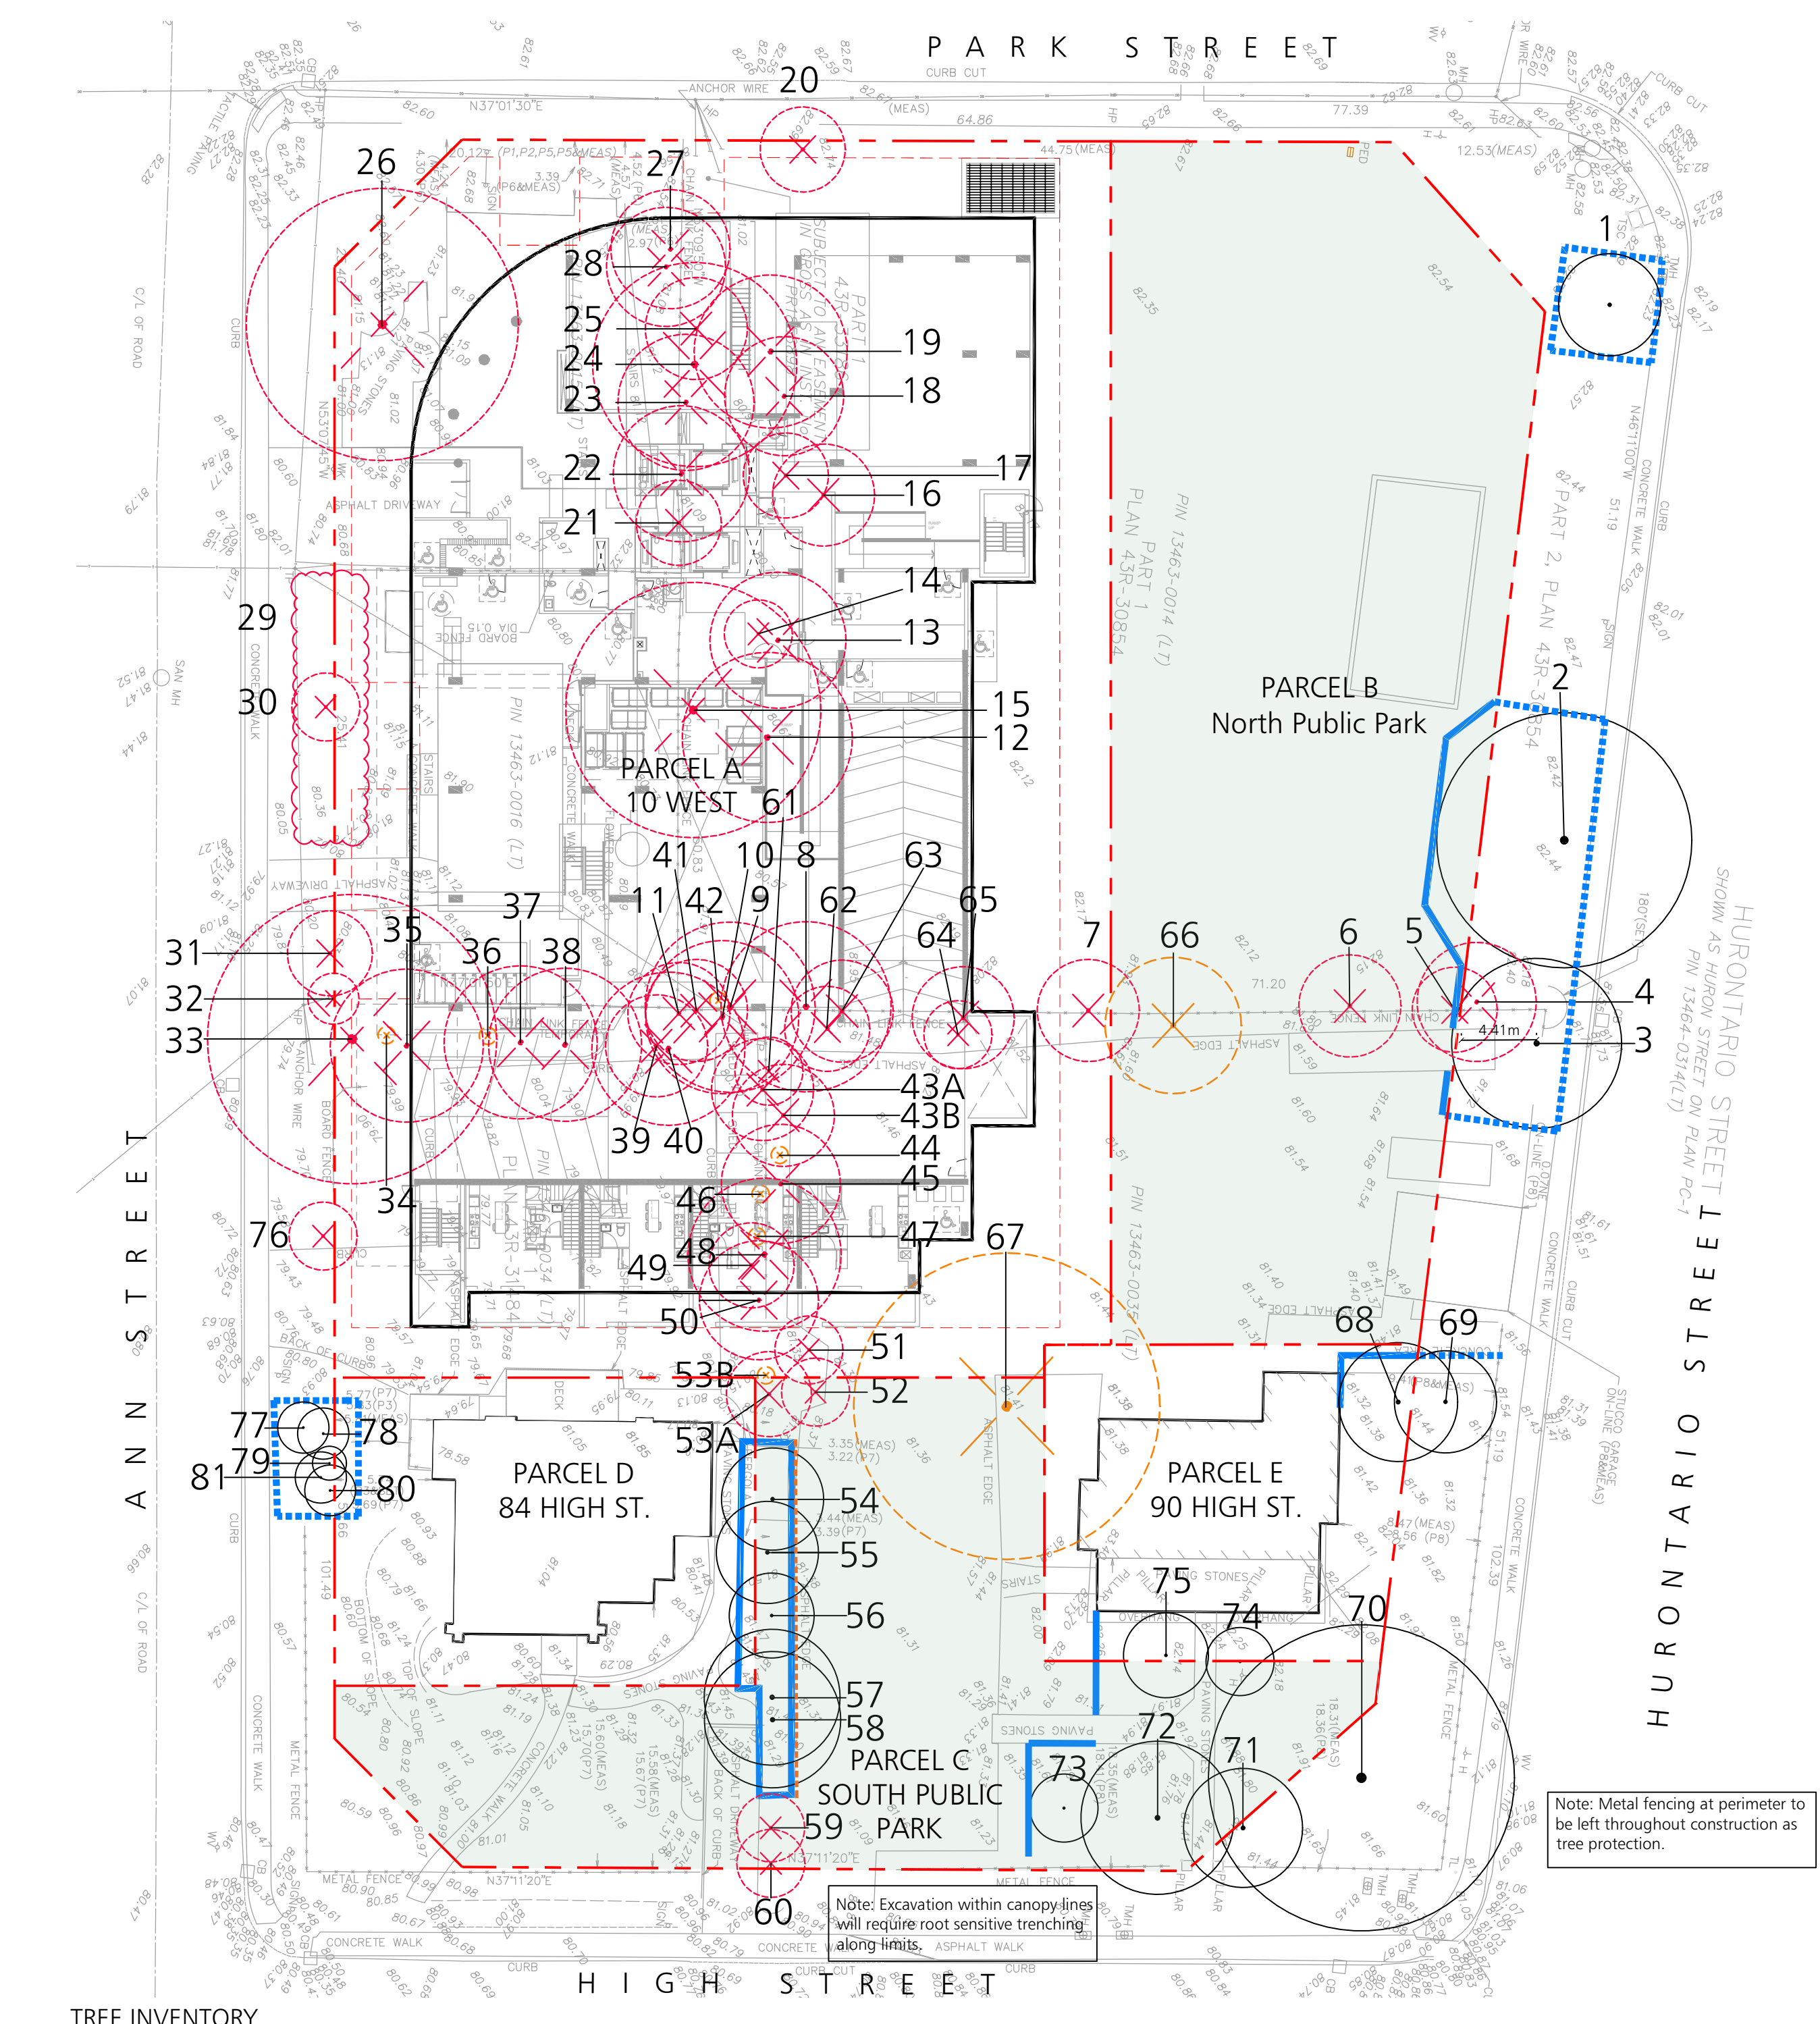
Tree No.	Species	DBH (cm)	Canopy diameter (m)	Biological Health	Structural Condition	Recommended Action	Comments	Existing Location Designation	Future Location Designation
1	Acer platanoides	26	6	M	M	P	Large wound at base, 15% dia trunk damage, backfilled, and one medium-sized dead branch.	C	C
2	Juglans nigra	102	15	MH	MH	P	Grown over former fence still embedded in trunk, large hole/wound at 1m (15cm dia), some broken branches in interior of canopy but vigorous growth for size. One large crack and injury in upper canopy on central leader.	C	C
3	Acer platanoides	~55	10	M	M	P	Wounds from fence. Main union is in poor condition with 2 long healed cracks up to 8m height. There are 2 lower dead branches and one large broken branch. 10% of canopy covered in vine.	C	C
4	Morus alba	15, 15.5	7	MH	ML	RC	Multistem tree with included bark at unions. Leans towards park site. Some crossing branches.	C	C
5	Aesculus hippocastanum	35	5	ML	ML	RC	Growing through fence and vine covers 70% of canopy.	P	P

6	Acer platanoides	22, 11	6	ML	ML	RC	Vine covers 70% of canopy and one medium-sized dead branch.	P	P
7	Acer platanoides	31	6	M	M	RC	Growing through fence mesh and has thicker creeper in canopy.	P	S
8	Acer saccharinum	32, 44.5	10	MH	M	RC	Co-dominant leaders, two large dead branches, growing through fence mesh.	P	S
9	Acer platanoides	~32	10	M	M	RC	Growing through fence mesh, leans 10° to north east.	P	S
10	Acer platanoides	31, 46.5	9	M	M	RC	Co-dominant leaders with included bark at base to 30cm ht. Leans 10° to north west. Has girthing root at base.	P	S
11	Acer platanoides	22	6	M	ML	RC	Grows through fence mesh, suppressed, and leans 10° to north west.	P	S
12	Acer platanoides	14, 15x2, 18x2, 19x2, 15, 26.5	10	M	ML	RC	Multistem tree with included bark between all trunks. Girthing roots across the base. Three large injuries from fuse branches.	P	S
13	Acer platanoides	25, 33	8	M	M	RC	Included bark at base, leans 10° to east and a girthing root.	P	S

14	Acer platanoides	16	4	M	M	RC	Girthing root with tree #13 and has a small canopy.	P	S
15	Acer platanoides	91.5	15	M	ML	RC	Girthing root across 50% of base and over 15 medium-sized dead branches.	P	S
16	Acer platanoides	15.5	6	M	M	RC		P	S
17	Acer negundo	19.5	5	ML	ML	RC	45°L to east, slight canopy with 50% of branches with tip dieback.	P	S
18	Acer negundo	22.5	7	M	M	RC	Fused with another small tree at base to 1m ht.	P	S
19	Acer negundo	35.5, 40	9	M	M	RC	Co-dominant leader with one leader leaning 45° to north east. Some grape vine covers 5% of canopy.	P	S
20	Fraxinus pennsylvanicus	14	5	MH	M	RC	Grape covers the lower 25% of canopy, but no EAB obvious yet.	P	S
21	Acer platanoides	17	5	M	ML	RC	Supporting tree #22 and grows through a fence mesh.	P	S
22	Acer negundo	27.5	8	M	ML	RC	45°L to south on tree #21.	P	S
23	Acer platanoides	24, 25	8	M	ML	RC	Large central leader cut at 1.7m ht. an and wound from cut on remaining leader. Has included bark from 0.5 to 1.7m ht. One leader leans 30° to south. Has several small dead branches.	P	S

24	Acer platanoides	35, 41	12	M	M	RC	Included bark from 1m to 1.7m, tight branching causing injury from fusing trunk.	P	S
25	Acer negundo	23	6	M	ML	RC	Leans 45° to north east and has a sparse canopy.	P	S
26	Gleditsia triacanthos var. inermis	62	16	H	H	RC	Many 10 small dead branches.	S	S
27	Acer negundo	35	7	M	M	RC	Large pruned limb at 4m, medium-sized wound at base of 3% trunk damage.	S	S
28	Acer negundo	32	7	M	M	RC	Medium size wound from cut on dominant leader covering 15% trunk damage. Girthing root also present.	S	S
29	Thuja occidentalis (Hedge)	25x 2, 30x5, 15x2	5	M	M	RC	All multi-stem from 0.5m height.	S	B
30	Acer negundo	14	4	MH	H	RC	Leans 15° to west.	C	C
31	Thuja occidentalis	20.5	5	M	M	RC	45°L to south west and 20% trunk wounded.	C	C
32	Thuja occidentalis	16	3	ML	M	RC	Suppressed.	C	B
33	Acer negundo	78	17	M	ML	RC	45°L, with more than 6 large branches cut of over 15cm dia. Also 2 large cuts of 30cm dia.	S	S

34	Fraxinus pennsylvanicus	25, 25				R	DEAD	S	S
35	Acer negundo	44	9	M	M	RC	Tip dieback of 10% and 2 large dead branches.	S	S
36	Fraxinus pennsylvanicus	14				R	DEAD	S	S
37	Acer platanoides	28, 38	9	MH	M	RC	tip dieback of 10% and 2 large dead branches.	S	S
38	Acer platanoides	28.5	9	MH	M	RC	Large prune cut of 15cm at 2m	S	S
39	Acer platanoides	22	6	MH	M	RC	Large wound at 30% trunk damage at root crown.	S	S
40	Acer platanoides	32	6	MH	M	RC		S	S
41	Acer platanoides	23	6	MH	MH	RC	Small dead branches and small cuts at base.	S	S
42	Fraxinus pennsylvanicus	~30				R	DEAD	S	S
43A	Acer platanoides	~15	6	MH	MH	P	45° lean to south, branch fused creating wound at 43A.	S	S
43B	Acer platanoides	~25	6	MH	MH	RC	10°L to west.	S	S
44	Fraxinus pennsylvanicus	~30				R	DEAD	S	S
45	Acer platanoides	20	7	MH	MH	RC	Hanging branch in canopy.	S	S
46	Fraxinus pennsylvanicus	~30				R	DEAD	S	S
47	Fraxinus pennsylvanicus	~35				R	DEAD	S	S

48	Acer platanoides	29	9	MH	MH	RC	Backfilled and unbalanced canopy to east.	S	S
49	Acer platanoides	17	5	H	MH	RC	Crack from 0.5m to 2m, unbalanced canopy to west and second crack from 2m to 4m ht.	S	S
50	Acer platanoides	31	7	MH	M	RC	Backfilled.	S	S
51	Picea pungens	39	4	M	M	RC	Large wound of 15% of trunk diameter at base with sawdust and backfill over base. slight canopy and unbalanced crown to south.	S	P
52	Picea pungens	46	4	M	ML	RC	Large wound of 15% of trunk diameter at base with sawdust and backfill over base. slight canopy and unbalanced crown to south.	S	P
53A	Morus alba	18	5	M	M	RC		S	P
53B	Fraxinus pennsylvanicus	14				R	DEAD	S	B
54	Acer platanoides	21	6	MH	MH	P	crack from 1m to 1.5m ht.	S	P
55	Acer platanoides	20	6	MH	MH	P	Several medium-sized prune cuts.	S	P
56	Morus alba	14.5	5	H	MH	P	Small branch stubs	S	P

Tree No.	Species	DBH (cm)	Canopy diameter (m)	Biological Health	Structural Condition	Recommended Action	Comments	Existing Location Designation	Future Location Designation
57	Ailanthus altissima	51	8	H	MH	P	Large pruned limb with ripping wound and two other medium-sized broken branch wounds.	S	P
58	Morus alba	35	8	M	M	P	Leans 30° to south.	S	P
59	Ailanthus altissima	17	4	H	H	RC	unbalanced canopy to south.	S	P
60	Acer platanoides	16	4	M	M	RC	backfilled, has 5 small prune cuts and a thin wound from 30cm to 1m ht.	S	P
61	Acer platanoides	20.5	4	MH	MH	RC		S	S
62	Acer negundo	19.5	5	M	M	RC	30° lean to south, one dead trunk fallen.	S	S
63	Acer platanoides	35	6	MH	MH	RC		S	S
64	Salix alba 'Tristis'	19	4	M	ML	RC	multibranch node.	S	S
65	Salix alba 'Tristis'	25	6	MH	M	RC	10°L to north east.	S	S
66	Ulmus americana	44.5	8	L	L	R	50% of canopy is dead. Vine is covering 50% of remaining canopy.	S	P
67	Ginkgo biloba	131.5	18	L	L	R	80% of canopy dead. Three leaders and included bark from base to 2m height also at 4 to 8m ht. Large cut at 1m height.	S	P

68	Malus sp.	29, 17	7	MH	MH	P	10% trunk damaged at 30cm ht. and greater than 2 medium-sized dead branches.	S	S
69	Malus sp.	10, 10	6	M	ML	P	Leans 45° to east.	C	C

- TREE PROTECTION RECOMMENDATIONS:
- Install hoarding for subsequent municipal review/approval.
 - Hoarding may be moved temporarily to provide access for tree removal only. These trees should be felled away from protected areas to avoid pulling and breaking of roots of trees to remain.

- Pruning, if required, should be done prior to construction and in accordance with current arboricultural practices.
 - Storage of any materials, fill, vehicles/equipment, and disposal of liquids is not permitted within 1m of protected areas.

- Excavation in close proximity to protected areas are to be undertaken with a certified arborist present.
 - Roots encountered due to excavation are to be cut with a clean sharp blade. Tearing and ripping of roots is not permitted.

- Hydroacoring is recommended as the preferred method for excavation, within 1m of protected areas.
 - Exposed roots are to be covered immediately with mulch or topsoil and watered thoroughly. A light coloured tarpaulin may also be used to prevent root desiccation.

- Deep root fertilize (3-1-1) following backfilling.
 - Trees should be re-assessed periodically in order to maintain an up to date understanding of health and structure.
