Clarke Memorial Hall **Restoration**  
Port Credit, City of Mississauga

Heritage Building Permit Presentation  
**Port Credit Heritage Conservation District**

July 7 & 22, 2025

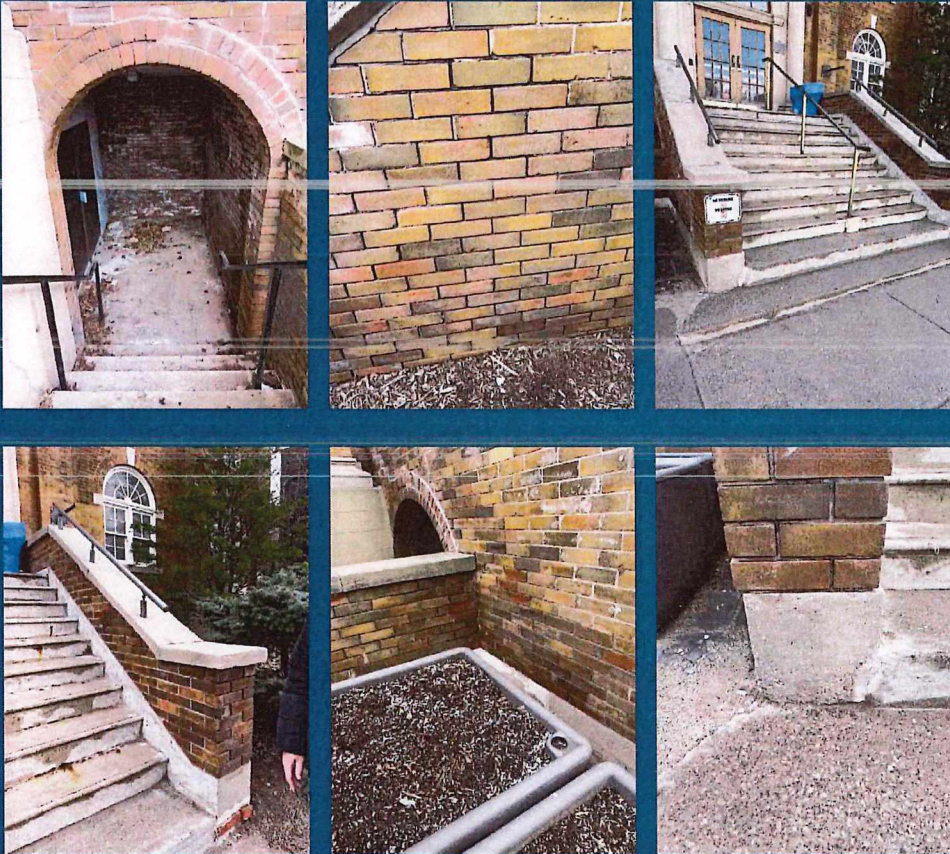
- Replace Front Entrance Stair
  - Not Original; Replaced in the 1990s
  - Existing Stair is Shifting
  - Landing
  - Brick Walls
  - Railings to Meet FADS

- To be Rebuilt to Match Existing
  - Use the Existing Stair and Landing as a Model to Reproduce the Stair with the Same Materials
  - Existing Columns Supported on Landing to be Maintained and Shored
  - Railing Extended to Meet FADS
  - Bronze Railing same as Existing
  - Stair Risers to be Even to Meet FADS

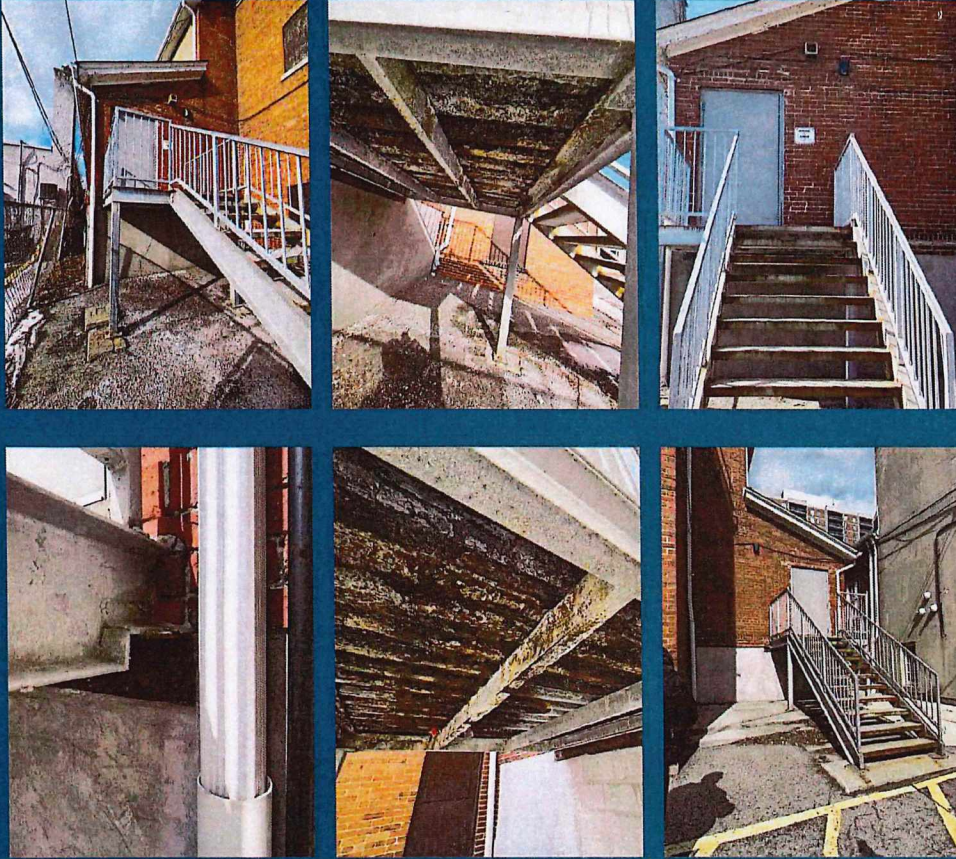
- Replace Emergency Stair
  - Rusting
  - Meet FADS

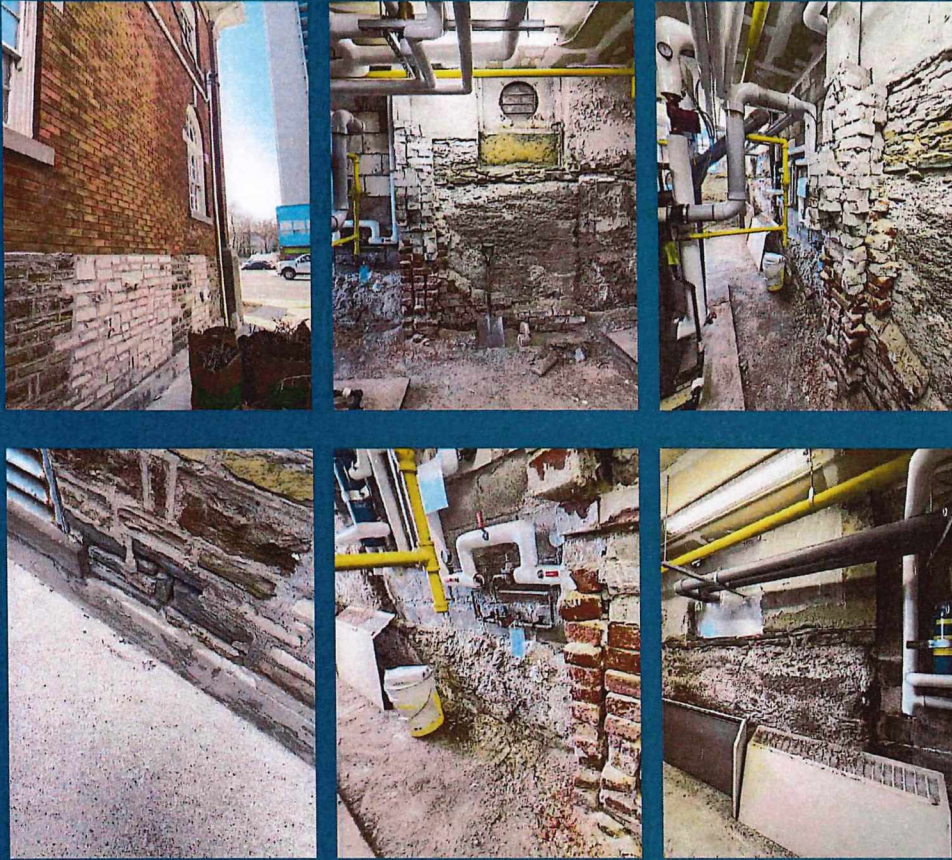
- Repointing
  - Stone Masonry from Grade to Ground Floor
  - Refill Original Filled Window Openings
  - Reinstate Concrete Foundation at Utility Room

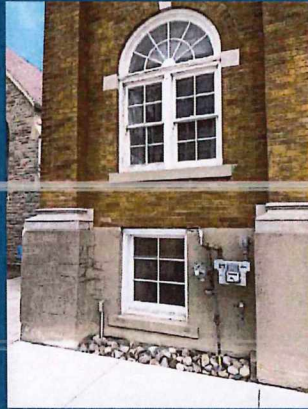
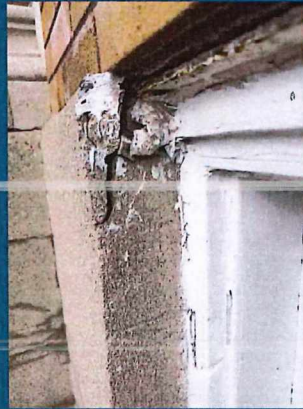
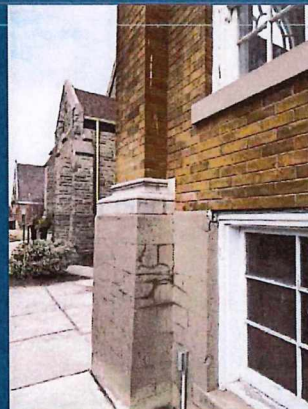
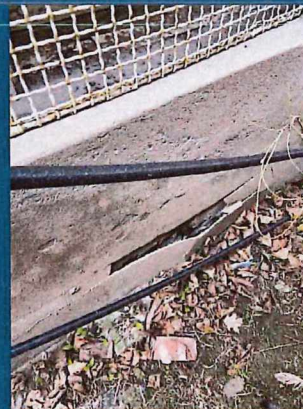
- Parging and Repairs
  - Remove Parging on above Grade Stone Masonry to Expose Original Stone Masonry
  - Remove and Replace Corroded Window Lintels

- Repair Damaged Exterior Wall
  - Remove Parging to Expose Original Stone
  - Repointing Masonry where Deteriorated
  - Repairs to Match Existing Work as Closely as Possible, both Physically and Visually

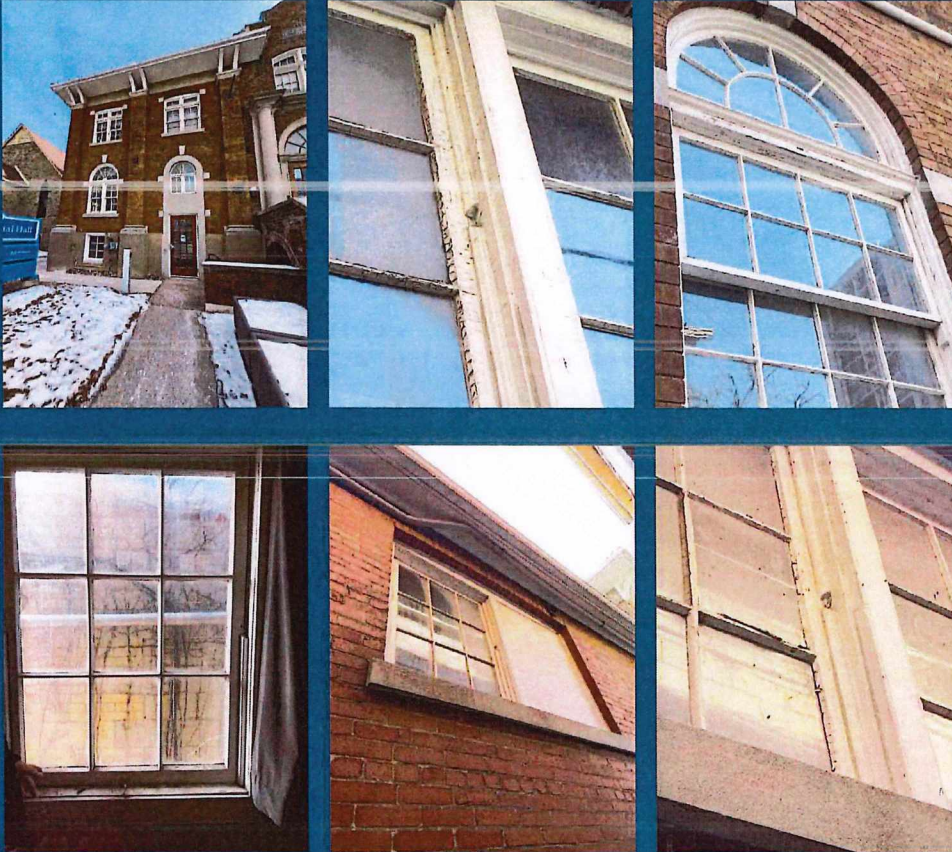
- Retain and Restore Windows
- Existing Wood Windows Sound and Repairable
- Repaint

- To be Restored
  - Remove Dirt, Debris, Deteriorated Paint
  - Selective Repair of Damaged Wood
  - Repaint Wood Frames to Match the Existing
  - Existing Caulking to be Removed, and Re-sealed.
  - Install Wood-Framed Interior Storm Windows on all Fixed Units

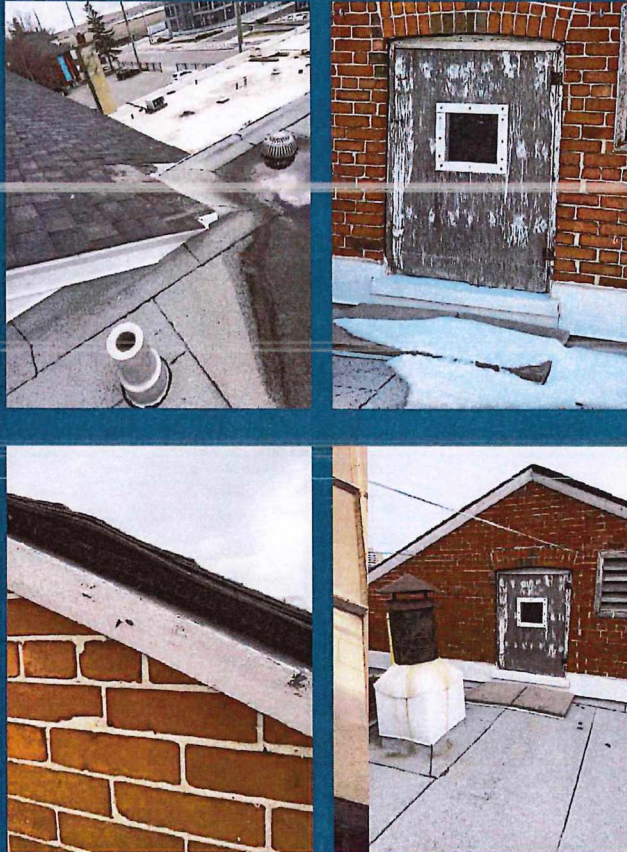
- Attic Doors
  - Replace Two Wood Doors
- Roof Fascia and Soffit
  - Repairs Wood Fascia and Soffit

- Attic Doors
  - Install Two New Cedar Doors
- Roof Fascia and Soffit
  - Selective Repairs of Existing Wood Fascia and Soffit in Cedar
