Project Name:
**MEADOWVALE VILLAGE HALL
NEW BELFRY & EXTERIOR RESTORATION**
Location:
6970 Second Line West, Mississauga

PLANS & ELEVATIONS

Drawing Name:
PHOTO RECORDS

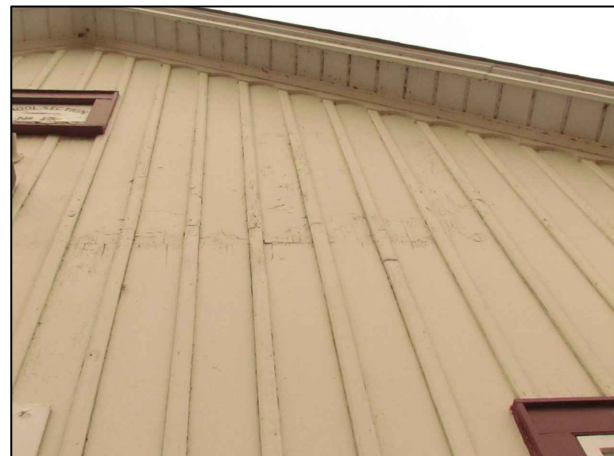
A. DETERIORATION AT BOARDS' ENDS

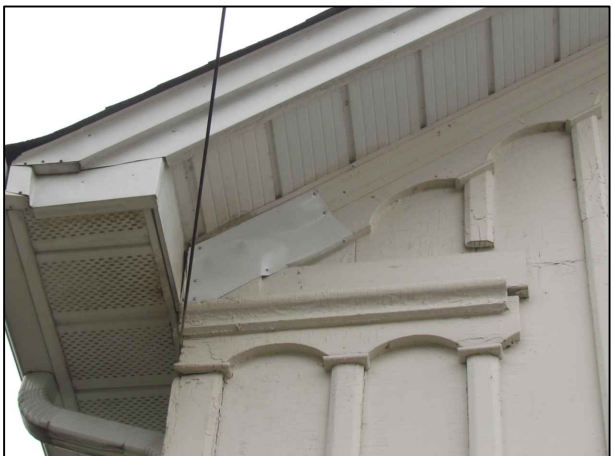
B. DAMAGE TO TOP TRIM

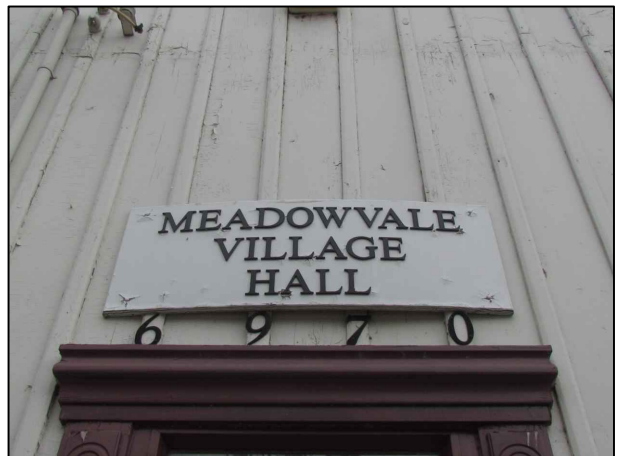
C. CONDITION OF LOWER SIGN & DOOR TRIM

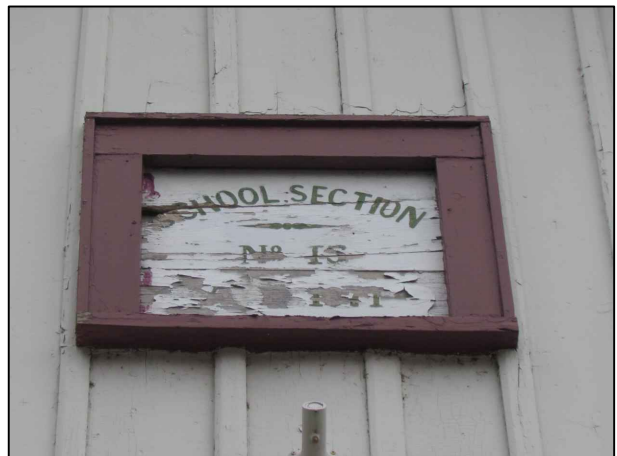
D. CONDITION OF UPPER SIGN

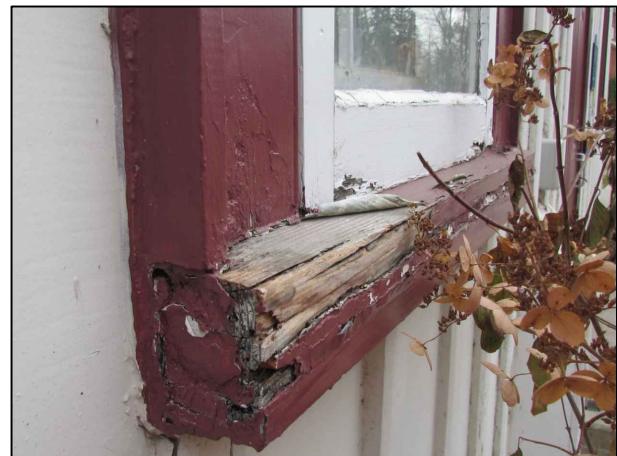
E. CONDITION OF SILL & STORM WINDOW AT W19

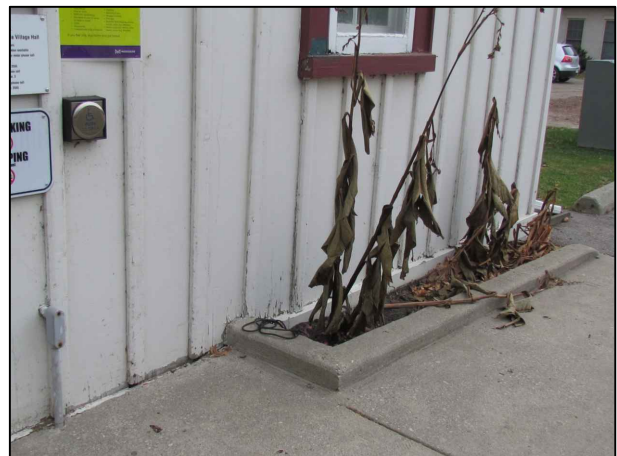
F. CONDITION OF SILL & TRIM AT W16

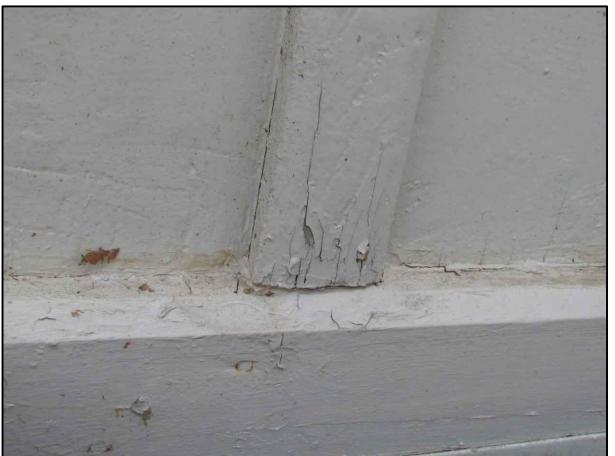
G. DETERIORATION AT BOTTOM OF BOARDS & BATTENS

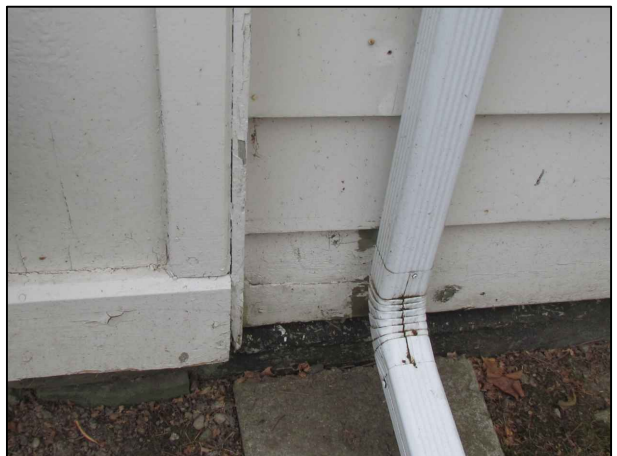
H. DETERIORATION AT BOTTOM BOARD & SKIRTING

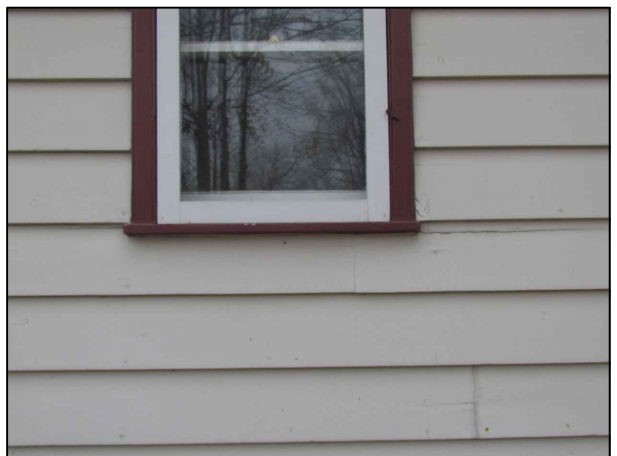
I. WINDOW SILL & CRACKED BOARDS

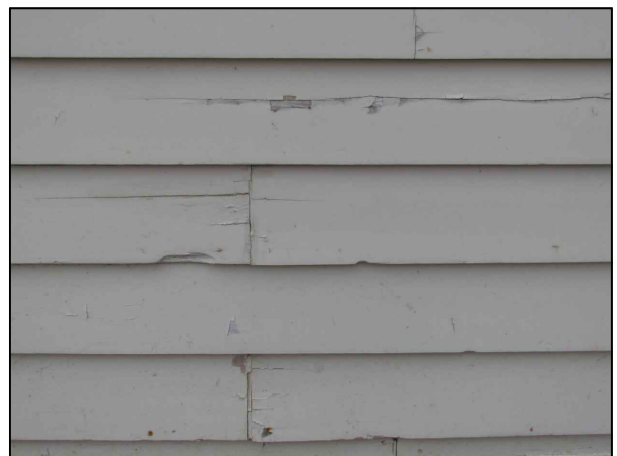
J. CRACKED BOARDS & DETERIORATED BOARDS' ENDS

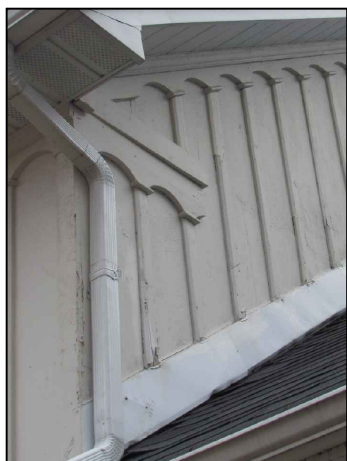
K. CONDITION OF BOARD & BATTEN ABOVE ADDITION'S ROOF, AS WELL AS FLASHING

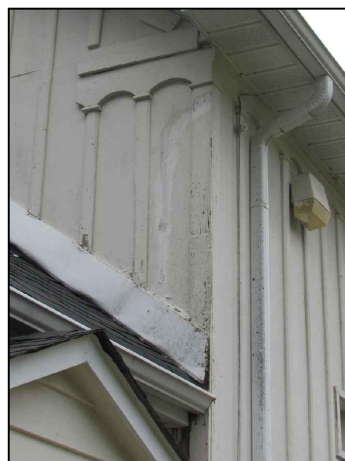
L. BOARDS FOR REPLACEMENT

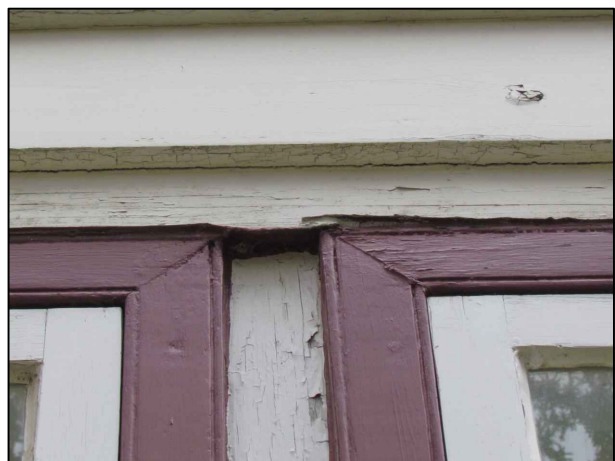
N. DETERIORATED STORM FRAMES

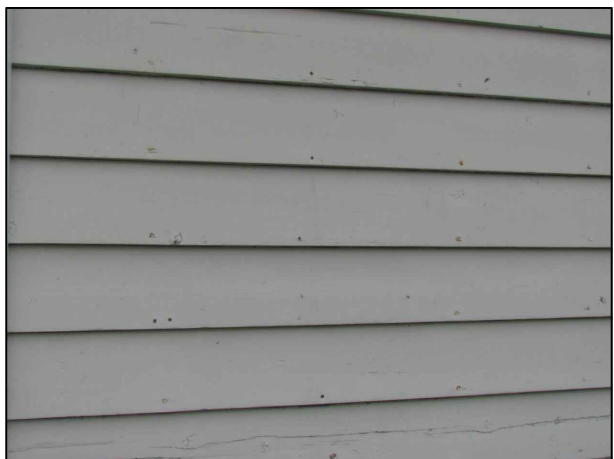
T. SPLIT BOARDS AND RUSTED NAILS
