SUBJECT: Request to Replace a Structure on a Heritage Designated Property
Old Port Credit Village Heritage Conservation District
24 John Street South
(Ward 1)

HERITAGE IMPACT STATEMENT

A PHYSICAL, HISTORICAL AND CONTEXTUAL ASSESSMENT OF
24 JOHN STREET SOUTH
MISSISSAUGA, ONTARIO

Structural Assessment and Recommendations
for 24 John Street South, Port Credit, Mississauga

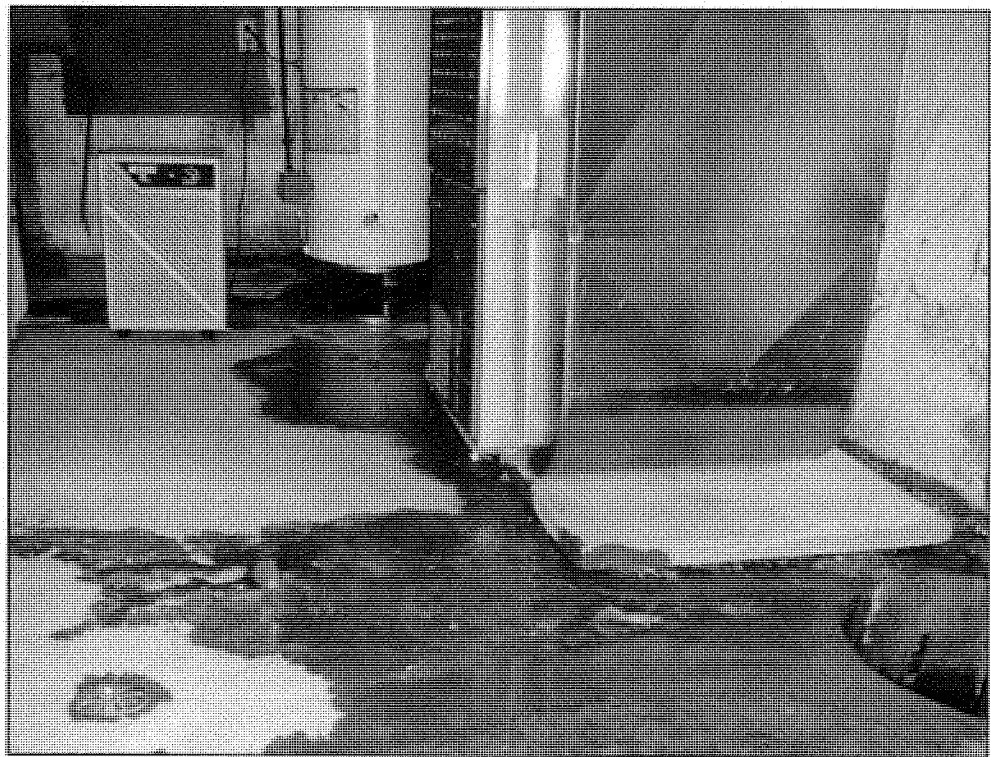
Groundwater seepage in the basement.

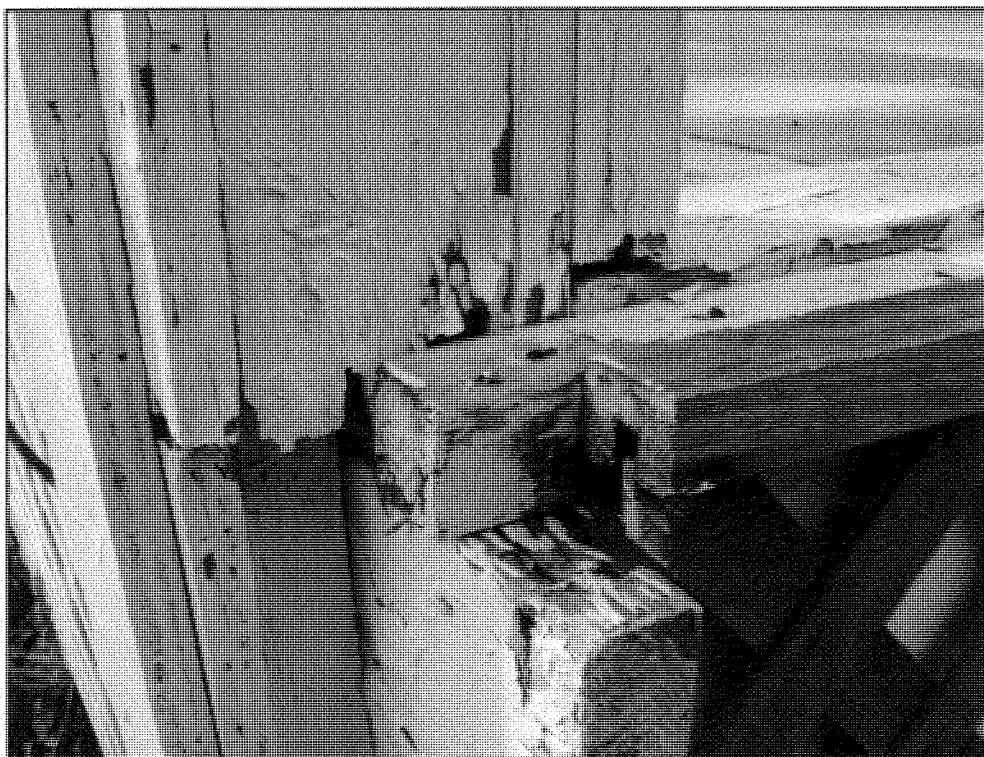
This porch is in urgent need of reconstruction. The structural integrity of the posts that sustain the porch is seriously compromised. The planks of wood on its flooring are cracked and decaying. The roofing is rotten and sagging. The railing was damaged years ago and removed."

Poor condition of the porch.

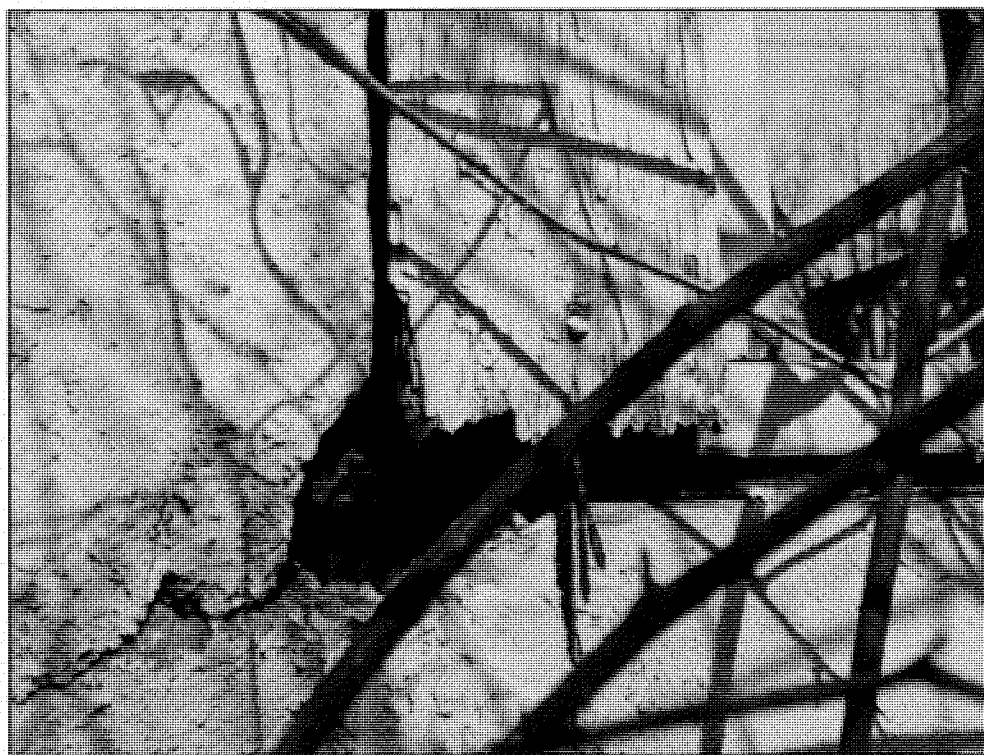
A structural report by Shoalts Brothers Construction Limited reports that the stucco surface of the exterior walls is crumbling at many places. Most of the wood on the verandah is rotting. From the author's own personal observations, the foundation appears to have shifted over the years. The interior floors are now uneven. An environmental inspection report by Environmental Services Group has registered levels of mould in the basement and excess moisture content in the home's subfloor.

Rotting wood and chipped stucco.

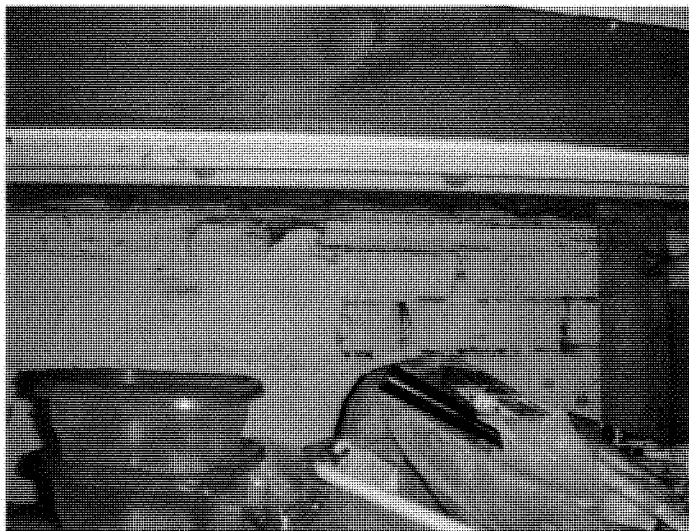
however it does extend under what is almost certainly a later addition. This leads one to believe that either the basement was constructed at the time of the addition and was extended under part of the existing house, or as the oral history states, the house was relocated from elsewhere onto an existing basement. After relocation of a building onto an existing concrete foundation, whether constructed for the purpose or remaining from another structure, it is common practice to build up the top of the foundation with masonry infill. This building has both brick masonry and concrete infill between the concrete foundation walls and the wood floor structure.

Brick infill

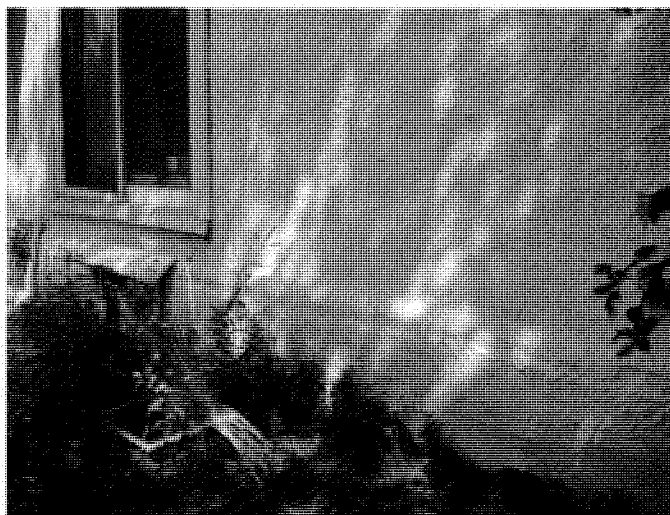
The addition could have been built when the house was relocated to extend the house and to cover the portion of the basement that the original house did not fit. This seems to be the more likely scenario given the brick infill at the top of the wall, the projection of the foundation beyond the rear wall of the house, and the arbitrary and illogical location of the front wall of the basement with respect to the structural requirements of the floor system.

Misaligned foundation at rear wall

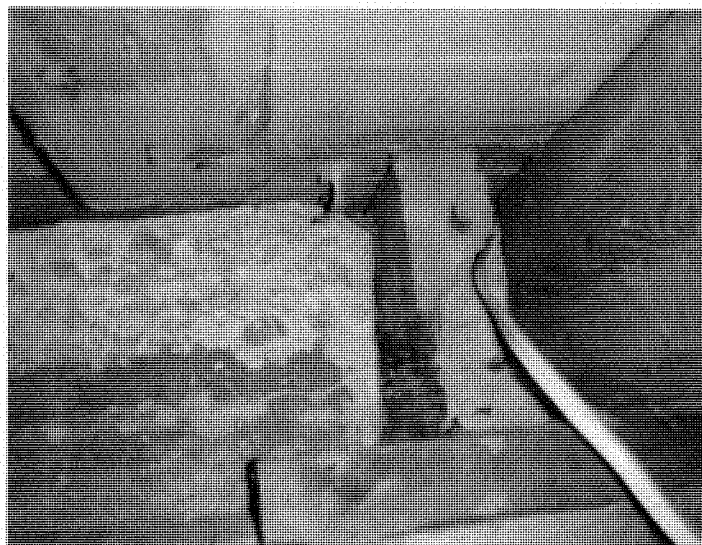
There is an inaccessible crawlspace under the front of the house, and the top of the basement wall has been infilled with concrete around the joists preventing one from seeing the condition of the crawlspace, however the foundation is not located at an original bearing line of the floor. The floor joists and beams are undersized and must be sistered if they are to remain in service. There are some previous floor openings that have been improperly filled; they must be framed in correctly. The close contact of the masonry and concrete has resulted in serious deterioration of the ends of some joists.

Concrete infill and rotted joist

The height of the basement is substandard, there is inadequate foundation drainage, and the crawlspace must be made accessible, which means that in all practicality, the house must be lifted and a new and proper basement must be constructed if it is to remain in service. Lifting the house would prove to be challenging because of the haphazard and insufficient framing of the floor, the additions, and the front porch. The rear addition that provides access to the basement does not appear to have any sort of proper foundation at all, and the bottom wall plate is much lower than the main house, further complicating the prospect of salvaging it for future use.

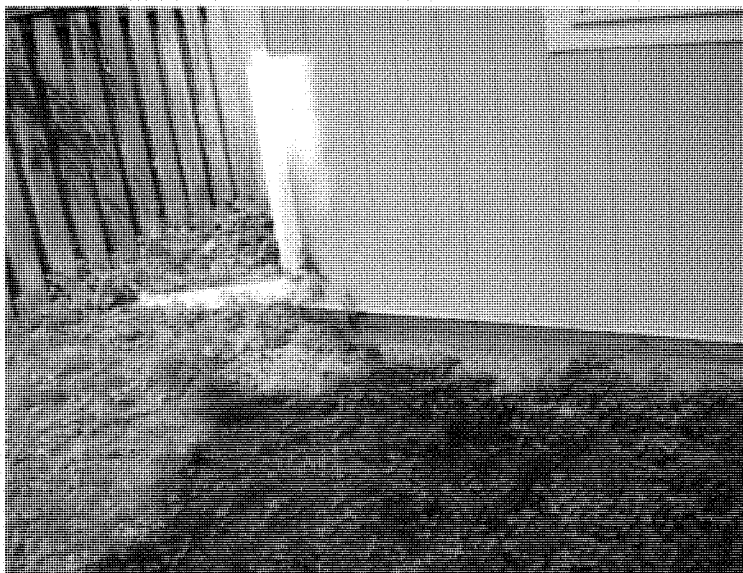
The structure of the main floor of the dwelling has been modified numerous times in its history. There are at least three, and possibly four additions to the original building, as well as substantial alterations to the original and subsequent structures. What appears to have been a rear porch has been winterized and finished, albeit improperly, and it does not meet the most basic standards for structural integrity and weatherability, and should be removed and replaced. It has fairly new siding and roofing, however there does not appear to be a proper foundation, there is unprotected spruce framing lumber within a few centimetres of the exterior grade, and flashing and caulking details are incorrect and will quickly lead to serious deterioration.

Rear addition with improper foundation and moisture protection

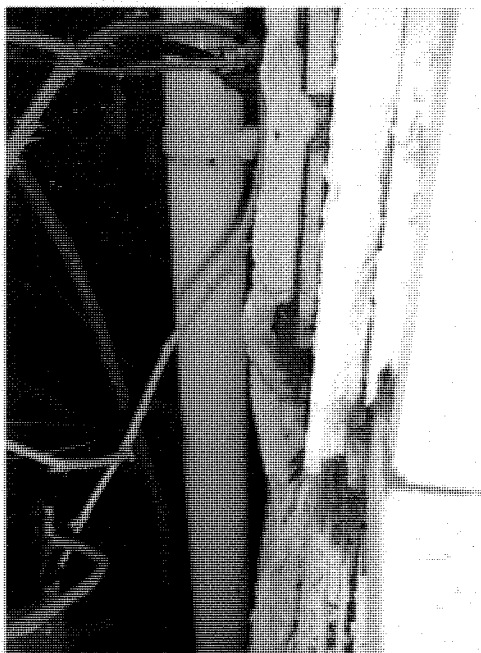
The main house and early west addition have an exterior finish of roughcast stucco. This appears to be the original finish on the addition, however the main house was originally clad with horizontal wood clapboard siding over which the stucco was applied. There was no attempt at proper flashing or weatherproofing of original wood trims and penetrations, and although the porch roof has protected some of these areas, there is serious deterioration in other areas, much of which has had subsequent substandard stucco repair, and requires further work. It is quite likely that the underlying sheathing and structure in these areas has experienced serious decay and should be repaired or replaced, however without intrusive or destructive investigation this cannot be confirmed.

Stucco over wood trim

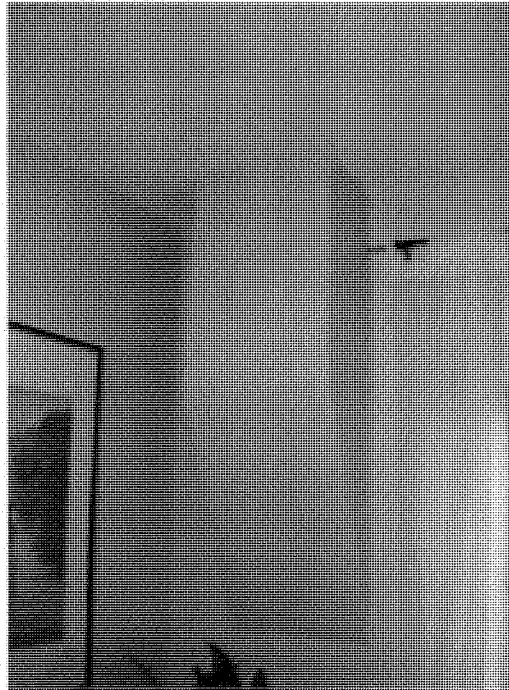
An apparently original chimney for a woodstove still exists on the rear wall of the house although it no longer extends through the roof. As was common in the 19th century, and less so in the 20th, the chimney is supported on the wood framing of the rear wall. While this is a poor construction detail and is not permitted under today's building code, the chimney could be permitted to remain if there were a good reason to do so. Because it no longer serves even a decorative purpose, it should be removed to eliminate the excessive stress that it places on the already inadequate building structure.

Obsolete and improperly supported chimney

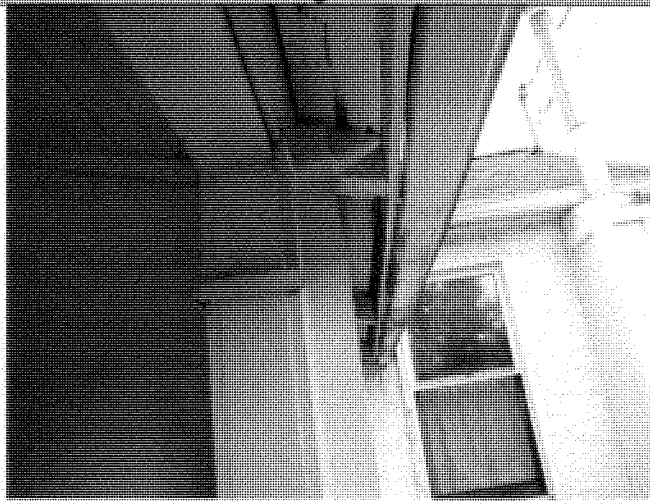
Photo 3: Porch

Unvented porch attic space.

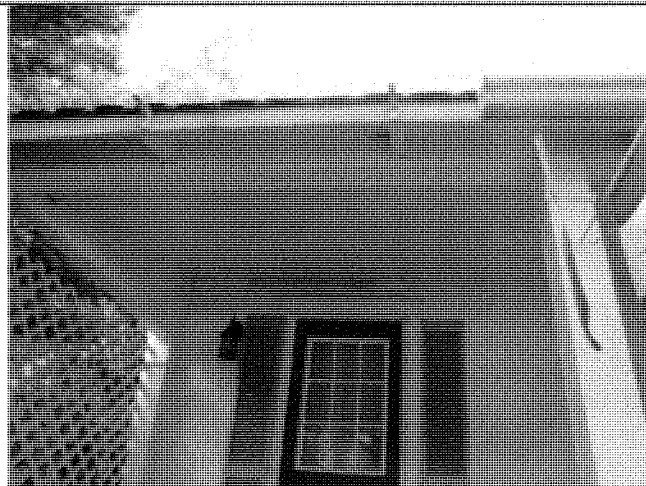
Photo 4: Side View Exterior

No soffit venting present for this attic.

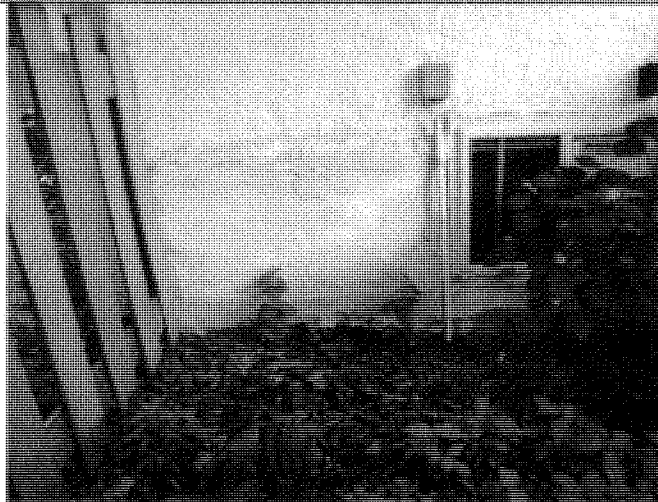
Photo 5: Exterior

Parging repairs to the foundation.

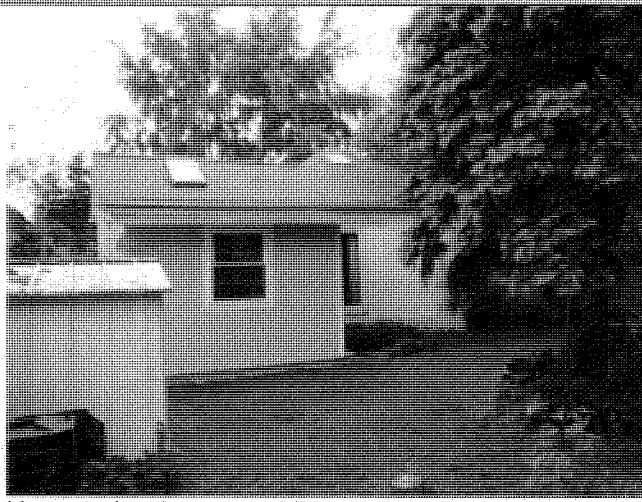
Photo 6: Roof

Unvented attic over addition, unvented main attic and unvented cathedral ceiling cavities. All roof/attic spaces are prone to condensation and mold growth because of insufficient ventilation.

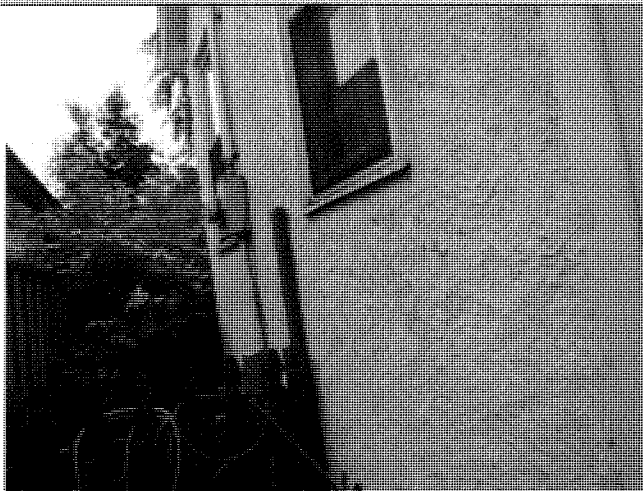
Photo 7: Exterior

Wood trim is built into the stucco finish. The trim is deteriorating around windows.

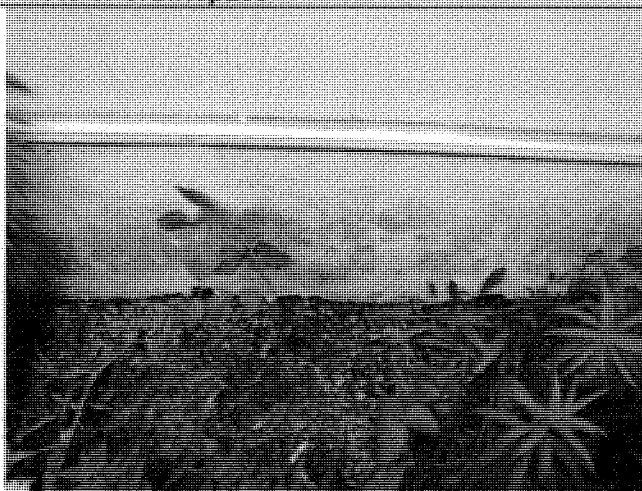
Photo 8: Crawlspace

No access available to the crawlspace under the bathroom at the side of the home or the crawlspace at the front of the home.

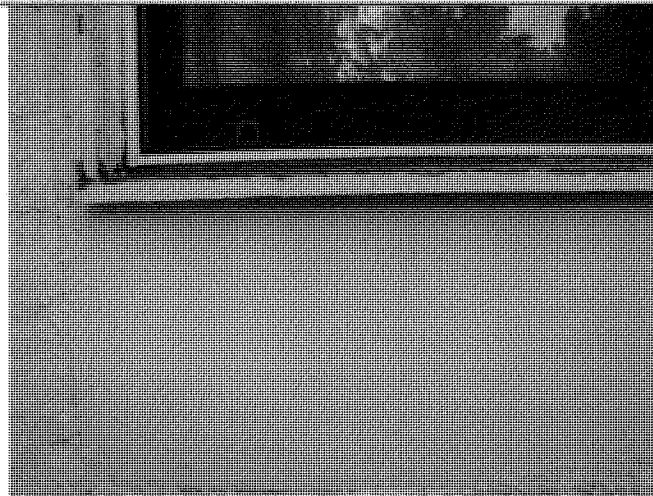
Photo 9: Window

Plywood is built into stucco and needs to be kept painted. Some wood deterioration is visible on the trim.

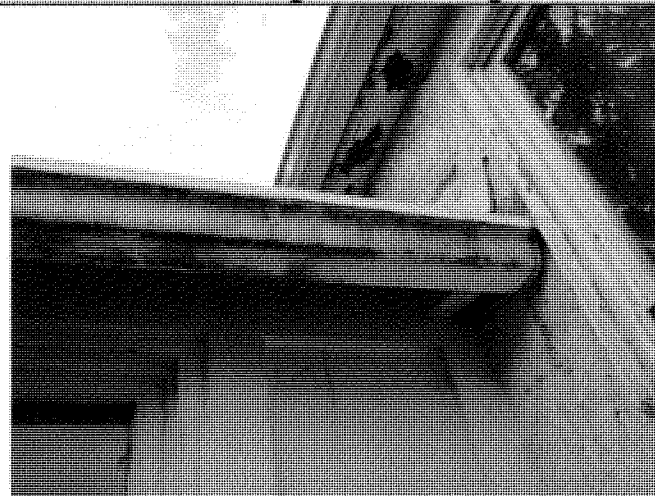
Photo 10: Poor drainage at Eavestrough

Ice damming may be occurring in this area affecting the bottom side soffit and interior building materials. As well the stucco is starting to deteriorate.

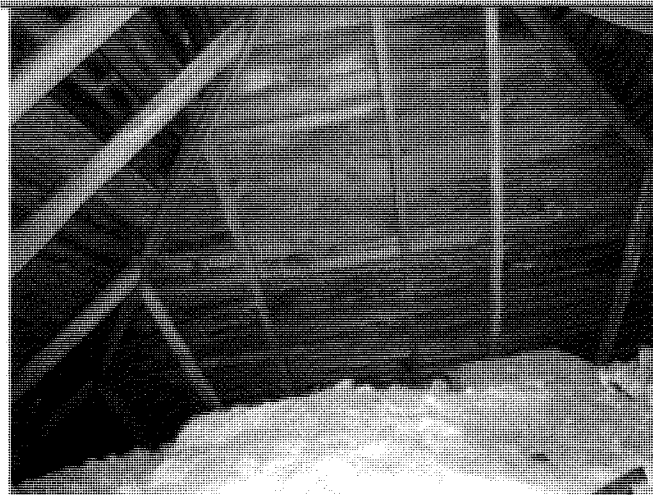
Photo 11: Attic

Mold growth was detected on swabs taken of the attic sheathing.

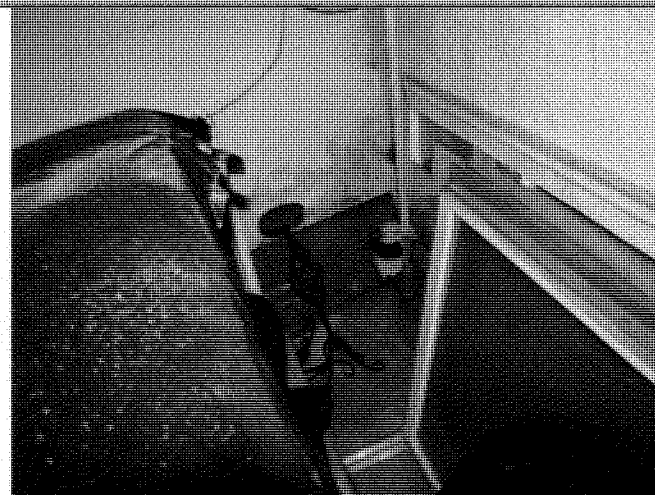
Photo 12: Basement

A strong musty odour is present upon descending into the basement. There is evidence of water intrusion and mold growth affecting this area of basement.

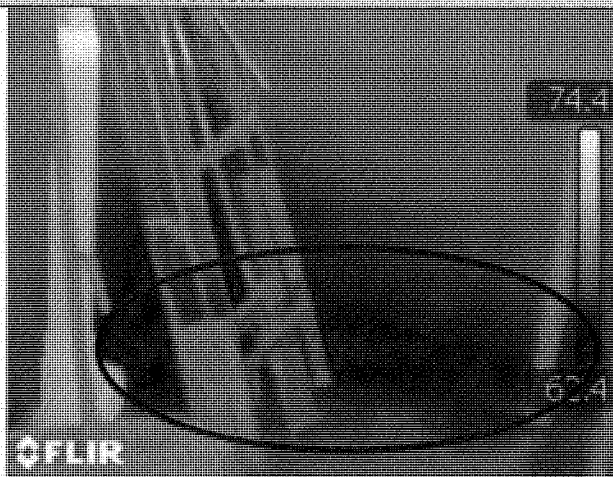
Photo 14: Basement

Moisture intrusion occurring at floor height.

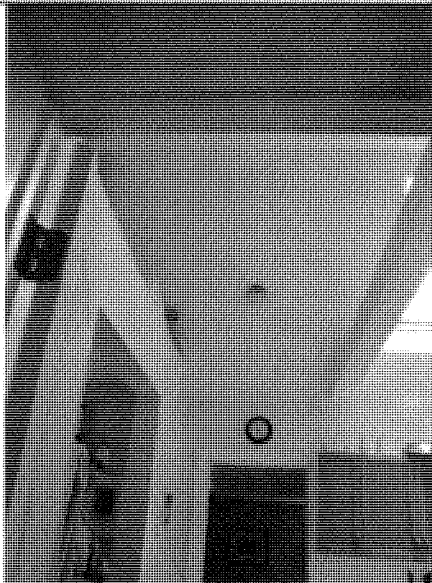
Photo 15: Kitchen Cathedral Ceiling

Most of the cathedral ceiling in the kitchen shows some heat loss.

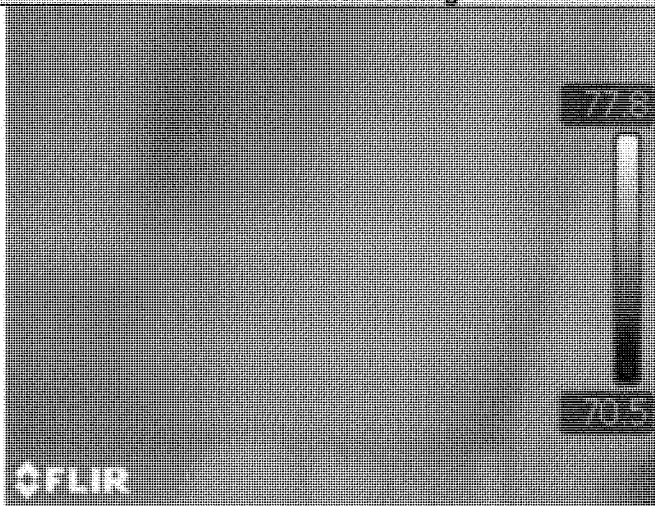
Photo 16: Kitchen Cathedral Ceiling

The heat loss may affect the roof in winter months causing ice damming because of insufficient ventilation.

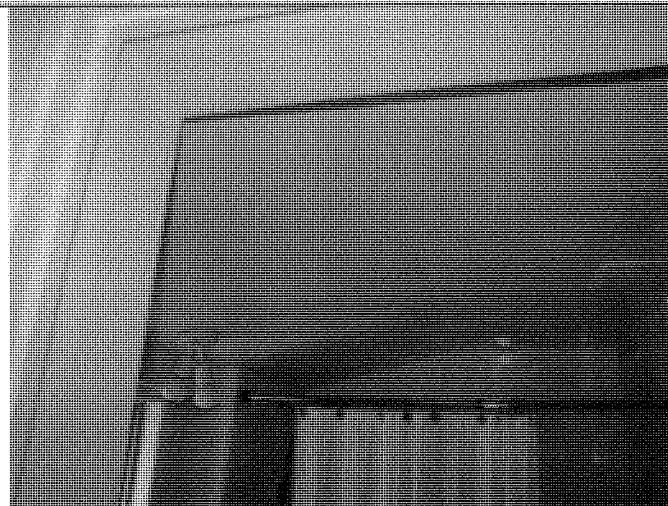
Photo 17: Bathroom

The bathroom fan vents into the inaccessible attic. The attic does not have ventilation.

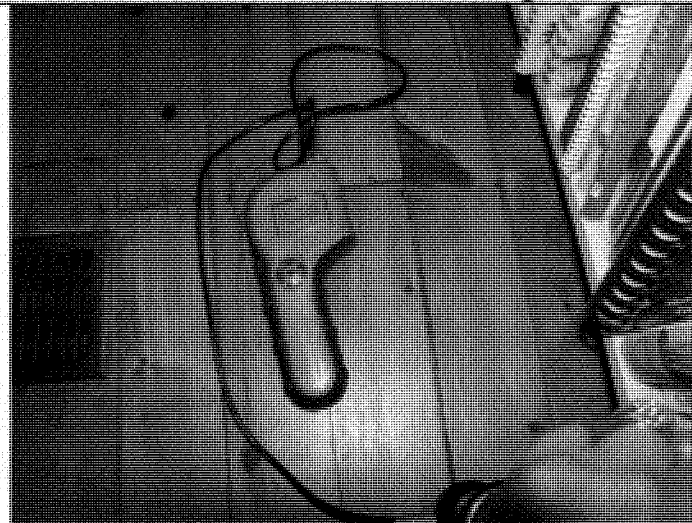
Photo 18: Main Floor Entrance and Living Room

The wood floor in this area including subfloor is moist up to 16% wood moisture content. A crawlspace is below with no access.
