# Corporate Report

**SUBJECT:** Request to Replace a Structure on a Heritage Designated Property  
Old Port Credit Village Heritage Conservation District  
24 John Street South  
(Ward 1)

A PHYSICAL, HISTORICAL AND CONTEXTUAL ASSESSMENT OF  
24 JOHN STREET SOUTH  
MISSISSAUGA, ONTARIO

Structural Assessment and Recommendations  
for 24 John Street South, Port Credit, Mississauga

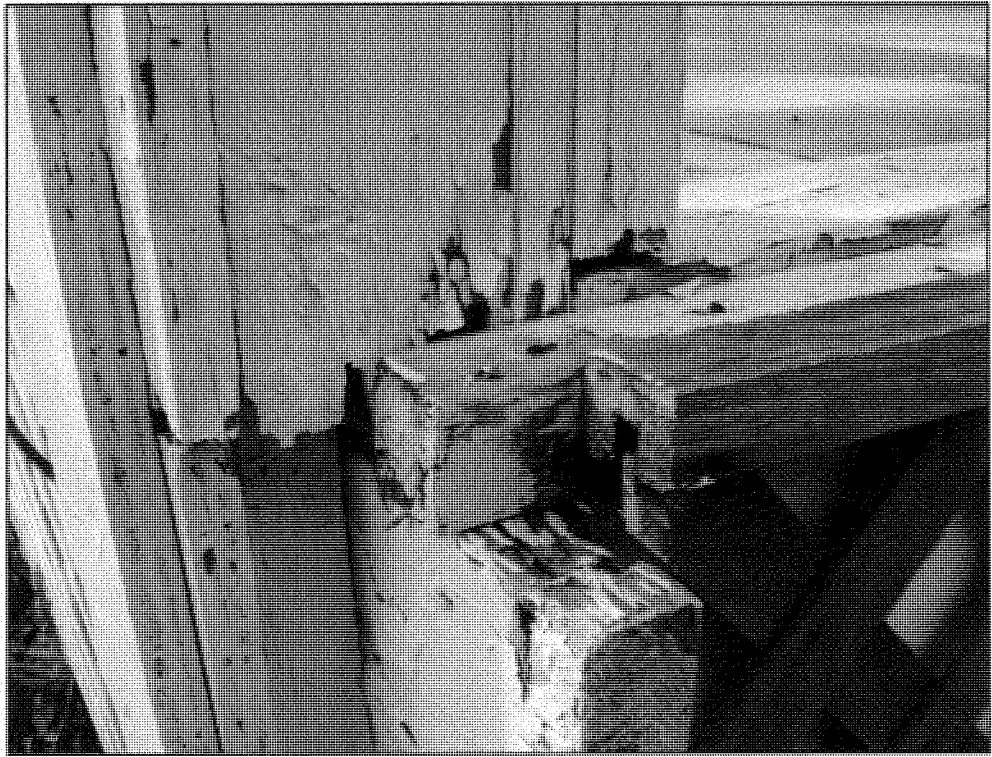
This porch is in urgent need of reconstruction. The structural integrity of the posts that sustain the porch is seriously compromised. The planks of wood on its flooring are cracked and decaying. The roofing is rotten and sagging. The railing was damaged years ago and removed."

Poor condition of the porch.

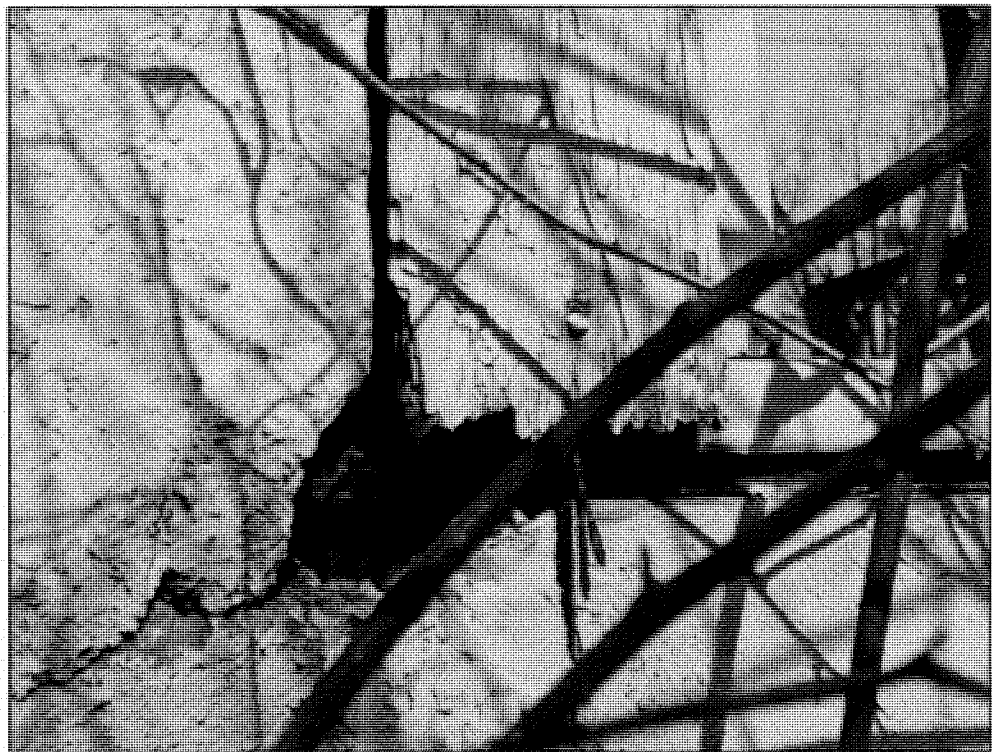
A structural report by Shoalts Brothers Construction Limited reports that the stucco surface of the exterior walls is crumbling at many places. Most of the wood on the verandah is rotting. From the author's own personal observations, the foundation appears to have shifted over the years. The interior floors are now uneven. An environmental inspection report by Environmental Services Group has registered levels of mould in the basement and excess moisture content in the home's subfloor.

Rotting wood and chipped stucco.

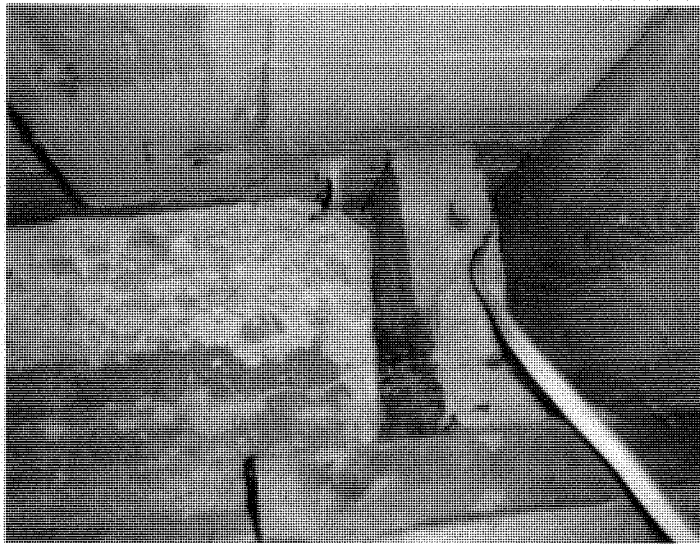
There is an inaccessible crawlspace under the front of the house, and the top of the basement wall has been infilled with concrete around the joists preventing one from seeing the condition of the crawlspace, however the foundation is not located at an original bearing line of the floor. The floor joists and beams are undersized and must be sistered if they are to remain in service. There are some previous floor openings that have been improperly filled; they must be framed in correctly. The close contact of the masonry and concrete has resulted in serious deterioration of the ends of some joists.

Concrete infill and rotted joist

The height of the basement is substandard, there is inadequate foundation drainage, and the crawlspace must be made accessible, which means that in all practicality, the house must be lifted and a new and proper basement must be constructed if it is to remain in service. Lifting the house would prove to be challenging because of the haphazard and insufficient framing of the floor, the additions, and the front porch. The rear addition that provides access to the basement does not appear to have any sort of proper foundation at all, and the bottom wall plate is much lower than the main house, further complicating the prospect of salvaging it for future use.

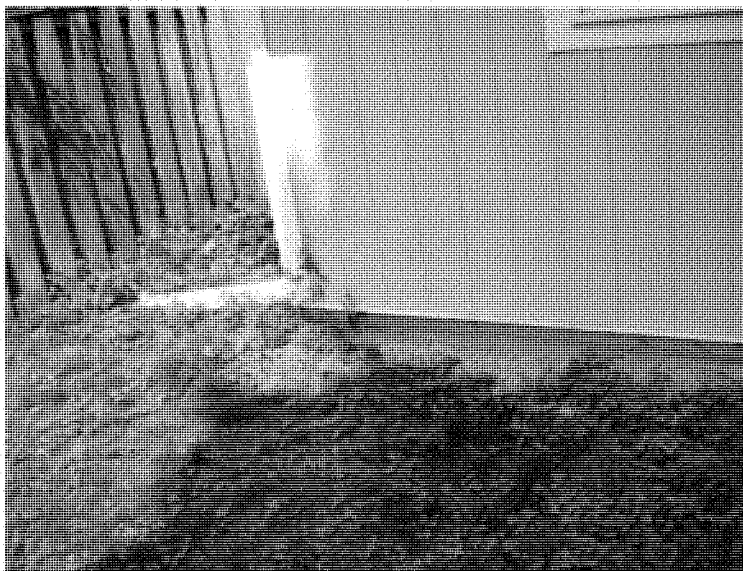
The structure of the main floor of the dwelling has been modified numerous times in its history. There are at least three, and possibly four additions to the original building, as well as substantial alterations to the original and subsequent structures. What appears to have been a rear porch has been winterized and finished, albeit improperly, and it does not meet the most basic standards for structural integrity and weatherability, and should be removed and replaced. It has fairly new siding and roofing, however there does not appear to be a proper foundation, there is unprotected spruce framing lumber within a few centimetres of the exterior grade, and flashing and caulking details are incorrect and will quickly lead to serious deterioration.

Rear addition with improper foundation and moisture protection

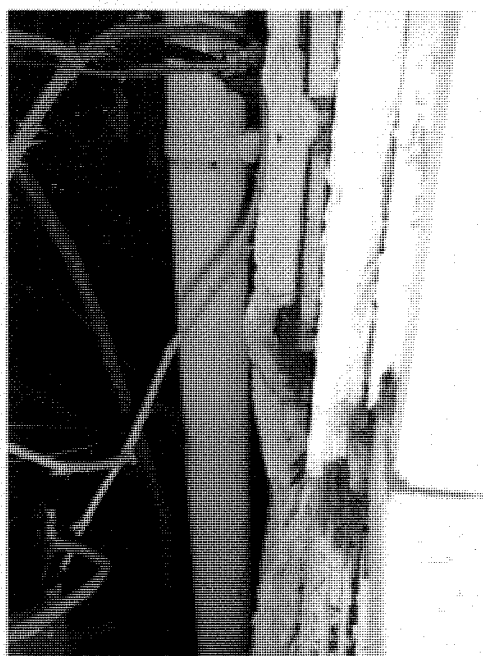
The main house and early west addition have an exterior finish of roughcast stucco. This appears to be the original finish on the addition, however the main house was originally clad with horizontal wood clapboard siding over which the stucco was applied. There was no attempt at proper flashing or weatherproofing of original wood trims and penetrations, and although the porch roof has protected some of these areas, there is serious deterioration in other areas, much of which has had subsequent substandard stucco repair, and requires further work. It is quite likely that the underlying sheathing and structure in these areas has experienced serious decay and should be repaired or replaced, however without intrusive or destructive investigation this cannot be confirmed.

Stucco over wood trim

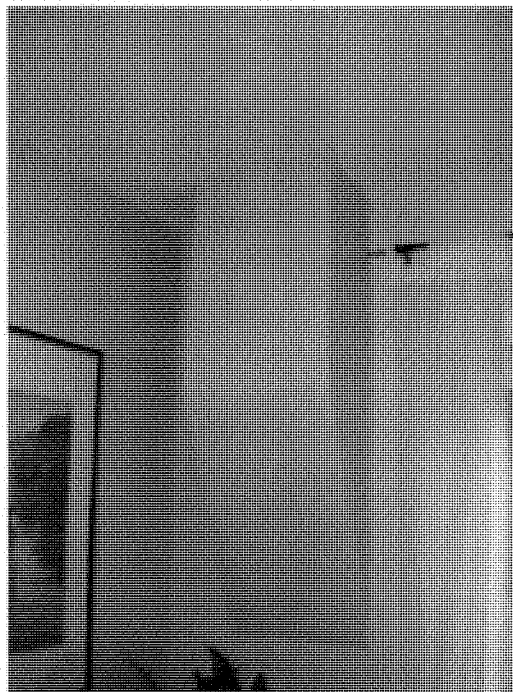
An apparently original chimney for a woodstove still exists on the rear wall of the house although it no longer extends through the roof. As was common in the 19th century, and less so in the 20<sup>th</sup>, the chimney is supported on the wood framing of the rear wall. While this is a poor construction detail and is not permitted under today's building code, the chimney could be permitted to remain if there were a good reason to do so. Because it no longer serves even a decorative purpose, it should be removed to eliminate the excessive stress that it places on the already inadequate building structure.

Obsolete and improperly supported chimney

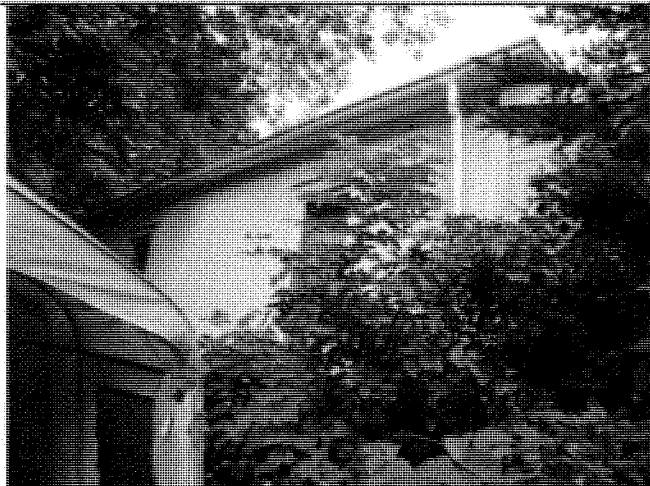
**Photo 4: Side View Exterior**

No soffit venting present for this attic.

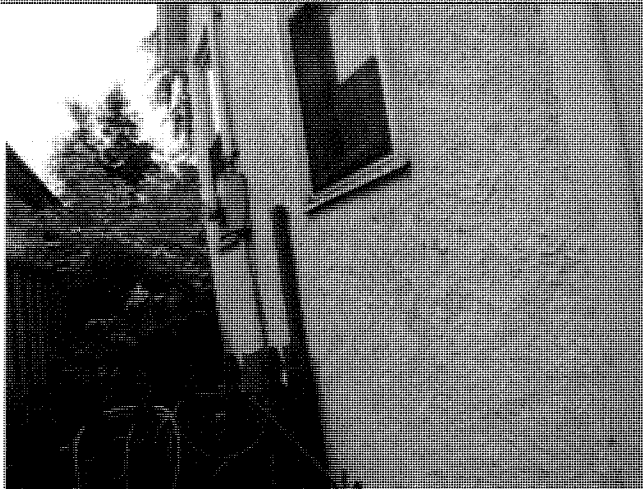
**Photo 7: Exterior**

Wood trim is built into the stucco finish. The trim is deteriorating around windows.

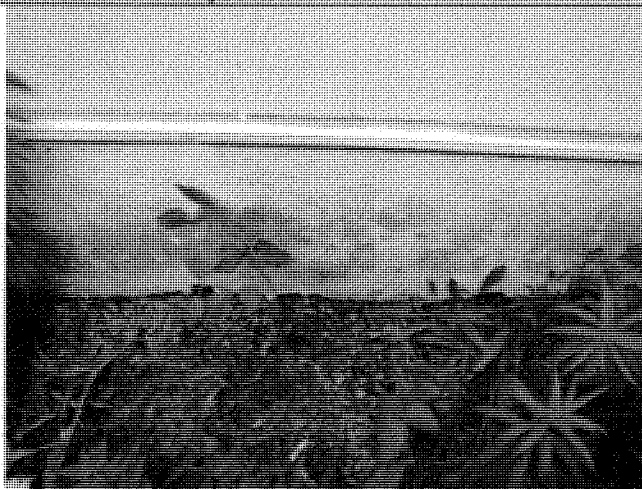
**Photo 8: Crawlspace**

No access available to the crawlspace under the bathroom at the side of the home or the crawlspace at the front of the home.

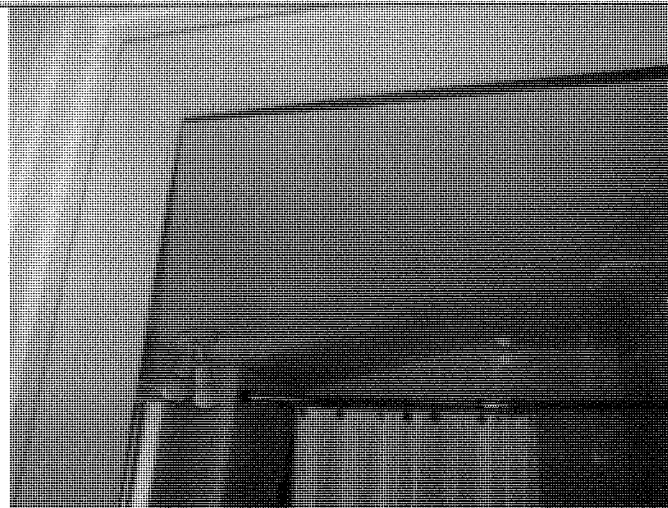
**Photo 17: Bathroom**

The bathroom fan vents into the inaccessible attic. The attic does not have ventilation.

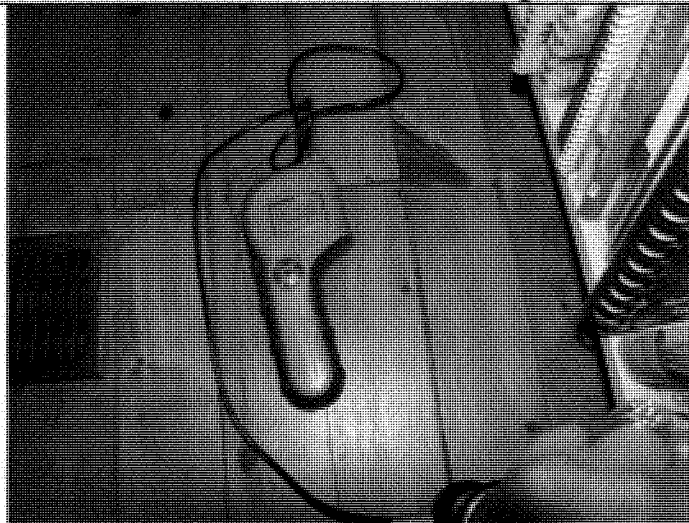
**Photo 18: Main Floor Entrance and Living Room**

The wood floor in this area including subfloor is moist up to 16% wood moisture content. A crawlspace is below with no access.
