Port Credit Heritage Conservation District Subcommittee

SUBJECT: Request to Replace a Structure on a Heritage Designated Property
Old Port Credit Village Heritage Conservation District
24 John Street South
(Ward 1)

HERITAGE IMPACT STATEMENT

Structural Assessment and Recommendations
for 24 John Street South, Port Credit, Mississauga

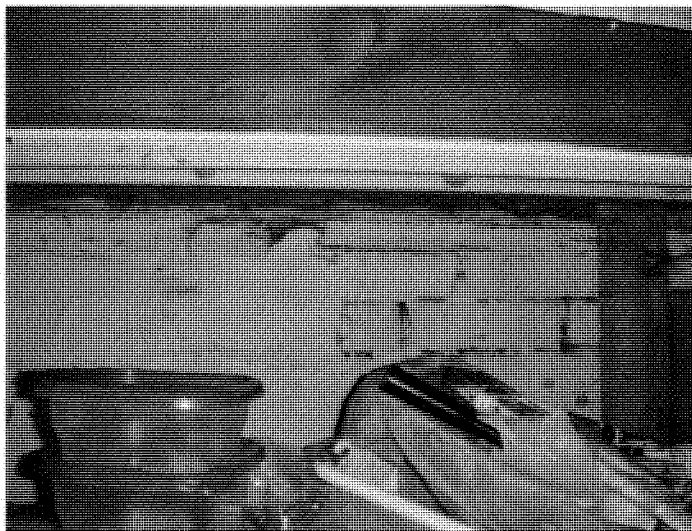
however it does extend under what is almost certainly a later addition. This leads one to believe that either the basement was constructed at the time of the addition and was extended under part of the existing house, or as the oral history states, the house was relocated from elsewhere onto an existing basement. After relocation of a building onto an existing concrete foundation, whether constructed for the purpose or remaining from another structure, it is common practice to build up the top of the foundation with masonry infill. This building has both brick masonry and concrete infill between the concrete foundation walls and the wood floor structure.

Brick infill

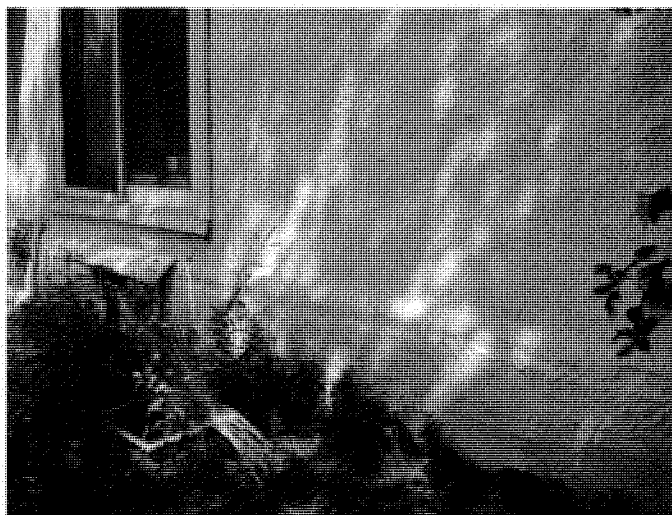
The addition could have been built when the house was relocated to extend the house and to cover the portion of the basement that the original house did not fit. This seems to be the more likely scenario given the brick infill at the top of the wall, the projection of the foundation beyond the rear wall of the house, and the arbitrary and illogical location of the front wall of the basement with respect to the structural requirements of the floor system.

Misaligned foundation at rear wall

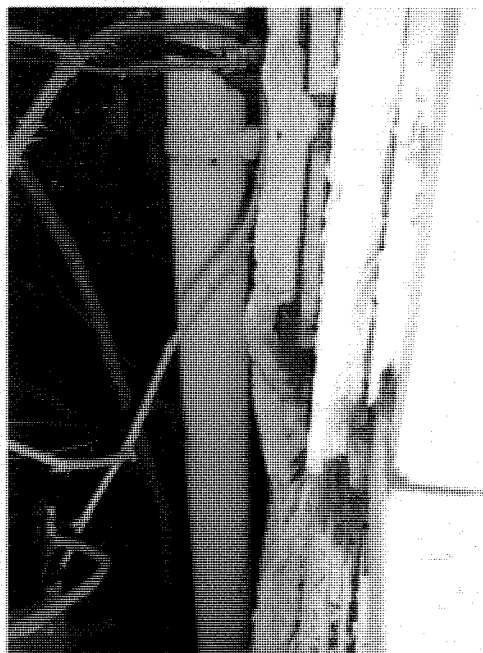
The main house and early west addition have an exterior finish of roughcast stucco. This appears to be the original finish on the addition, however the main house was originally clad with horizontal wood clapboard siding over which the stucco was applied. There was no attempt at proper flashing or weatherproofing of original wood trims and penetrations, and although the porch roof has protected some of these areas, there is serious deterioration in other areas, much of which has had subsequent substandard stucco repair, and requires further work. It is quite likely that the underlying sheathing and structure in these areas has experienced serious decay and should be repaired or replaced, however without intrusive or destructive investigation this cannot be confirmed.

Stucco over wood trim

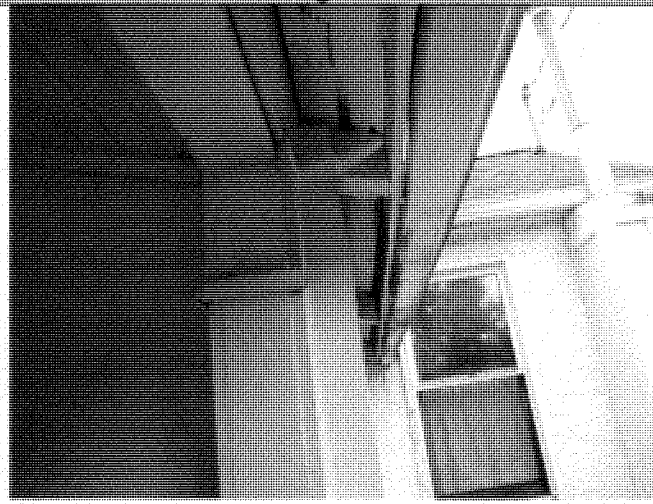
Photo 2: Porch Overhang

Wood is deteriorating over enclosed bathroom built into porch.

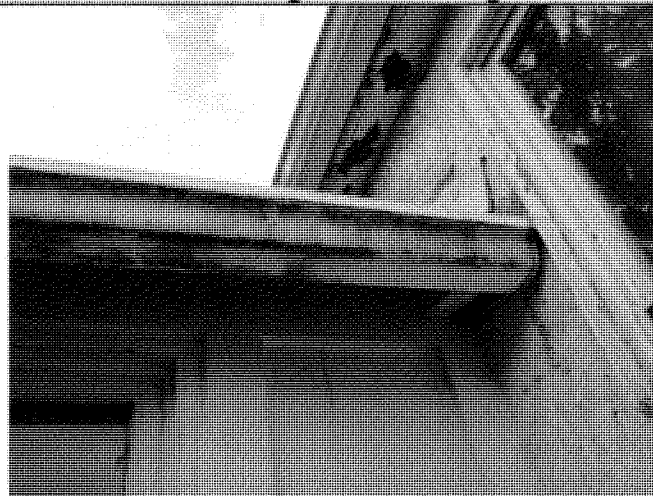
Photo 10: Poor drainage at Eavestrough

Ice damming may be occurring in this area affecting the bottom side soffit and interior building materials. As well the stucco is starting to deteriorate.

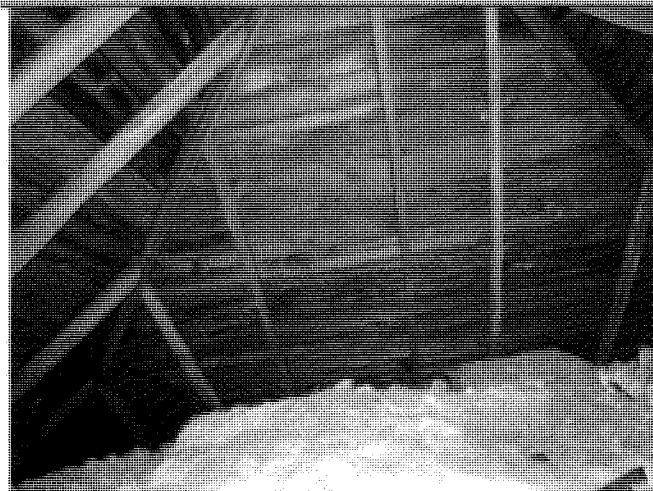
Photo 11: Attic

Mold growth was detected on swabs taken of the attic sheathing.
