SUBJECT: Arborist Report and Tree Preservation Plan (Heritage report) 1427 Dundas Crescent, Mississauga

## Arborist Report and Tree Preservation Plan

## 1427 Dundas Crescent, Mississauga

February 22, 2021

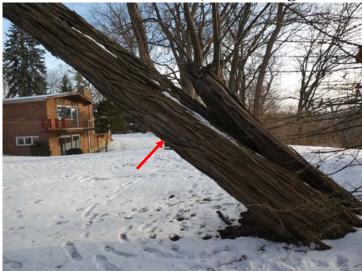
**Photo #3 (Tree #38)**

37	Subject Site	Black Locust	Robinia pseudoacacia	80	16	8	Fair	Good	Small-caliper deadwood in canopy; topped at 8m with epicormic re-growth	Preserve: TPZ = 4.8m
38	Subject Site	Red Oak	Quercus rubra	116	24	12	Poor	Poor	Large-caliper deadwood in canopy; appears to be at least 90% dead (small leaf canopy at apex); basal <i>Ganoderma spp.</i> conks on stem	Remove: Potential safety hazard

The above photos show the two (2) hazard trees proposed for removal on the site at 1427 Dundas Crescent, Mississauga.

These trees are in poor structural condition and represent an increased 'level of risk.' These 2 trees are recommended to be safely removed to grade level as soon as is reasonably possible.
