**SUBJECT: Arborist Report and Tree Preservation Plan
1220 Stavebank Road, Mississauga**

Arborist Report and Tree Preservation Plan

1220 Stavebank Road, Mississauga

October 15, 2015

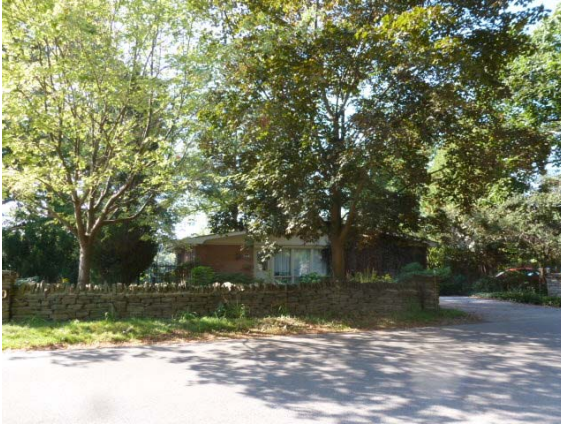
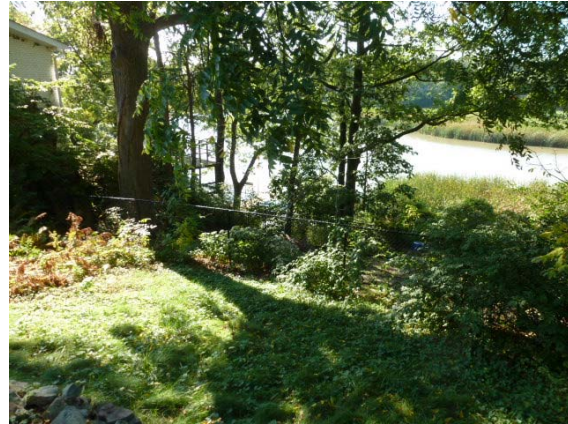
Figure #1: These 2 photos show the front and back yard of the property at 1220 Stavebank Road as they appeared during the tree inventory conducted on September 24, 2015.

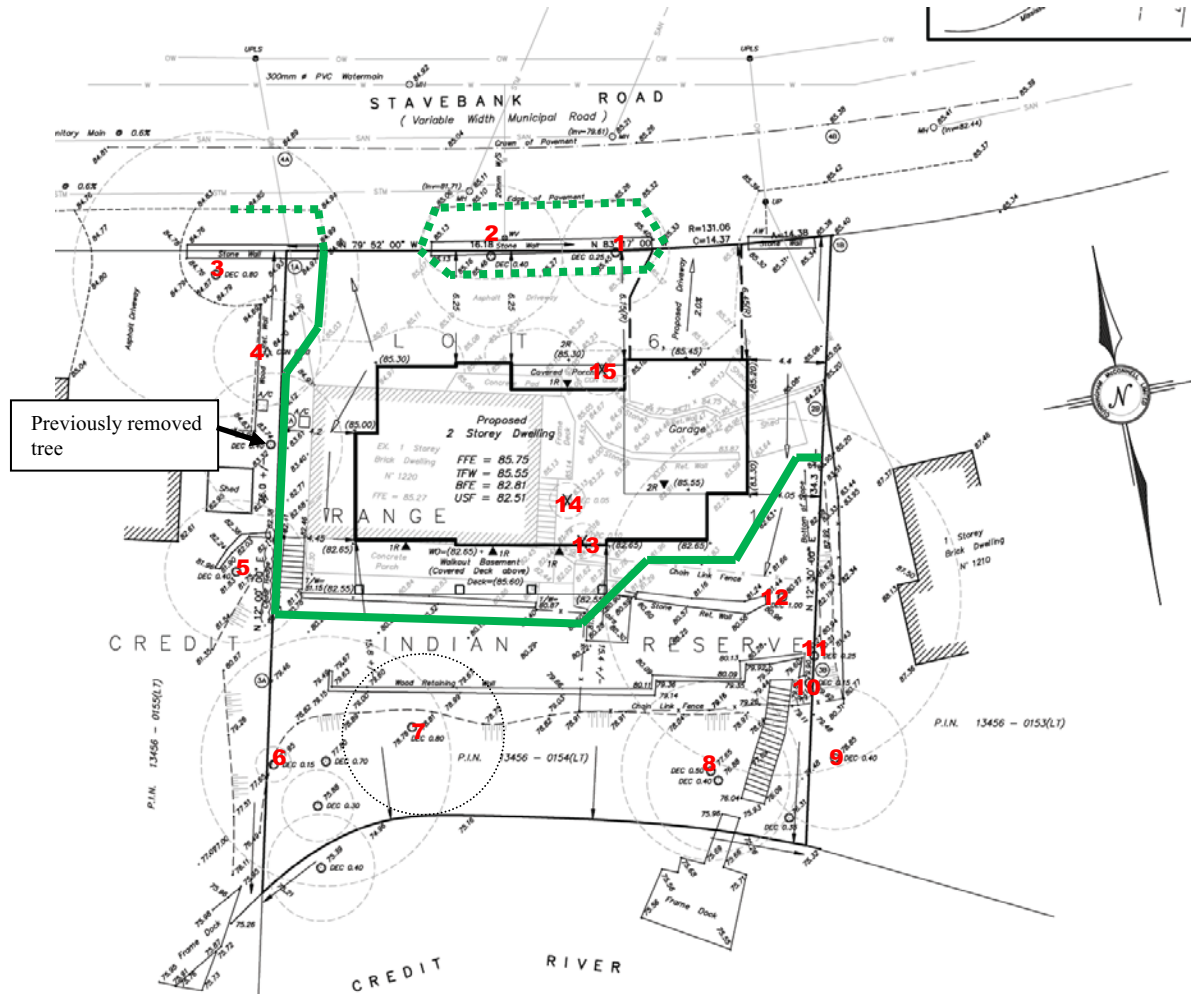
Appendix A: Proposed Site Plan

2.) A Certified Arborist shall be on-site during excavation of proposed building foundation within proximity of northwest side of Tree #12 (Black Walnut – DBH = 98cm)

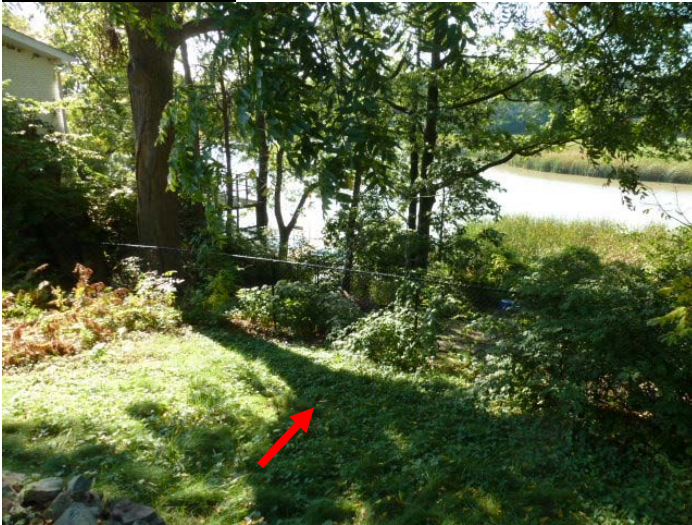
Figure #2: Potential root pruning on northwest side of Tree #12

- Photo #3 shows the approximate area of the southeast portion of the proposed building foundation excavation which may potentially injure the root system of Tree #12 (Black Walnut – subject site – DBH = 98cm). The minimum required TPZ for this tree is 6.0m
- Photo #4 shows the rock retaining wall to the west of Tree #12.

A Certified Consulting Arborist shall be on-site during the proposed building foundation excavation to determine the size and quantity of Tree #12's roots that could be affected. Any roots in the immediate area of the excavation shall be assessed and, if feasible and reasonable, properly pruned by the attending Arborist. This action should reduce the potential for root injury caused by the excavating equipment, and provide any pruned roots with the best opportunity to regenerate.
