9.2 Appendix 2 11 Plainsman Road

Project Address: 11 Plainsman Road , Mississauga, Ontario

Data Collection and Report Prepared by: Stephen Shelton ON-0542AT, TRAQ 1589 <u>steve@summitsks.ca</u> 12 October 2022

SHEET Tree Protection Plan

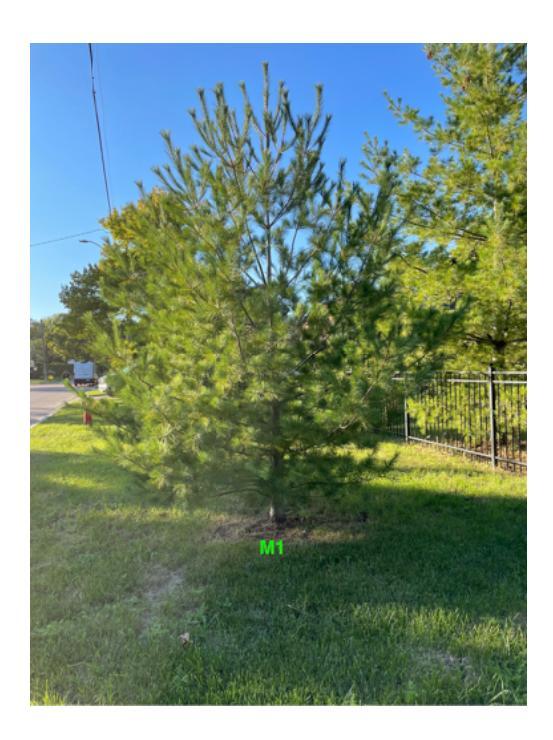
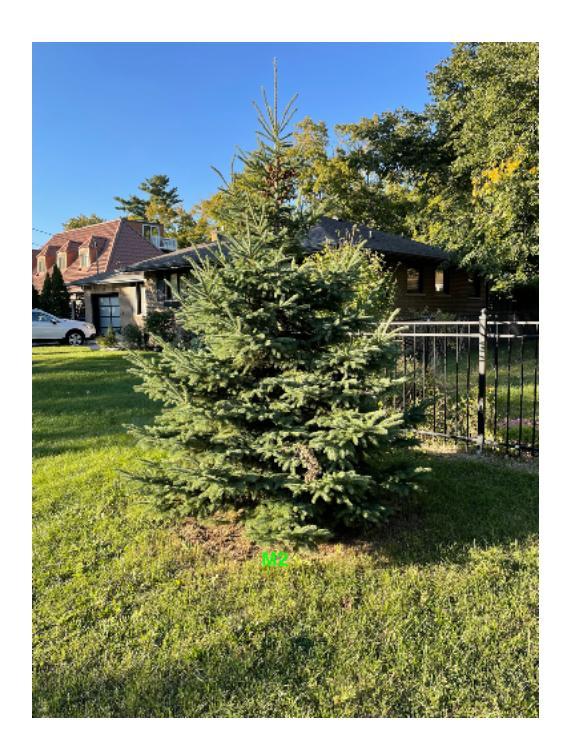
Tree number M1 is a 6cm dbh Pine Eastern White that is growing on the municipally owned boulevard. This tree is in good condition and requires a tree protection zone of 1.8m.

Tree number M2 is a 4cm dbh Pine Eastern White that is growing on themunicipally owned boulevard. This tree is in good condition and requires a tree protection zone of 1.8m.

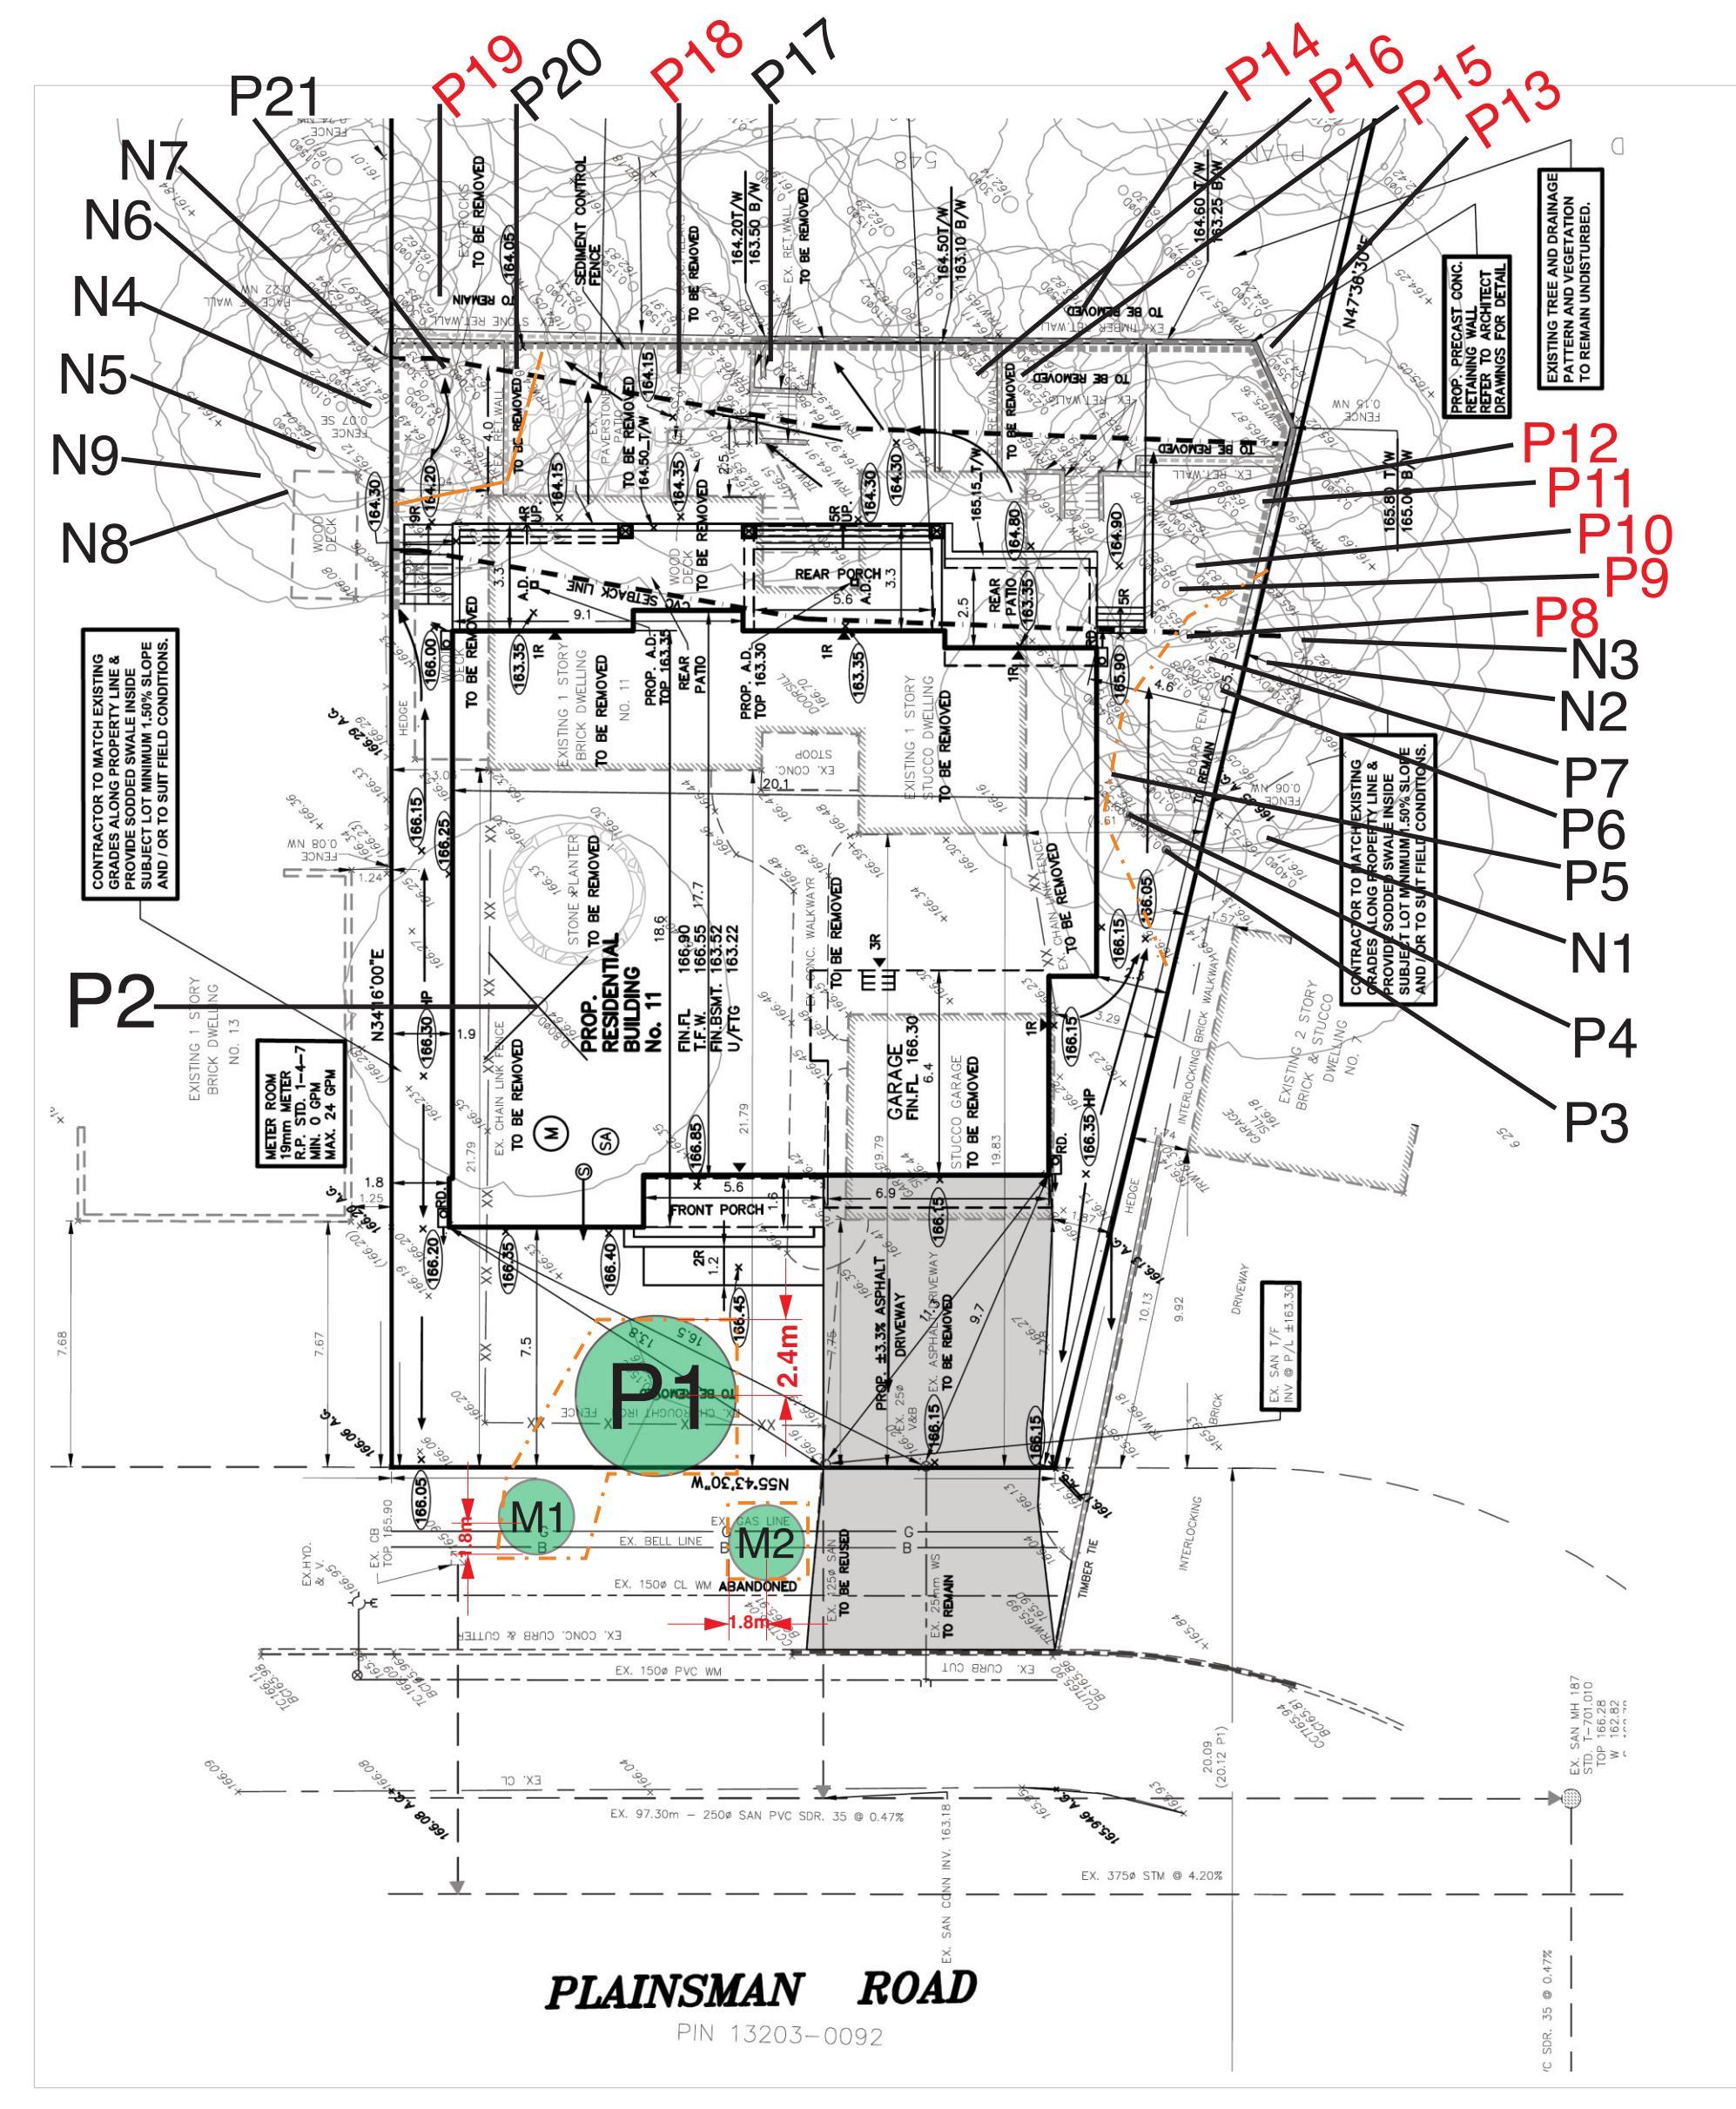
The purpose of this report is to inventory and assess trees 15cm in diameter, measured at breast height and larger on the subject property, in the city road allowance adjacent to the property and any trees within 6m of the property line. There are eleven (11) trees recommended for removal as a result of this proposed construction.

# All protective tree hoarding shall be installed prior to commencement of any construction activities as per City of Mississauga specifications.
