HERITAGE IMPACT ASSESSMENT

EDITH CLARKSON HOUSE 1160 Clarkson Road North CLARKSON - CITY OF MISSISSAUGA

04 SEP 2020

MEGAN HOBSON CAHP

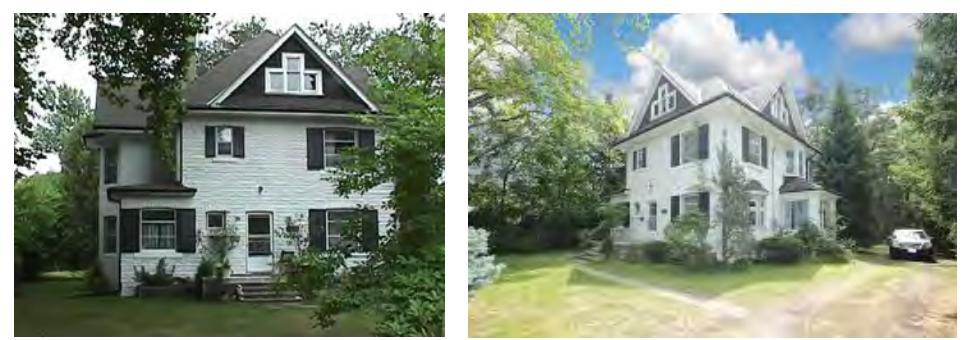
MAIN ELEVATION (left): re-clad with stone in the 1960s and the porch replaced with a concrete stoop SIDE ELEVATION (right): bay window and side entrance oriented towards the driveway

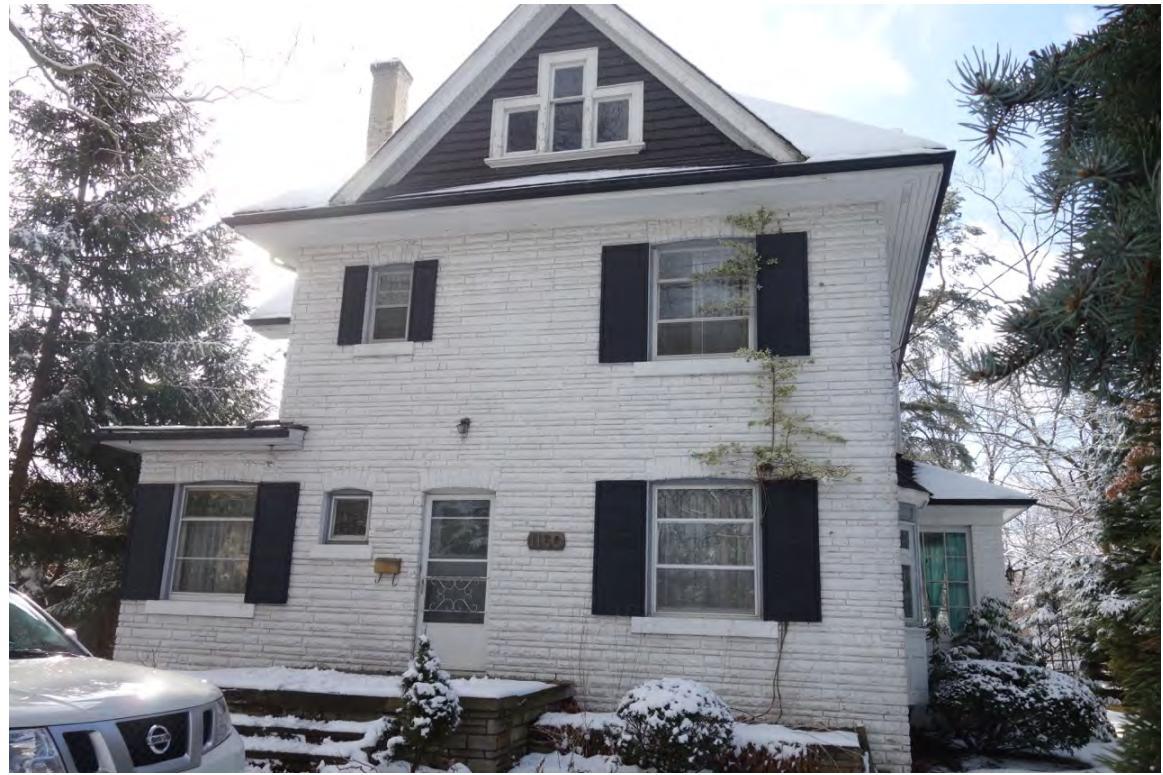
In the later 20th century, subsequent owners made changes to the house including re-facing of the front with a cultured stone that was popular in the 1960s and commonly called 'Angel stone'. A concrete stopp faced with the same stone replaced the original wood porch. A new fireplace was built in the living room using the same stone. The hay barn at the back of the property was converted to a garage and garage doors and windows were installed.

FRONT ELEVATION – re-clad with stone in the 1960s

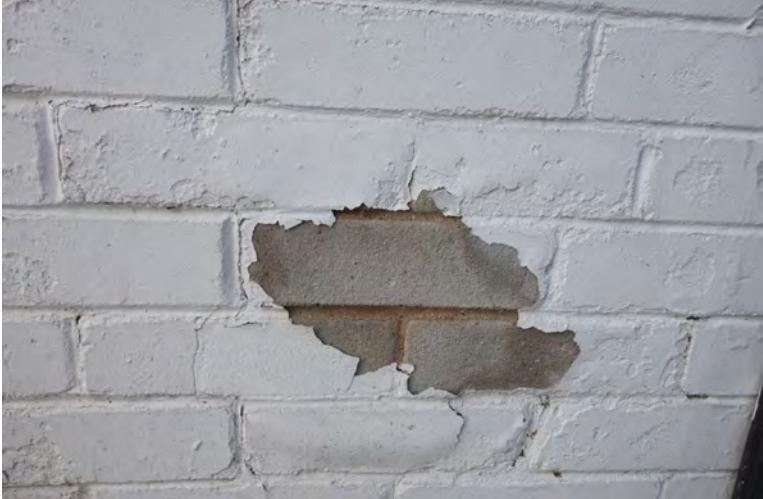
MASONRY DETAILS – the edge of the 1960s stone veneer at the corner of the façade (left) and the original 1913 cement brick (right)

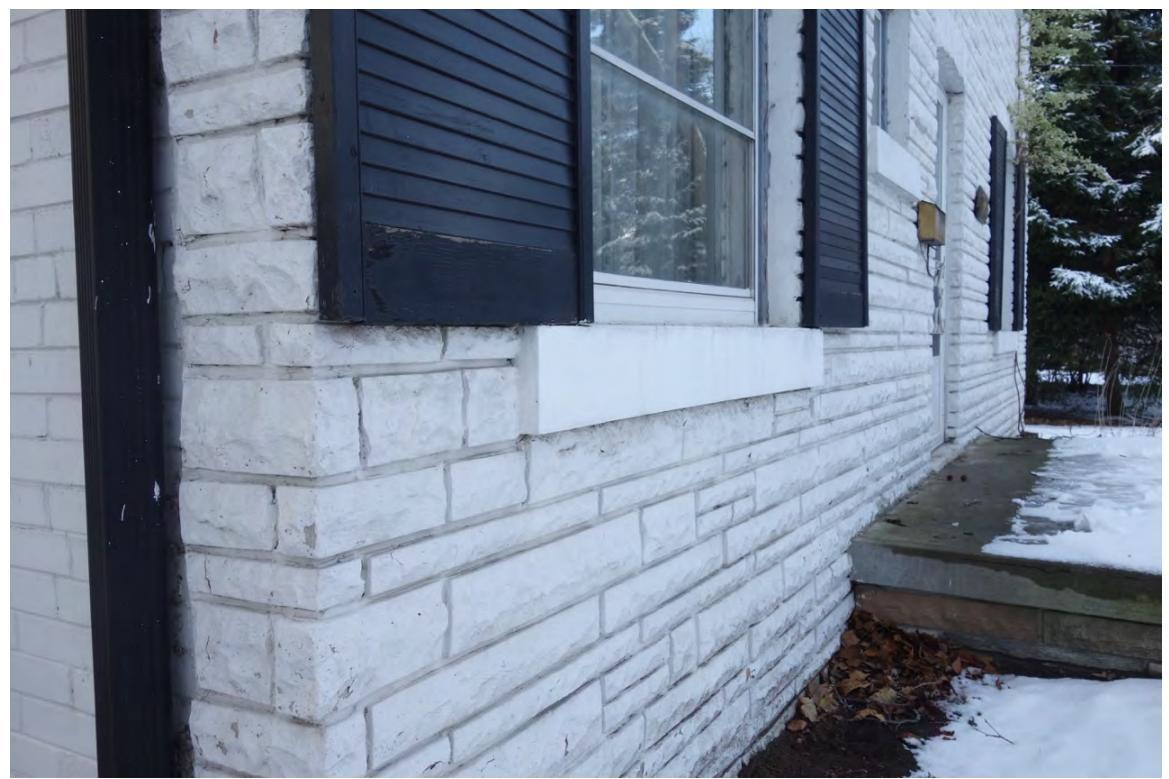
MASONRY DETAIL – front façade was re-clad with stone in the 1960s

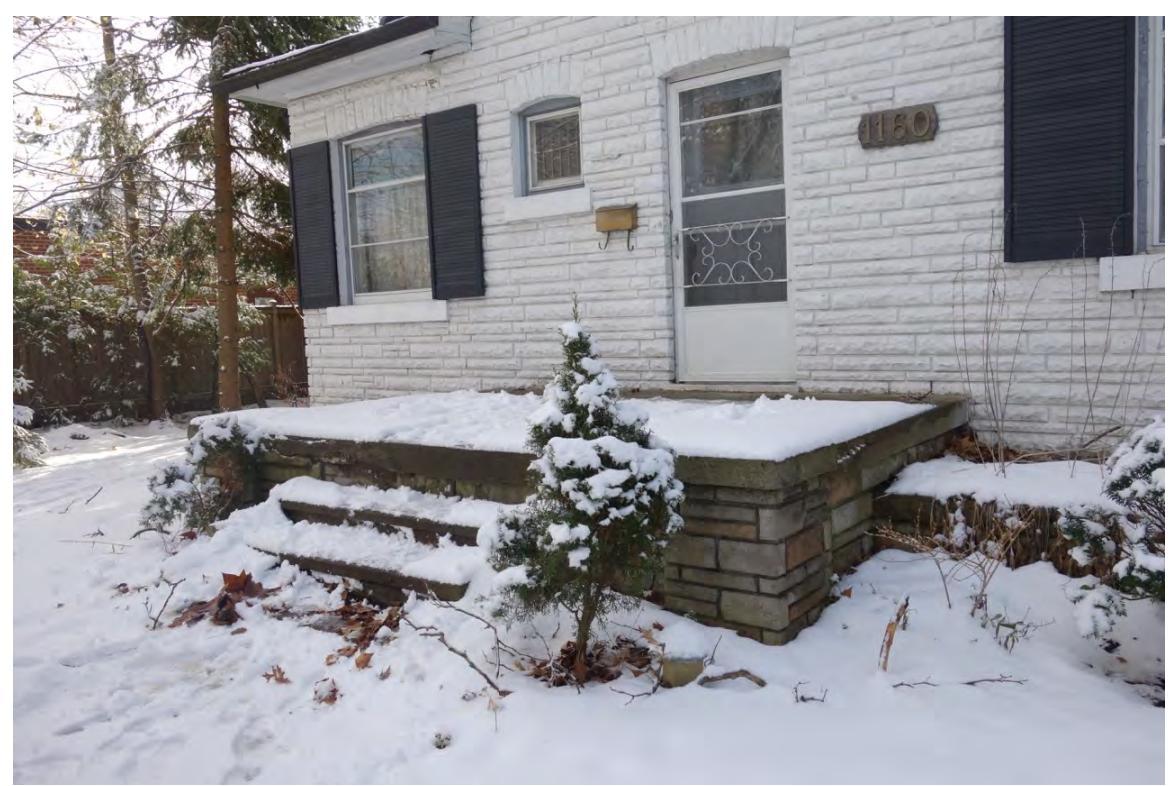
FRONT ENTRANCE – concrete stoop with stone veneer that replaced the original front porch

The conservation strategy is to retain original features and improve the façade of the Edith Clarkson house by reinstating the front porch in a complimentary style and reinstating wood shingle in the gables. The proposed interior renovations will support ongoing residential use and are compatible with the existing layout so that original interior features can be retained. The approach is to renovate the existing dwelling without making any new additions so that minimal intervention is required.

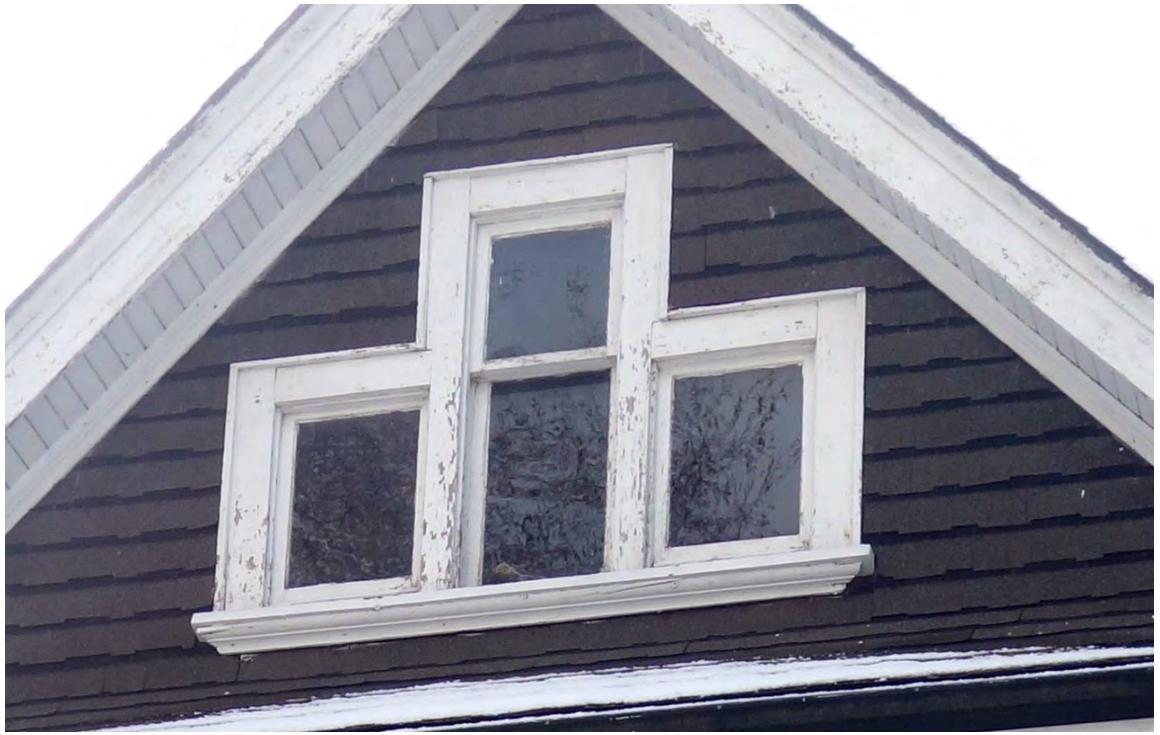
FRONT GABLE – wood shingle replaced (or covered?) with asphalt shingle

- The original wood shingle in the gables may be preserved under the asphalt shingle. It is therefore recommended that they be inspected to determine if repair is feasible. The rear sun porch has original cedar shingle that can be used as a guide for selecting new shingle if it is required.
- If the fireplace in the master bedroom is not required and the new use of this space is not compatible with this feature, it could be boxed-in with drywall so that it's protected and could be reinstated in the future
- The wood siding on the barn may be suitable for repair rather than replacement. If it cannot be repaired it could be replaced with a similar wood siding. If feasible, the metal railings above the hay doors could be retained to preserve a record of the original use, since the doors will be replaced with glazing.

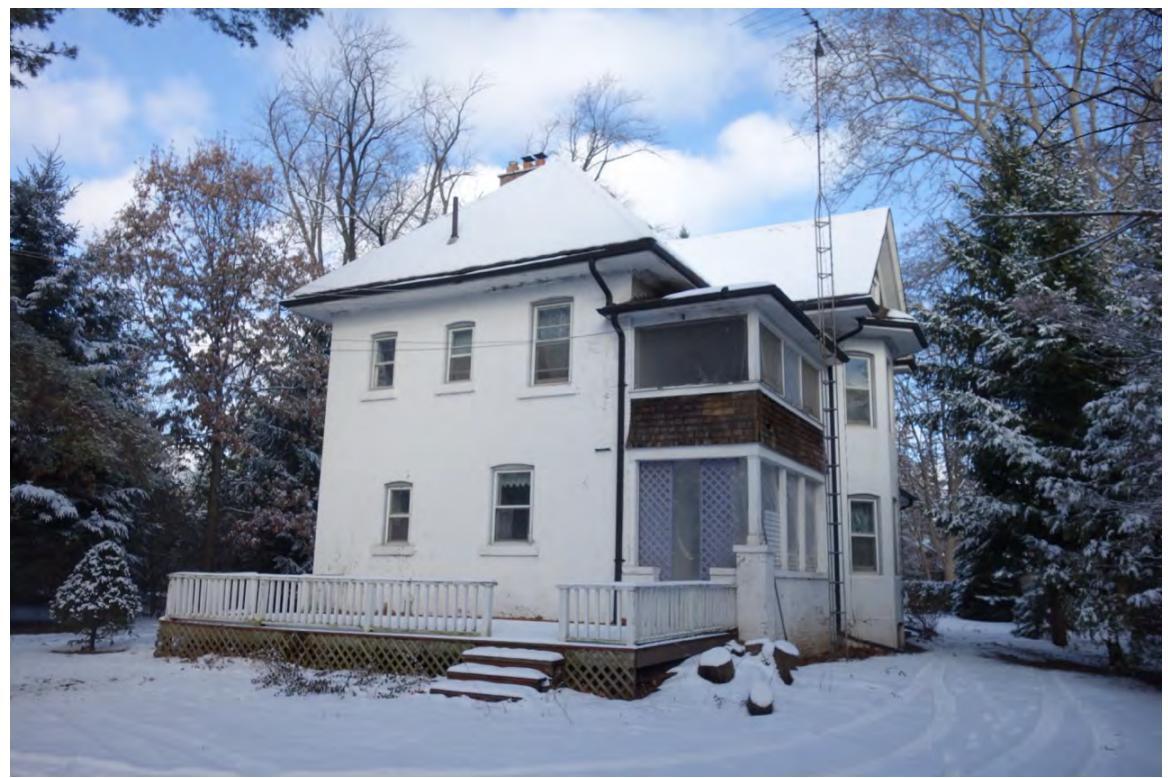
REAR & SIDE ELEVATION – the 2-storey screened sleeping porch – original wood shingles

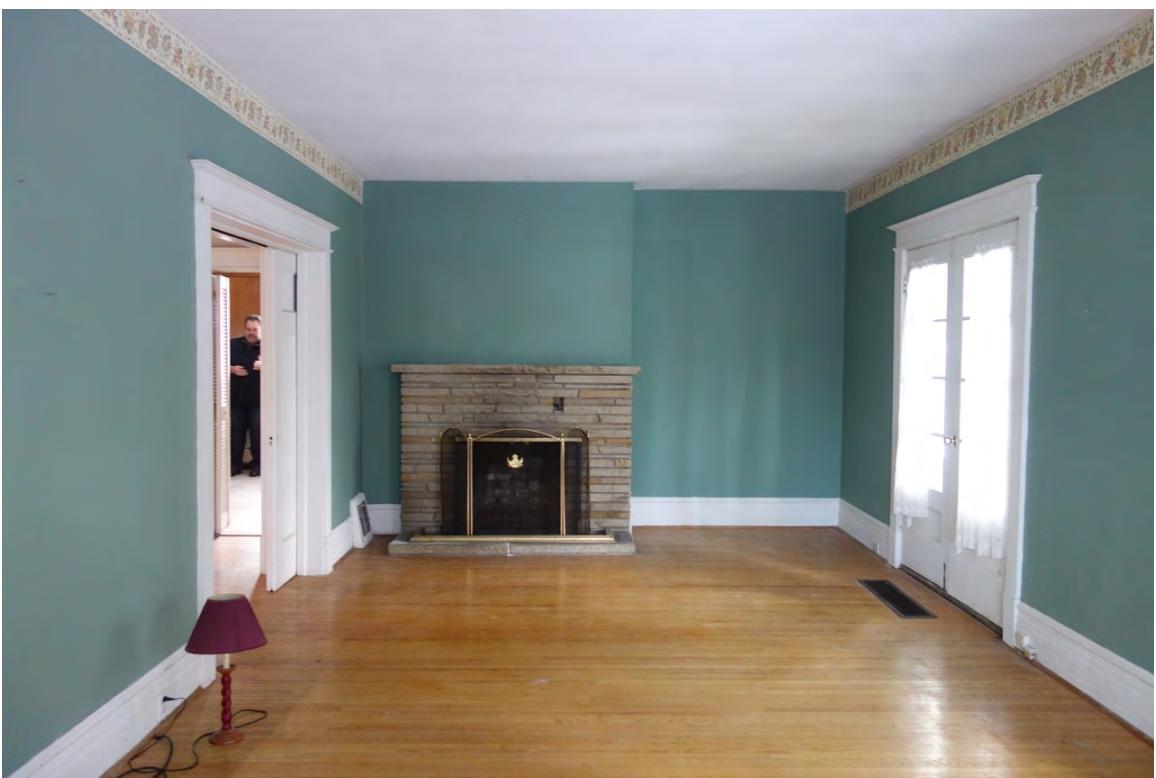
1ST FLOOR – Living Room with 1960s stone fireplace

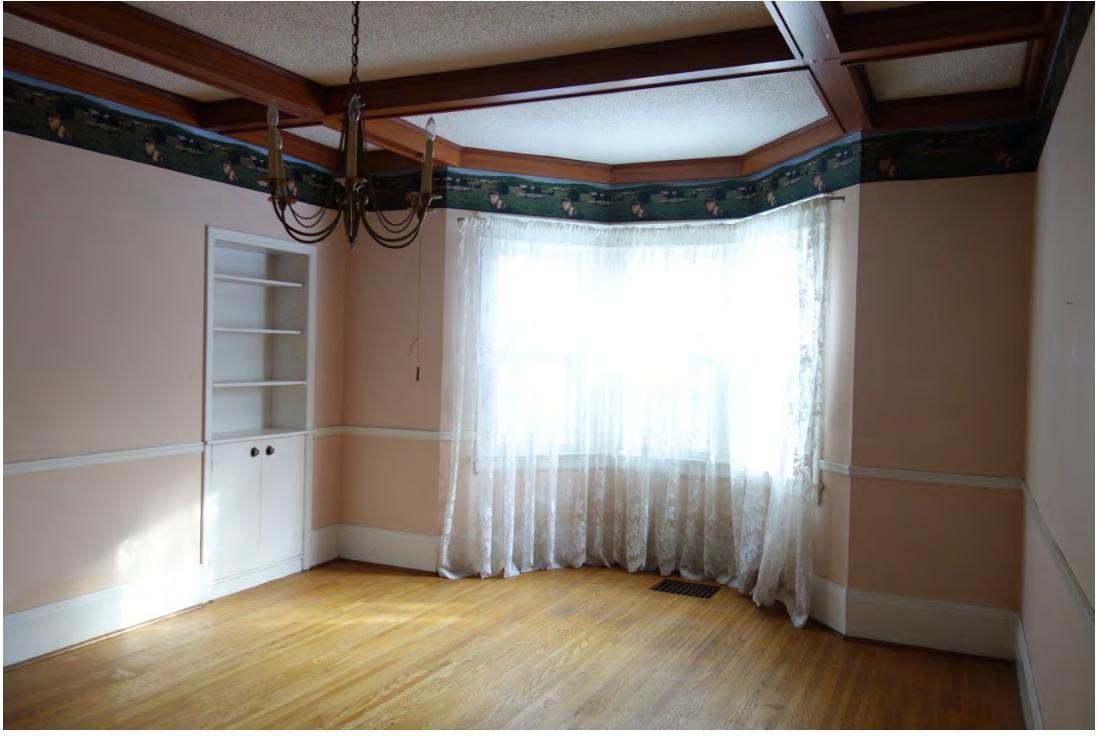
1st FLOOR – Dining Room – ceilling timbers are not original

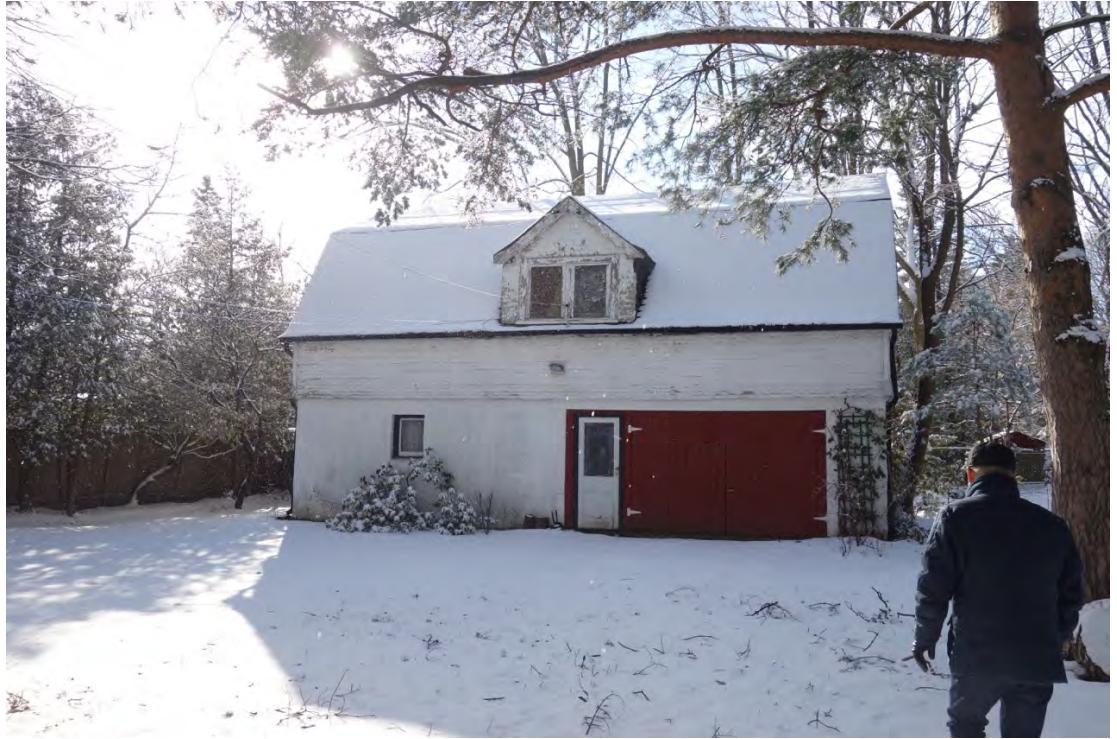
There is a small bay window in the front that does not appear to be original. The windows and garage doors on the ground floor are not original and were likely installed when the building was converted to a garage, probably in the mid-20th century.

GARAGE – front – doors and windows are not original

Alterations proposed for the outbuilding include replacement of the wood siding with new wood siding to match the existing, installation of new windows and doors in a compatible style, and construction of a bathroom on the ground floor. The old hay doors will be removed and replaced with glazing. The doors and windows are not original so replacement is not a heritage concern. The stucco on the lower level will be retained. The proposed changes are minor and will contribute to the preservation and ongoing use of this structure.

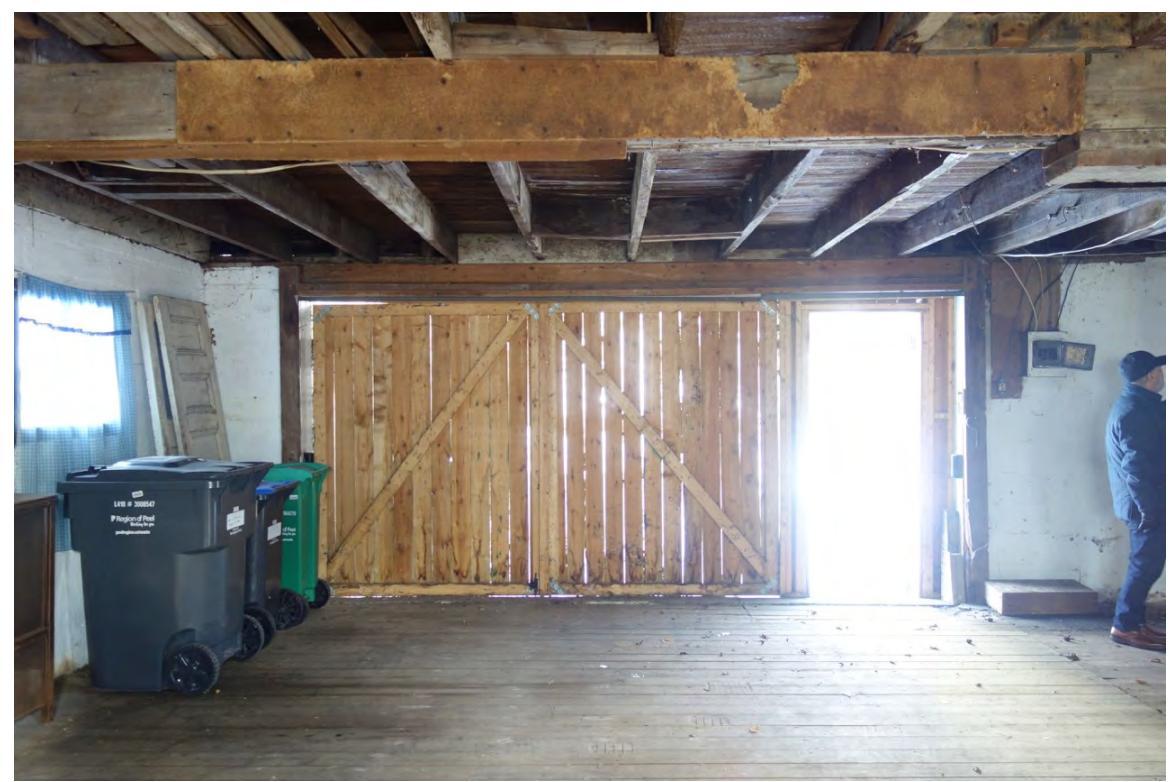
GARAGE – interior – door is not original
