The purpose of this memorandum is to request your approval to Rebuild Alectra's (Legacy Enersource's) existing hydro pole line along Mississauga Road South from Lake St. to High St. West along the east boulevard. This is to reinstate the current temporary condition of the poles along the east boulevard of Mississauga Road from Lake Street to Lake Shore Road West. The existing poles were trimmed due to condition of the assets and safety reasons. The customers had been temporarily accommodated from the existing pole line on the west boulevard of Mississauga Road, which is also of the same vintage.

# **Arborist Report**

Tree Inventory and Assessment

17 Mississauga Rd N to 53 Lake St Mississauga, ON

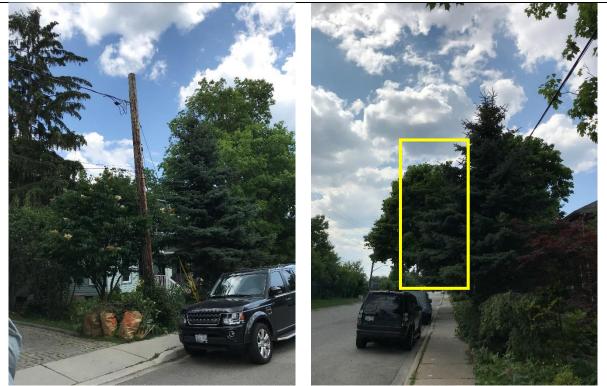
Figure 3. Left: Trees #3 and #4 from right to left. Right: Tree #3.

Trees #2, #3, #5-10, #12-15, #17, and #19-21 are recommended for utility clearance pruning and should be pruned in accordance with good arboricultural practices.

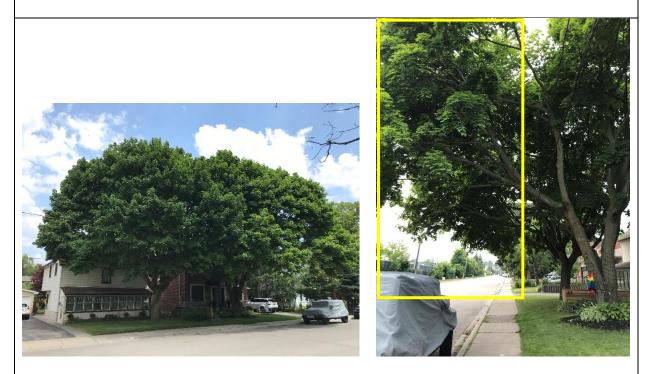
Trees #5, #6, #9, and #15 are planned to have a utility pole installed within their drip lines. Excavation for utility pole installation should be done by low pressure hydro vac within tree drip lines to minimize damage to roots. Once roots are exposed, roots should be pruned by a Certified Arborist. The expected impact of injury ranges from Low to High. Trees #19, #20 have both a utility pole removal and installation within their drip lines.

Figure 4. Left: Trees #5 and #6 from right to left. Right: Trees #5 and #6 from foreground to background.

- For trees #2, #4, #5, #6, #9, #14, #15, #19, and #20, we recommend a Certified Arborist supervise utility pole removals and installation within drip lines. We recommend using low pressure hydro vac as the excavation method and having exposed roots pruned by a Certified Arborist.
- For trees #32 and #33, we recommend that roots within drip lines be excavated by low pressure hydro vac or air spade under the supervision of a Certified Arborist. Once roots are exposed, we recommend root pruning by a Certified Arborist.

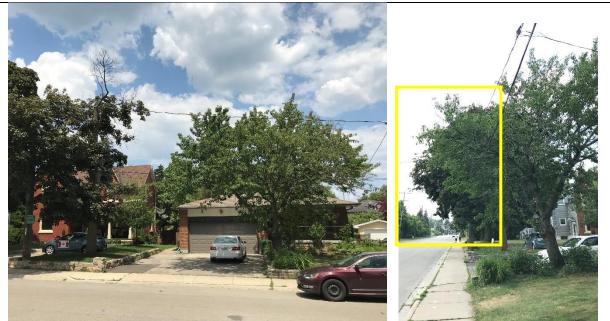
Figure 5. Left: Trees #7 and #8 from right to left. Right: Tree #7.

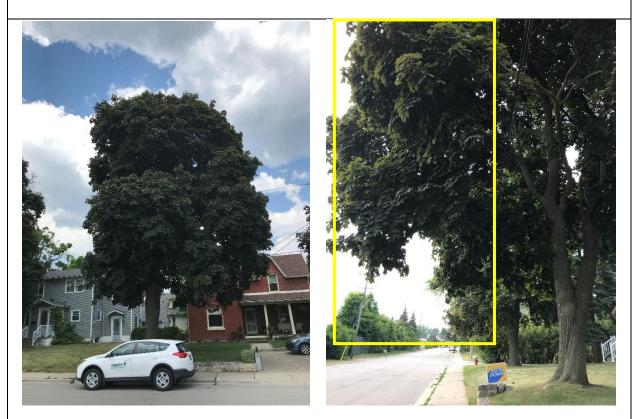
Figure 6. Tree #9.

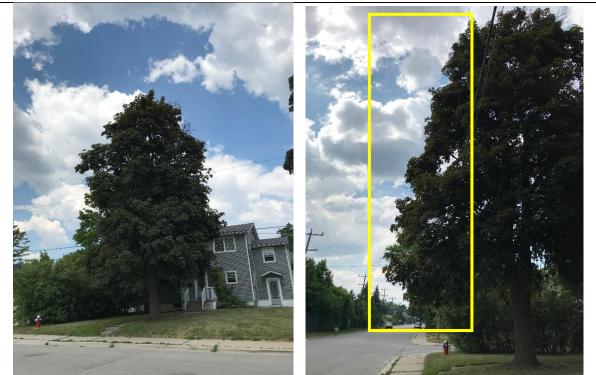
Figure 7. Tree #10.

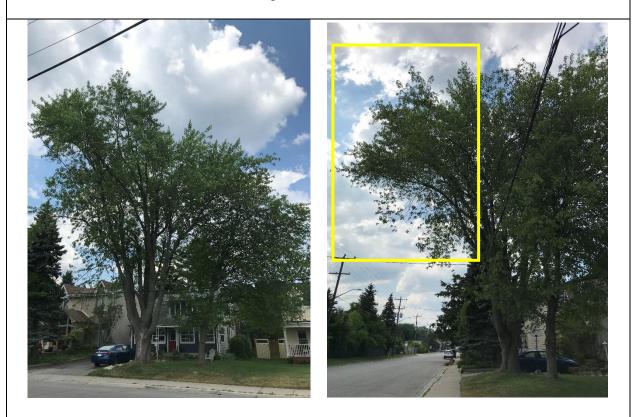
Figure 8. Left: Tree #11 and #12 from right to left. Right: Trees #11 and #12 form foreground to background.

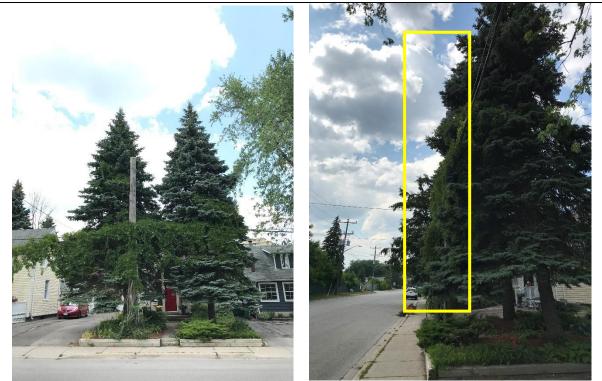
Figure 9. Left: Trees #13 and #14 from right to left. Right: Tree #13.

- For trees #1, #3, #8, #13, #16, #17, #23, #24, #36, and #37 we recommend the client install tree protection hoarding following the Tree Protection Plan (Appendix 2) prior to and during construction work.
- Hoarding shall consist of 1.2 m orange plastic fencing framed with solid top and bottom rail, or 1.2 m plywood following City specifications (Appendix 3), and should be installed around the drip line of each tree to protect roots from tearing and soil compaction during construction.
- We recommend all materials storage be kept outside of TPZs at all times during construction.

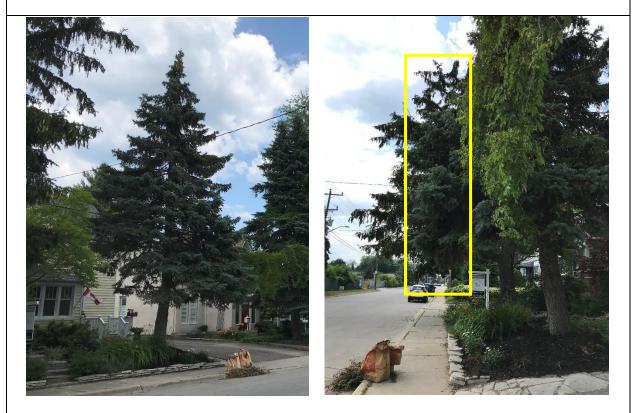
Figure 10. Left: Tree #15. Right: Tree #15 (foreground).

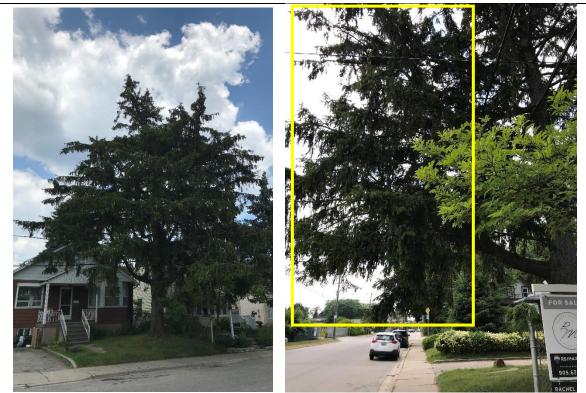
Figure 11. Left: Trees #16 and #17 from right to left. Right: Tree #17.

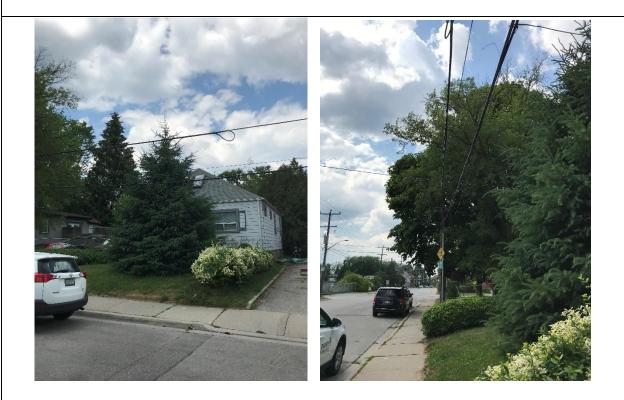
Figure 12. Left: Tree #18. Right: Tree #18 (foreground).

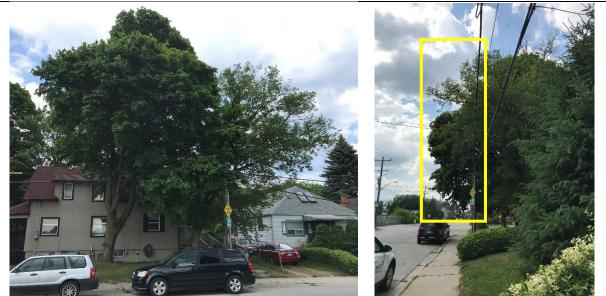
Figure 13. Left: Trees #19 and #20 from right to left. Right: Trees #19 and #20 (background).

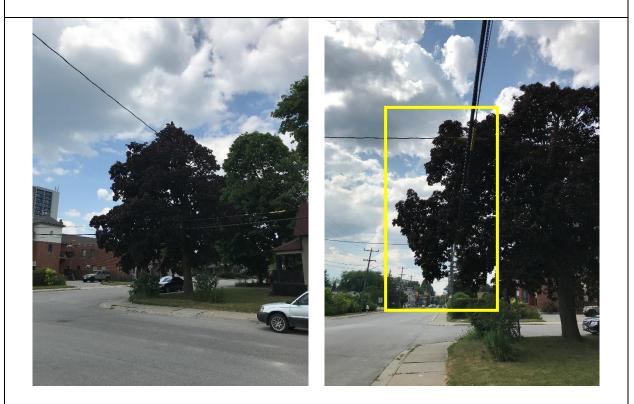
Figure 14. Tree #21.

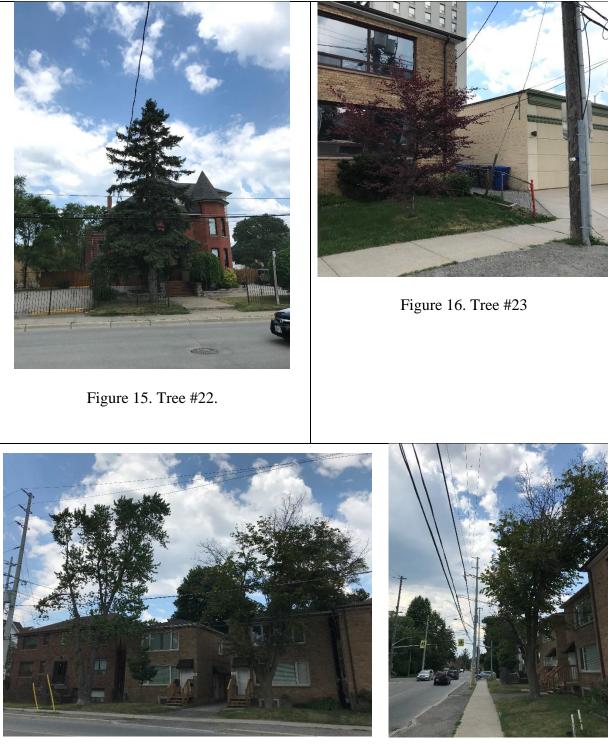
Figure 17. Left: Trees #24-#26 from right to left. Right: Trees #24-#26 from foreground to background.
