Arborist Report

Tree Inventory and Assessment

17 Mississauga Rd N to 53 Lake St Mississauga, ON

July 15, 2020

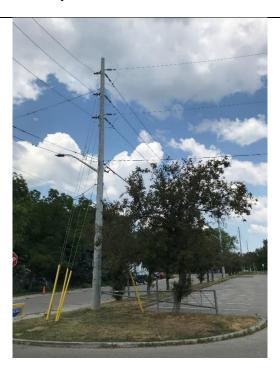
Figure 1. Tree #1.

- For trees #1, #3, #8, #13, #16, #17, #23, #24, #36, and #37 we recommend the client install tree protection hoarding following the Tree Protection Plan (Appendix 2) prior to and during construction work.
- Hoarding shall consist of 1.2 m orange plastic fencing framed with solid top and bottom rail, or 1.2 m plywood following City specifications (Appendix 3), and should be installed around the drip line of each tree to protect roots from tearing and soil compaction during construction.
- We recommend all materials storage be kept outside of TPZs at all times during construction.

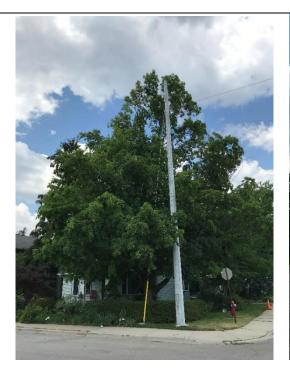
Figure 2. Tree #2.

- For trees #2, #4, #5, #6, #9, #14, #15, #19, and #20, we recommend a Certified Arborist supervise utility pole removals and installation within drip lines. We recommend using low pressure hydro vac as the excavation method and having exposed roots pruned by a Certified Arborist.
- For trees #32 and #33, we recommend that roots within drip lines be excavated by low pressure hydro vac or air spade under the supervision of a Certified Arborist. Once roots are exposed, we recommend root pruning by a Certified Arborist.

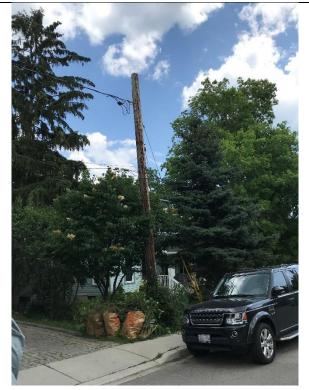
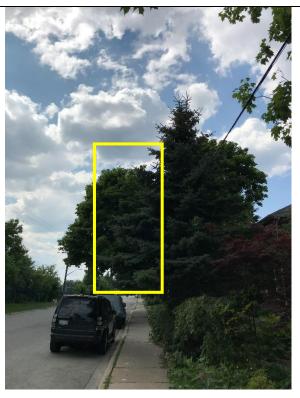
Figure 3. Left: Trees #3 and #4 from right to left. Right: Tree #3.

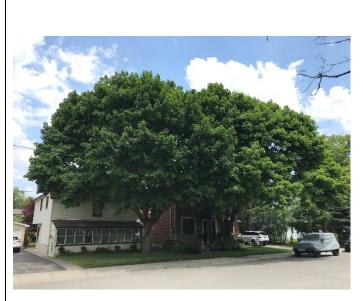
Trees #5, #6, #9, and #15 are planned to have a utility pole installed within their drip lines. Excavation for utility pole installation should be done by low pressure hydro vac within tree drip lines to minimize damage to roots. Once roots are exposed, roots should be pruned by a Certified Arborist. The expected impact of injury ranges from Low to High. Trees #19, #20 have both a utility pole removal and installation within their drip lines.

Figure 4. Left: Trees #5 and #6 from right to left. Right: Trees #5 and #6 from foreground to background.

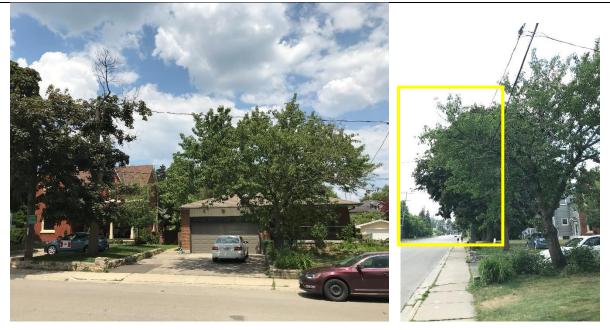
Figure 5. Left: Trees #7 and #8 from right to left. Right: Tree #7.

Trees #2, #3, #5-10, #12-15, #17, and #19-21 are recommended for utility clearance pruning and should be pruned in accordance with good arboricultural practices.

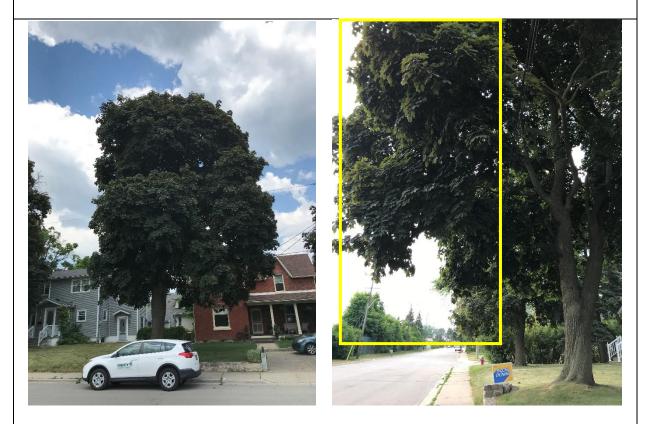
Figure 6. Tree #9.

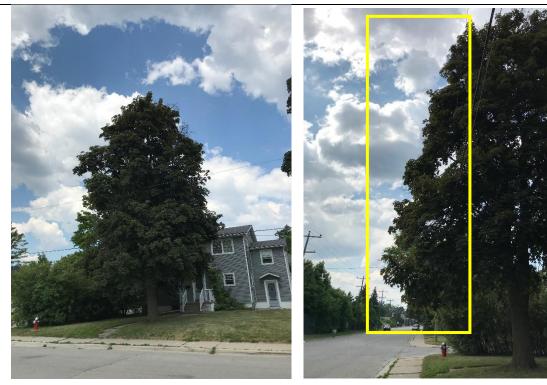
Figure 7. Tree #10.

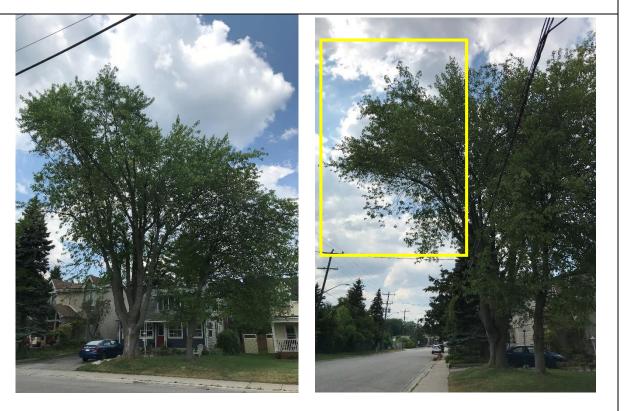
Figure 8. Left: Tree #11 and #12 from right to left. Right: Trees #11 and #12 form foreground to background.

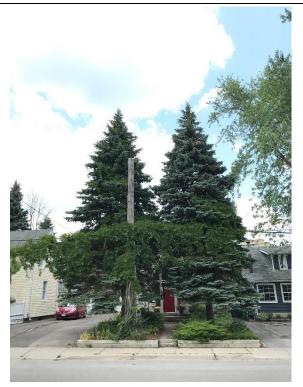
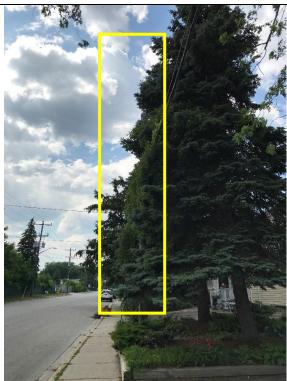
Figure 9. Left: Trees #13 and #14 from right to left. Right: Tree #13.

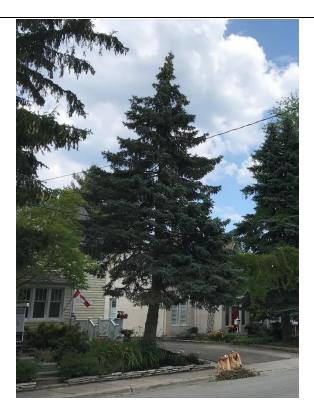
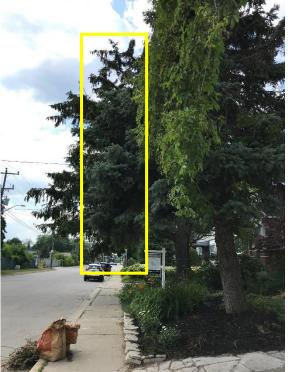
Figure 10. Left: Tree #15. Right: Tree #15 (foreground).

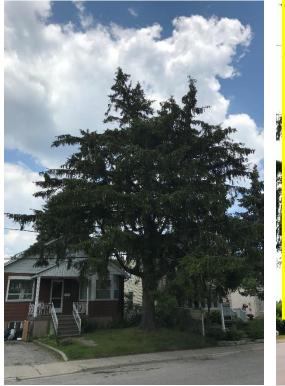
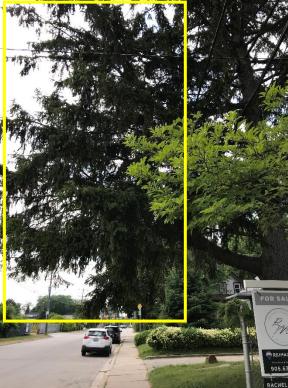
Figure 11. Left: Trees #16 and #17 from right to left. Right: Tree #17.

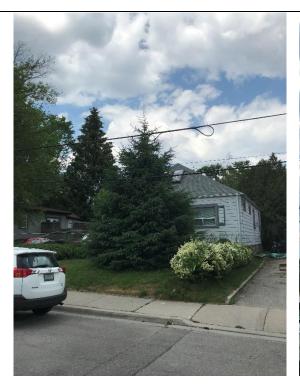
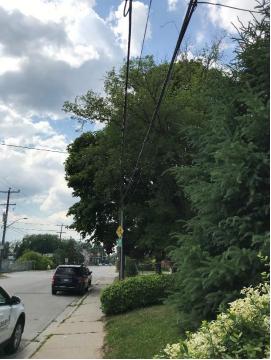
Figure 12. Left: Tree #18. Right: Tree #18 (foreground).

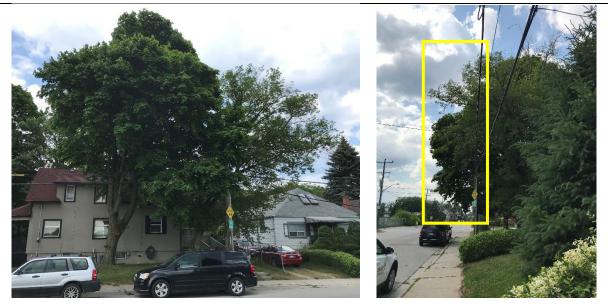
Figure 13. Left: Trees #19 and #20 from right to left. Right: Trees #19 and #20 (background).

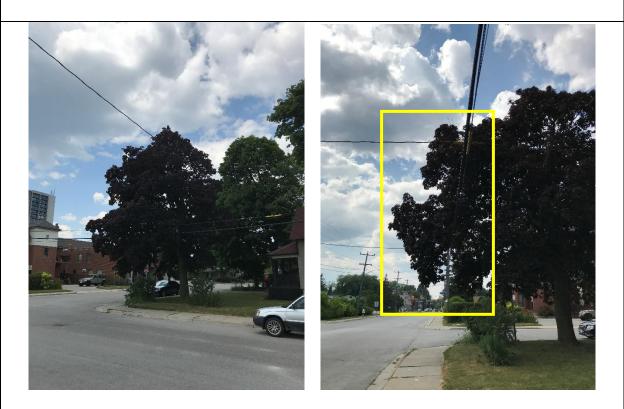
Figure 14. Tree #21.

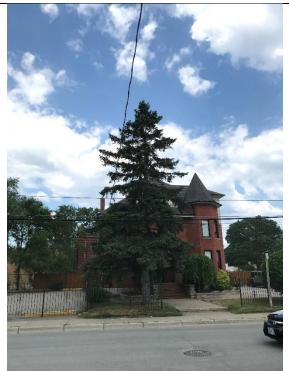
Figure 15. Tree #22.

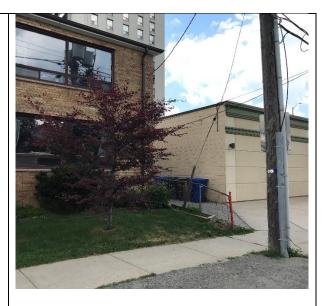
Figure 16. Tree #23

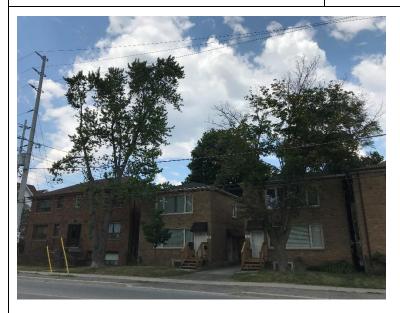
Figure 17. Left: Trees #24-#26 from right to left. Right: Trees #24-#26 from foreground to background.

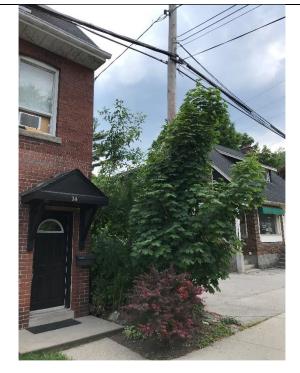
Figure 18. Tree #27

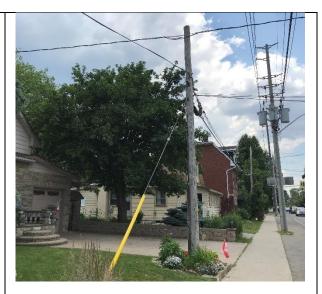
Figure 19. Tree #28

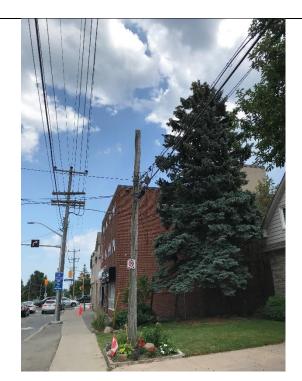
Figure 20. Tree #29

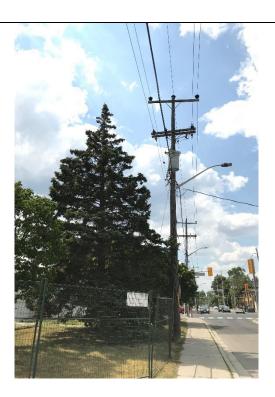
- 3 Trees are located in the proposed easement to be trenched on Mississauga Rd. As these 3 trees are in good condition, 3 replacement trees are required by the City of Mississauga.
 - o Tree #30, a 40 cm Colorado Blue Spruce (Private tree at 181 Lakeshore Rd W)
 - o Tree #34, a 32 cm Japanese Tree Lilac (Private tree at 181 Lakeshore Rd W)
 - o Tree #35, a 32 cm Japanese Tree Lilac (Private tree at 181 Lakeshore Rd W)
- Tree #31, a 41 cm Manitoba Maple in Poor condition (Boundary tree between 181 Lakeshore Rd W and the City right-of-way. As the tree is in poor condition, the City of Mississauga should not request replacement trees.

Figure 21. Tree #30 (foreground) and #35 (behind/under tree #30).

- We recommend the client remove trees #30, #31, #34, and #35 prior to construction.
- We recommend the client plant 3 replacement trees within the property at 181 Lakeshore Rd W to account for the removals of 3 healthy trees (#30, #34, and #35). Replacement trees must be at least 1.8 m tall if coniferous and 6 cm in diameter if deciduous.

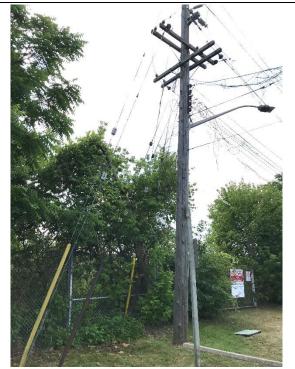
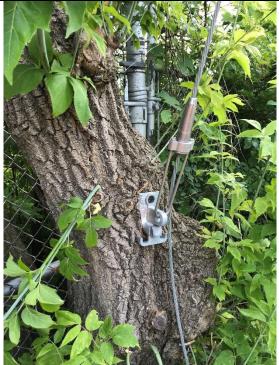
Tree #31 is a 41 cm Manitoba Maple located on the boundary between 181 Lakeshore Rd W and the City right-of-way. The tree is in poor condition and is negatively affected by a grape vine growing on it. The existing utility pole has guy wires that are fastened to the tree. A new utility pole is planned to be installed in the location of the existing tree. For this reason, the tree must be removed to accommodate construction.

Figure 22. Tree #31

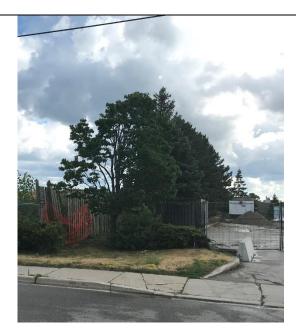
Figure 24. Tree #37
