Heritage Advisory Committee

Date: April 13, 2021
Time: 9:30 AM
Location: Online Video Conference

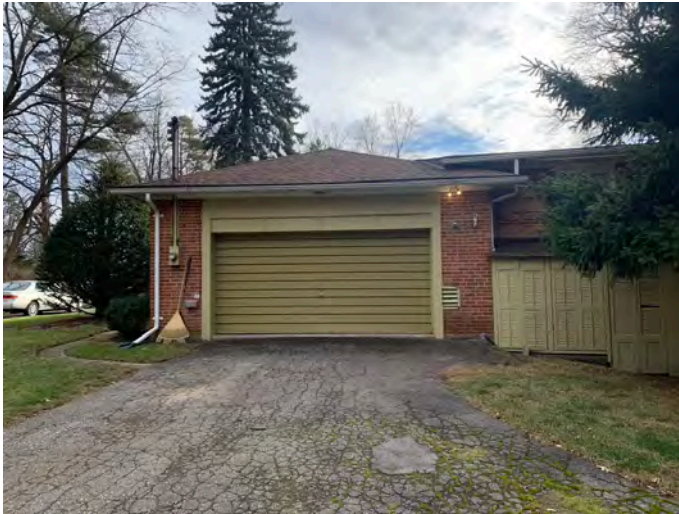
PHOTO 4 & 5: NORTH ELEVATION

This is the north end of the property

looking south.

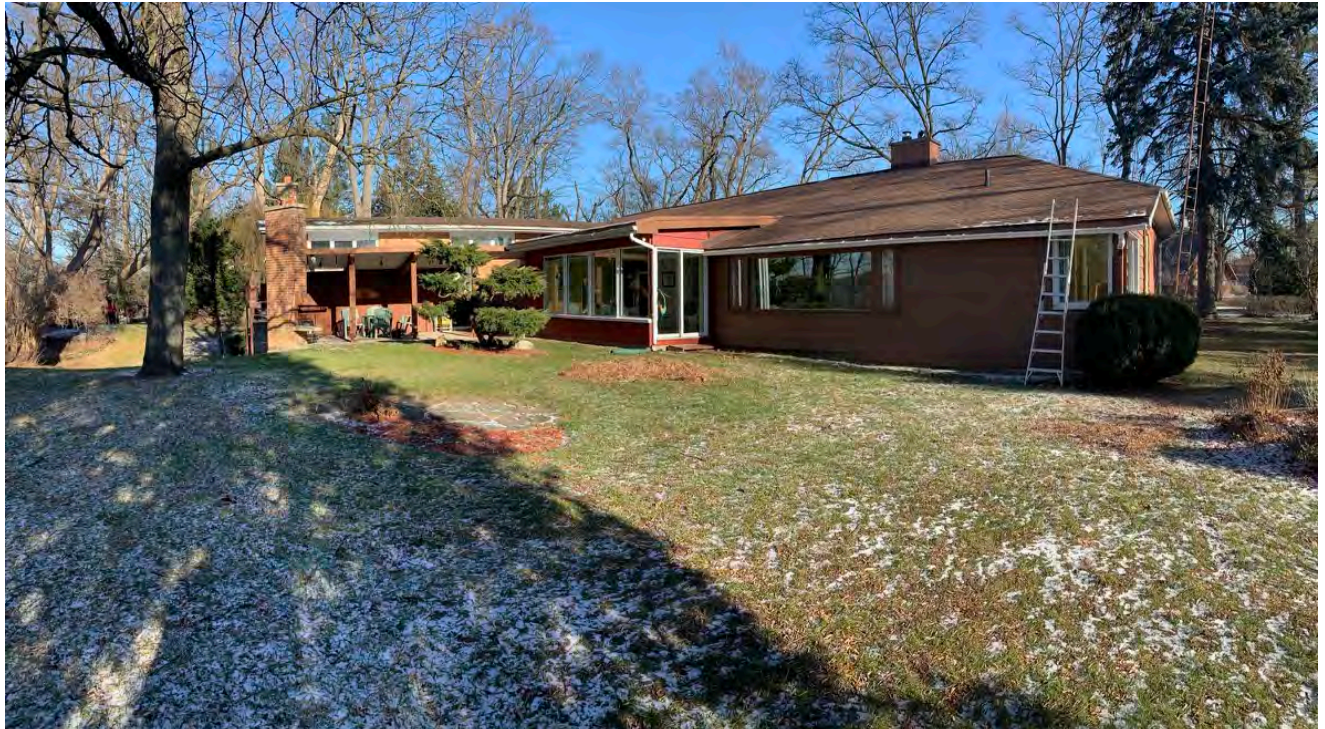
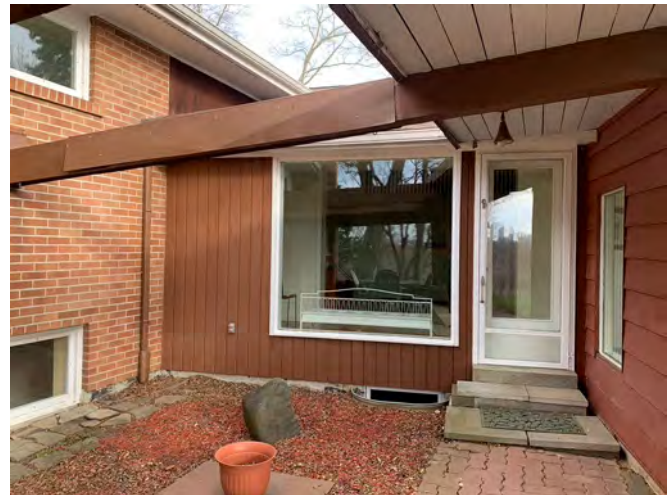
PHOTO 7, 8 AND 9: REAR ELEVATION VIEWS

The exterior of the dwelling is a combination of brick, aluminum siding and wood panel siding. Windows and doors can be dated to the time of the additions.

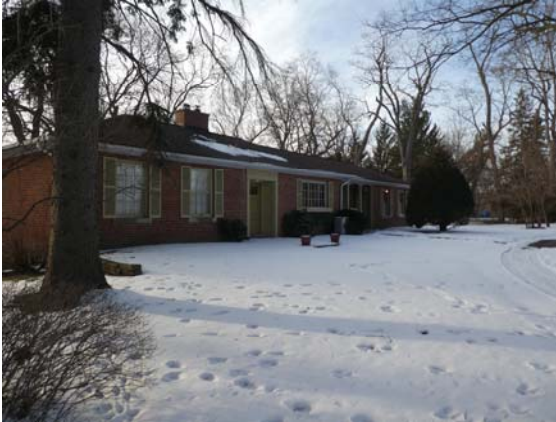
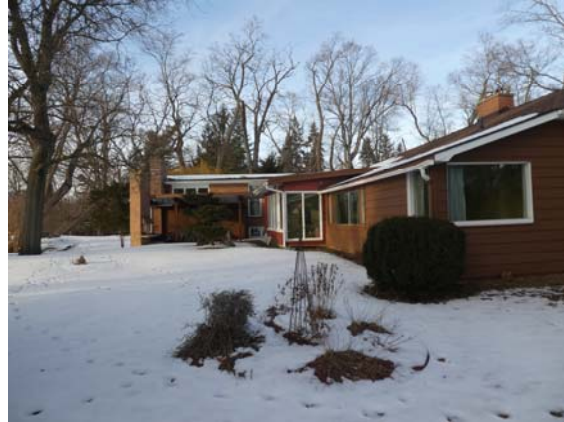
Photo #1

Figure #1: These 2 photos show the front and rear yard of the property at 1427 Dundas Crescent as they appeared during the tree inventory conducted on February 4th and 18th, 2021.

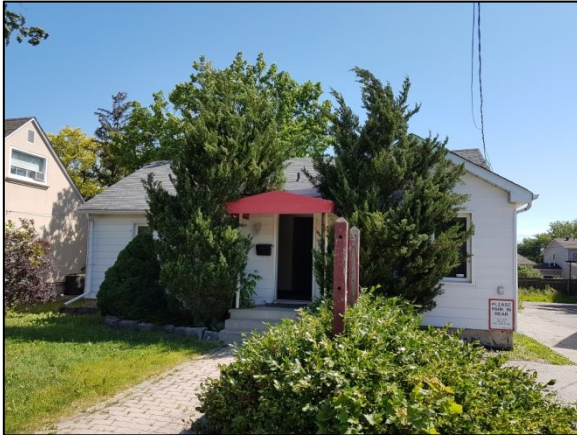
Figure 19: Southwest elevation

The structure at 29 Queen Street South is a one-storey residential building built c.1950 that has been converted for commercial use (Figure 19). Built in the post-war bungalow style, the building sits on a cement block foundation and features a gable roof made of asphalt shingles. The building is clad in two types of white siding: aluminium on the front and side elevations and clapboard on the rear elevation (Figure 27). Clapboard siding was found beneath an exposed portion of the side elevation, which suggests that the building was likely clad in clapboard when it was built (Figure 28). A portion of cladding on southeast elevation has been poorly replaced and the staggered seams between the old and new siding are visible (Figure 26).

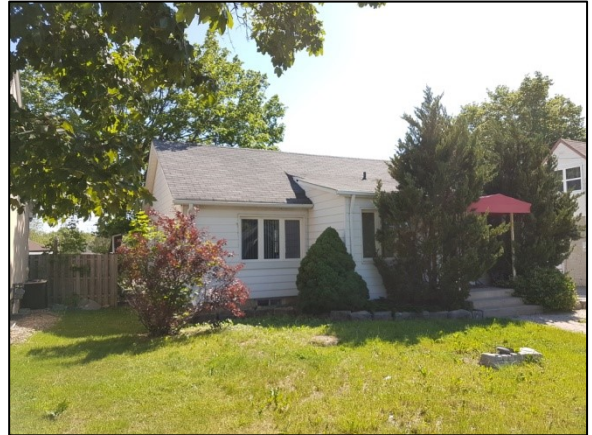
Figure 20: Southwest elevation

The front elevation consists of a trio of three-casement windows (Figure 20). Basement windows are located on either side of the entranceway. A fabric porch roof attached to metal poles was installed above the cement front porch. The southeast and northwest elevations each contain one set of two one-over-one windows and three and two basement windows respectively (Figure 21, Figure 22 & Figure 24). The rear elevation contains a one-over-one hung window and two one-over-one windows flanking a rear entrance to the basement (Figure 23).

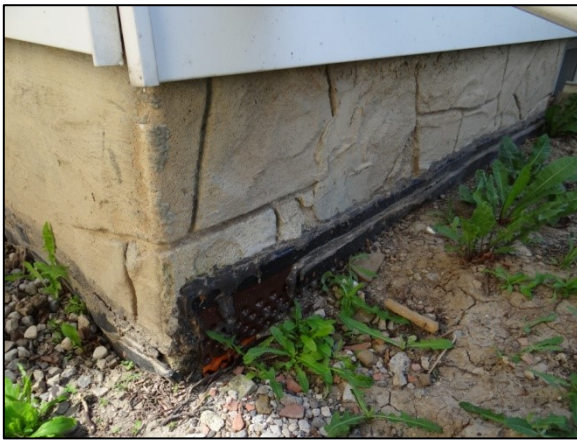
Figure 25: Lined parging along the foundation

Two-thirds of the building's front elevation extends toward the street and may have been altered at some point in the building's history (Figure 29). Based on the slope of the roof above the entranceway and the configuration of internal space, it is possible that the original porch was enclosed. The roof above this potential alteration was built at a different slope from the rest of the house and is inconsistent with the other houses in the area (Figure 30). The residential building at 17 Queen Street South appears to have a similar facade and architectural features as the subject property, and may provide an understanding of what the residence looked like before the porch was enclosed (Figure 17). Additionally, the facade at 17 Queen Street South features lined parging to give the facade a stone appearance, which also appears on the foundation of the front elevation of 29 Queen Street South (the remainder of the foundation features smoothed parging).

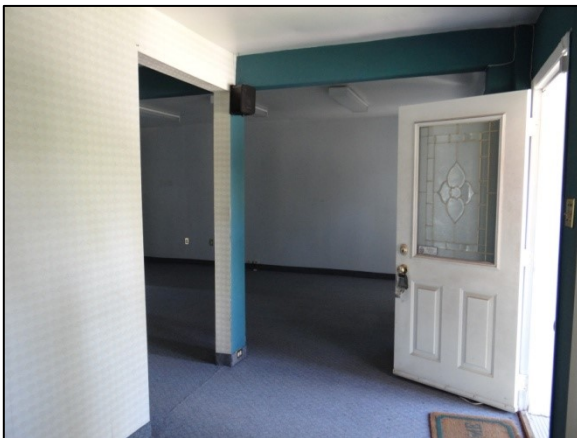
Figure 31: Enclosed porch, interior.

The interior of 29 Queen Street South has been altered for commercial use. The interior features a large front foyer where the front porch was likely enclosed (Figure 31), a living room (Figure 32 & Figure 33), three bedrooms (Figure 37 to Figure 40), a bathroom (with a shower that has been converted into a closet) (Figure 36) and a small office space where the kitchen was originally located (Figure 34). The entire first floor is carpeted apart from one bedroom, which features hardwood floors. The doors to each room are office doors with five-by-three glass panels. The ceilings throughout the living room, office space and hallway are drywall, while the bedrooms have a drop ceiling with panelling.

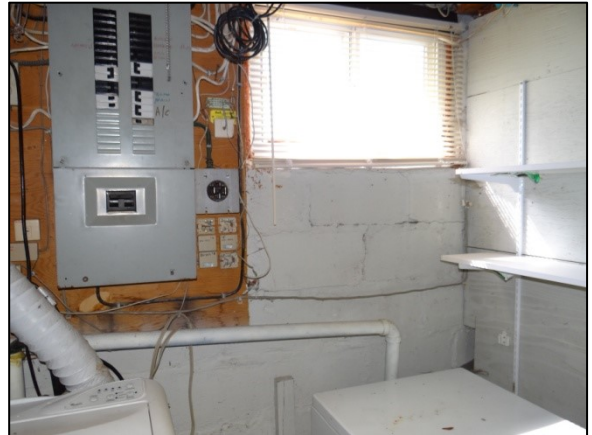
Figure 46: Concrete block foundation

The basement is accessed via a rear entry (Figure 41). The basement is finished with a drop ceiling with panelling, drywall walls and both hardwood and carpeted flooring. The basement has an unequipped kitchen containing sink and cupboards (Figure 43), a large living room (Figure 44 and Figure 45), bedroom, bathroom and furnace room. The cement block foundation is visible from within the furnace room (Figure 46)

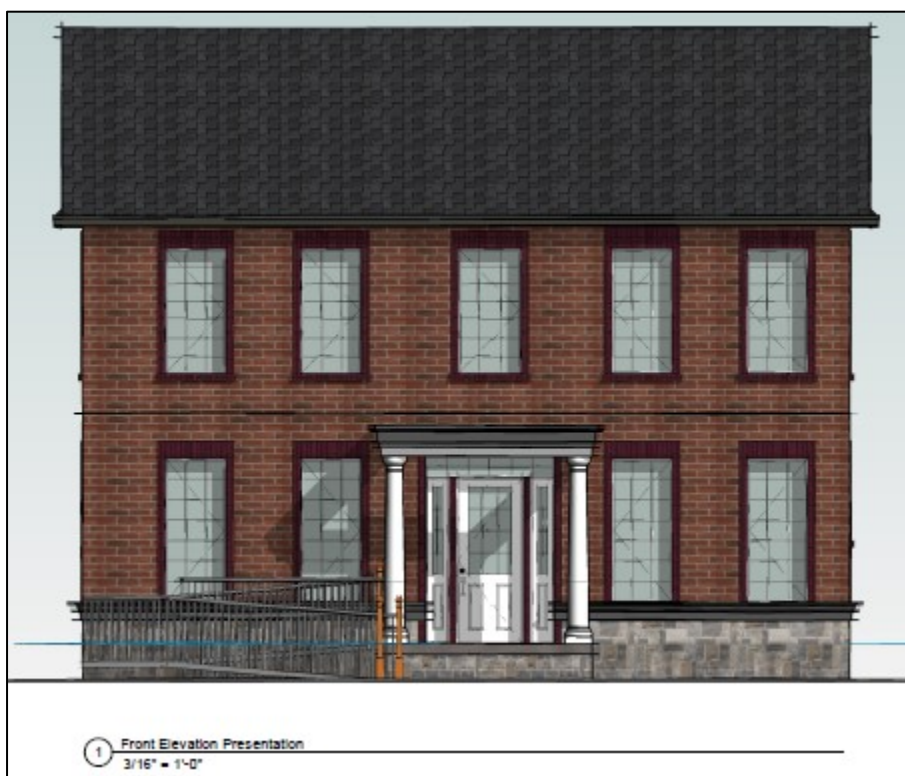
Figure 51: Proposed front elevation

The front elevation is a symmetrical design with a centre entrance with sidelights and transom and sets of two windows on either side. The second floor consists of five windows aligned with the first storey fenestration. All of the windows consist of 3x7 panes of glass. Similar windows are found throughout the side and rear elevations. The rear entrance incorporates an entrance and porch that are identical to the front elevation. The existing rear parking lot will be maintained.

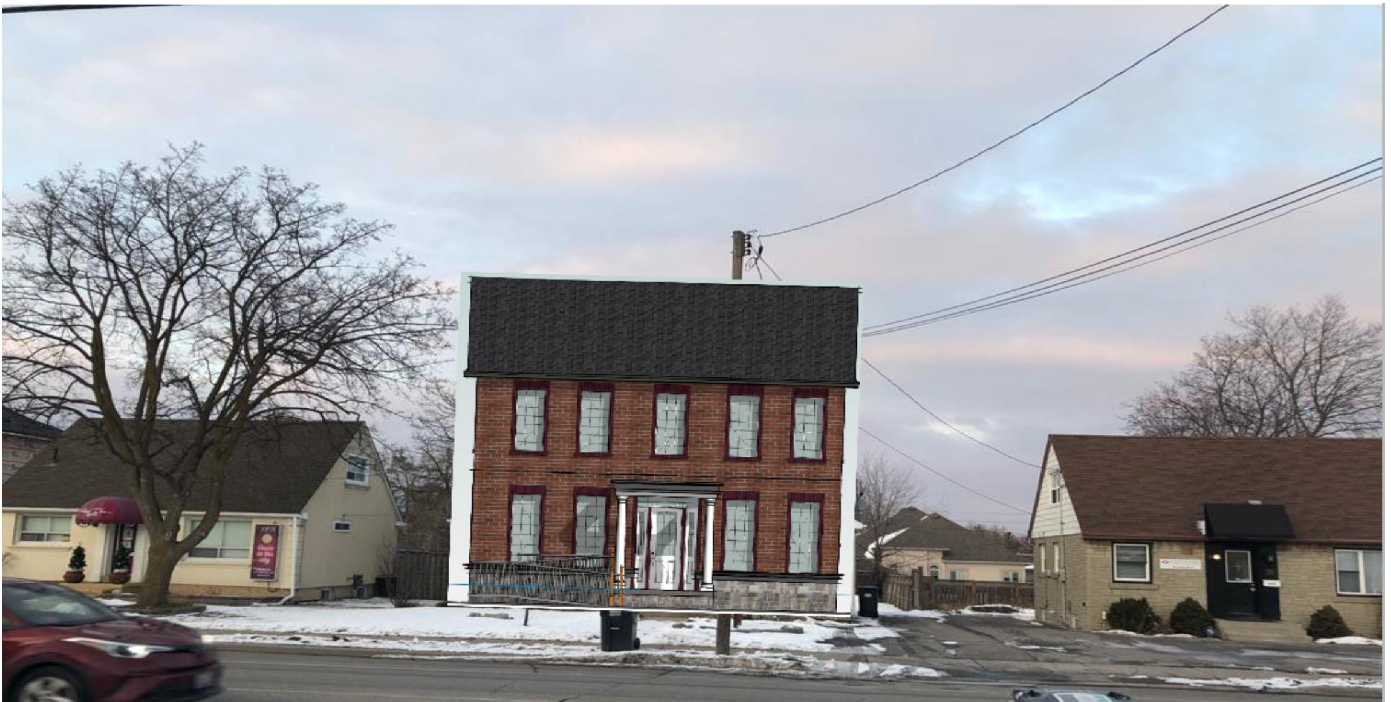
Proposed Streetscape

The proposed mixed dwelling including dental office on the main floor and 2 residential self contained units on the second floor, as per the included site plan. Setback on the both adjacent dwelling will be maintained as per city guidelines. Right hand side will be 2.69m where existing offset is 2.66m. Left hand will be 1.22m. As per site plan offset from the street will be 7.96m where existing dwelling offset is 7.98m

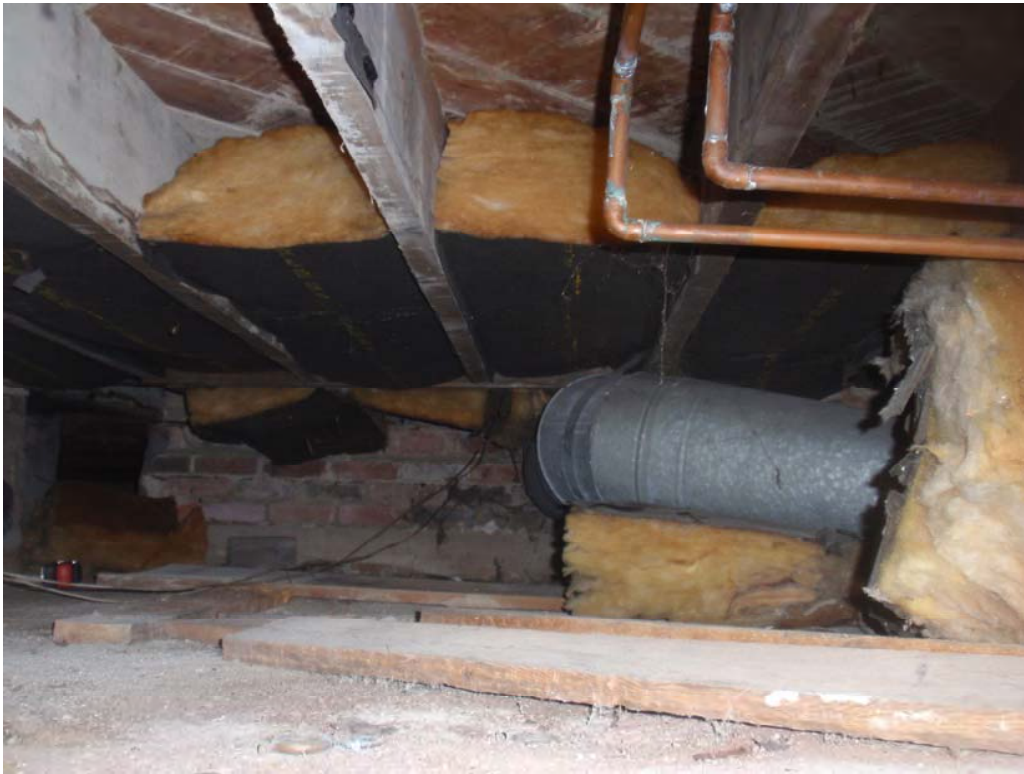
West Part of Basement (2-2x10 beam)

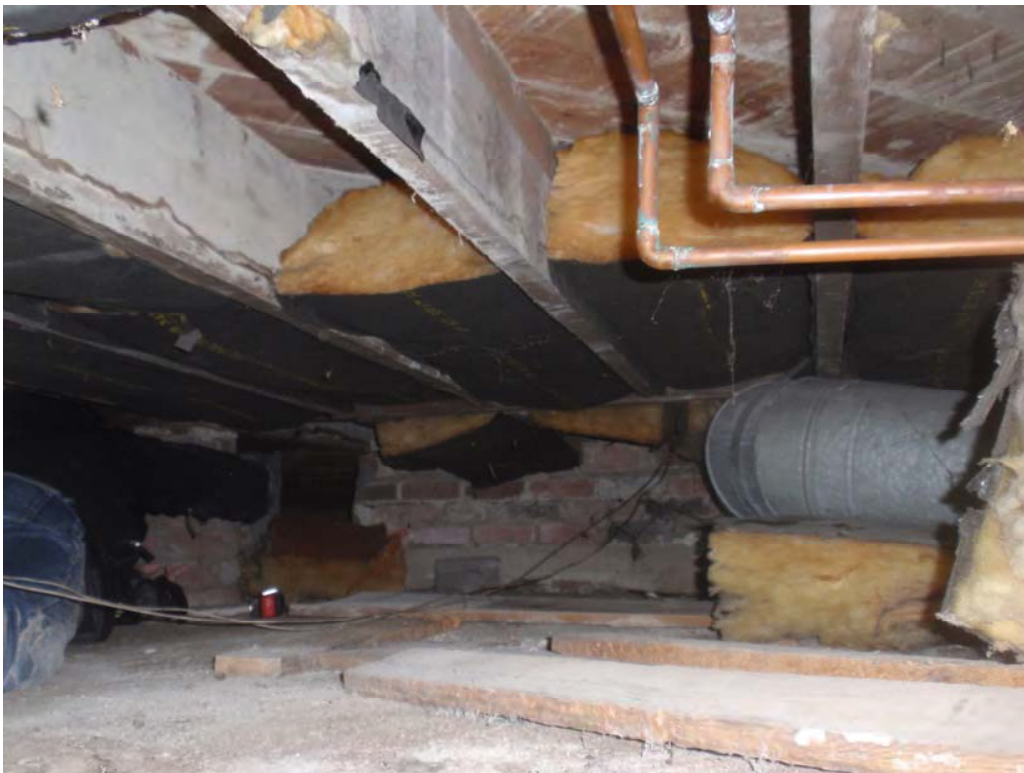
West Part of Basement (window to most west crawl space)

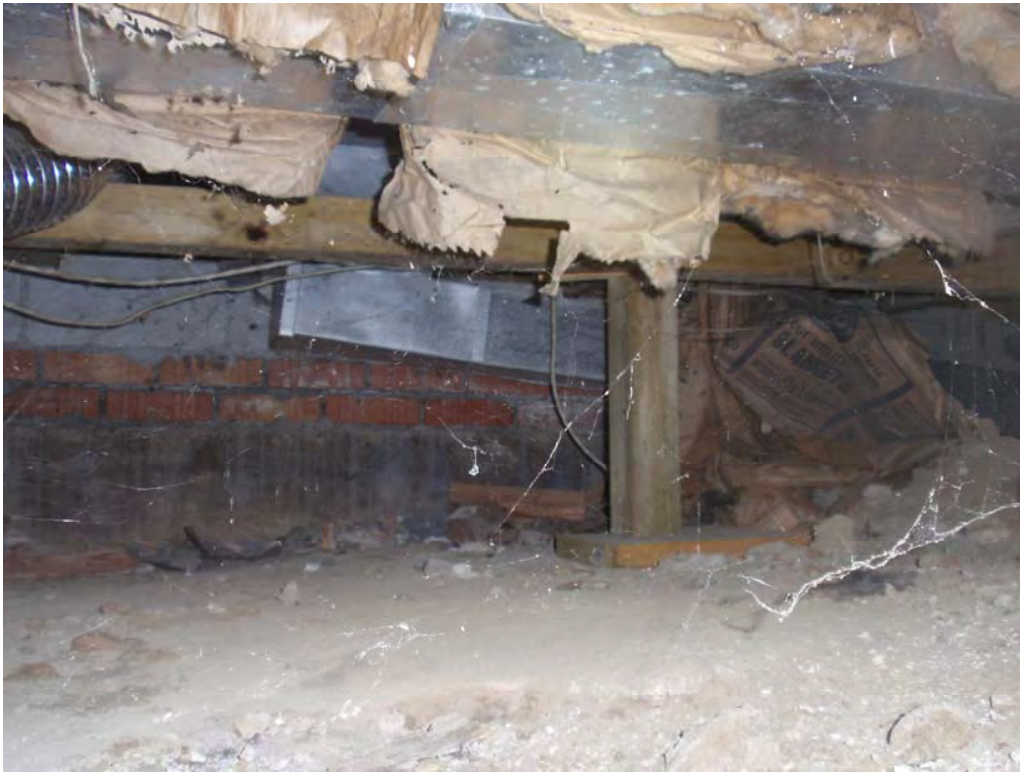
North- East Portion (posts and beam)

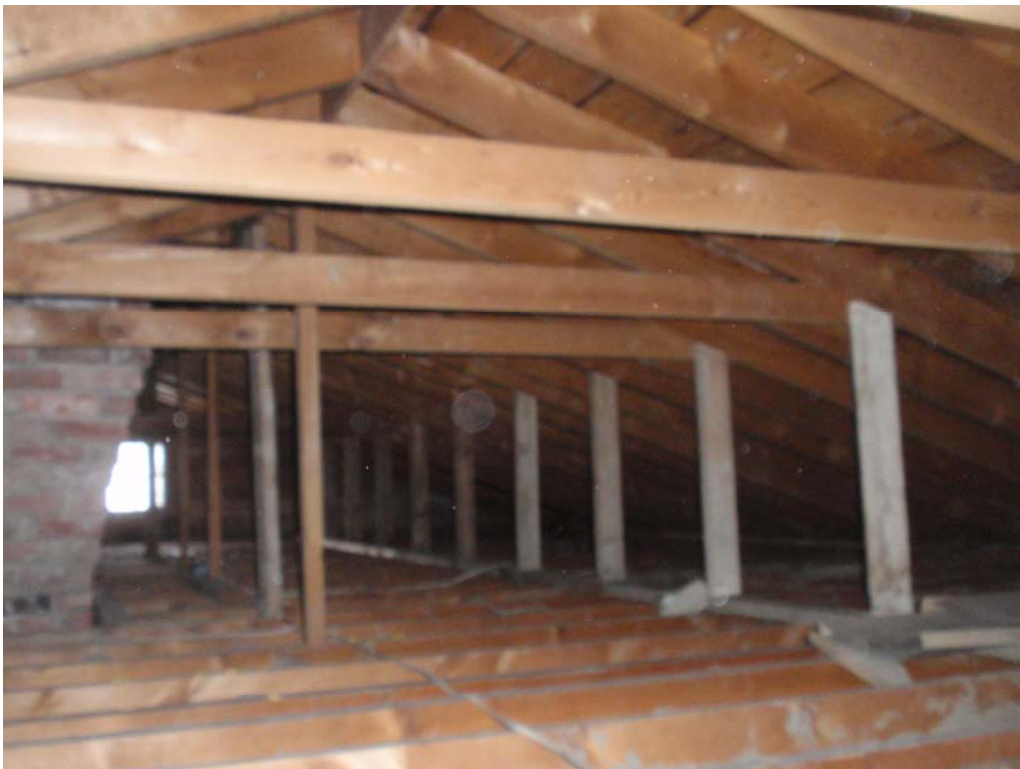
South Higher Roof

Existing roof assemblies must be removed so that the condition of the roof deck could be reviewed. All elements of the roof deck or the structure that show deterioration will be inspected and determine if replacement is required.

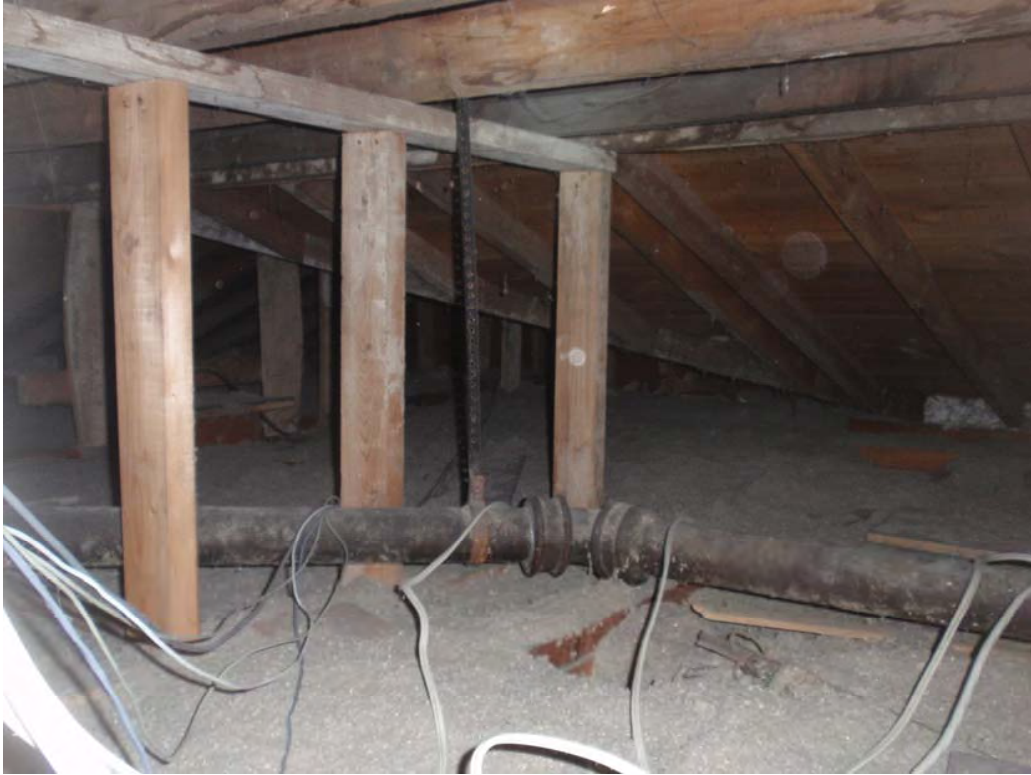
South-West Roof

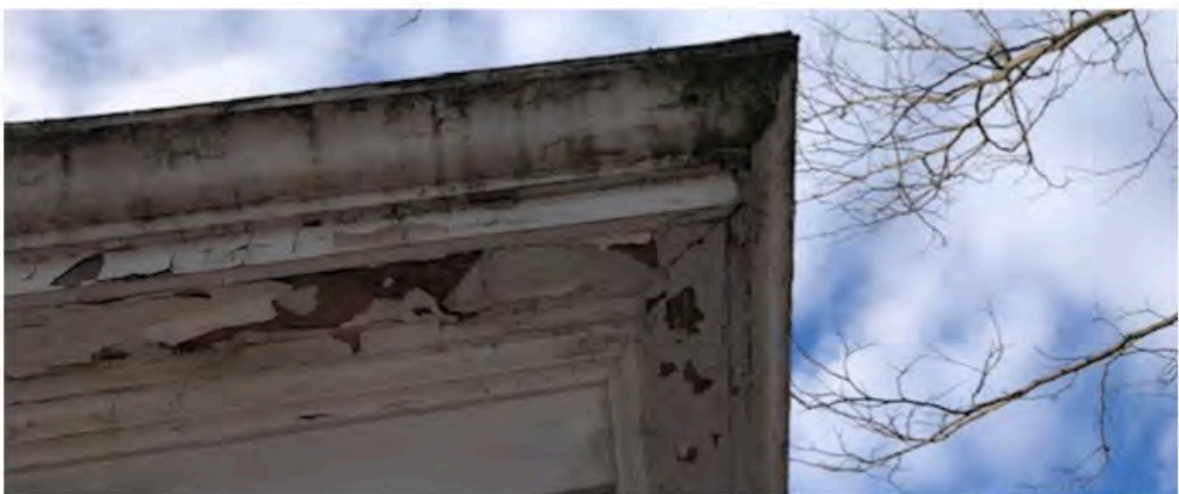
East wing - Soffit

Even though existing assembly appears to be in fair condition the condition of the all soffit and fascia boards will be inspected after gutters are removed and all deteriorated elements or parts will be replaced with new to match the profiles of the existing boards.

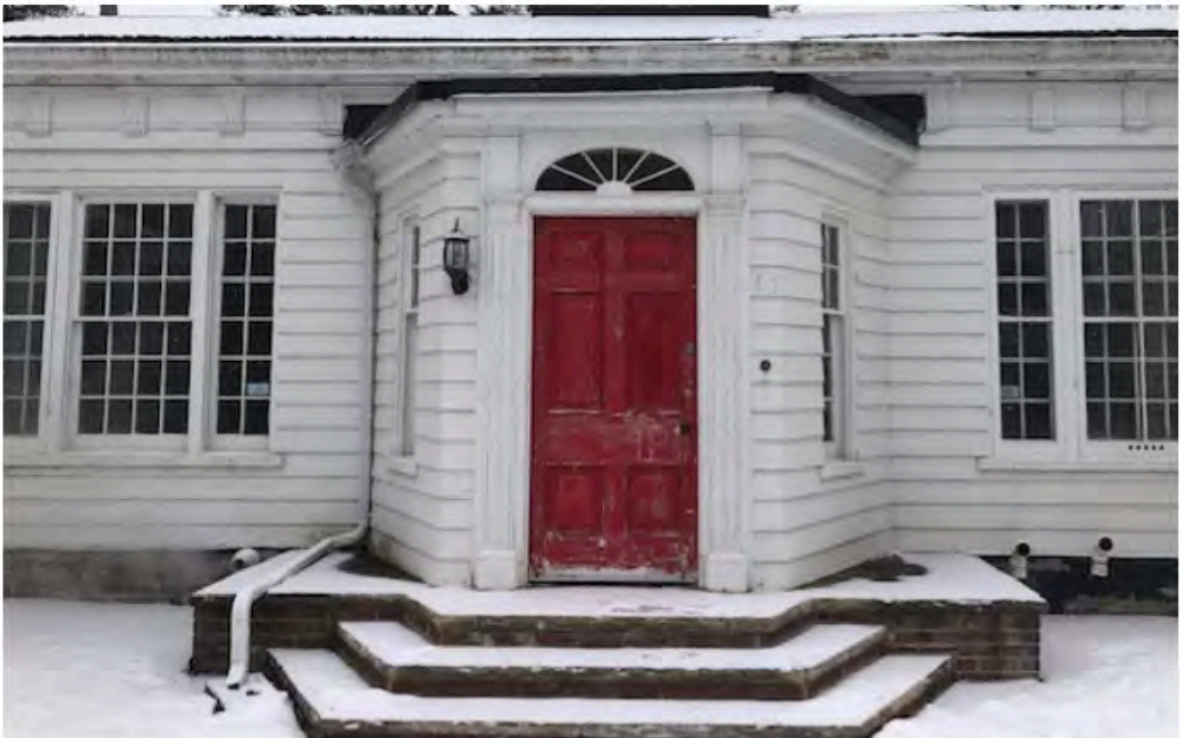
Main entrance - North elevation

Existing main entrance wood door will be repaired. All loose and peeling paint will be removed, wood filler applied and sanded prior to application of a primer and paint. Paint colour will match existing.

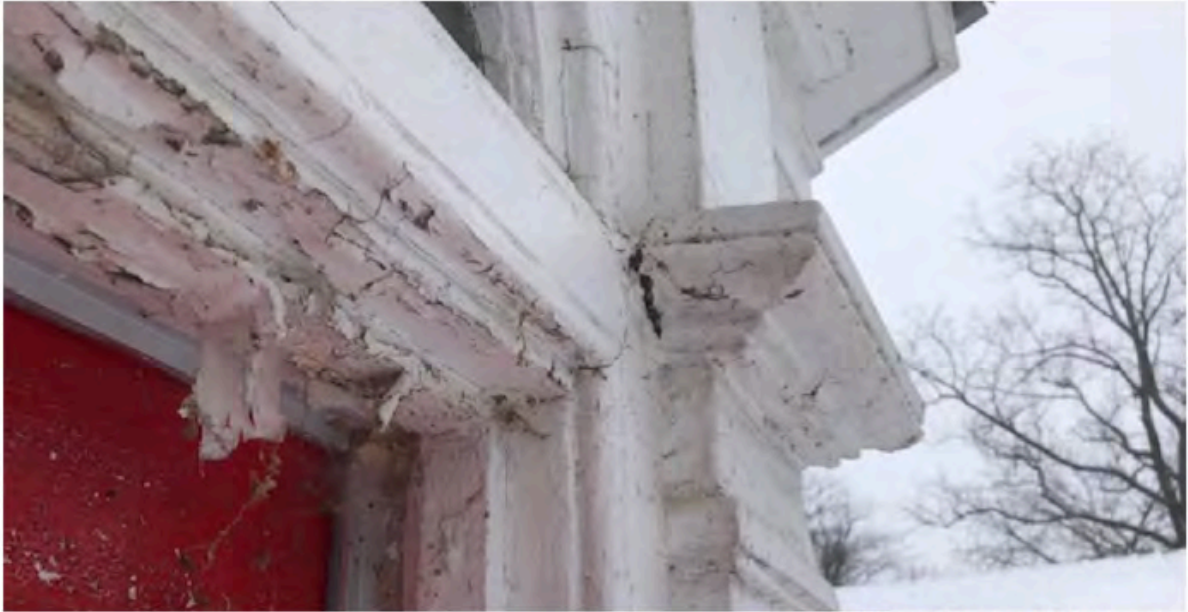
Main entrance - North elevation

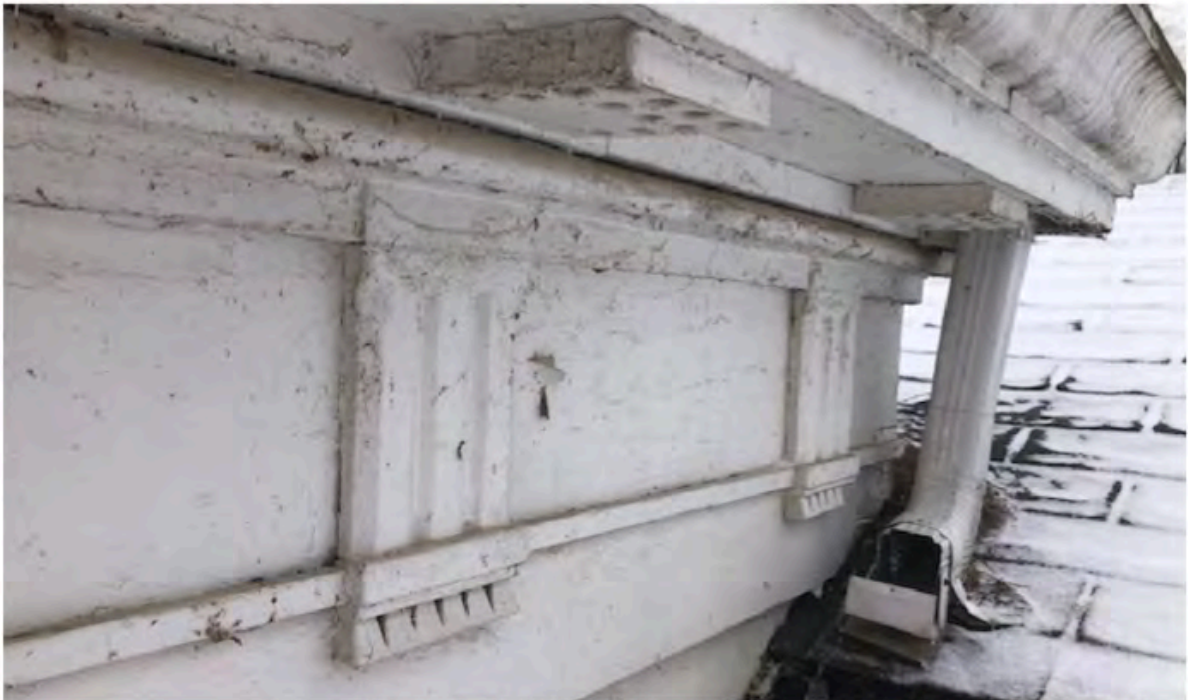
Frieze board with the triglyph detail – Central part of the building north elevation

Areas where soffit or fascia board are replaced will be primed and painted at the same time when existing soffit, fascia, pediment details at the gable ends and frieze triglyph details at the central part of the building are being painted.

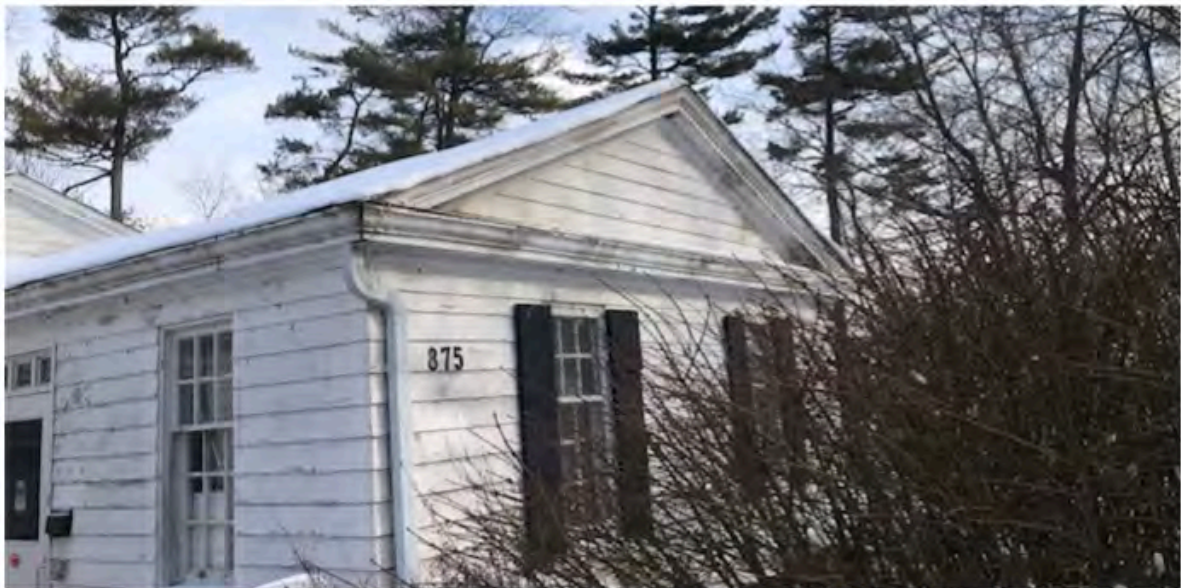
Typical pediment gable end details - West elevation

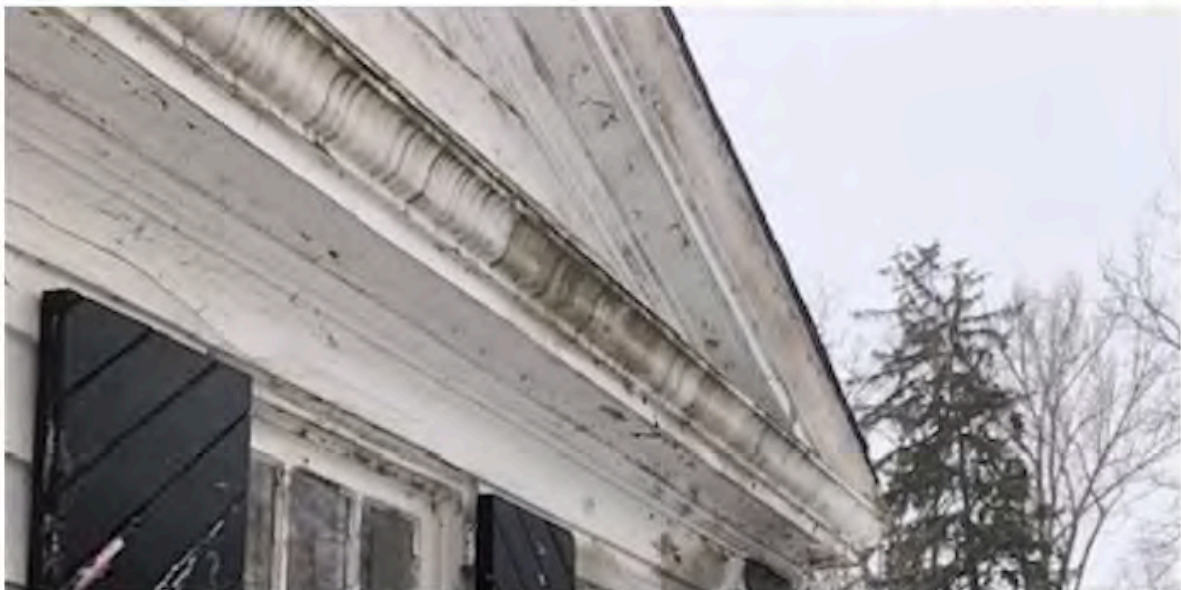
Typical pediment gable end details - West elevation

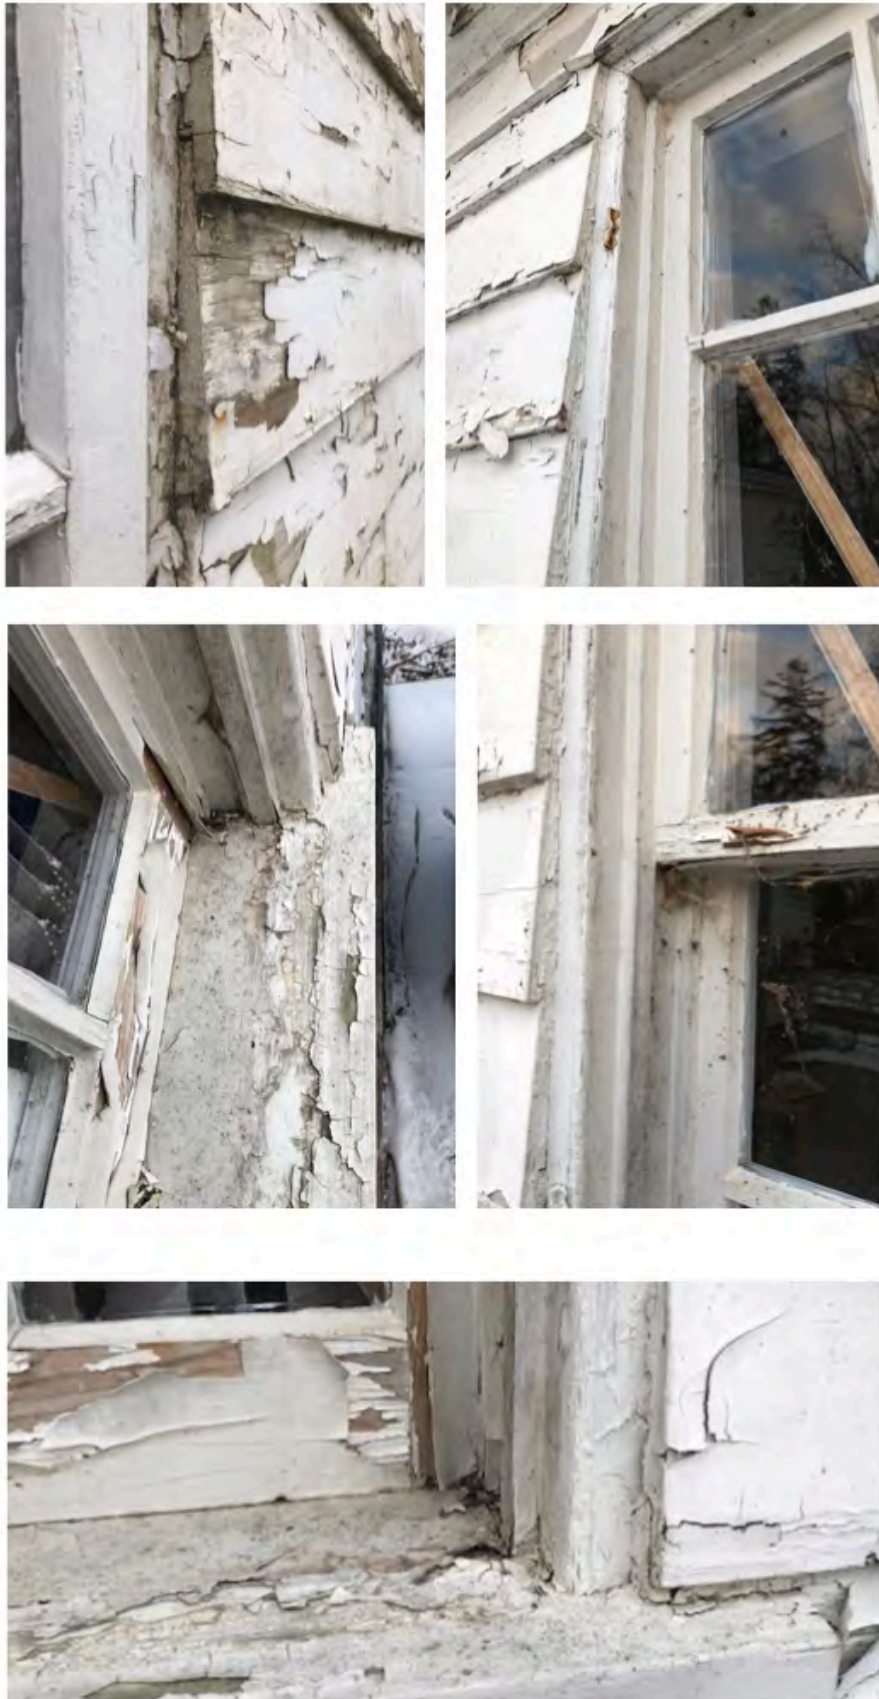
Typical window / siding details

Loose or peeling paint at the window frame, window, storm window and window sill surfaces will be removed to solid material by scraping and sanding. Surfaces will be inspected and determine if the material requires replacement or could be primed or painted.

All replacement material will match the profiles of the existing and be primed and painted using the same material as reused elements. The surfaces of the existing storm windows and window frames will be filled with a wood filler, sanded, primed and painted to match the colour of the existing window frames and storm windows.

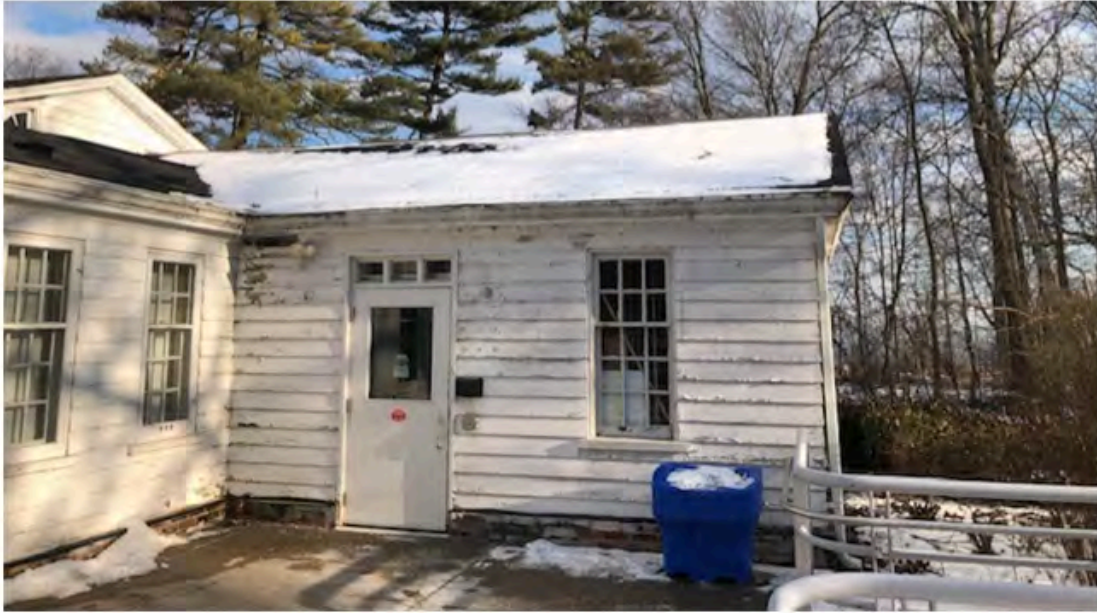
Deteriorated soffit, siding & foundation wall - West wing north elevation

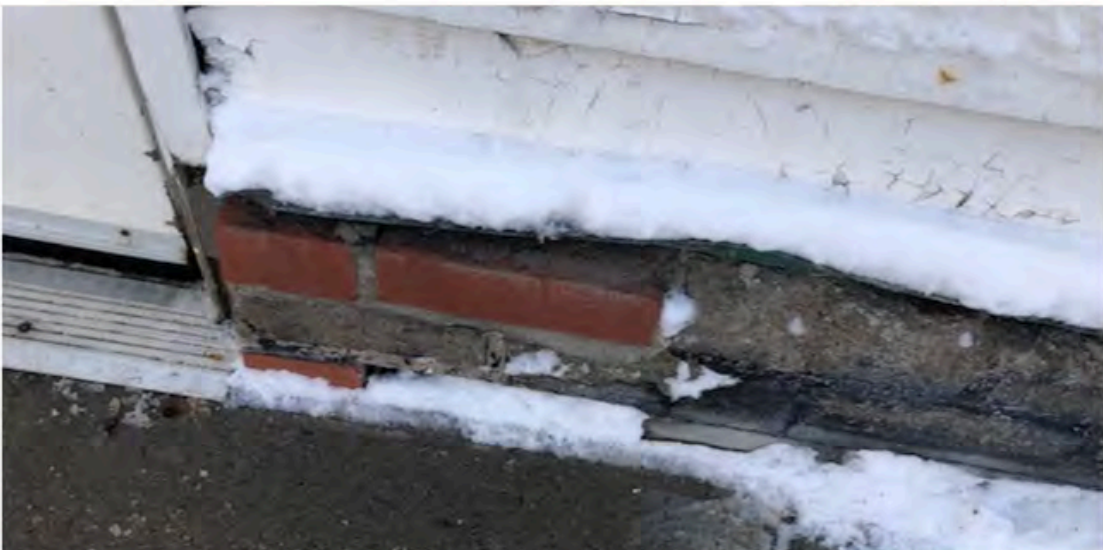
Deteriorated brick at the foundation wall - West wing north elevation

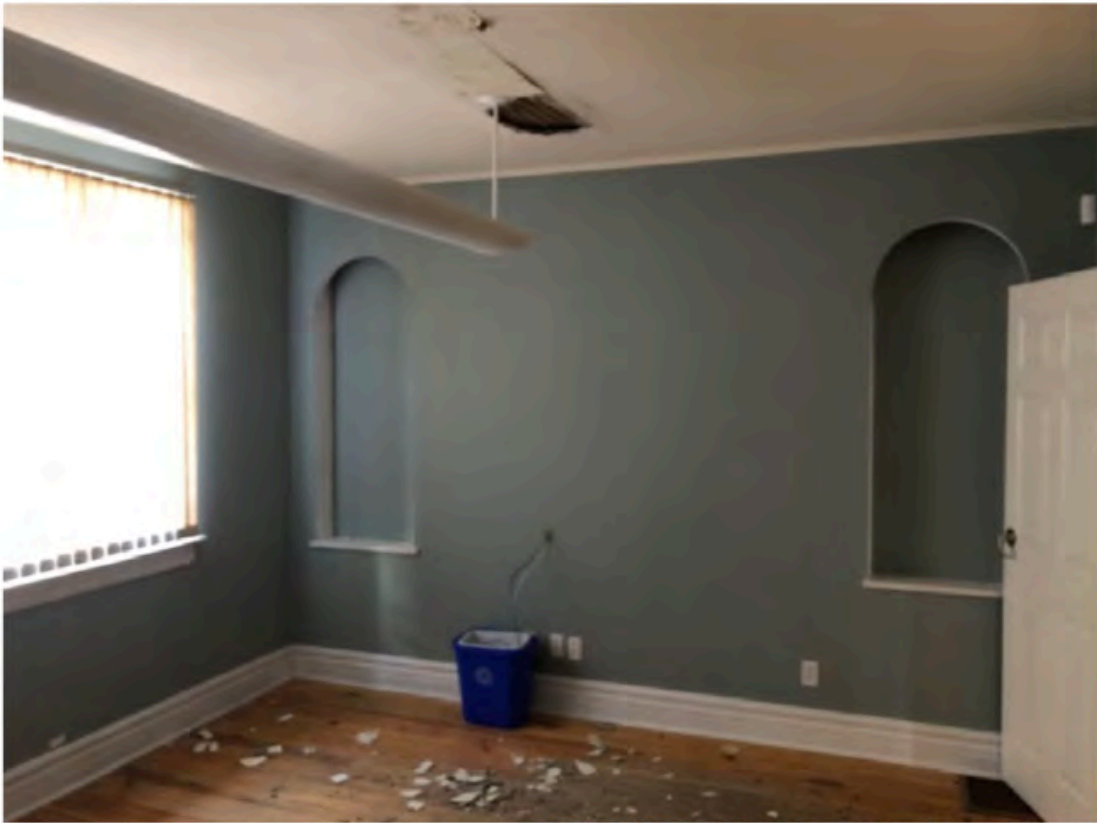
Ceiling damaged due to roof leaks - West wing office

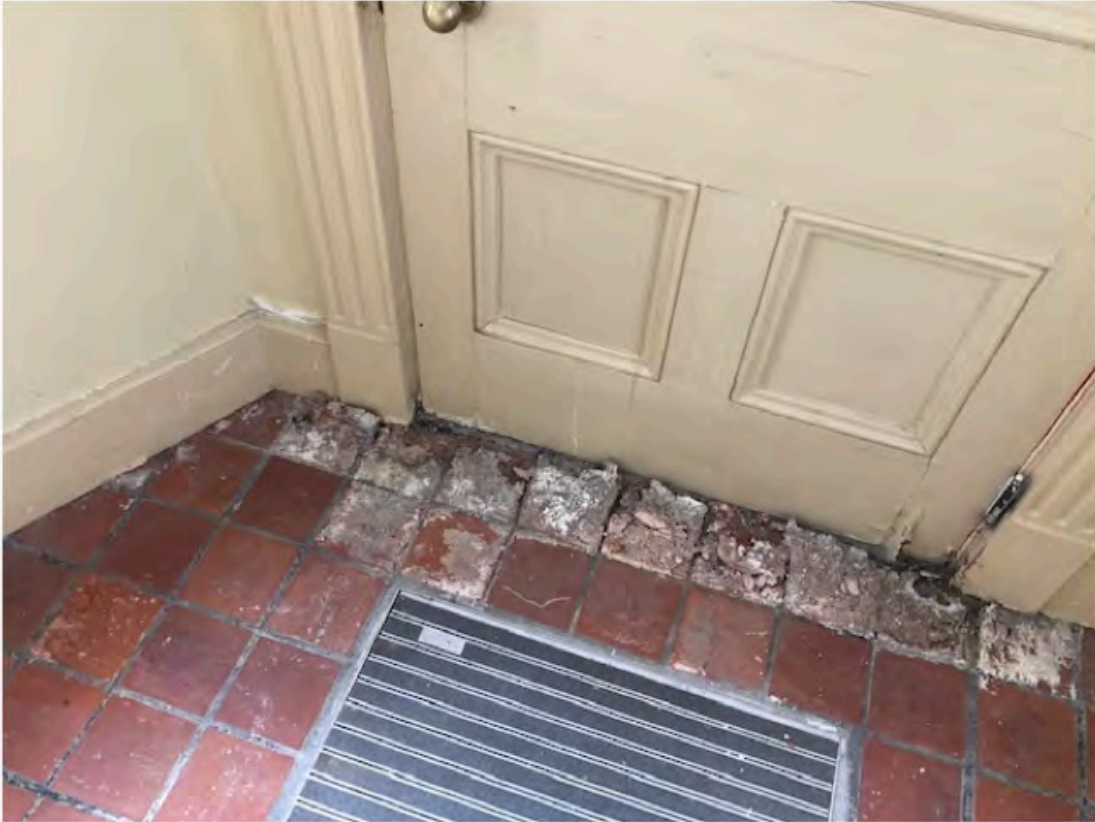
Deteriorated floor tiles - Main entrance vestibule

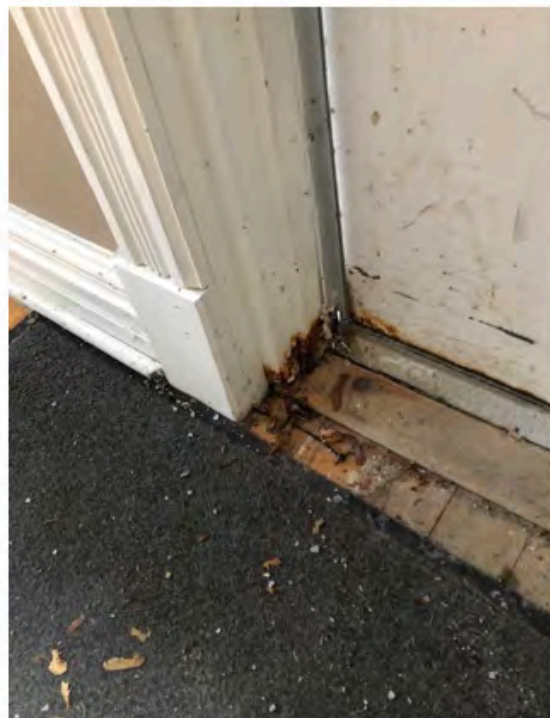
Deteriorated steel frame and door - West entrance

The hollow metal frames and doors located at the north elevation of the building were found in poor condition and require replacement. Existing hardware will be removed and reused and H.M. doors and frames will be replaced with new to match existing. Those two doors and frames as well as H.M frame and door located at the south elevation of the building will be painted to match existing.

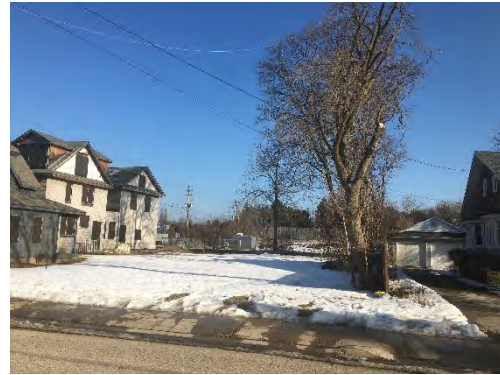
Figure 9: Rear of the lot (West elevation), proposed location for the underground ductbank.

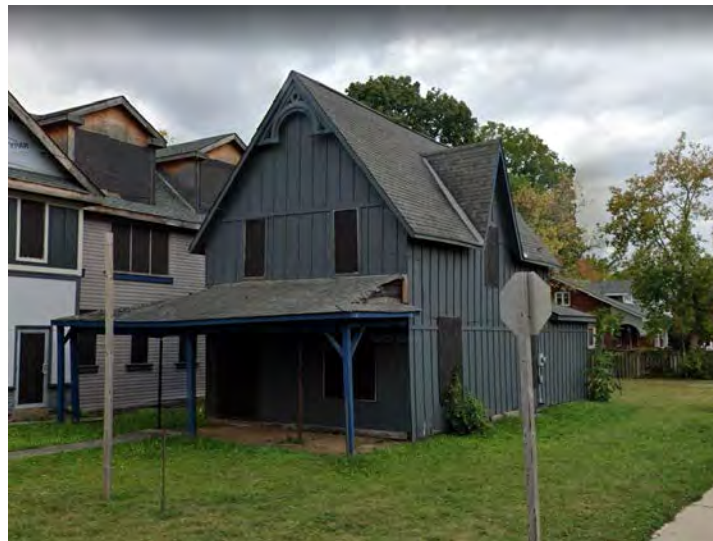
The William Clarkson House is a vernacular wood frame residence with a front/cross gable roof, rectangular floor plan, symmetrical arrangement of openings on the principal facades and a wrap-around verandah. The exterior cladding material is clapboard siding with corner boards and door and window openings with triangular shaped heads on the front elevation. Despite later alterations to the exterior including the installation of new siding, the addition of two roof dormers, removal of the original chimneys and some modifications to the door and window openings, the building retains its dominant form and exterior elements of its original design character.

Figure 17: William Clarkson House, 2021

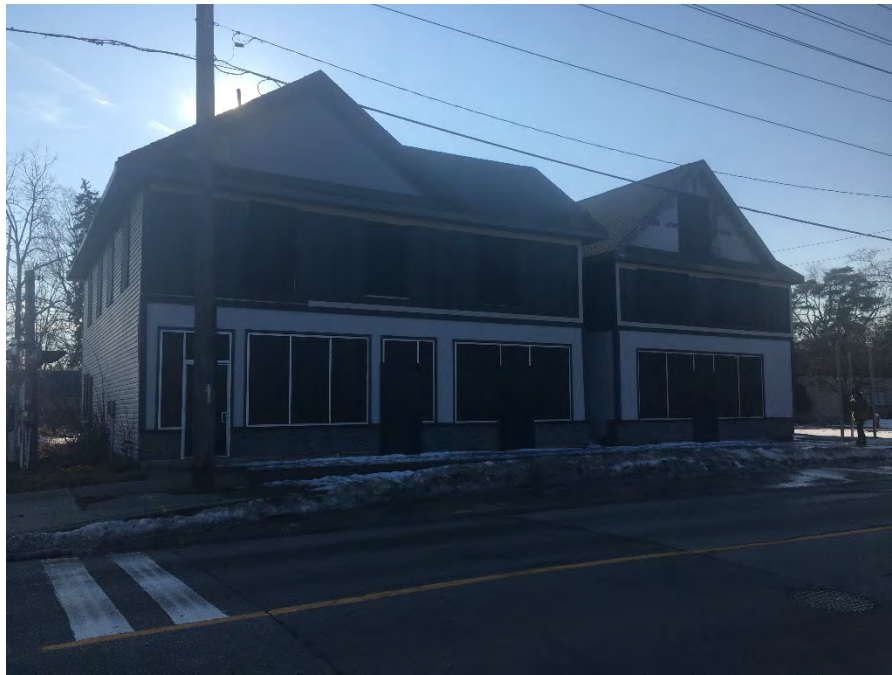
William took over operation of the family store and post office in 1865. (Figure 16). The General Store and Post Office provided one of the cornerstones of the community. On this site Warren Clarkson built the first store around 1835. The current building dates from the later half of the 19th century. The Clarkson Store was substantially altered from its 19th century form c. 1906-1910. These early 20th century alterations are considered to be of sufficient age as to form an integral part of the history of the building. Although more recent exterior alterations have been completed (Figure 18), the store building still retains its 1906-1910 height, scale, shape, form and massing and a commercial storefront of an early 20th century rural store¹³.

Figure 18: General Store and Post Office building, February 2021
