Heritage Advisory Committee

Date: April 13, 2021
Time: 9:30 AM
Location: Online Video Conference

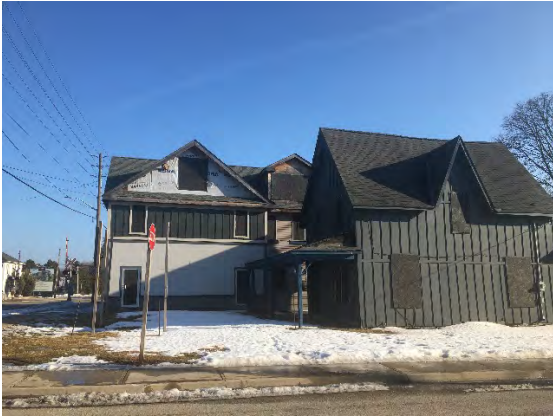
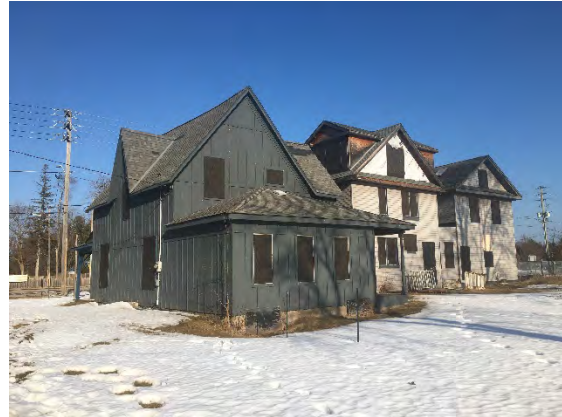
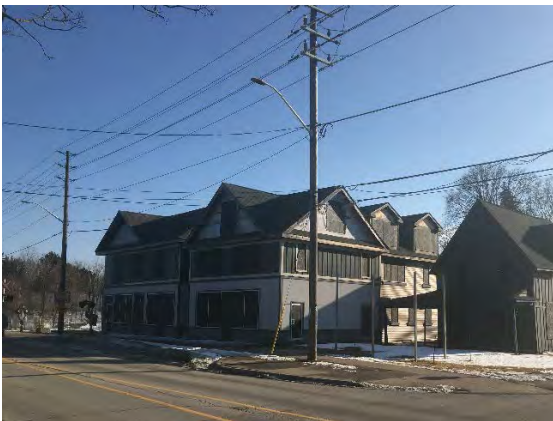
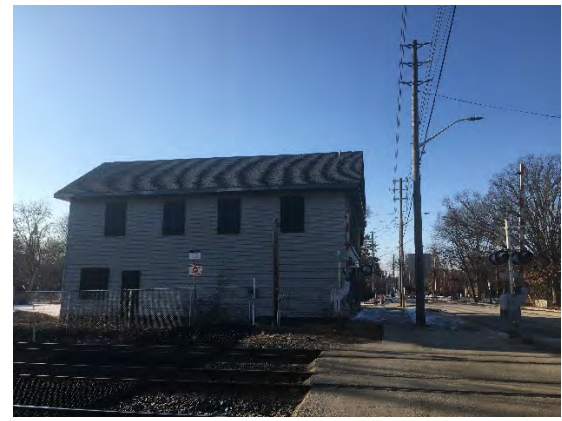
Figure 19: North Elevation of the William Clarkson House and store

Figure 20: View of the William Clarkson House and store from Balsam Avenue looking southeast

Figure 21: View of the subject lot from Clarkson Road North looking southwest.

Figure 22: View of the subject lot from Clarkson Road North looking northwest.

The windows and doors were all boarded at the time of review (Figures 19-22). The William Clarkson House had undergone substantial renovations to the exterior and interior of the building in 2014. No further modifications were observed till date. The rear addition to the house dates back to 1913. A wrap-around verandah possibly existed on the south side along with a rear building which was demolished later (See Appendix F, Figure 59). The Clarkson Store was a brick structure which was later reclad. After the addition of the second floor and a north addition

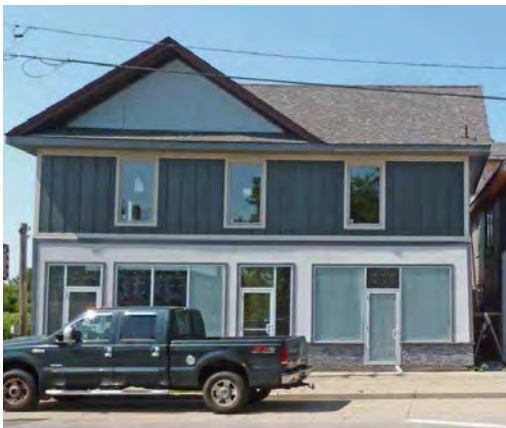
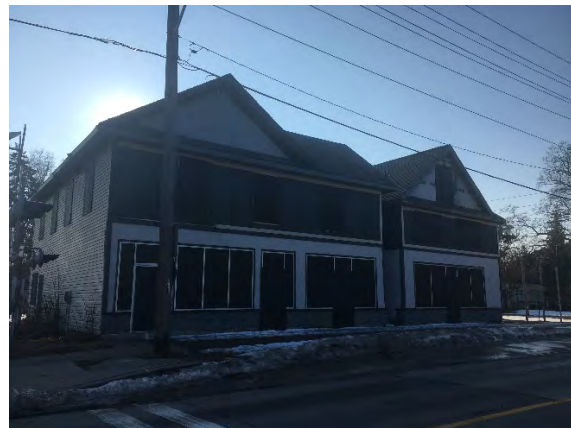
The original Clarkson store built in 1835 was replaced with a simple, one-and-a-half storey, wood frame building with a front gable roof circa 1865. The exterior cladding was horizontal clapboard siding. This building was significantly altered between 1906 and 1910 when a second floor was added along with an addition to the north side transforming it into a two-and-a-half storey 'L-shaped structure' with a front gable roof and storefront. In 2015, the building was again renovated (Figure 44).

Figure 44: East (front) elevation of the Clarkson Store, left - July 2015 (Source: CHER: 1130-1140 Clarkson Road North, City of Mississauga, Ontario, October 2015, 26), right – February 2021

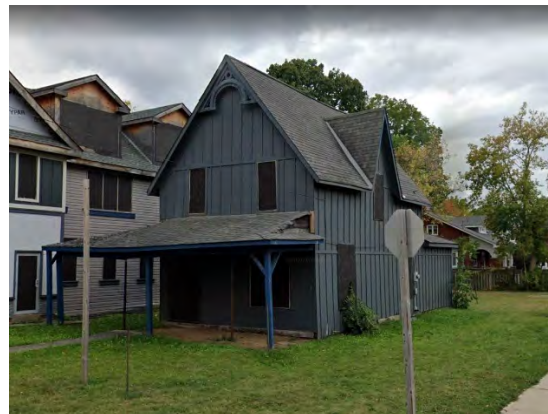
Figure 49: The main elevation of the William Clarkson House, 2020 (Source: Google Maps 2021)

In 2005, Heritage Mississauga Report described the exterior of the house as follows.

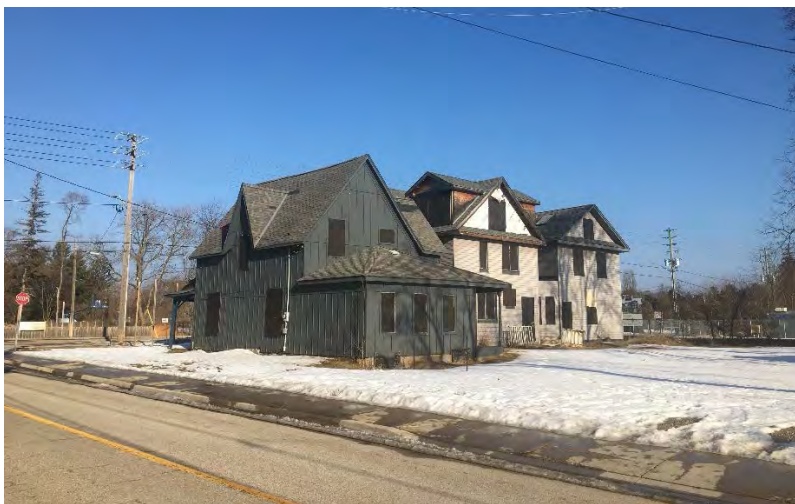
Figure 50: View of the subject property and existing overhead electric distribution system from Balsam Avenue looking southeast (February 2021)

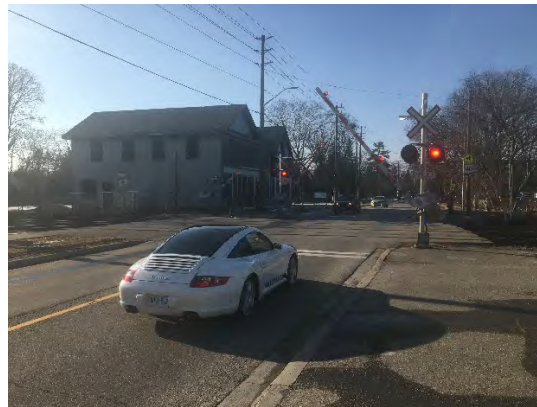
Figure 51: View of the subject property and existing overhead electric system from Clarkson Rd. N looking northwest (February 2021)

- Wood poles are generally congested, due to multiple service attachments and communication drops. This makes it impossible to sufficiently climb poles. Crews must, therefore, use ladders to access these poles. Alectra Utilities is limited in utilizing ladders to access the overhead system due to Ministry of Labour restrictions for congested areas which complicates the situation further. Figures 51 & 52 show the existing wood poles.

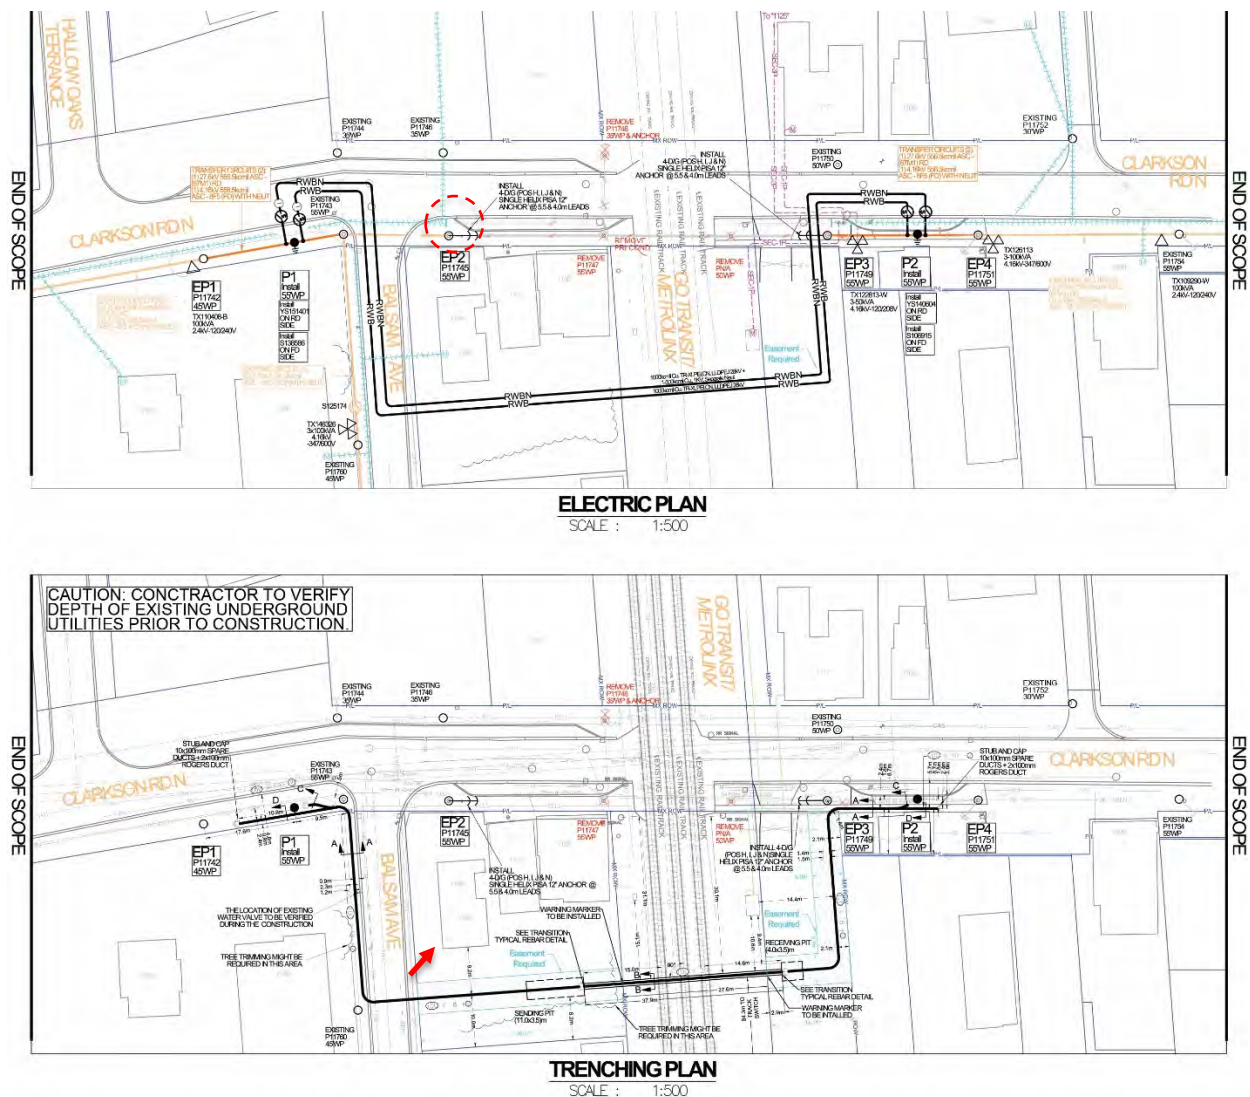
Figure 54: Electric Plan and the Trenching Plan of the proposed development showing the Heritage Resource fronting onto Clarkson Road North, annotated by AREA (Source: Metrolinx GO Elec. LWL – CONFLICT #LW26 Clarkson Road North-Lakeshore Road West to Truscott Drive, Electrical and Trenching, Sheet No. D07-396295-002)

The above electric and trenching plan show the location of both existing and proposed single phase transformers, power trenches, cables, hydro poles, circuits, switches etc. For further details, drawing legends and construction notes, please refer to Appendix D Electrical Drawings.

5.4.1 SCOPE OF WORK³² (Figure 54):**Poles:**

anchors proposed to be installed on the existing pole in front of the property to provide structural stability, this will be visible above ground (Figures 54 & 55).

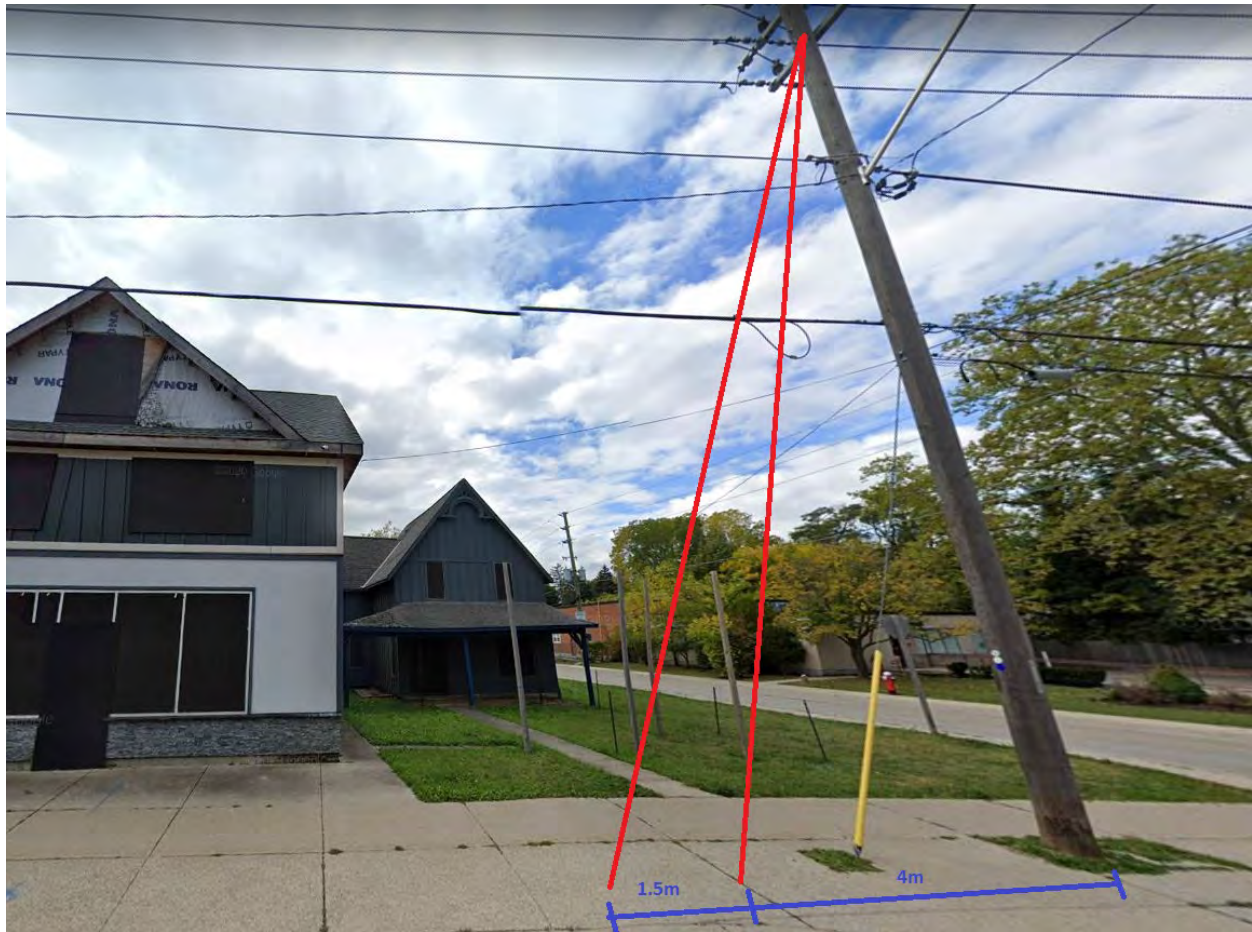
Figure 55: Sketch of the 2 new anchors to be installed on the existing pole in front of the property to provide structural stability, overlayed on the current conditions at 1140 Clarkson Rd N.
(Source: CIMA+)

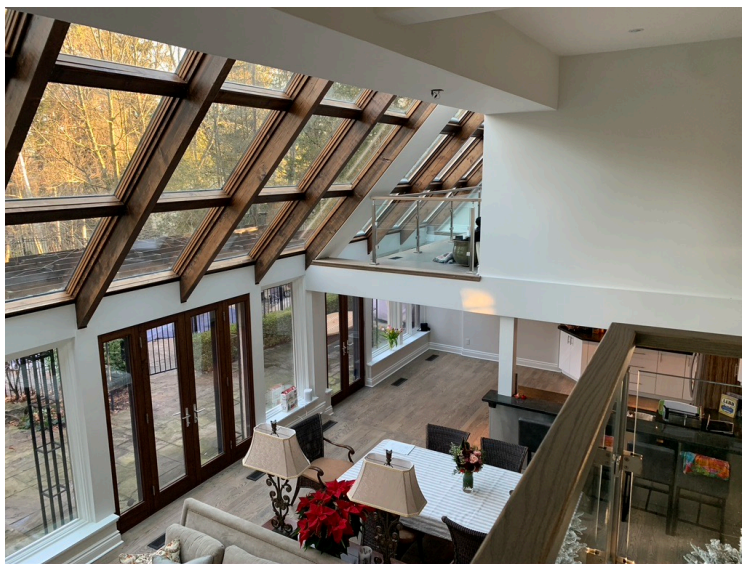
PHOTO 1: LOOKING OVER THE LOWER LEVEL FROM THE MAIN FLOOR.

Extensive renovations were undertaken on the dwelling in 1983 by the then owner, Bryce Taylor. In speaking with Dr. Taylor, he indicated that the entire rear of the dwelling was removed to 'bring the outdoors in' and to take advantage of the rear views. Renovations included relocating the kitchen to the basement, where a walk-out condition was created. A major portion of the main floor was removed to create an 'open to below' affect. See photo 1.

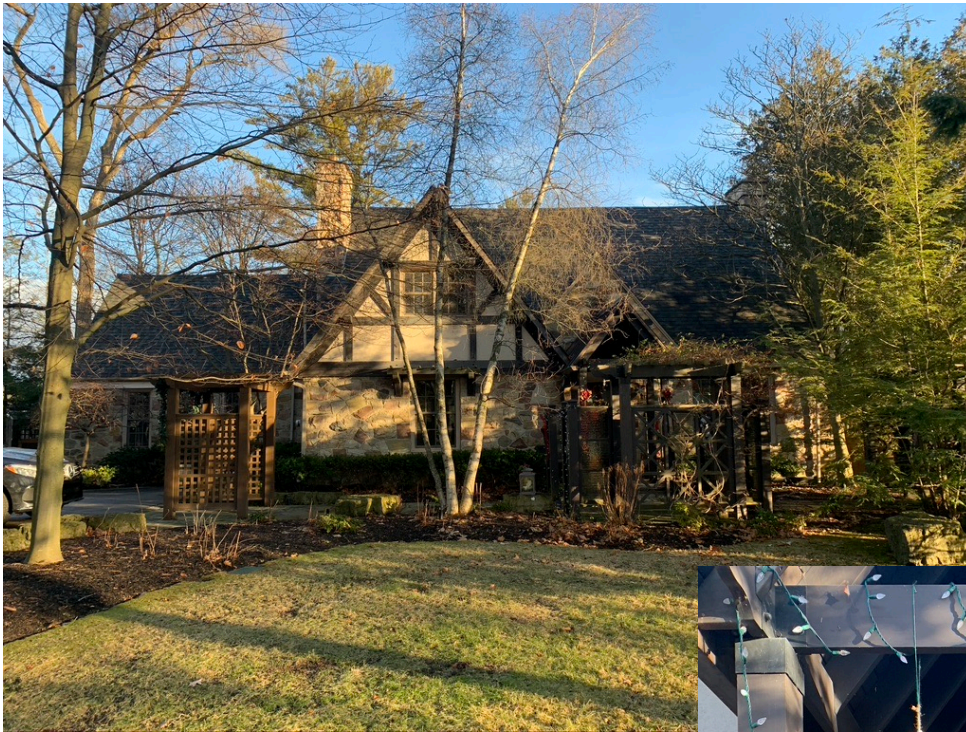
**PHOTO 2: FRONT
ELEVATION****PHOTO 3: FRONT DOOR DETAIL**

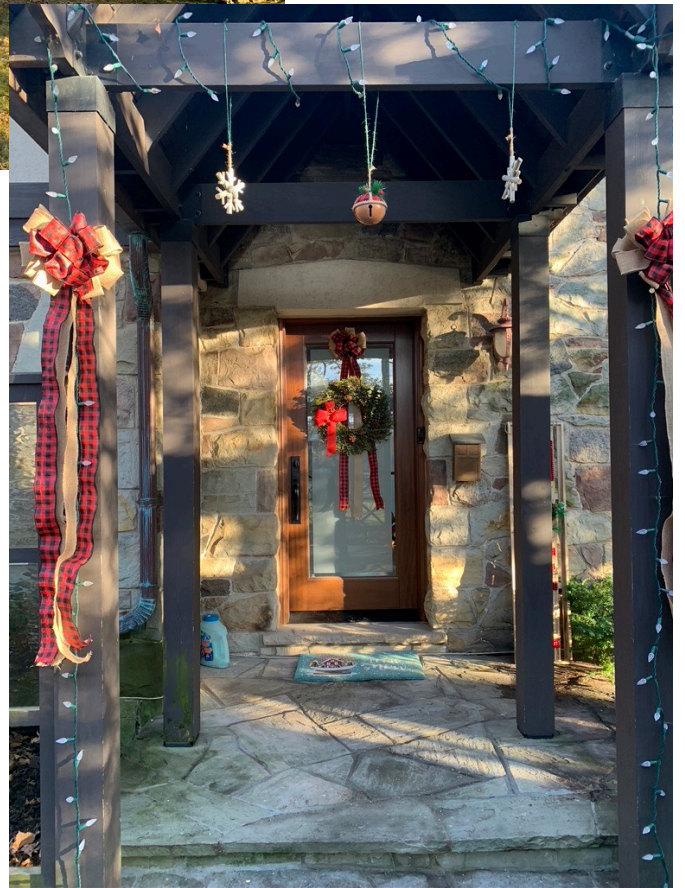
PHOTO 4: NORTH SIDE ELEVATION

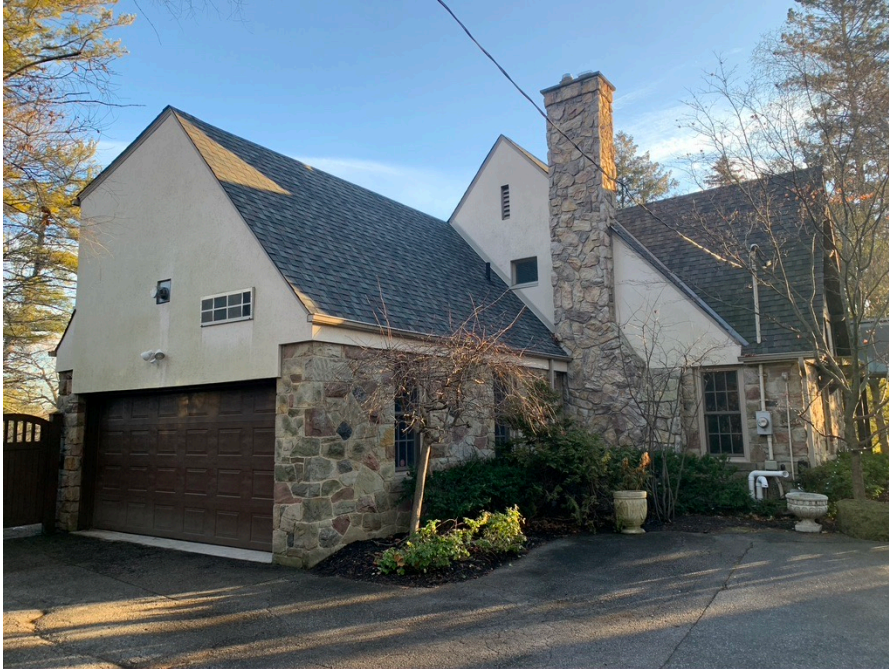
PHOTO 5: STONE WORK DETAIL
ON FRONT OF DWELLING

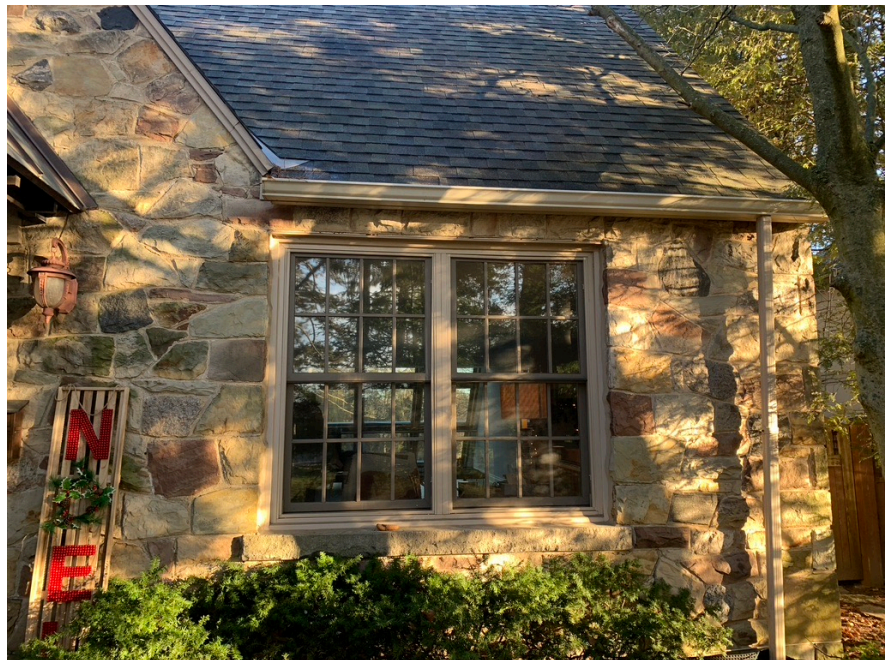
PHOTO 6: REAR ELEVATION

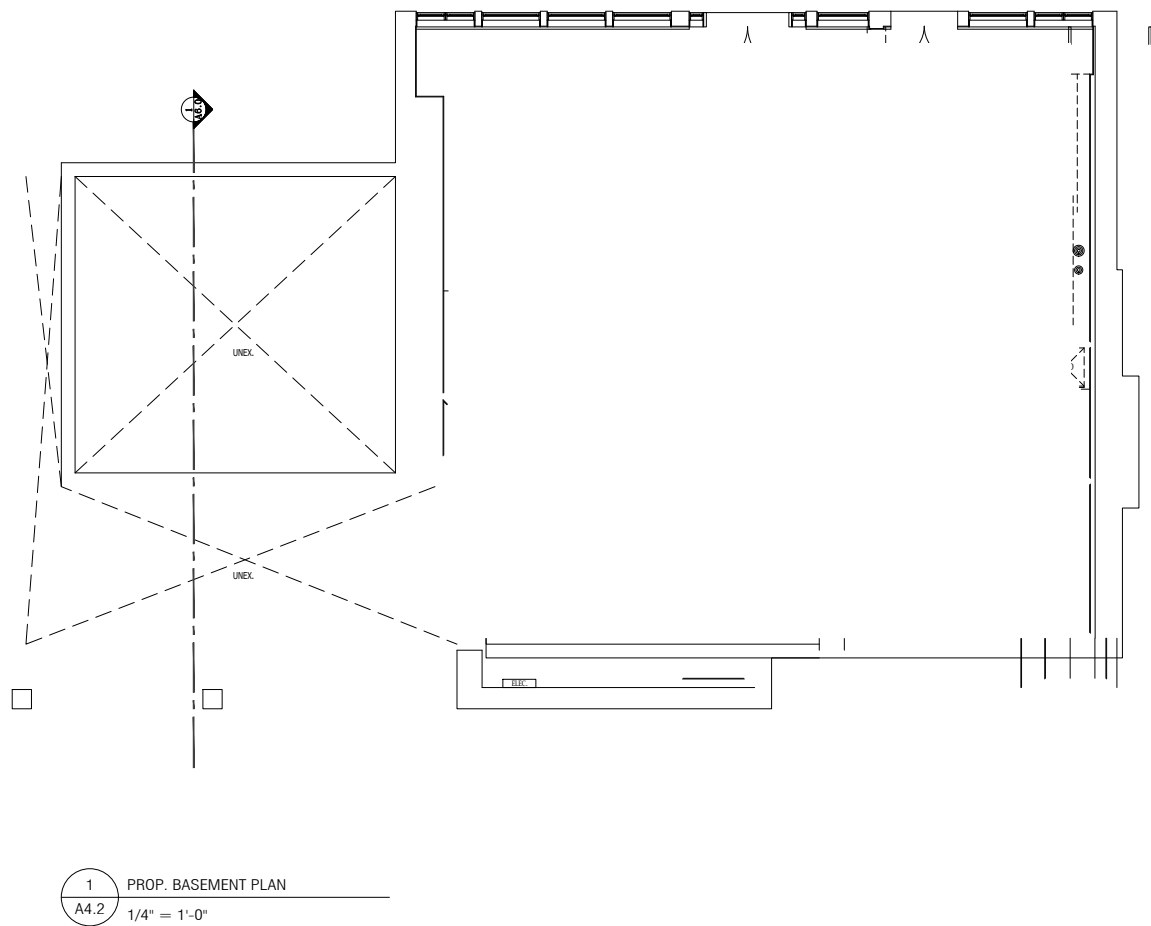
The proposal in the basement area is the increase of the foundation. It will be un-excavated and no additional living space.

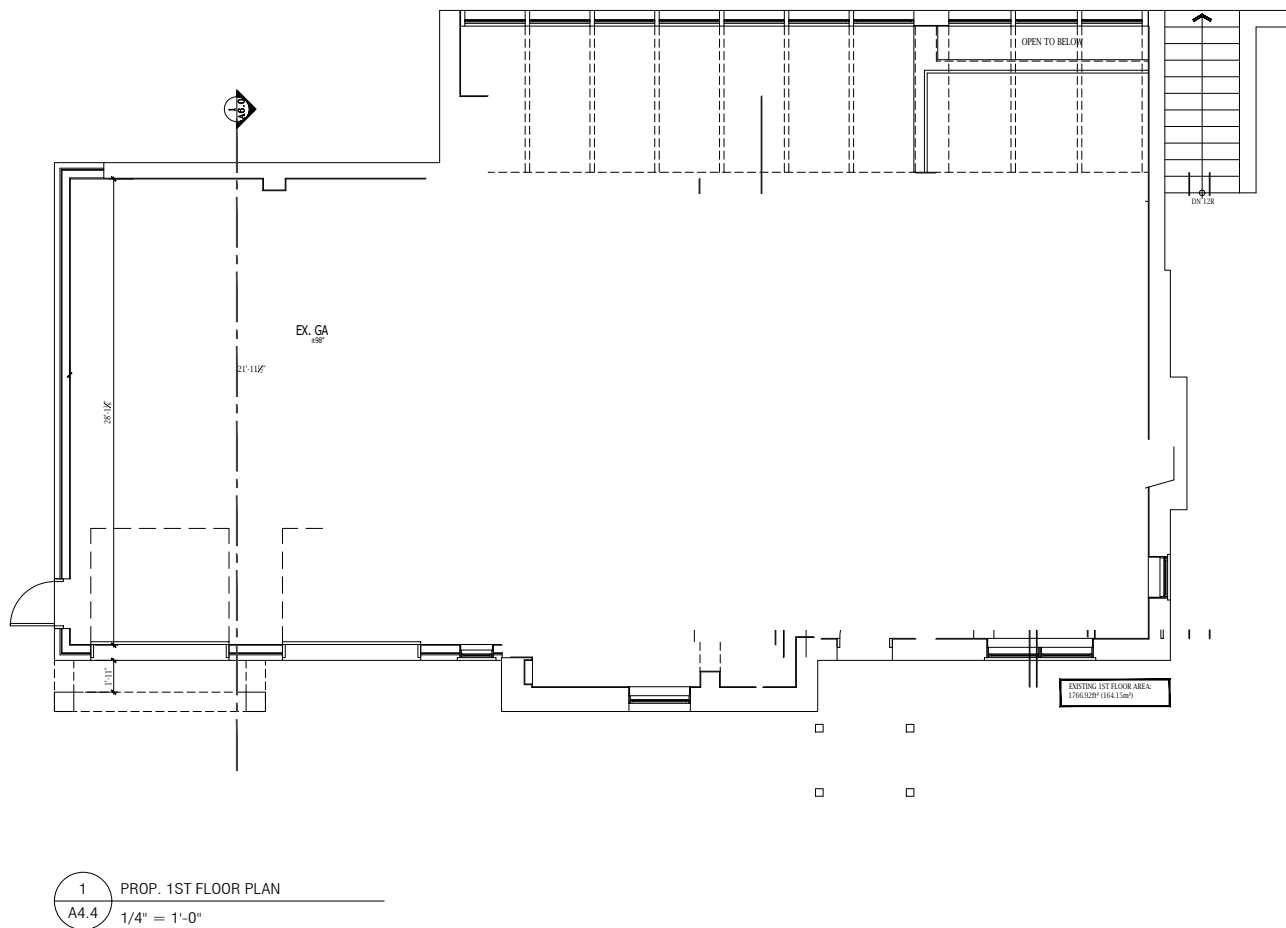
The addition to the main floor area is the expansion of the garage and the orientation of the access from the side to the front of the dwelling. No alterations are proposed to the existing main floor.

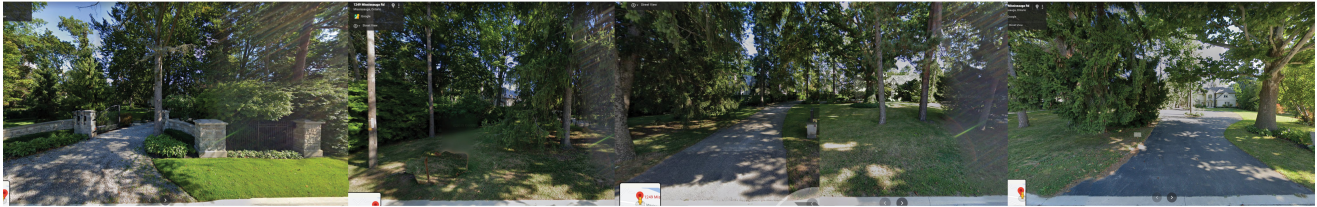
FIGURE 17: PROPOSED STREETScape

Utilizing google street view images, and imposing the proposed addition, the streetscape above was created.

The proposed addition will not be visible from the street in the summer months when trees are in full foliage.
