Heritage Advisory Committee

Date: October 13, 2020
Time: 9:30 AM
Location: Online Video Conference

7.1. Request to alter a Heritage Designated Property: 5961 Hurontario Street (Ward 5)

7.2. Request to alter a Heritage Designated Property: 707 Dundas Street East (Ward 3)

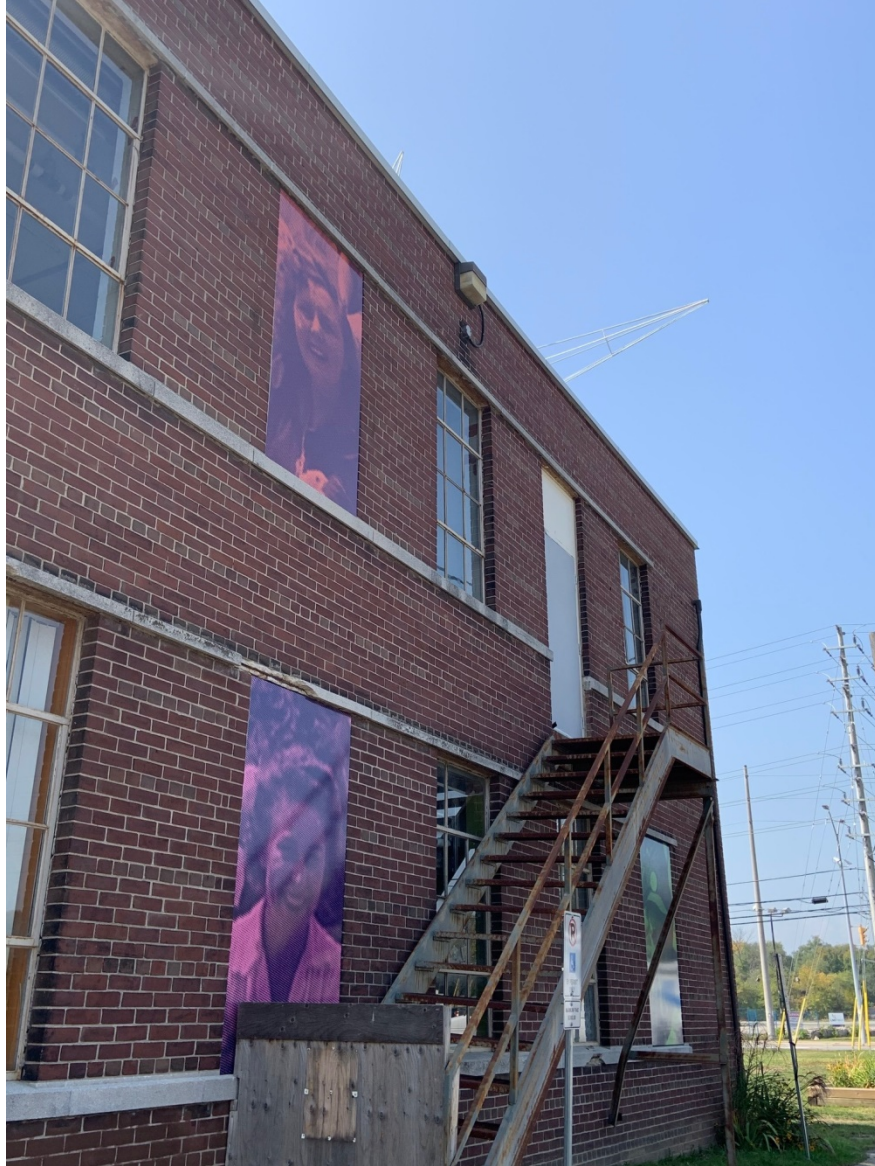
Photo 3: Existing light fixture to be replaced by new light fixture.

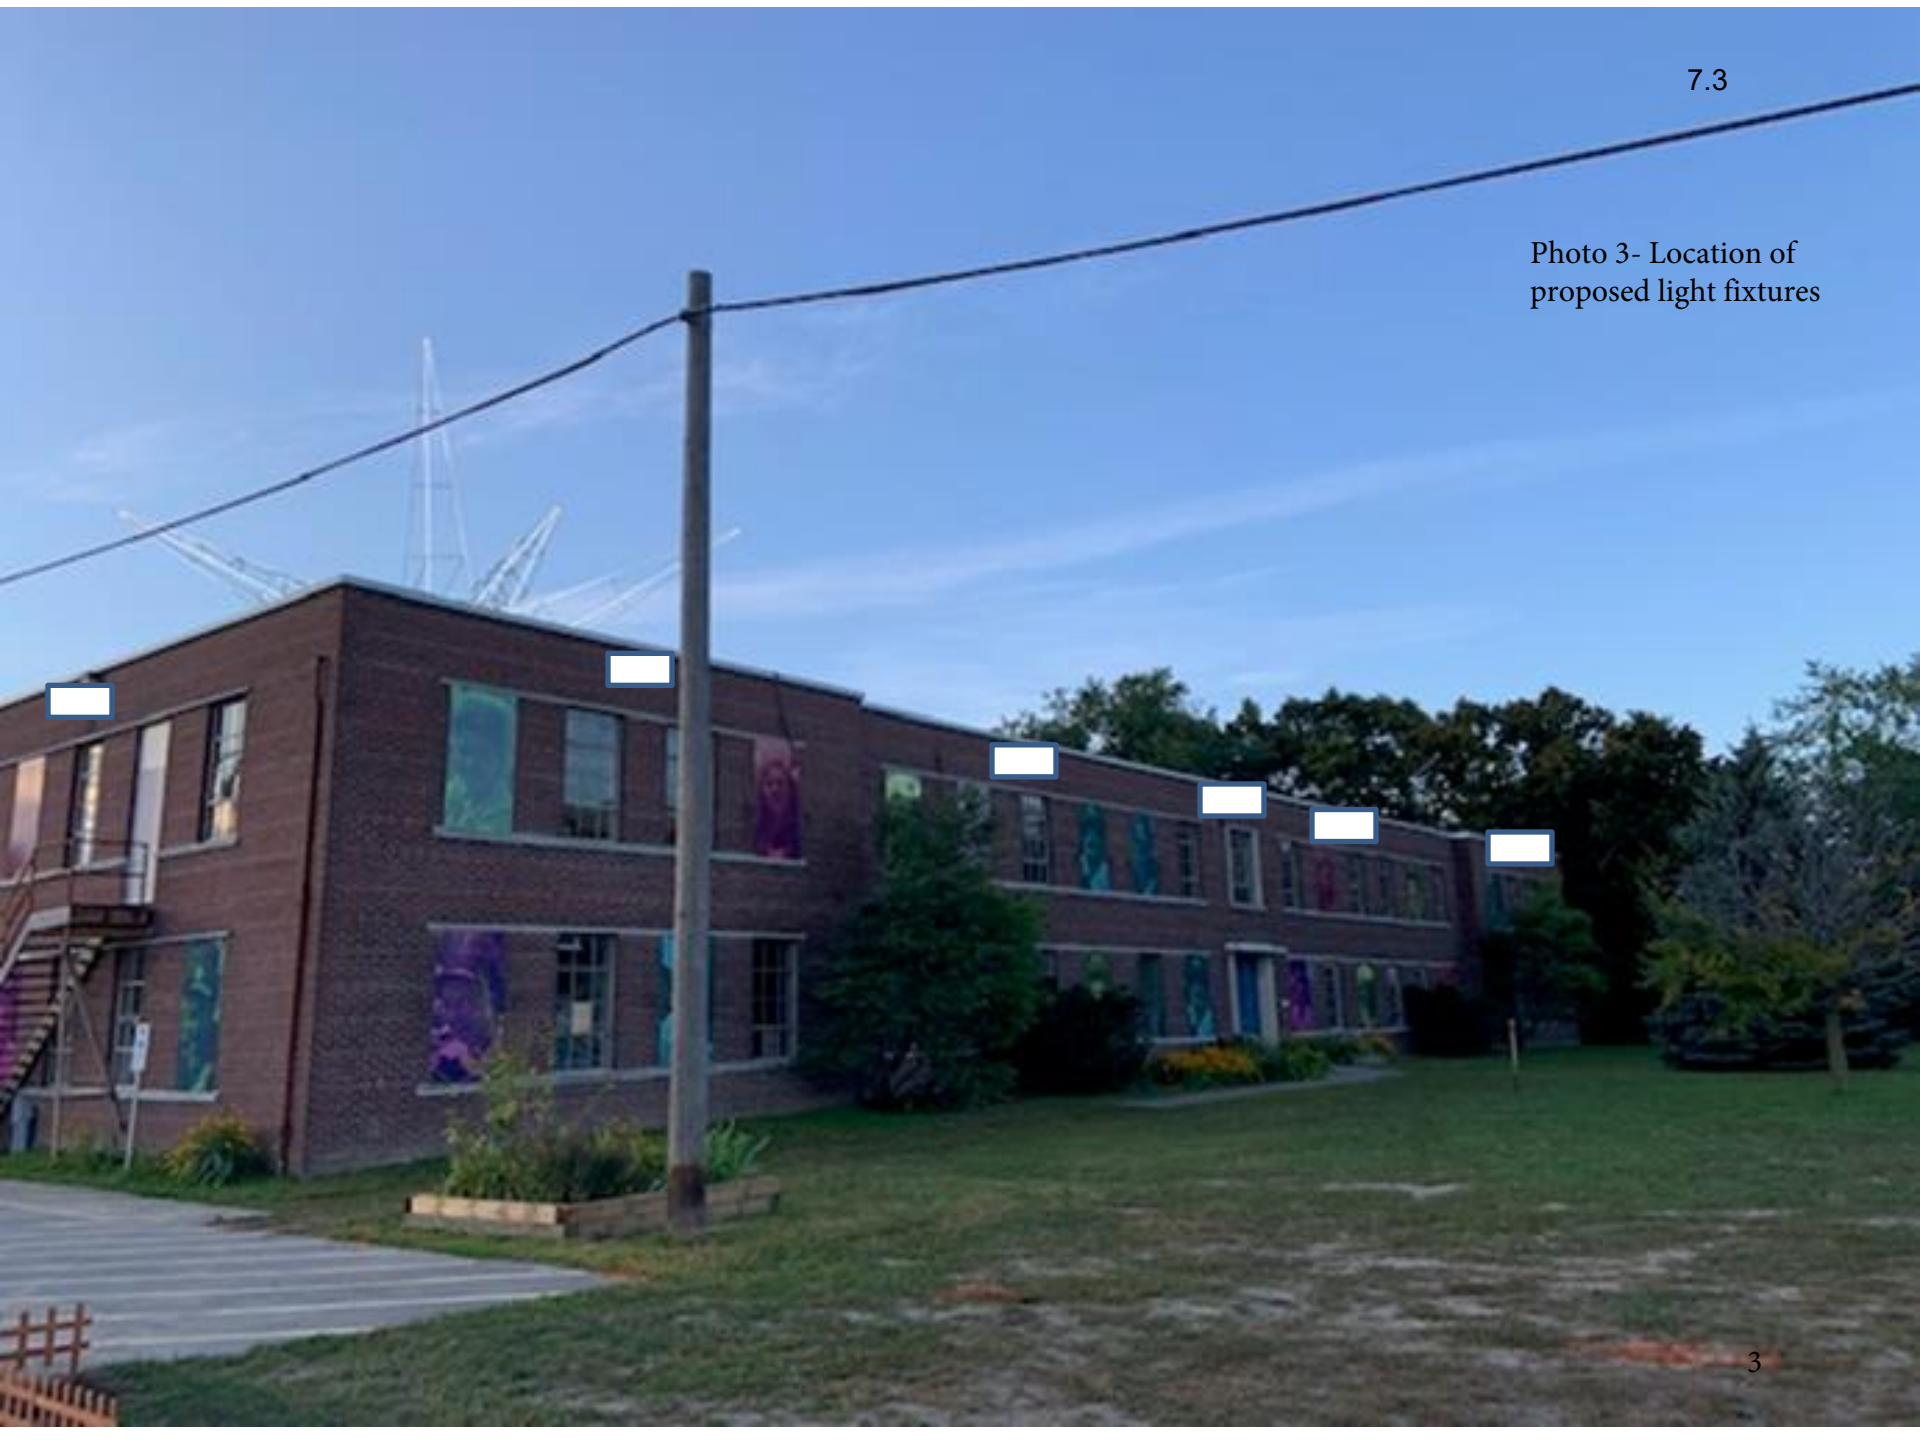
Photo 3- Location of
proposed light fixtures

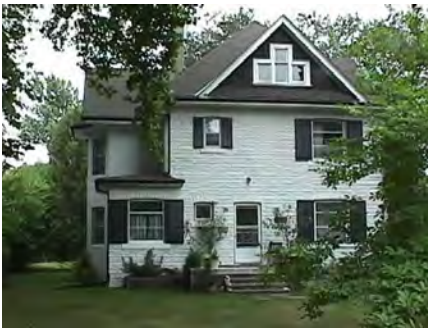
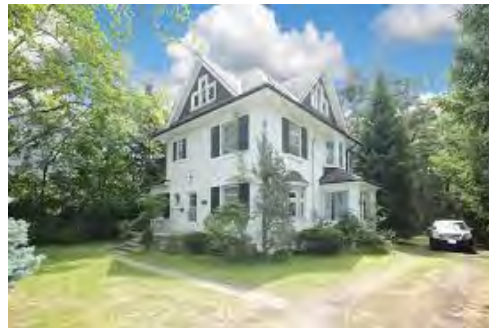
Edith Clarkson House

MAIN ELEVATION (left): re-clad with stone in the 1960s and the porch replaced with a concrete stoop
SIDE ELEVATION (right): bay window and side entrance oriented towards the driveway

The house is a good example of residential building influenced by Edwardian Classicism with Queen Anne features. The square plan, simple roofline, compact massing, lack of ornamentation and use of concrete block are stylistic features associated Edwardian Classicism. The shingled gables, Palladian inspired windows in the gables, the bay windows on the side elevations, and the leaded and stained glass windows on the principal elevations are ornamental details associated with the Queen Anne Revival style. The front elevation that now looks very austere, and oddly asymmetrical, originally had a porch across the ground floor that gave the elevation a more dignified appearance. There is a glazed entry porch on the driveway and a 2-storey screened sleeping porch at the back.

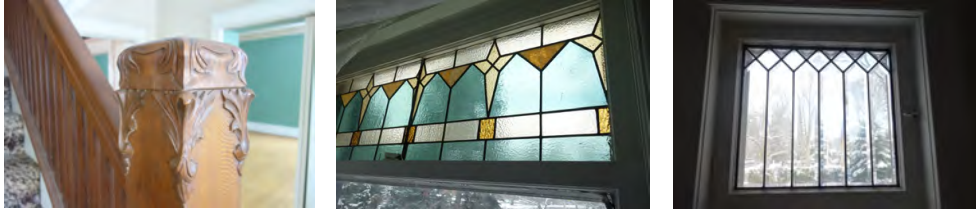
The interior features an Arts & Crafts' inspired staircase with organic tendrils carved on the newel post. There are wood paneled doors throughout including pocket doors between the living room and dining room. The doors and the wood trim have a simplicity associated with Arts & Crafts millwork that is typical of early 20th century residential interiors and contrasts with the ornamental design of the main staircase. The master bedroom has a small sitting room with a fireplace. The main fireplace in the living room is not original and the surround is angel stone that matches the stone veneer that was added to the main elevation, probably in the 1950s or 60s.

INTERIOR FEATURES – main staircase, leaded and coloured glass

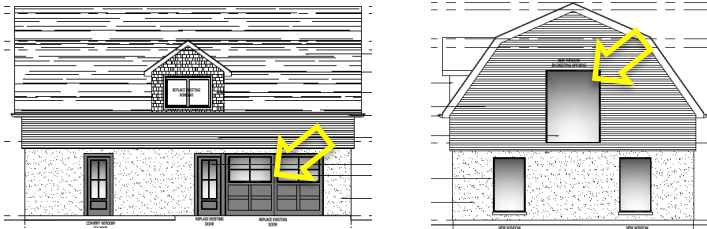
Alterations to the garage include replacement of the exterior wood siding on the upper portion, replacement of the existing garage doors, and installation of new windows. A bathroom will be installed in the lower level.

GARAGE – PROPOSED DOORS & WINDOWS – front and side elevations

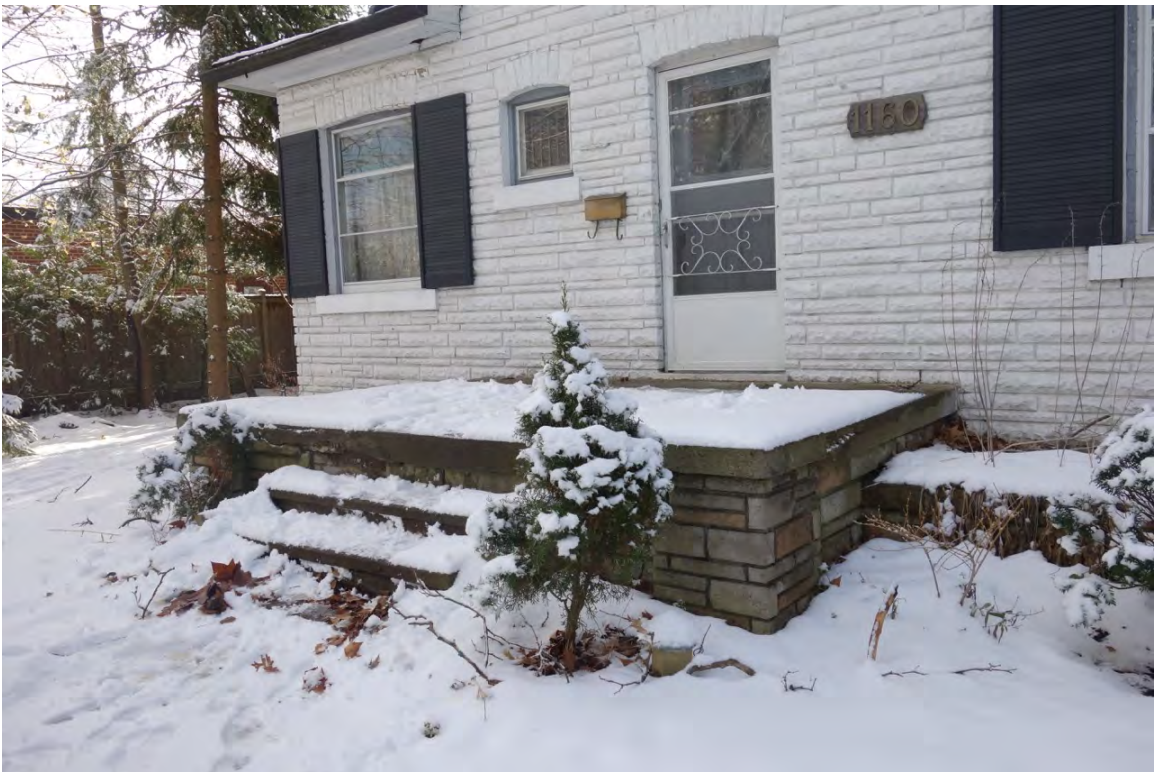
FRONT ENTRANCE – concrete stoop with stone veneer that replaced the original front porch

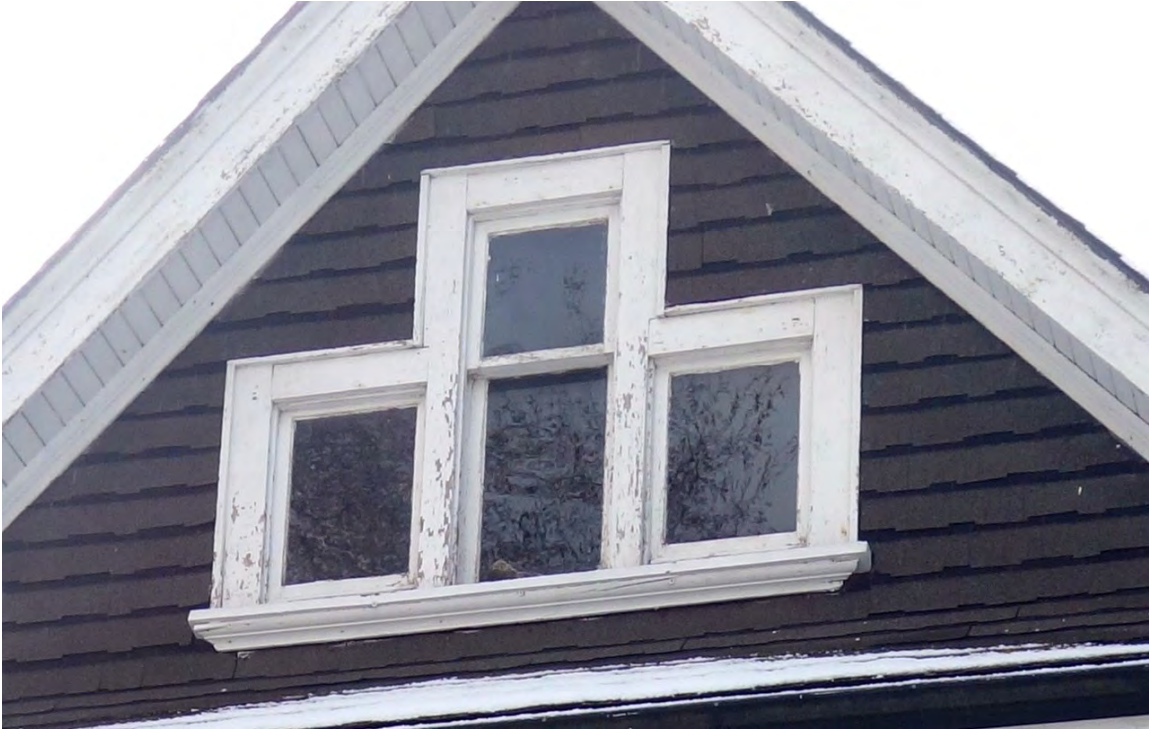
FRONT GABLE – wood shingle replaced (or covered?) with asphalt shingle

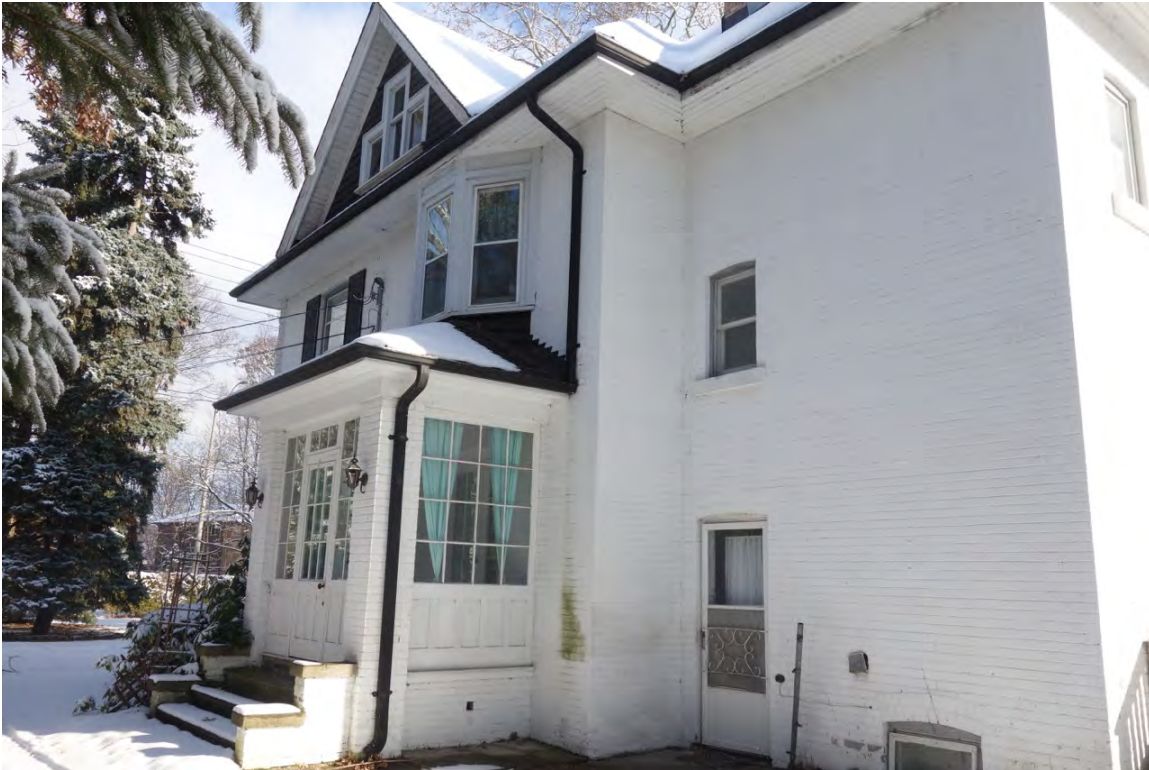
SIDE ELEVATION – covered and glazed entrance porch

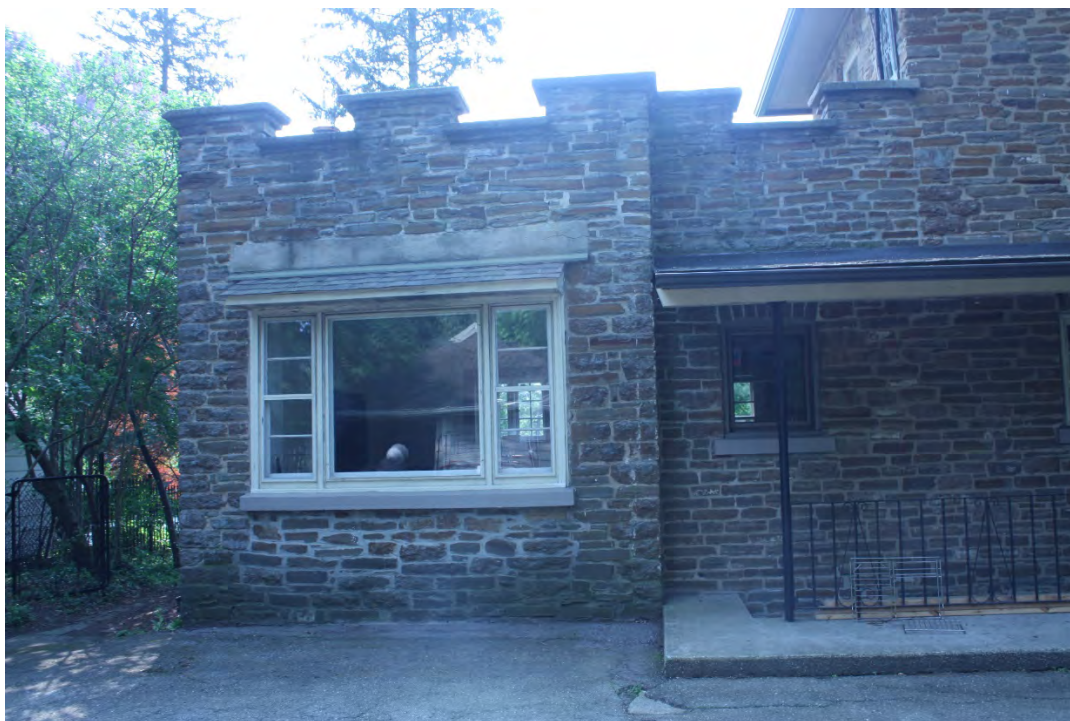
Figure 48 *Detail of the one storey portion of the structure that is to be replaced. (Photo by author.)*

The two storey addition will replace the existing one storey northern portion of the residence. While this plan will require the removal of a portion of the original fabric of the structure, the design features of the addition complement the architectural details of the existing structure. Where possible salvaged stone from the demolition of the one storey portion of the building will be used on the east and south façades. The proposed window design and roof elements reflect the existing features and the proposed addition is a visually pleasing extension of the current building. The addition will extend further to the west and will cover much of what is now the paved asphalt driveway. The existing garage will be retained but its doors will be changed to the south side of the building (Figure 45). The addition will have a minimal impact upon the existing landscape of the property. Figure 42 shows the proposed development set in the current landscape. Figures 47 to 50 show from various perspectives the one storey portion of the existing building that is to be replaced with a sympathetically designed two storey addition. A variance will be requested as part of the application for the new construction which will extend about one foot over the allowed building line along part of its northern wall.

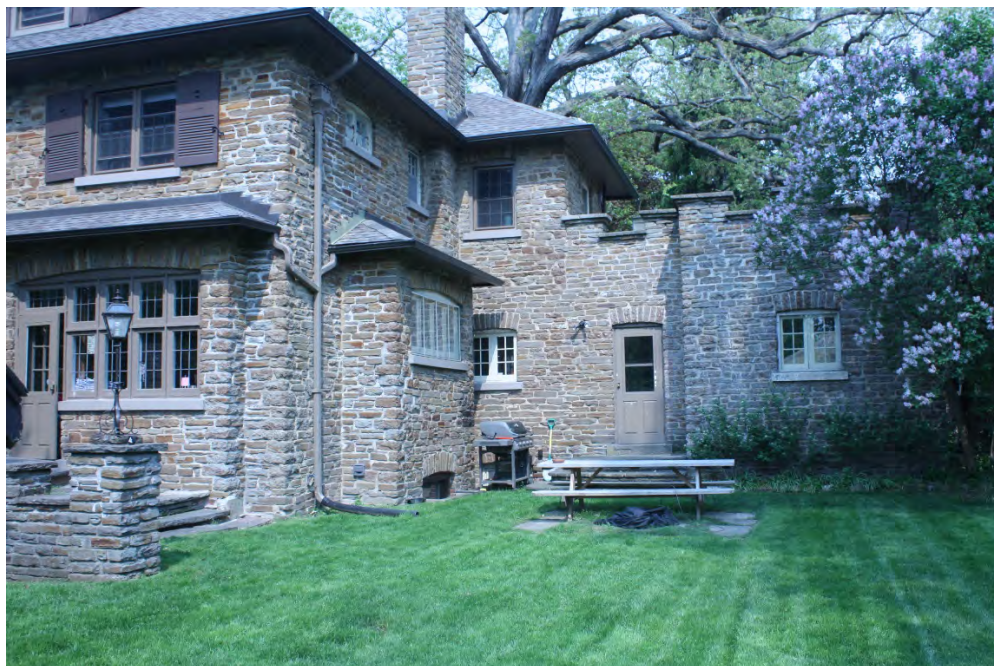
Figure 49 *The one storey portion of the structure to be replaced with a two storey addition.
(Photo by author.)*

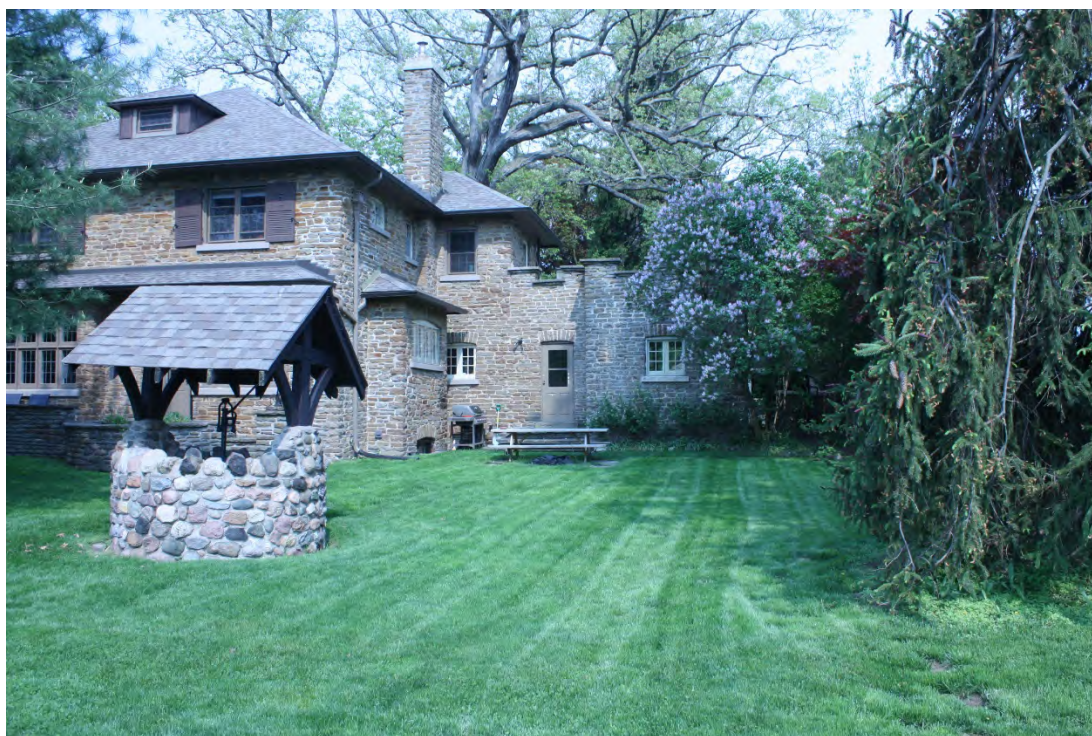
Figure 50 *A wider view of the one storey portion of the structure proposed to be removed.
(Photo by author.)*

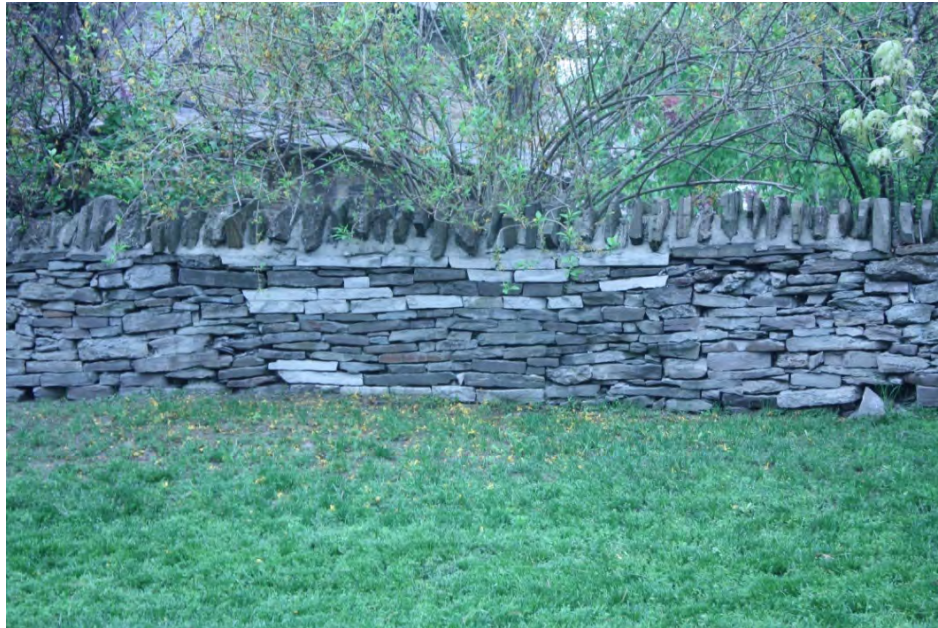
The low stone wall on the Stavebank property line is recognized as a heritage landscape feature. Its foundation is giving way in places and the wall requires periodic renewal. It is the intention of the current owners to stabilize this structure. They may also extend it along Stavebank Road west of the existing driveway. The wooden fence along the Mineola boundary may be replaced at a future date.

Figure 51 *A section of the low stone wall at 1341 Stavebank Road. (Photo by author.)*

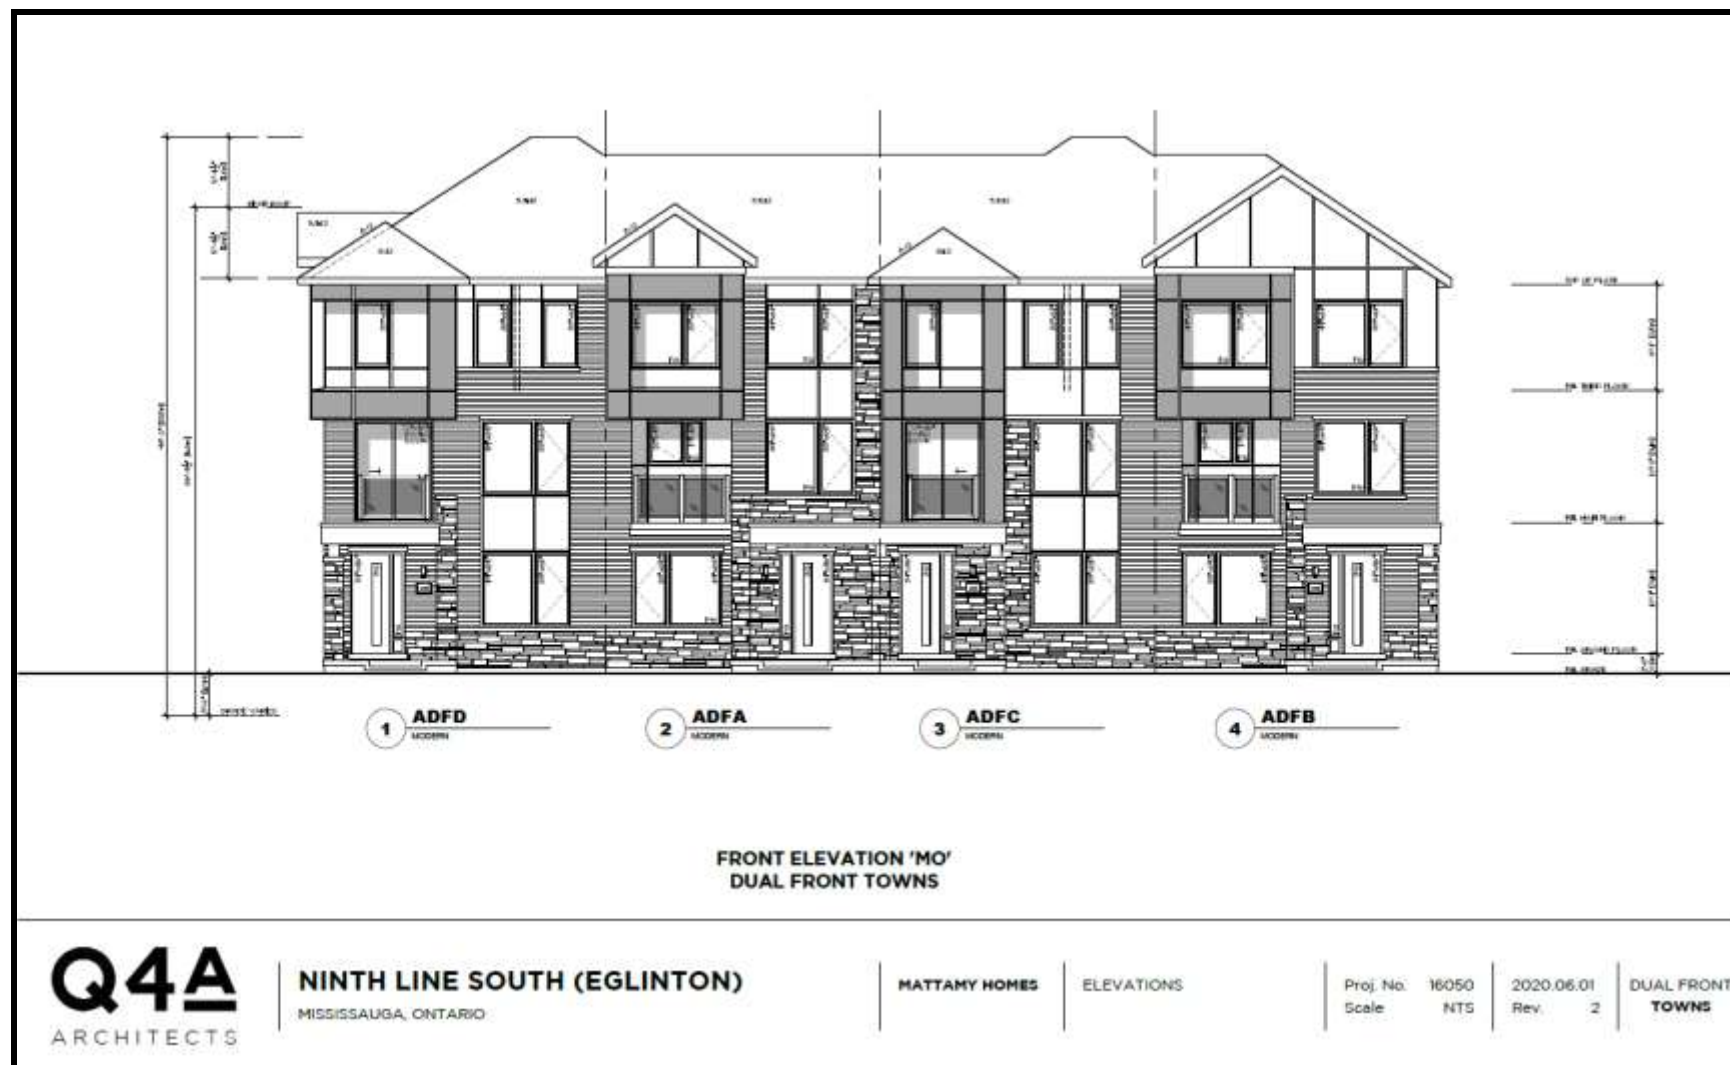
Figure 8: Dual Front Towns (Modern), 4 Unit Block – Front Elevation
(Q4A Architects 2020a)

Line are anticipated (Q4A 2020). The architectural design, construction materials and colour palate of the townhouses are not reflective of, or sympathetic to, the design of the neighbouring dwelling at 5104 Ninth Line.

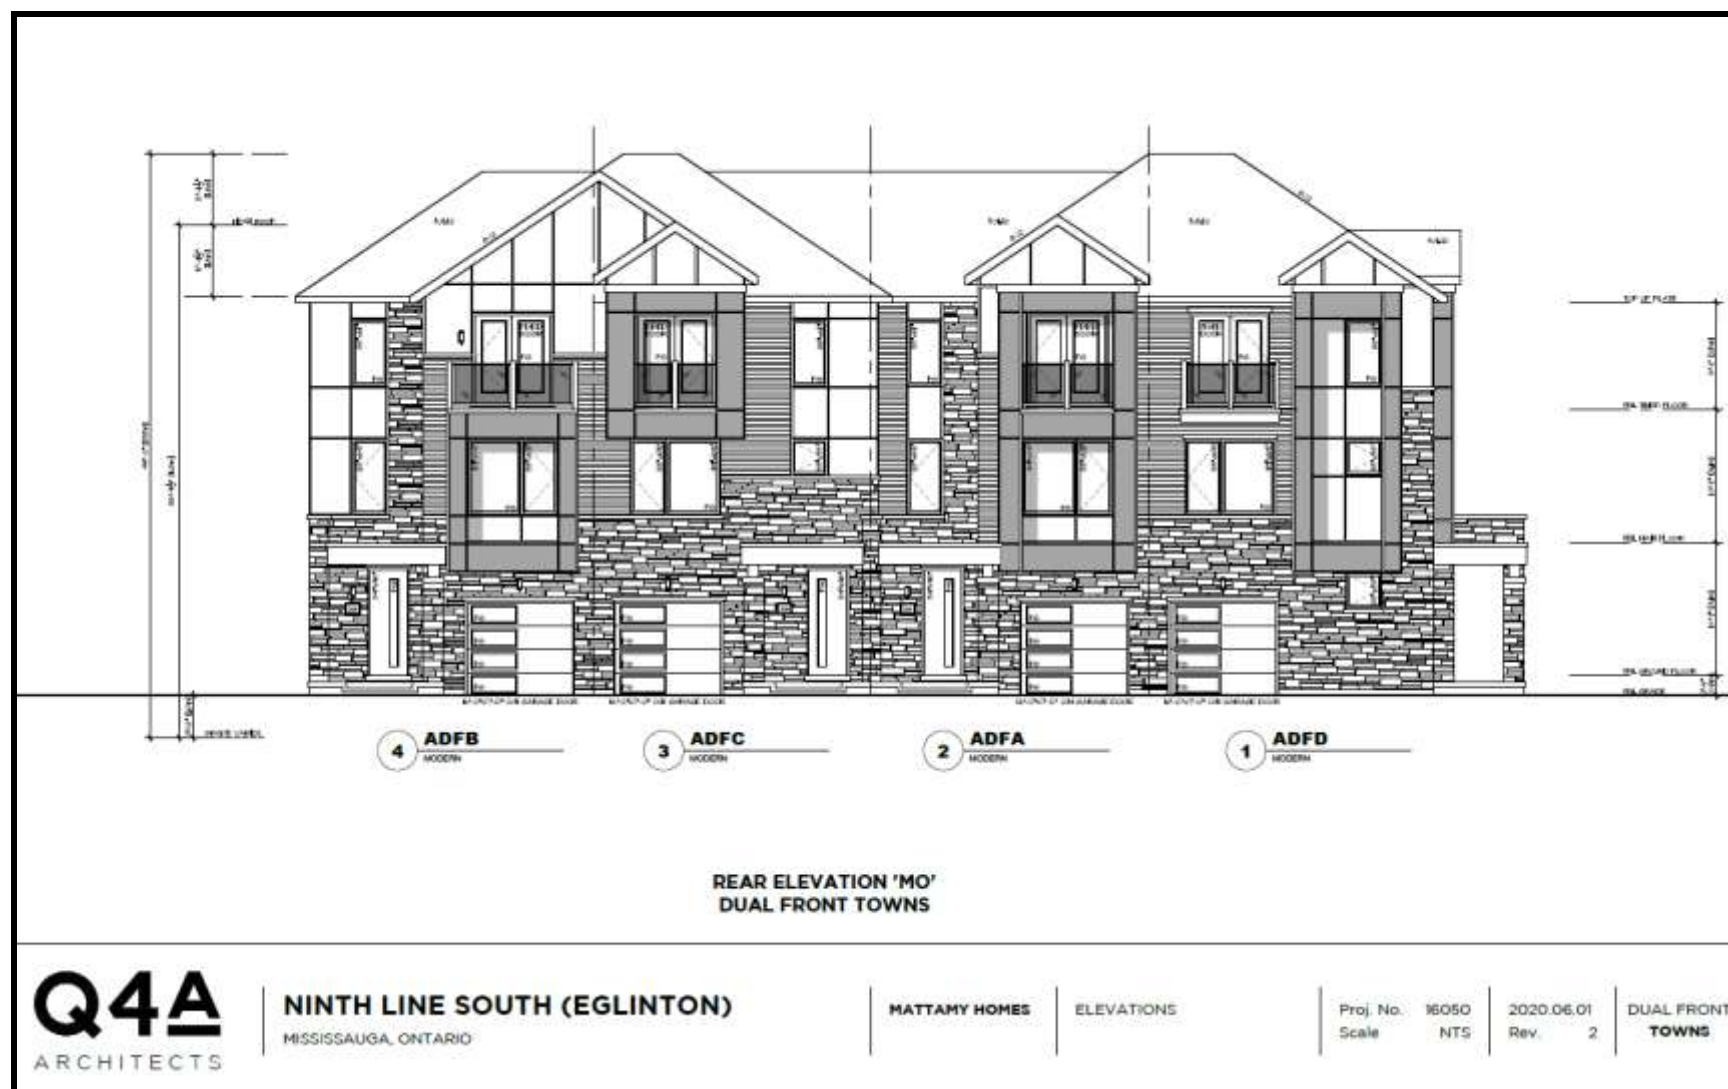
Figure 9: Dual Front Towns (Modern), 4 Unit Block – Rear Elevation
(Q4A Architects 2020a)
