Heritage Advisory Committee

Date: September 10, 2024
Time: 9:30 AM
Location: Council Chambers, Civic Centre, 2nd Floor
300 City Centre Drive, Mississauga, Ontario, L5B 3C1
and Online Video Conference

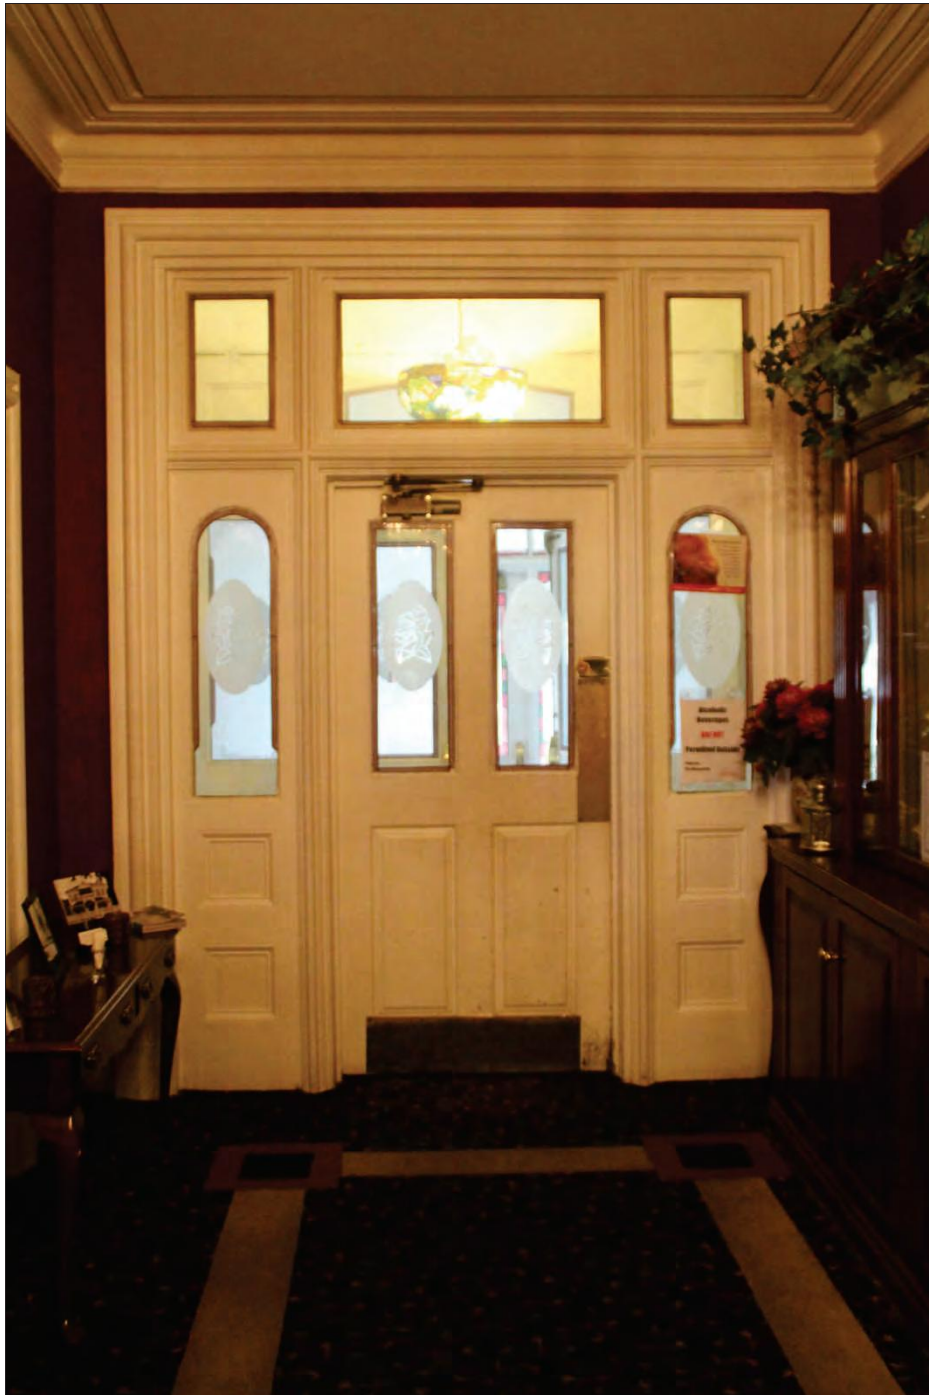
Figure 41 inside front door, transom & sidelights (replacement glass), ceiling moulding

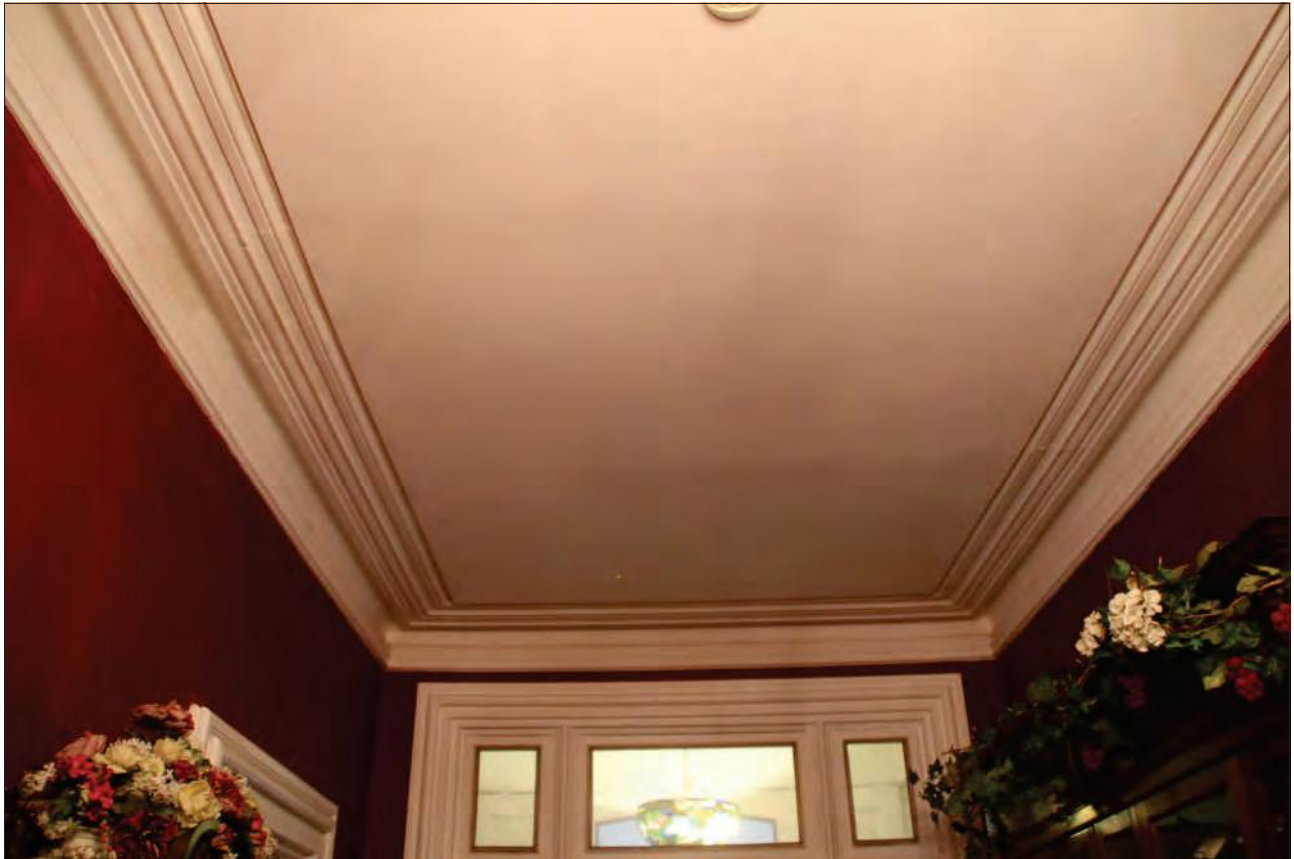
Figure 42

plaster ceiling moulding, front entrance hall

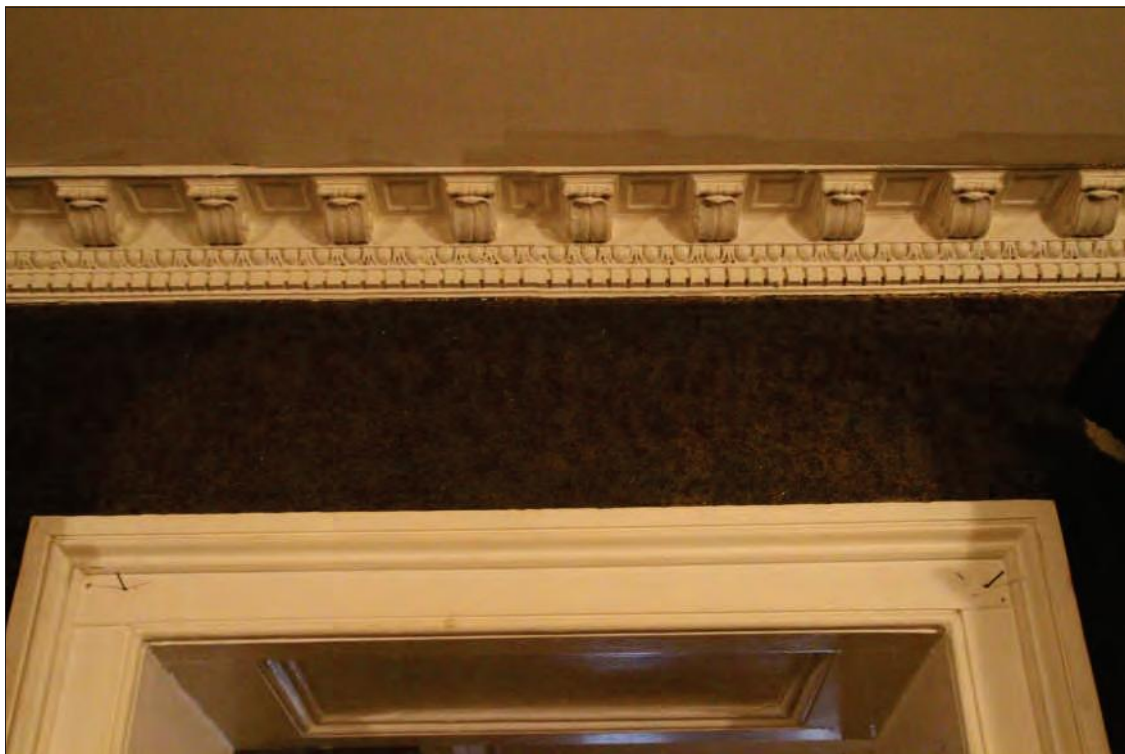
Figure 50 plaster ceiling moulding in current bar

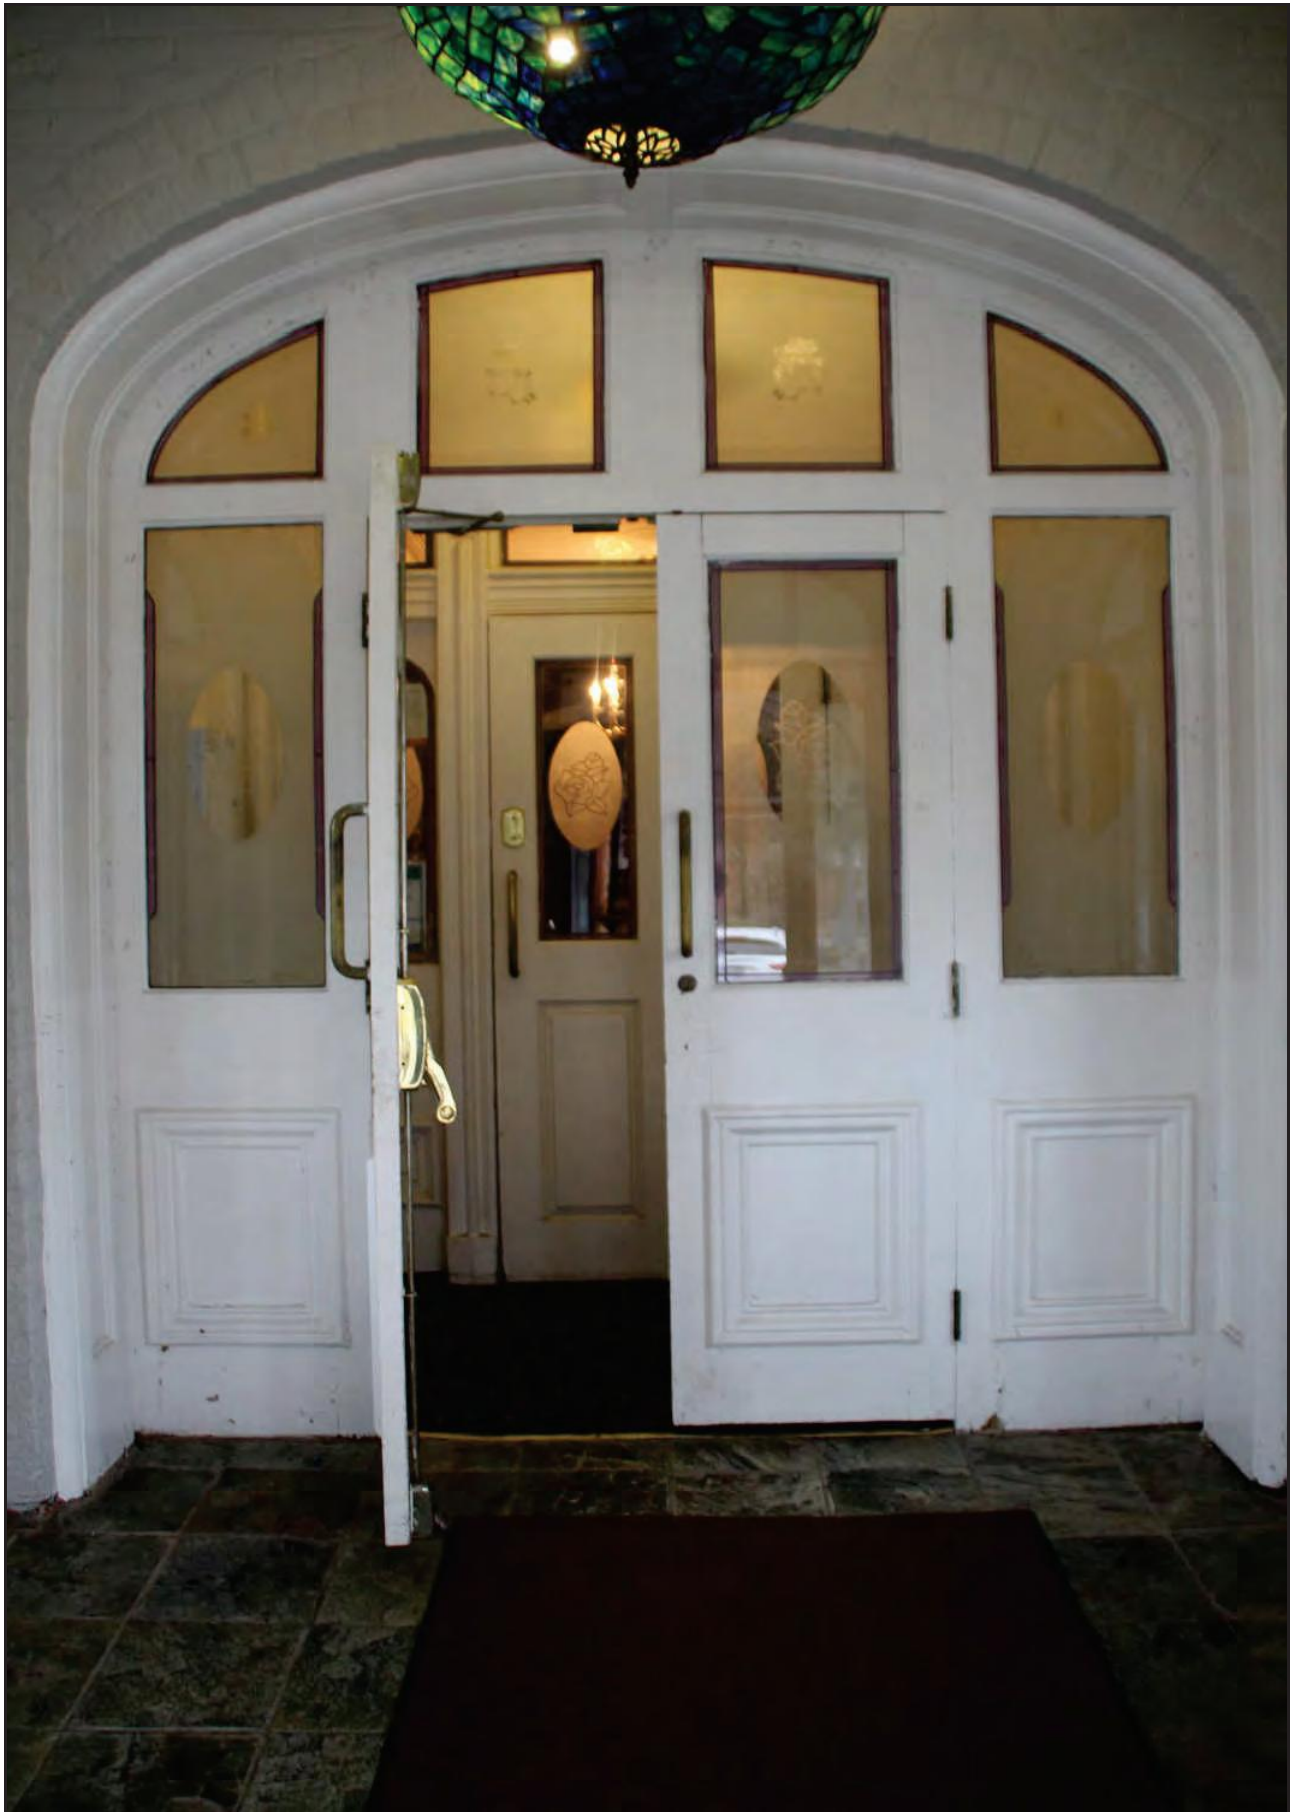
Figure 51 doors, top lights and sidelights (replacement glass & hardware) to umbrage from exterior

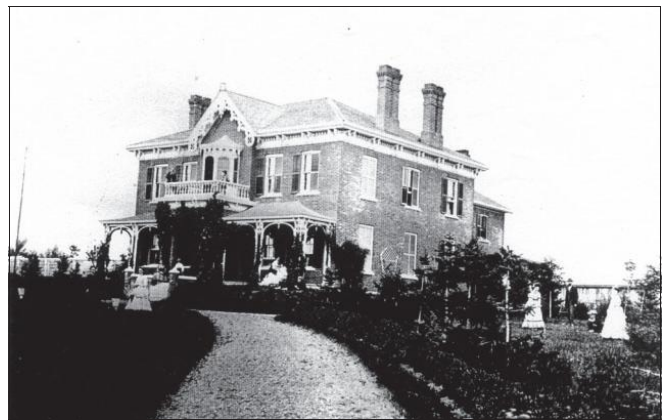
1895

The shuttered, blind, upper and lower front windows on the south side have been replaced with blind, glazed windows. Brick has been painted white. Brick chimneys have been rendered and painted.

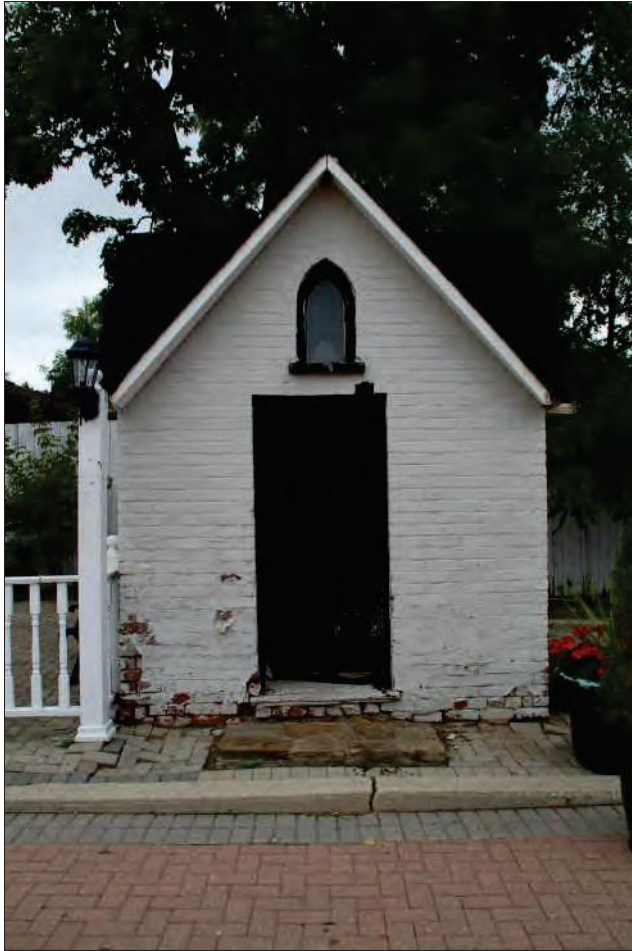
Figure 59 outbuilding - south facade

The property also includes a small, square, brick, 19th century outbuilding, its former function possibly a privy (Figures 59 and 60). A detached garage of uncertain vintage was demolished in 1984 (Figure 61).

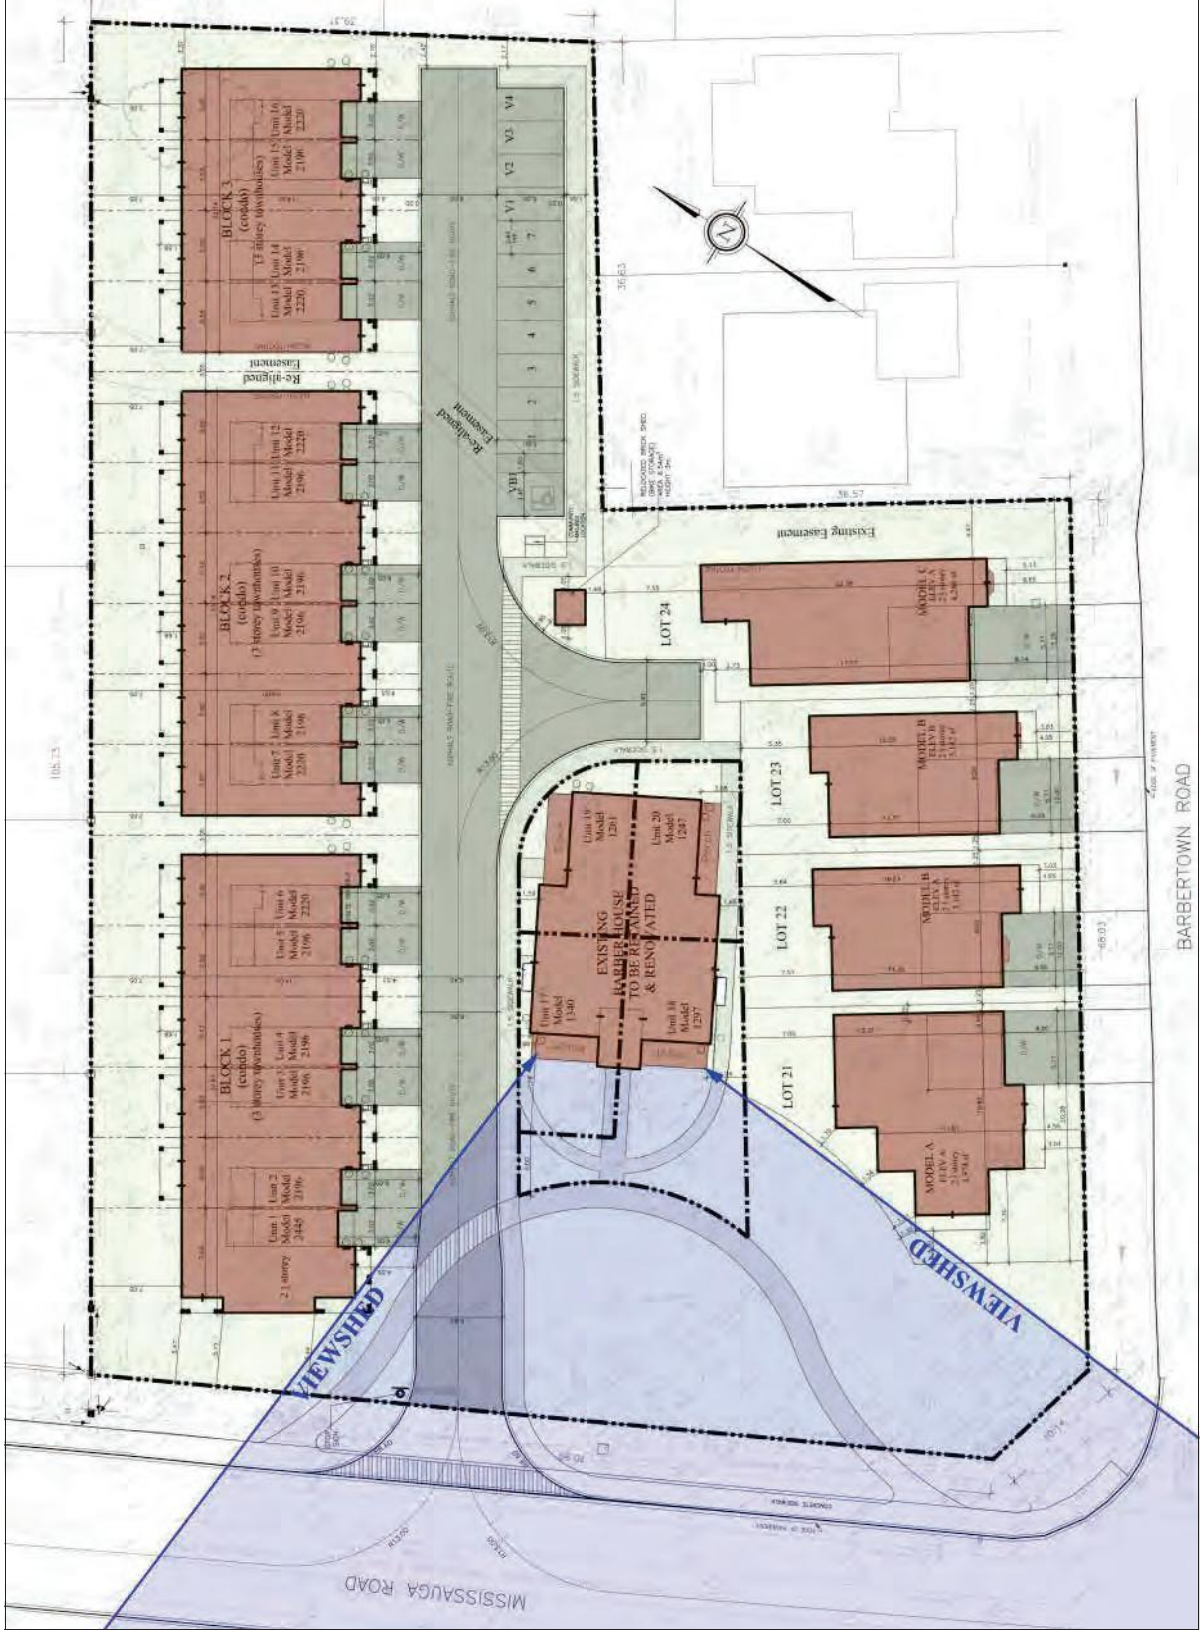
Figure 72

Site Plan - after Janagan beresford patteson architects, 10/18/17

The development proposal for this property is illustrated in Figures 72, 73 and 74 a site plan and elevations respectively for a residential development on the subject property that showcases the original c. 1862 William Barber House.

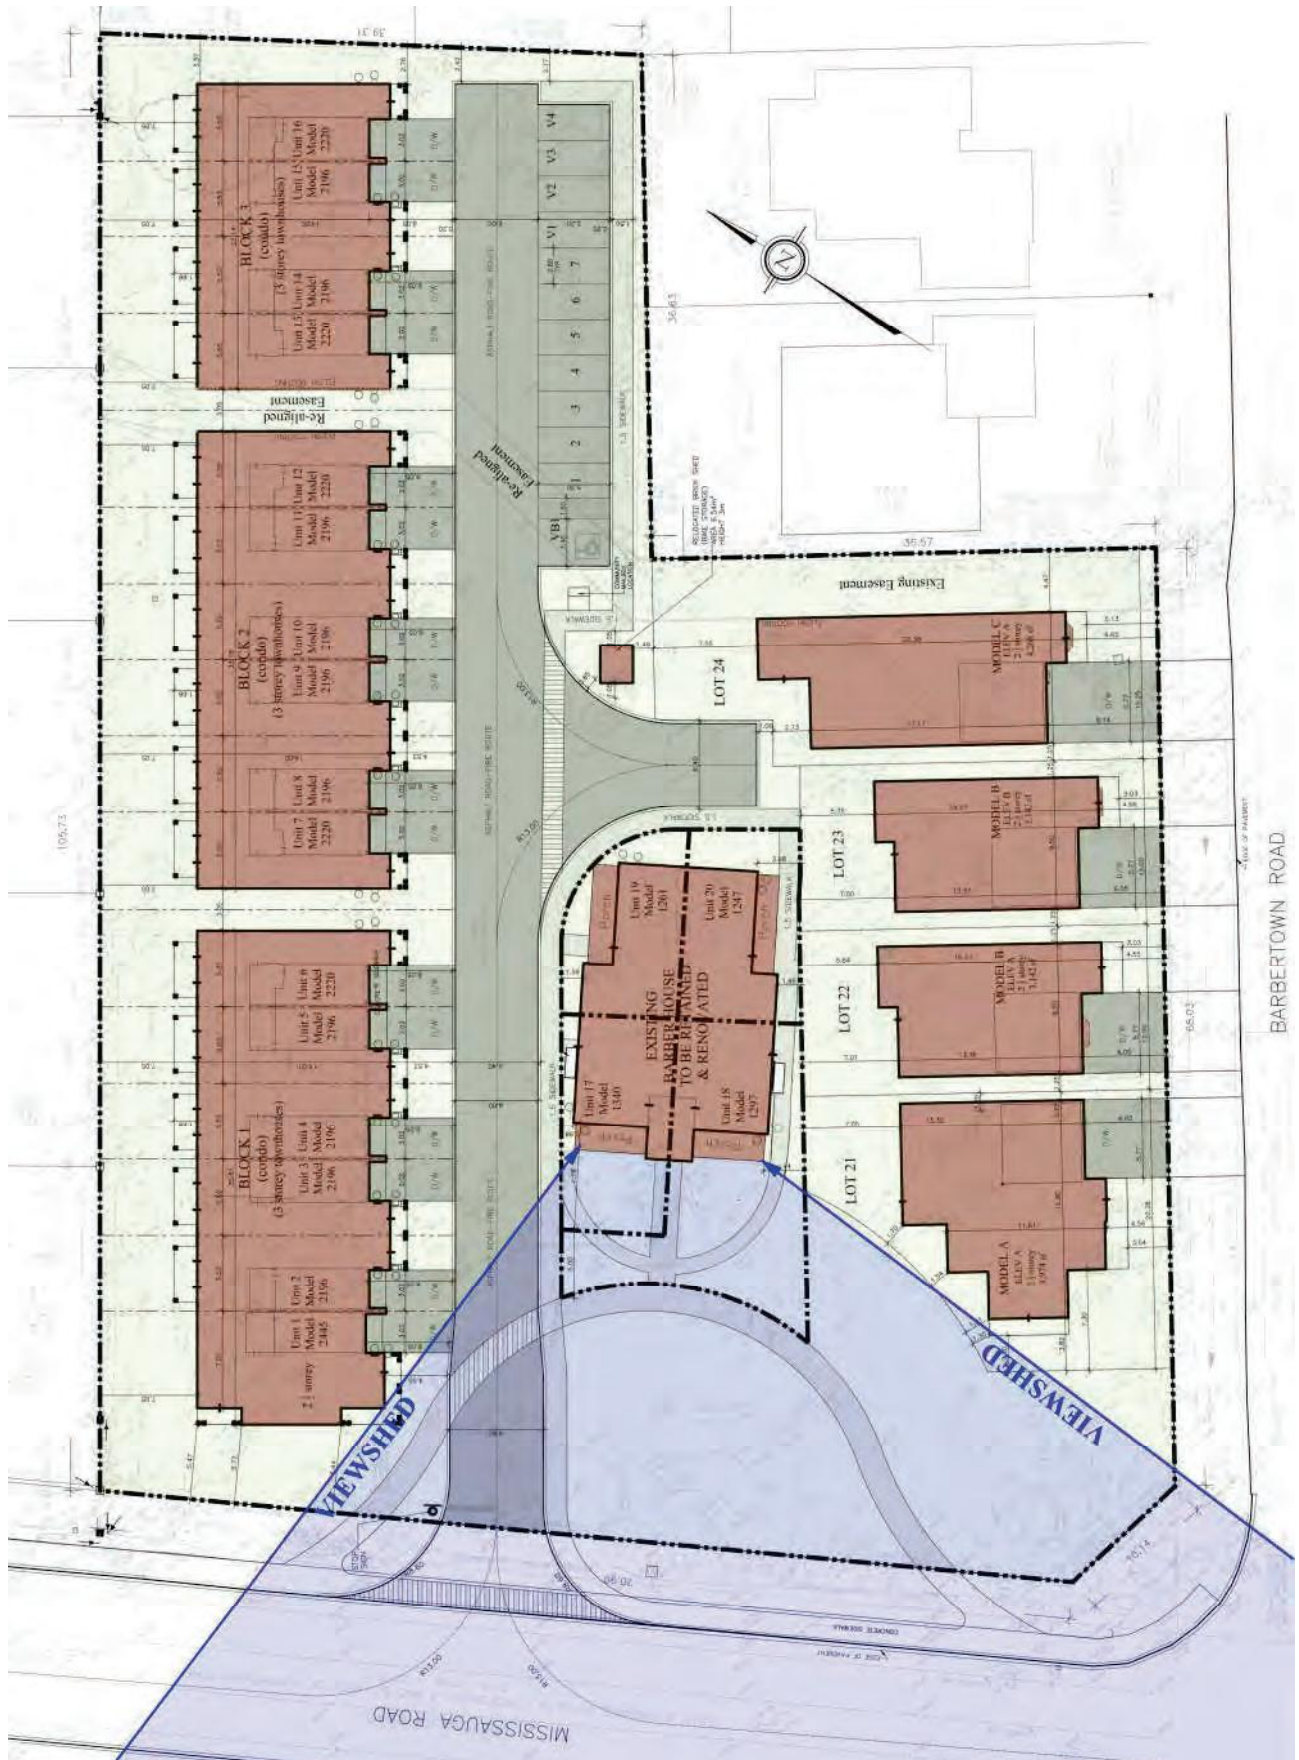
Figure 4 – Site Plan, Flanagan Beresford Patteson

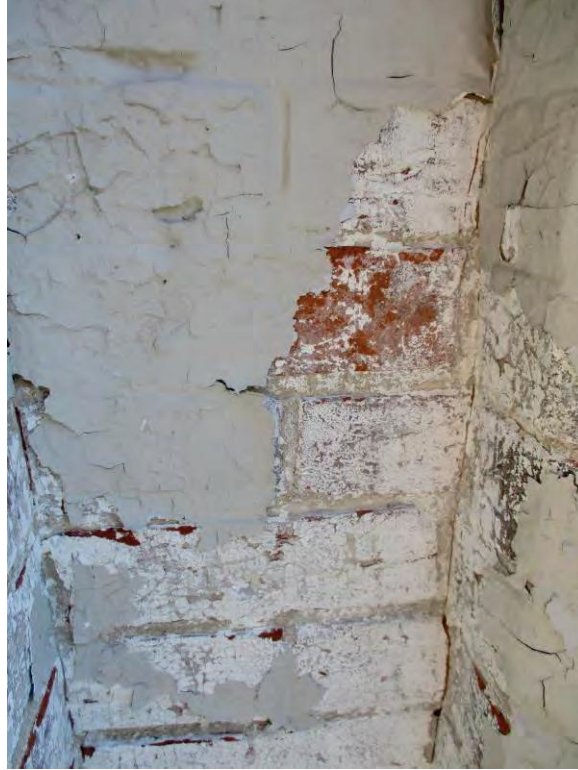
The brick has been coated with at least two (2) different coatings. Remnants of a third coating were visible, and it is possible that this lowest layer is a composite of a repeated lime wash, known to have been applied to other buildings of a similar vintage and construction.

Figure 2: Exterior coatings

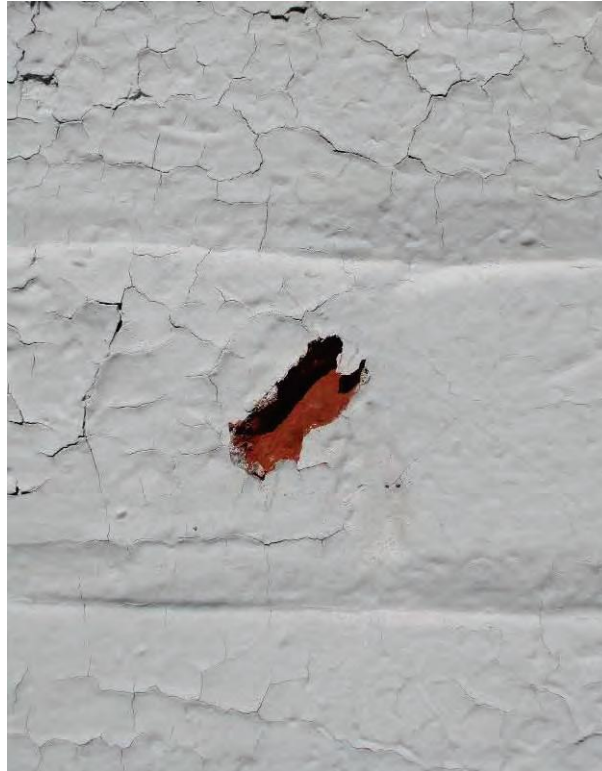
The outermost coating is very thick and has flaked off in many locations, most notably at interior corners or other locations more prone to moisture accumulation. The coatings exposed below are in varying states of decay, and have deteriorated to a form of powder, possible lime, in some locations. Where exposed below the coatings, the brick was found to be extremely soft.

Figure 3: Soft brick exposed below coatings

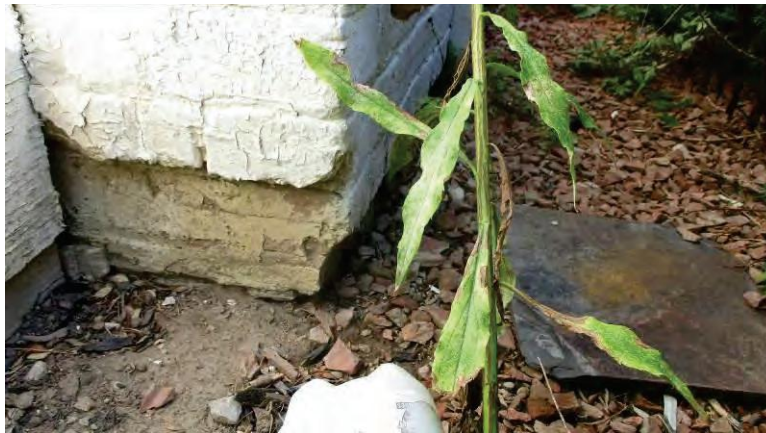
Coatings at or near grade are showing signs of more advanced deterioration, particularly where the wall is sheltered by gardens.

Figure 4: Deteriorated coatings near grade

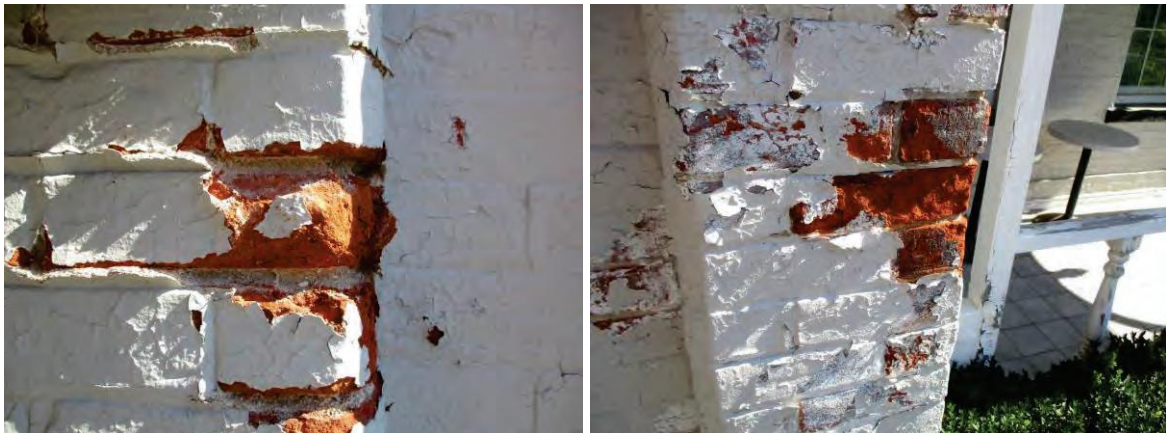
It appears that the concentration of run-off from the canopy has resulted in saturation of the brick at this location, and the loss of coatings has lead to advanced deterioration of the brick.

Figure 6a, 6b: Damage to masonry at south side of entry canopy

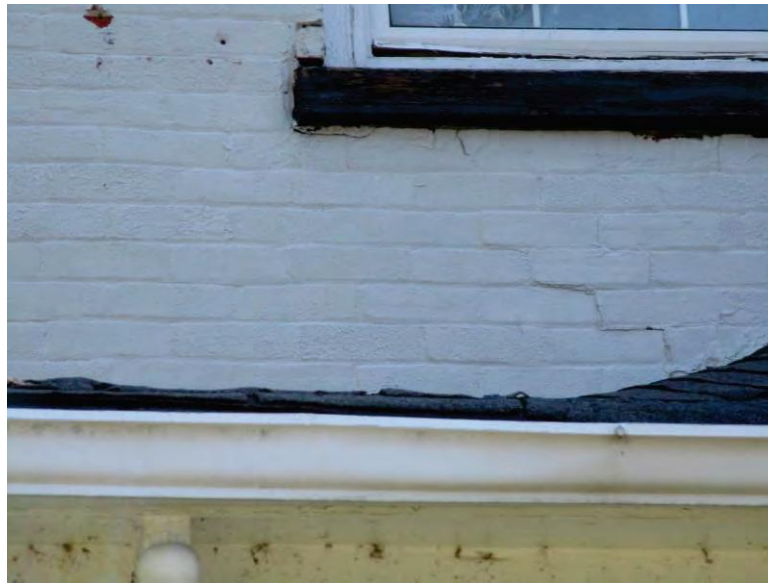
A step crack was noted on the front elevation below the second storey north window. The presence of the coatings precludes comment on the extent or width of the crack.

Figure 7: Step cracking below second storey window
