## Heritage Advisory Committee

**Date:** July 22, 2025  
**Time:** 9:30 AM  
**Location:** Council Chambers, Civic Centre, 2nd Floor  
300 City Centre Drive, Mississauga, Ontario, L5B 3C1  
and Online Video Conference

- 9.1 Request to Alter a Heritage Listed Property: 850 Enola Avenue (Ward 1)
- 9.2 Request to Demolish a Heritage Listed Property from the City's Registry: 33 Beverley Street (Ward 5)
- 9.3 Peel Region Cultural Heritage Conservation Orientation Session
- 9.4 Port Credit Heritage Conservation District Subcommittee Recommendation Report 3 - 2025 - dated July 7, 2025

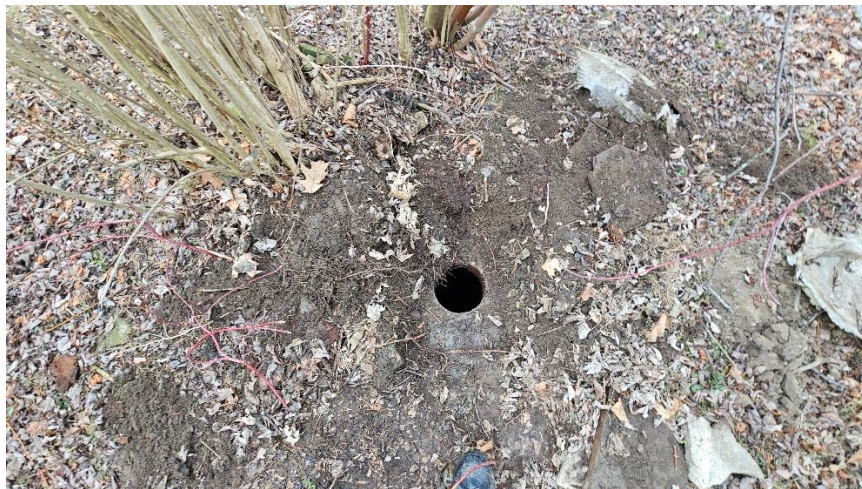
**Photograph 4:** Well Opening

**Observed Well Construction:** Brick lined

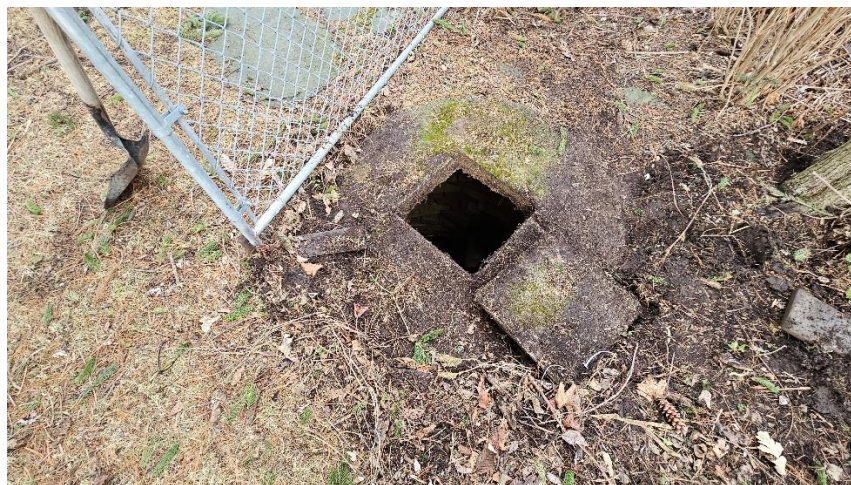
**Photograph 6: Cistern Exterior Surface**

**Observed Cistern Construction:** Brick lined

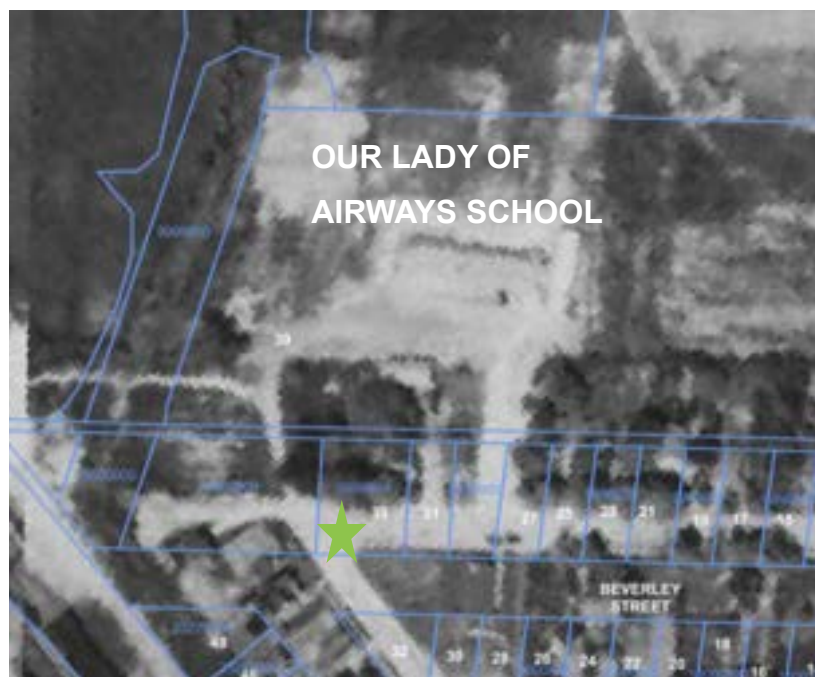
Figure 5: 1952 Aerial photo

Subject property defined by green star. The property does not appear to be associated with a farming operation. Our Lady of the Airways Catholic School was situated behind the property and opened in 1954.

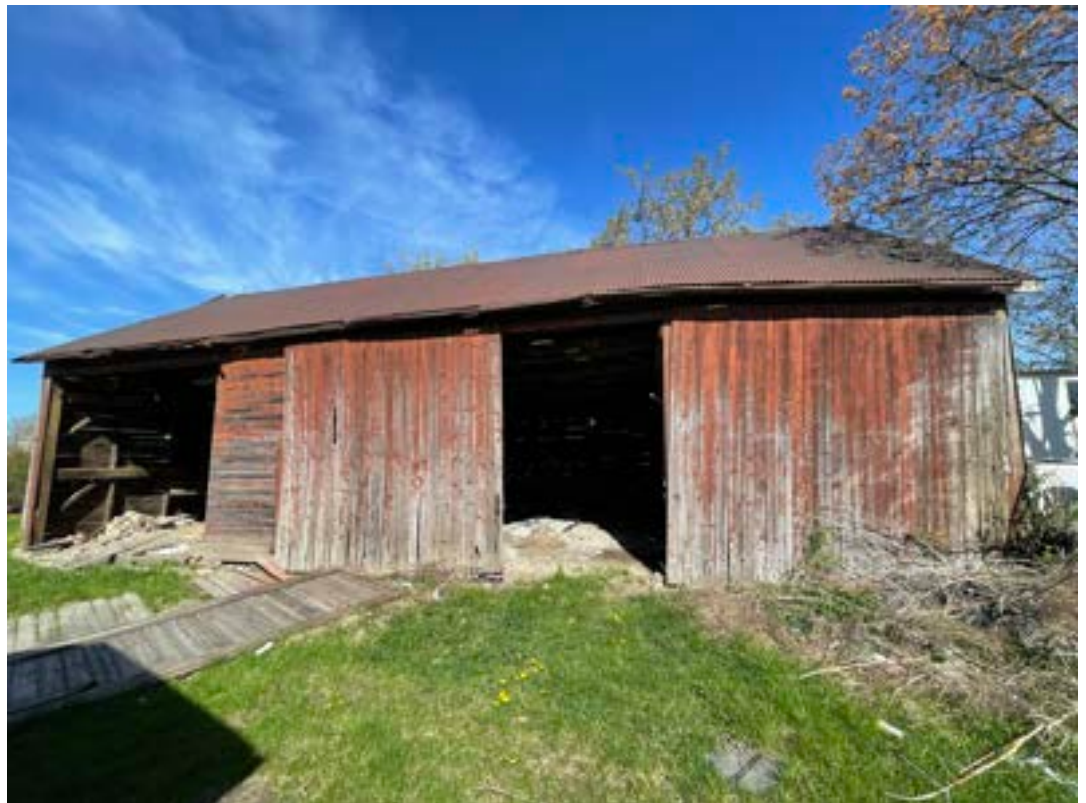
Photo 7: Barn,  
Front Elevation

There is no foundation visible. Sections of the barn (corners specifically) appear to have been propped by concrete blocks at some point. See photo #10. There are three sliding doors, all three on the front. One on the west side and two on the east. They are top hung sliding on a rail mounted to the exterior of the barn. Doors often exhibited material deterioration along the lower edge due to storm water backs-plash from the roof drip line.<sup>10</sup> The larger door on the west side has fallen off due to age and condition.

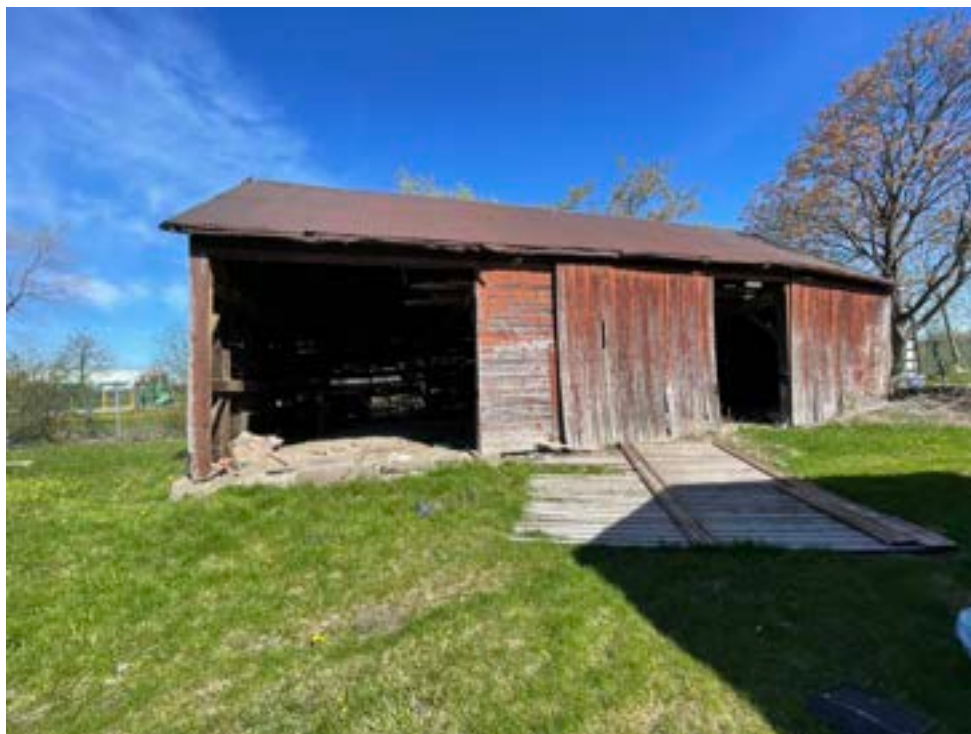
Photo 12: Front of Barn

The barn is original to the property.

**Construction:** Wood, with corrugated metal roof, no foundation evident.

**Condition:** poor, structurally unsafe

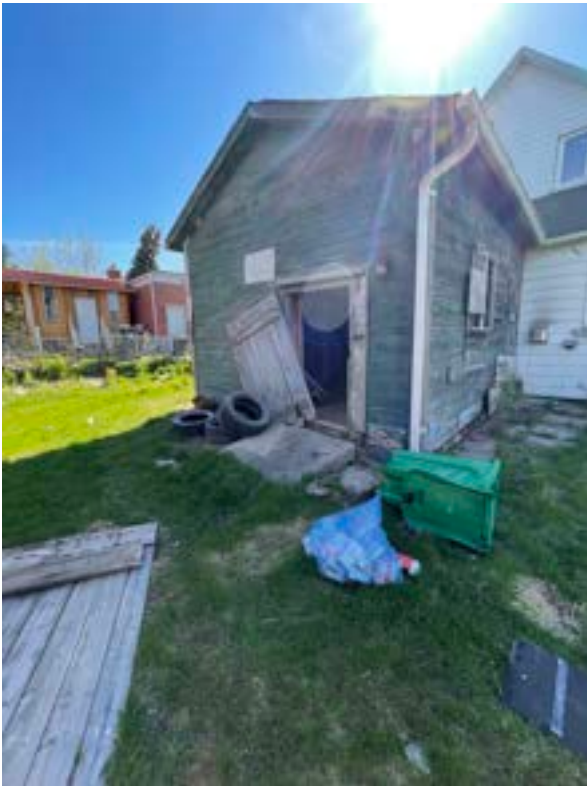
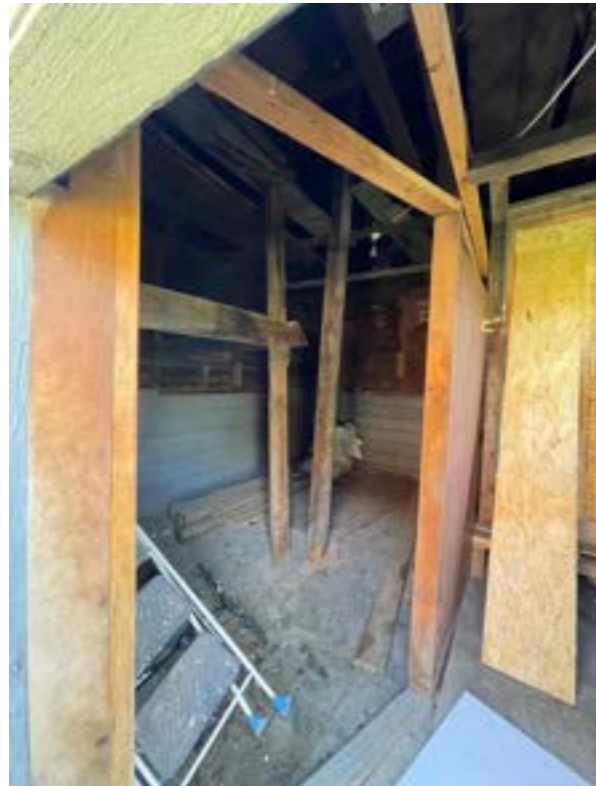
Photo 21 & 22 Rear addition, exterior and interior.

The interior of existing home has been significantly renovated. The main floor consists of two large open spaces. The space adjacent to the front hall way is a bedroom. The rear open space contains a laundry area and kitchen. There are two rear additions. One utilized as a second suite and the one beyond that is uninhabitable.

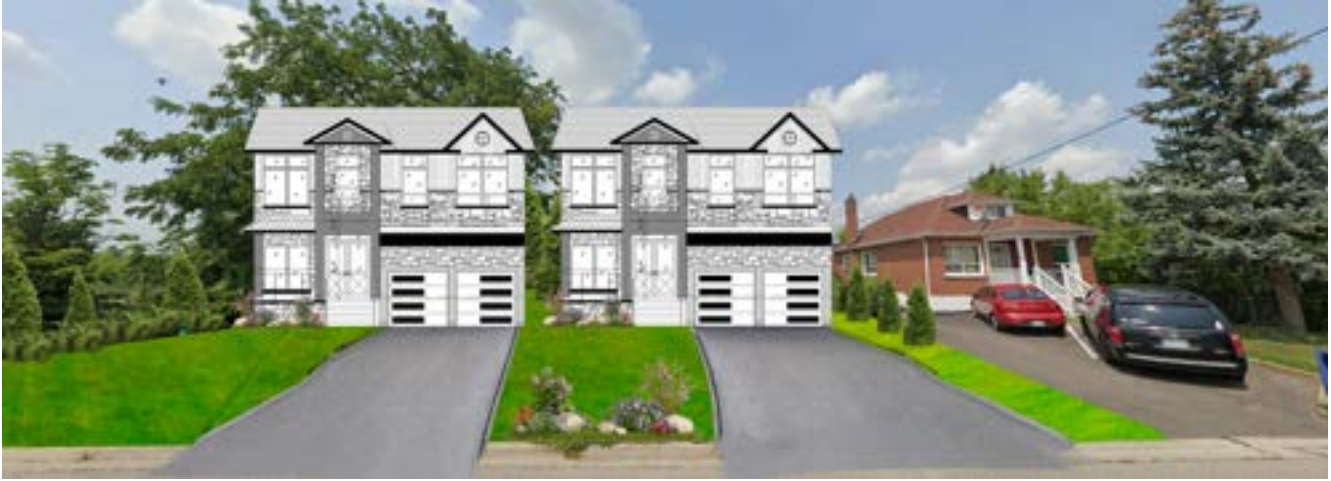
The new by-law permits a maximum dwelling height of 10.7m. The proposed height is 9.14m and complies with the by-law. The houses are in keeping with the new builds around the corner shown in the previous image.
