Heritage Impact Assessment

1427 Dundas Crescent

January 27, 2021

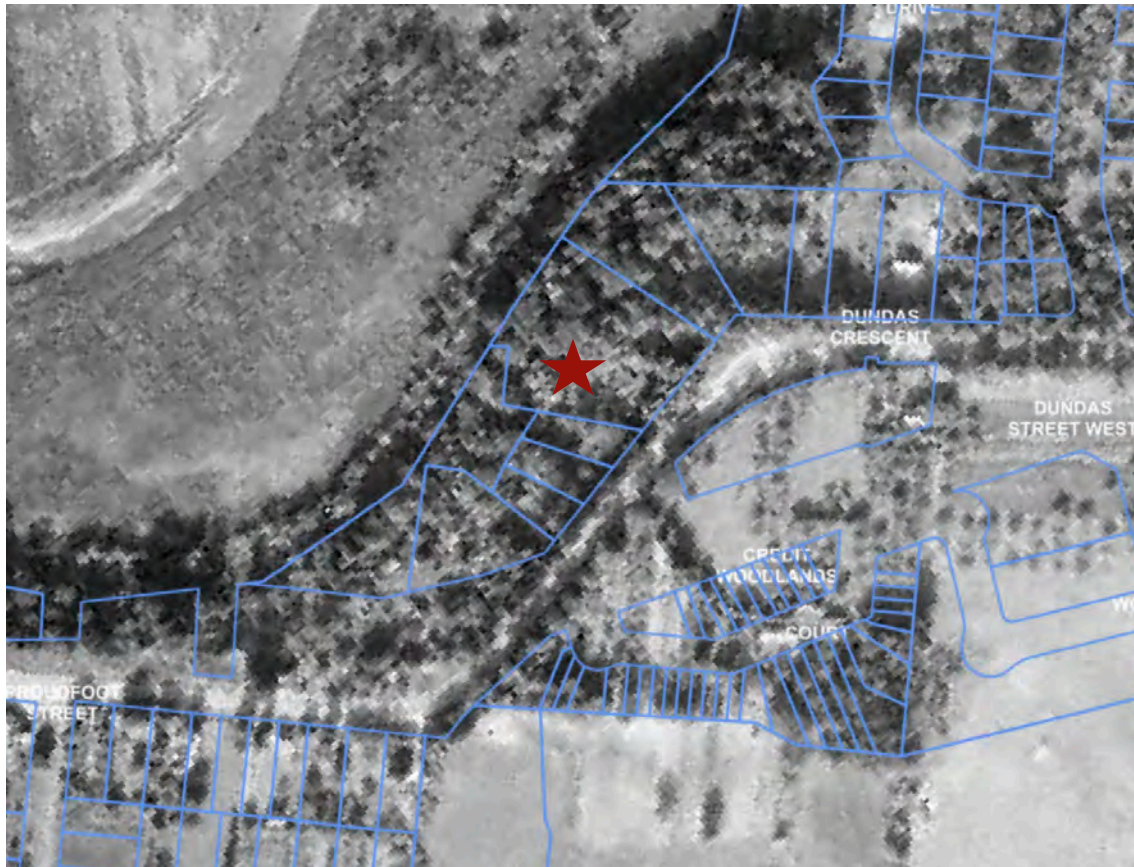
FIGURE 7: 1944 AERIAL IMAGE

The subject property is identified by the red star. You can faintly make out the house. Please note that Dundas Street had not yet been realigned yet.

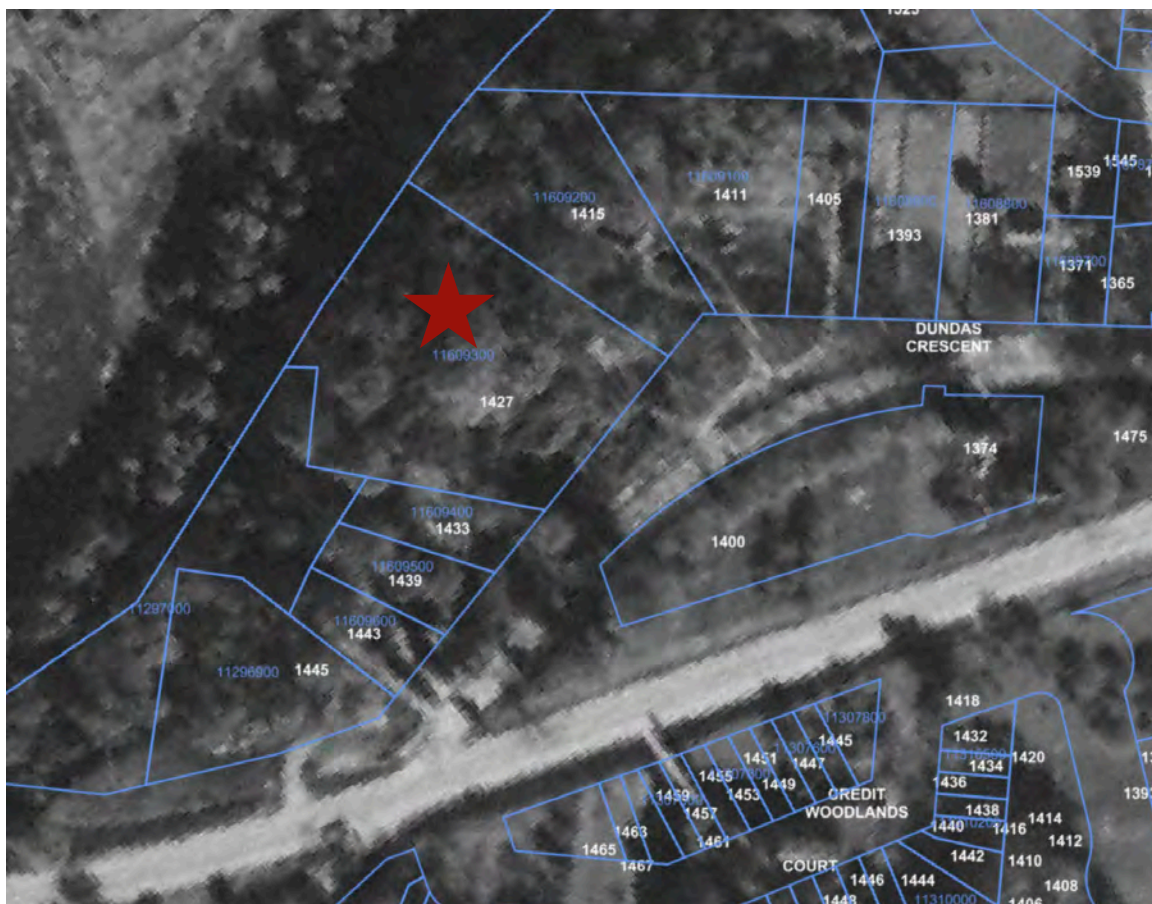
FIGURE 8: 1954 AERIAL IMAGE

The subject property is identified by the red star. You can faintly make out the house. Dundas Street has now been realigned. Dundas Street was straightened, raised and widened between 1948 and 1949.²

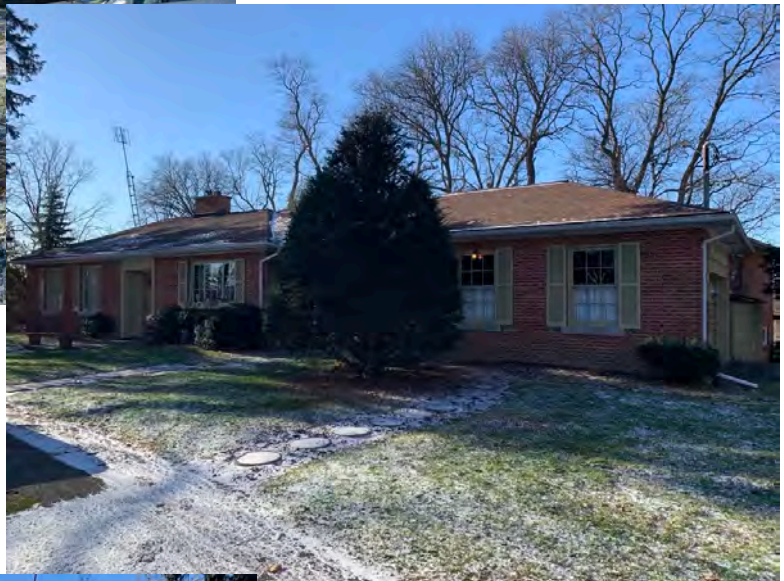
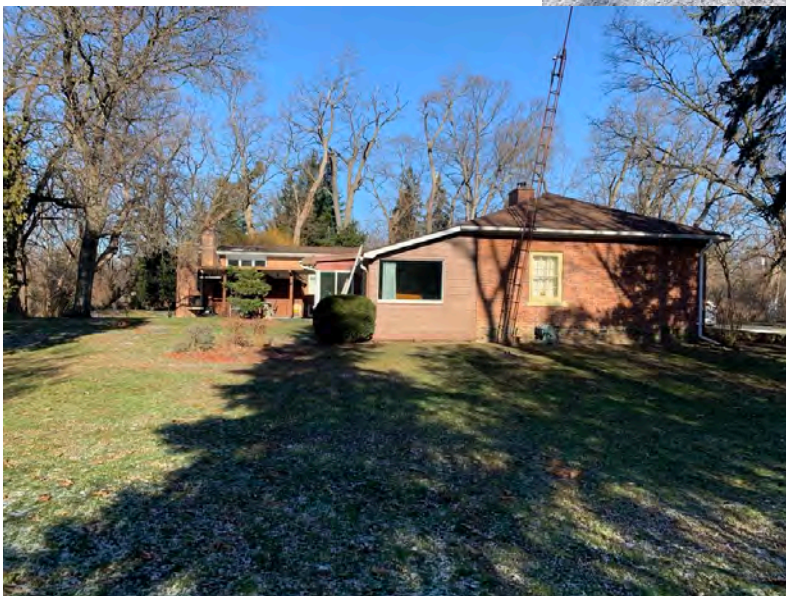
**PHOTO 3: SOUTH ELEVATION**

The change from brick to siding indicates the rear addition in approximately 1950.

This is the south end of the property looking north.

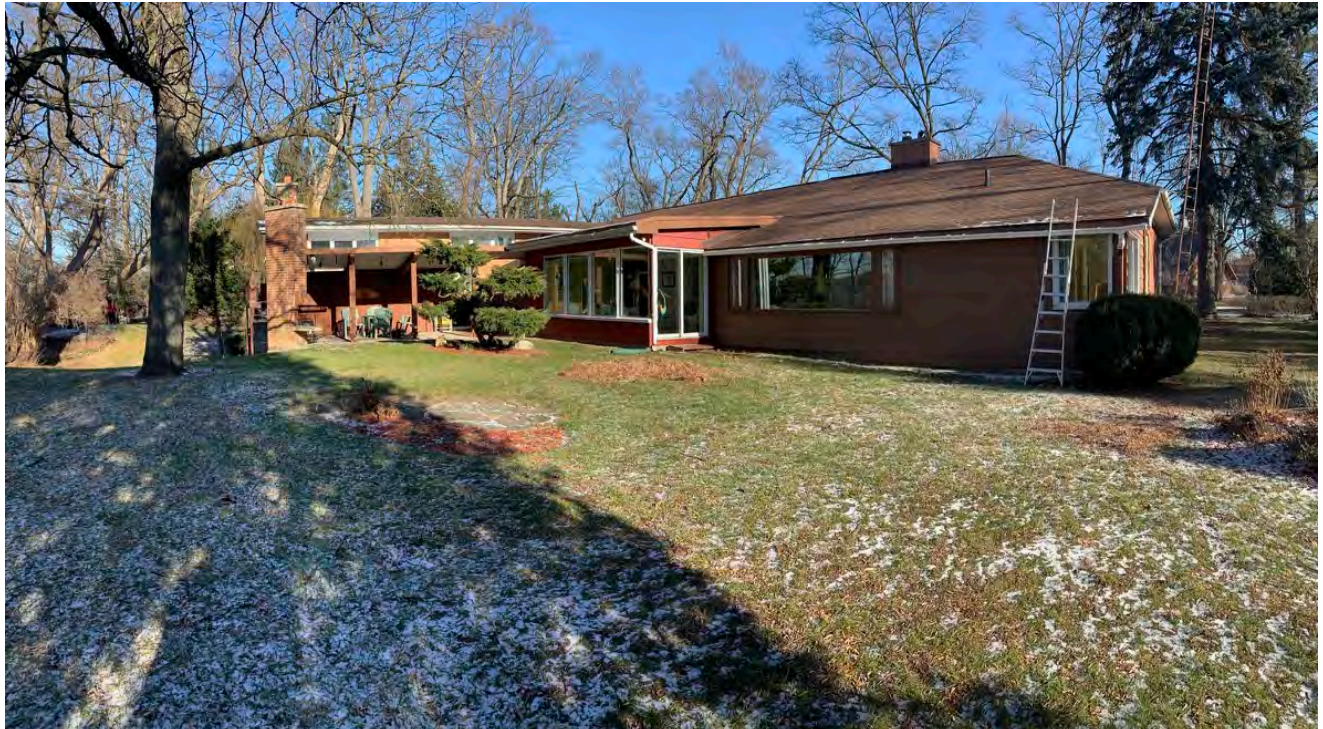
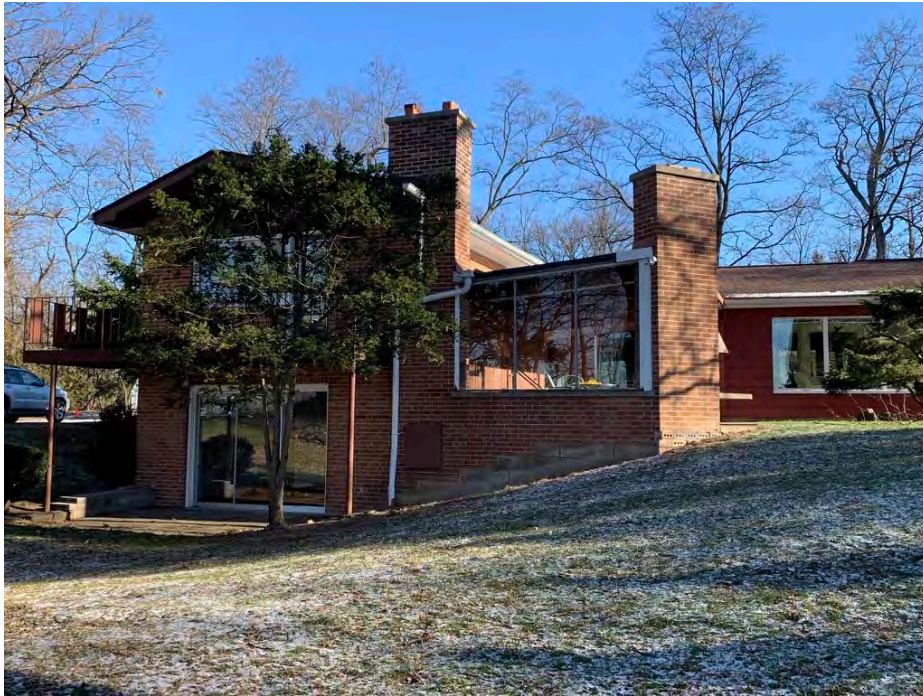
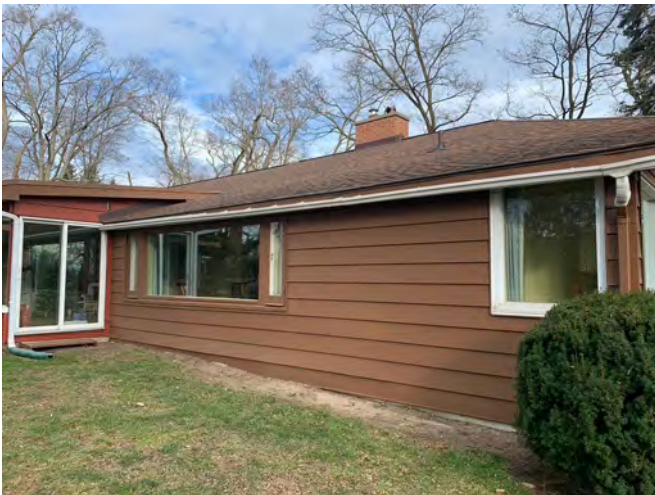
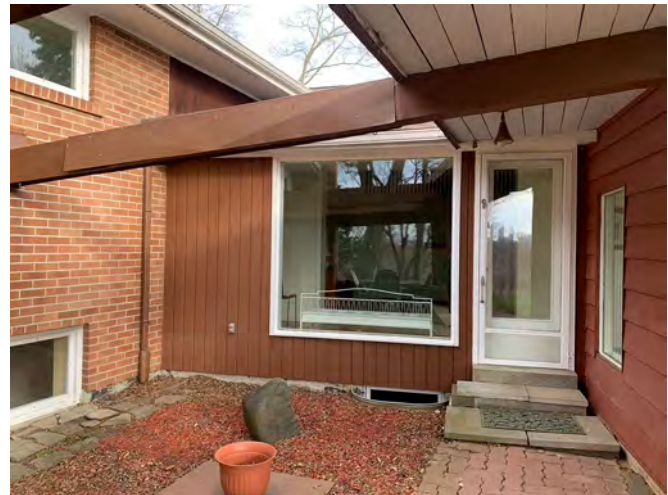
PHOTO 7, 8 AND 9: REAR ELEVATION VIEWS

The exterior of the dwelling is a combination of brick, aluminum siding and wood panel siding. Windows and doors can be dated to the time of the additions.

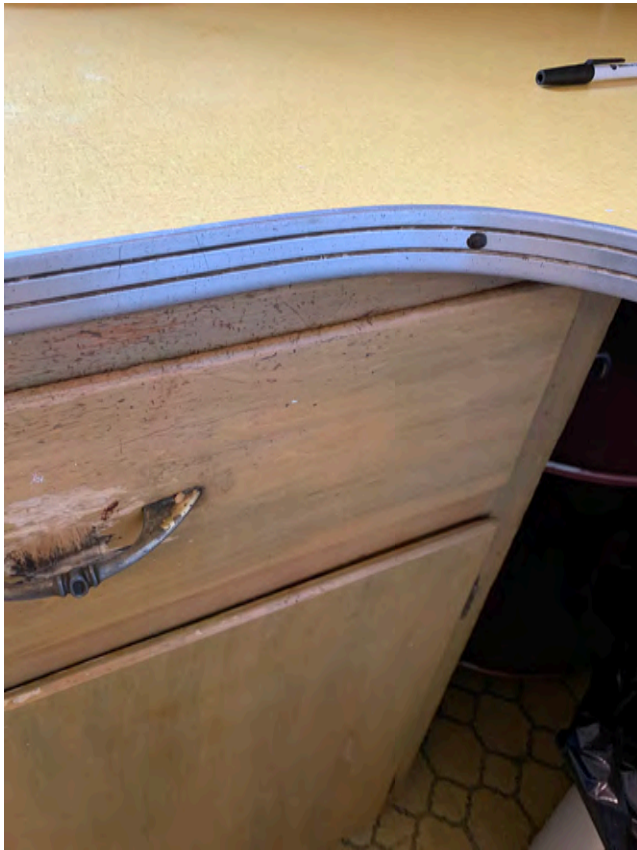
PHOTO 14: DETAIL OF COUNTERTOP

Yellow formica edged in aluminum.

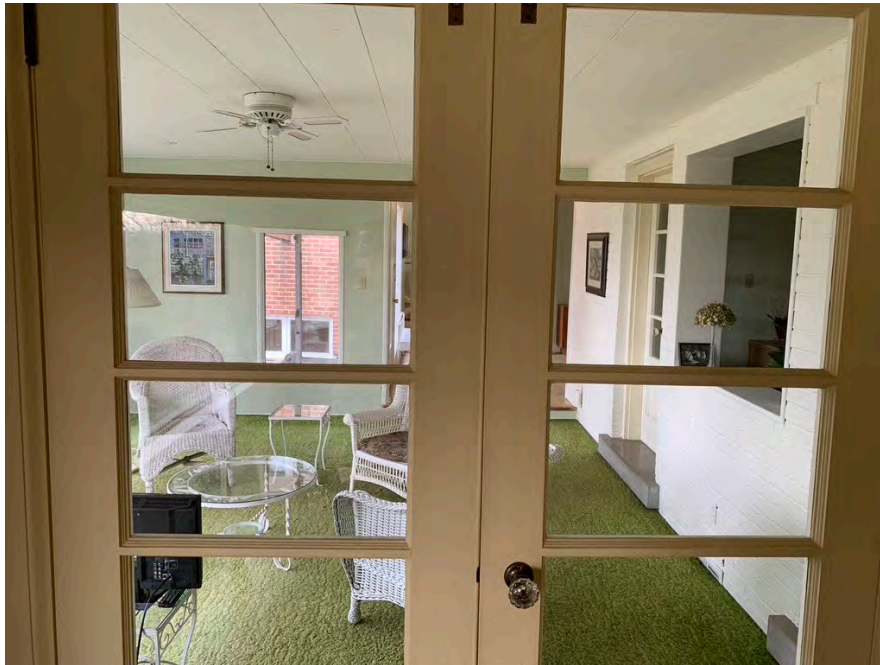
**PHOTOS 20 AND 21:
SUNROOM ADDITION**

This is the 1972 addition as noted in Figure 10.
