## **FEBRUARY 26, 2021**

## HERITAGE IMPACT STUDY - 1471 STAVEBANK RD., MISSISSAUGA

## **HERITAGE IMPACT STUDY**

# 1459 Stavebank Road Mississauga, ON

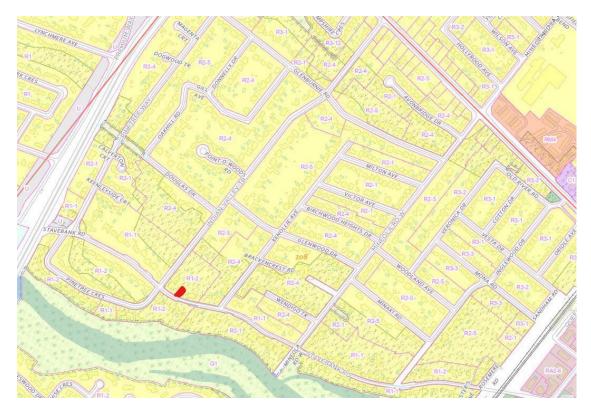
KEY PLAN SHOWING MINEOLA NEIGHBORHOOD. SUBJECT SITE IS IDENTIFIED IN RED

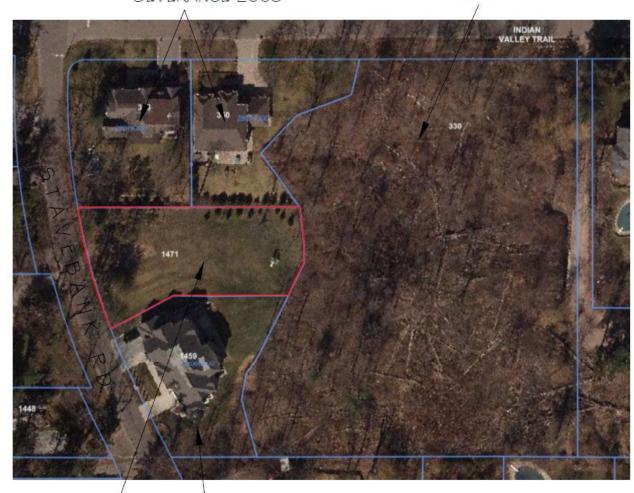
SUBJECT SITE CREATED BY SEVERANCE 2019 SINGLE FAMILY HOME BUILT 2013 SITE PLAN/CHRONOLOGY LOT 4 RANGE 2 CIR

The subject property was severed in 2019 from the adjacent property at 1459 Stavebank Rd. The 1459 Stavebank property was itself created by severance in 2008 when the former Lot 4 Range 2 CIR was divided into 4 parcels to create 350 and 358 Indian Valley Trail, 1459 Stavebank and a large woodlot (330 Indian Valley Trail) that was dedicated to the City of Mississauga. There was originally one single family home sharing all of these properties. The demolition of the original home and the relevant history and chain of title information on this site was documented in a Heritage Impact Study produced in 2011 to support the construction of a new single family home at 1459 Stavebank. This Heritage Impact Study follows from the 2011 Study. A copy of the 2011 Study is appended to this report.

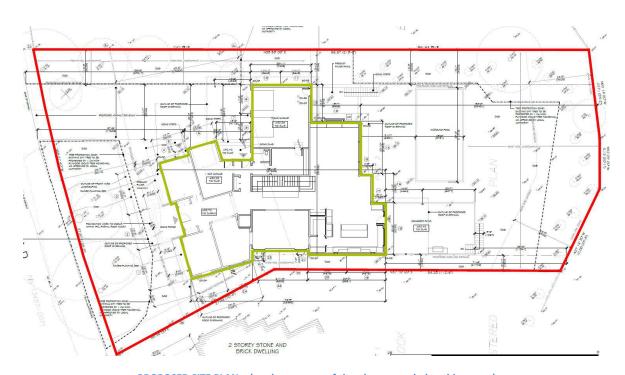
PROPOSED SITE PLAN – (see larger copy of site plan appended to this report)

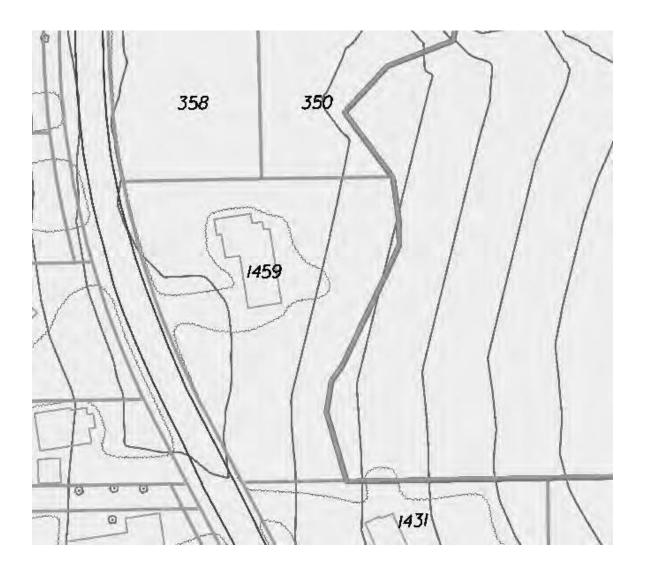
1459 Stavebank Rd Site Plan (showing existing building) NTS

The subject property is highly irregularly-shaped. It is approximately 81m wide x 66m and 25m deep at the north and south ends, respectively. Total lot area is approximately 3,500 m2. The site is bordered at the rear by City owned, densely forested land. There is a significant grade change from front to rear and the property falls approximately 5.0m from west to east, or from the street front to the forested area. This grade change, and the views it affords of the forested area to the rear are significant character-defining elements of the site. The property is also characterized by a large number of mature trees and also by other tree specimens that were probably planted by earlier residents but now have grown to significant size.

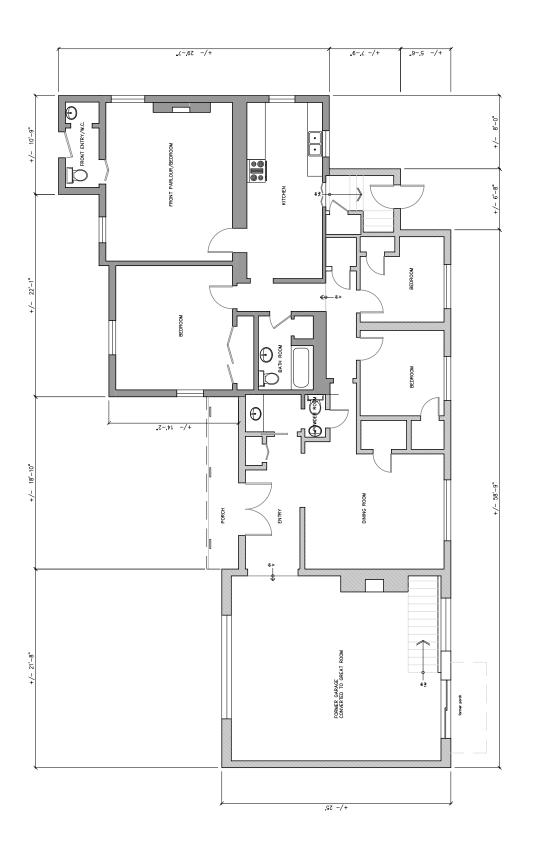
1459 Stavebank Rd Existing Dwelling Main Level Plan NTS/Measured Nov 2011

The existing house is a one storey dwelling with a partially finished basement level. The building is a compact, cohesive form. It has now fallen into dis-repair and dereliction but much original form and fabric remain to suggest its earlier appearance and to allow for analysis of its history. The earliest construction appears to be the rectangular part of the house on the north side, consisting of an entry vestibule, parlour, kitchen, bedroom and washroom. The form and detailing would suggest mid-20th century construction. Oddly situated floor height differentials and some obviously compromised rooflines help to chart later additions and renovations. A later addition added, on the same level, two bedrooms, a formal dining room, new entry with double doors and covered porch, an expanded walkout basement and a room which presently functions as a great room/ family room but which was presumably first a two-car garage. By its form, appearance and detailing the addition would almost certainly date from the 1960's. This addition would have served to vastly increase the size, prestige and functionality of the home. It also shows signs of obvious architectural intent and cultural interest. Notable in the addition are the double-door entry, the curious but intriguing powder room with two doors and separate vanity area and the basement recreation room which uses the grade differentials on site to good effect by incorporating large windows and a walk-out door to the rear yard. The addition would have transformed what was a small, mid-century cottage into an elegant, suburban house.

The conversion of the attached garage to a family room shows the greatest architectural expression and interest in the home. This space was developed with significant thought and expense. At the ceiling is a heavy wooden beam structure surmounted by a hipped, vaulted ceiling finished in cedar boards. A large, simply detailed but well executed stone fireplace dominates the room. Perimeter walls are finished with grass-cloth wallpaper typical of the 1970's. A large window facing the street replaced what would have been the garage door. The room exhibits a pleasant scale and proportion and the combination of dark finishes, high ceilings and ample natural light creates the effect of an elegant country lodge. Presumably it was during the time of this renovation that stairs from this room to the basement were created. This would have increased the functionality of the basement recreation room (previously access was by way of a more confined set of stairs from the kitchen). There are sliding doors at the back of the family room, which, considering the floor level in this room is considerably higher than the grade at the back of the house, suggests that there was once a patio or stairs to the backyard. This would have further increased its functionality and appeal.

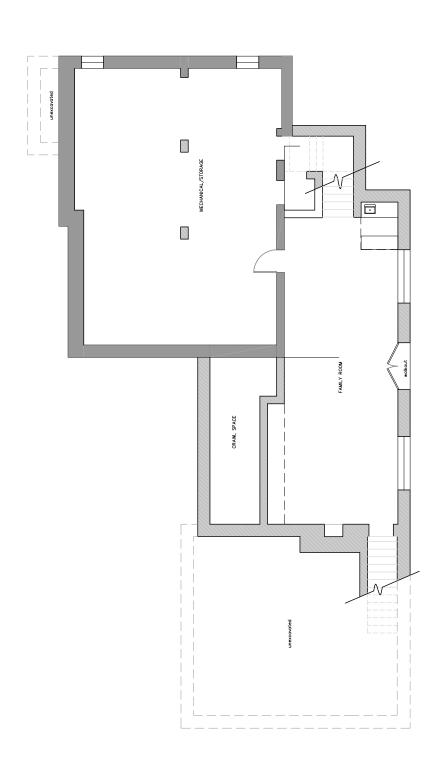
1459 Stavebank Rd Existing Dwelling Basement Level Plan NTS/Measured Nov 2011

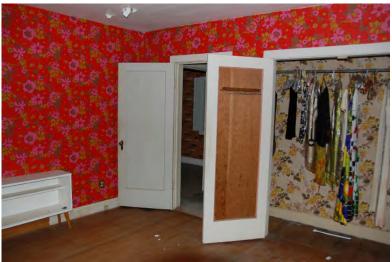
**Bedroom Interior**

The style of the interior finishes suggests that the house was maintained and cared for well into the 1970s and 80s, but has recently been abandoned and fallen into disrepair. There has been failure of the roof and the ceiling has fallen in one area.

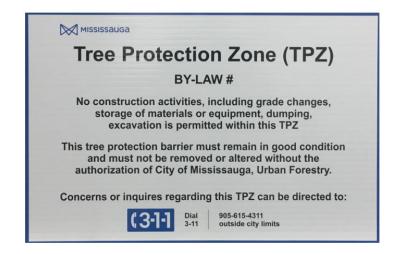
- The applicant shall notify the City of Mississauga and the Certified Arborist to confirm that the tree protection barriers are in place.
- A sign with a minimum size of 40cm x 60cm must be affixed to all sides of the Tree Protection Barrier for the duration of the project. The signs should be made of white gator board or equivalent material. The sign should be similar to the below image:

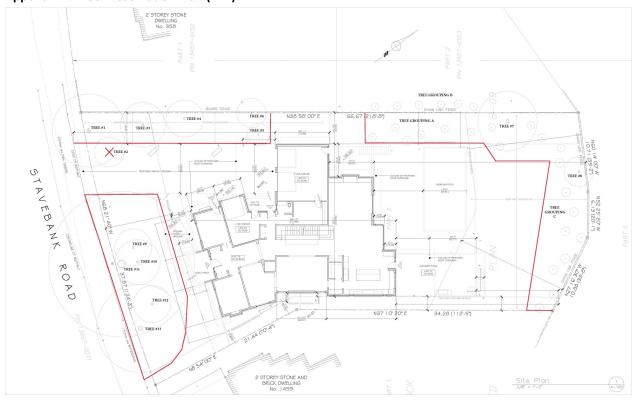
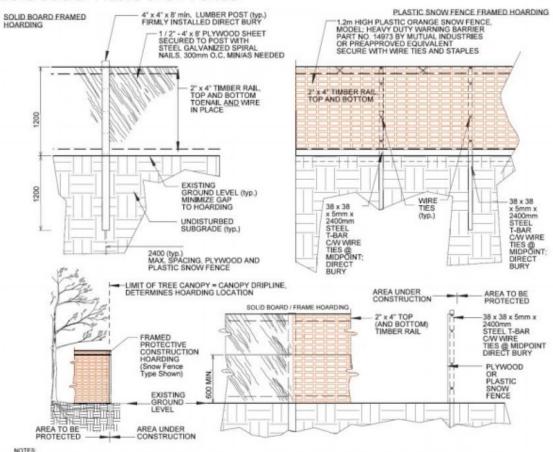
### FIGURE #1

- 1. HOARDING LOCATION AS PER DRAWINGS, HOARDING INSTALLATIONS ARE TO INCLUDE WOVEN GEOTEXTILE FABRIC FOR SEDIMENT CONTROL. NO MOBILIZATION OR CONSTRUCTION WORK TO OCCUR UNTIL HOARDING HAS BEEN INSPECTED AND APPROVED BY COMMUNITY SERVICES
  PROJECT MANAGER (CSPM). CONTRACTOR TO ARRANGE FOR A HOARDING INSPECTION WITH (CSPM), 48 HOUR NOTICE RQUIRED.
- 3. HOARDING TO BE SUPPLIED, INSTALLED AND MAINTAINED BY THE CONTRACTOR THROUGH ALL PHASES OF WORK ON SITE.

4. THE CONTRACTOR IS TO REMOVE AND DISPOSE THE HOARDING OFF SITE WHEN DIRECTED BY THE (CSPM).

There are twelve (12) individual trees and three (3) tree groupings inventoried in this report that are recommended for preservation. All trees to be preserved are to be protected by hoarding per City of Mississauga standards and as shown on an Urban Forestry approved Tree Protection Plan to ensure successful preservation.
