Heritage Impact Statement

306 King Street East - Shewcuk House

February 15, 2021, Revised, March 2021

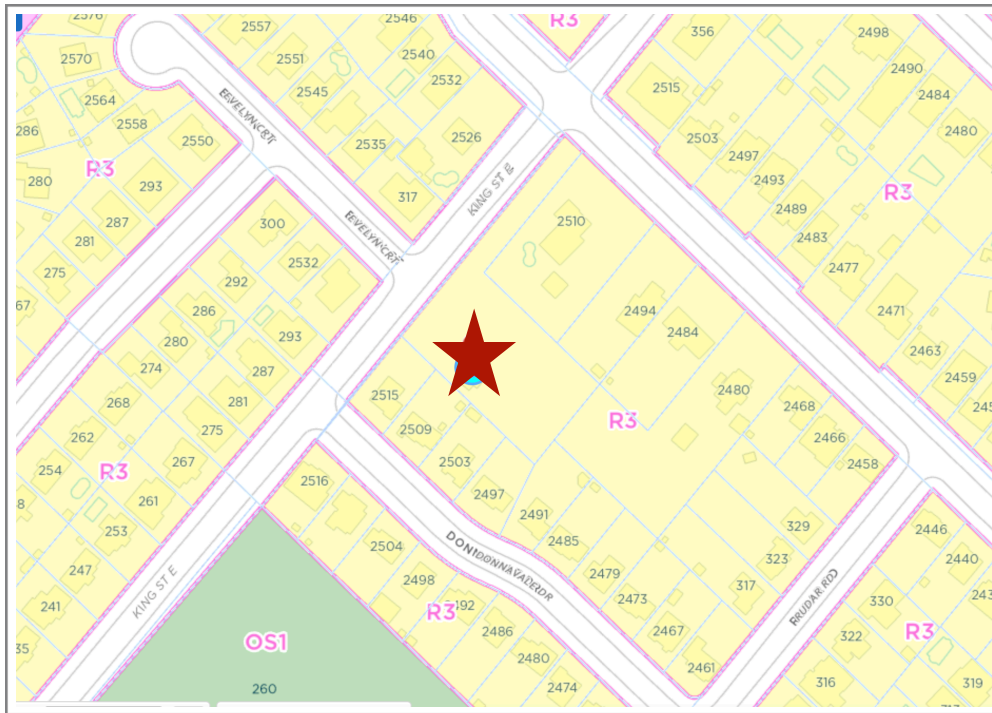
Figure 2: Site Location

The property is identified by a red star. The original property had a laneway access to Cliff Road, as it was established prior to the development of King Street.

The subject property contains a single

family detached dwelling and a shed. Both will be removed through this application.

The property has a row of cedars along King Street.

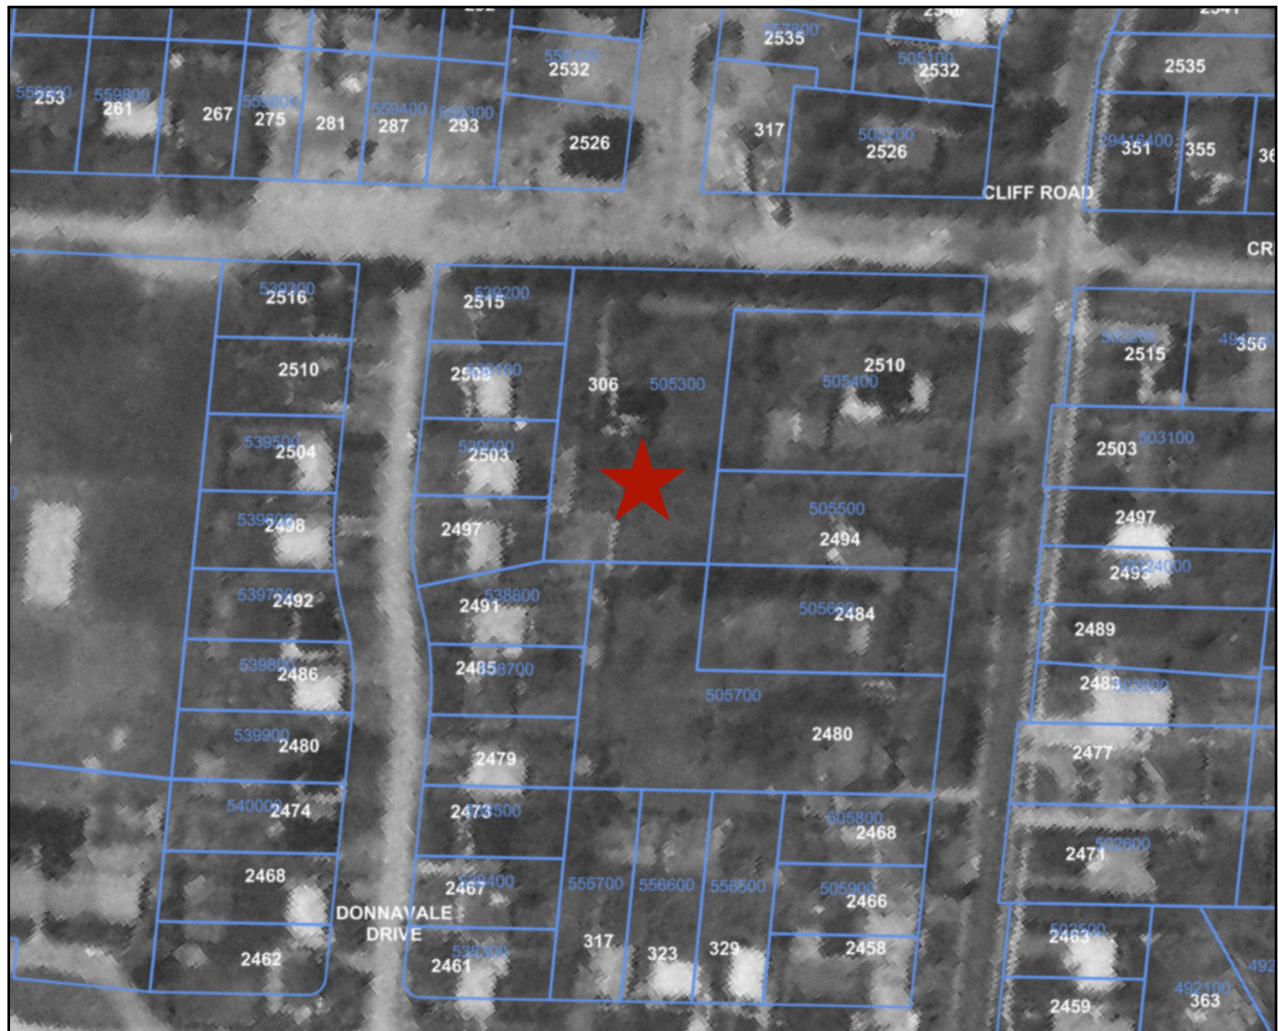
Figure 8: 1975 Aerial Photo

The subject property is identified by the red star.

King Street is just being constructed and the area to the north is being developed.

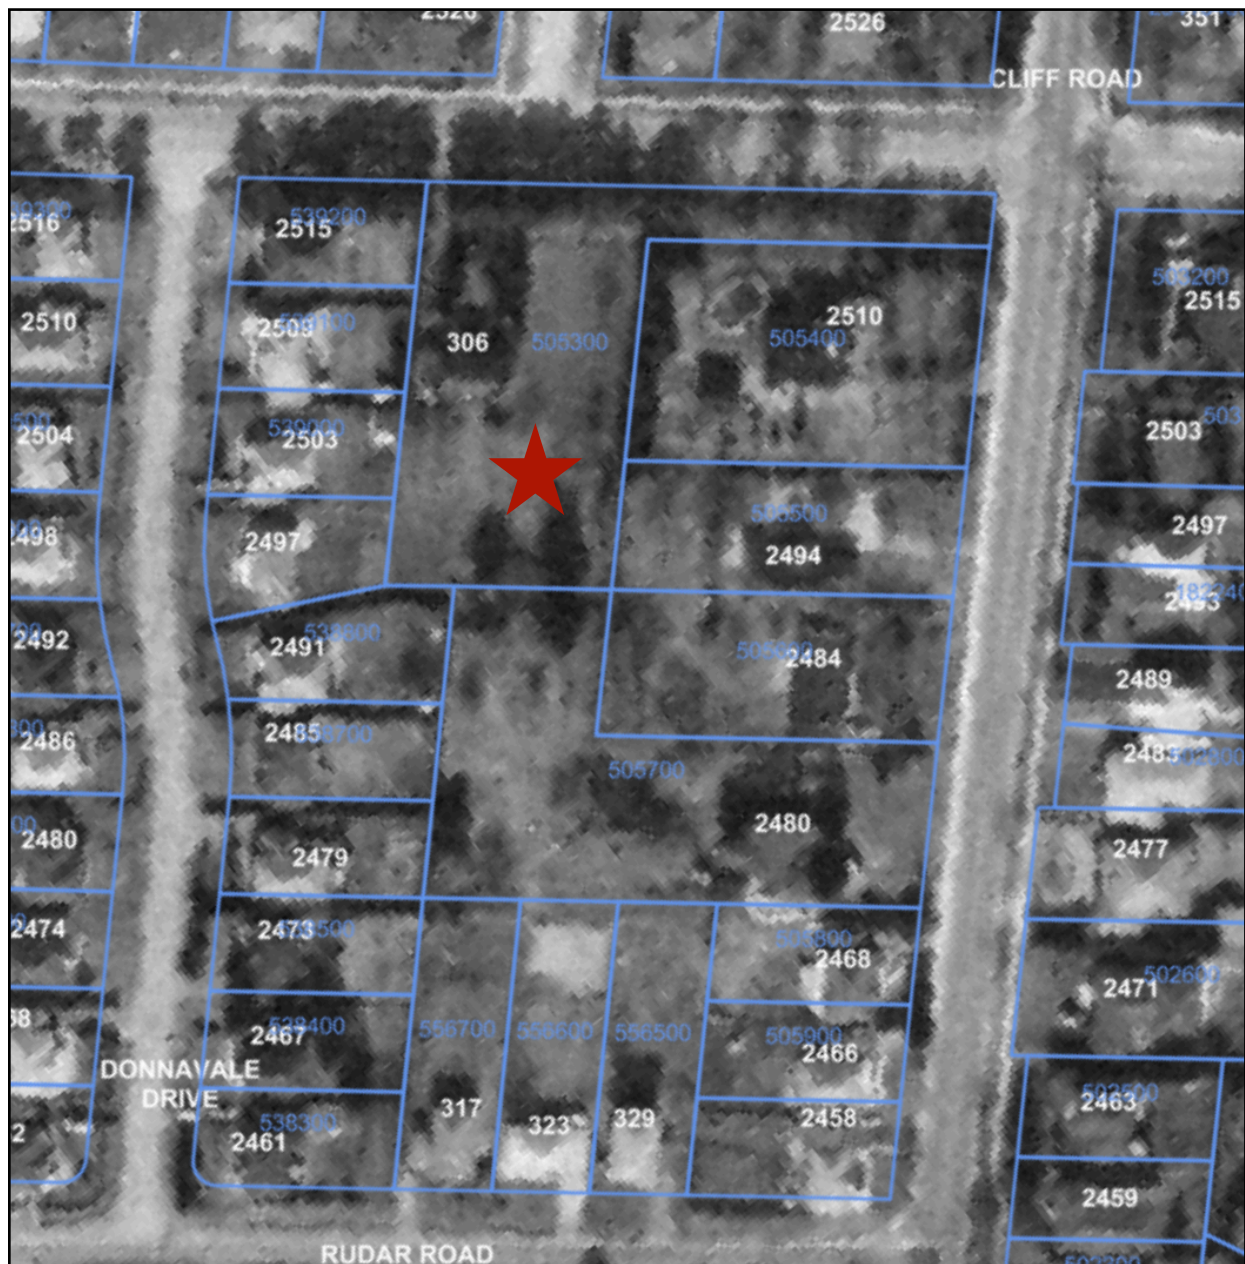
Figure 9: 1992 Aerial Photo

The subject property is identified by the red star.

The area is fully developed and the driveway access to the property is now from King Street.

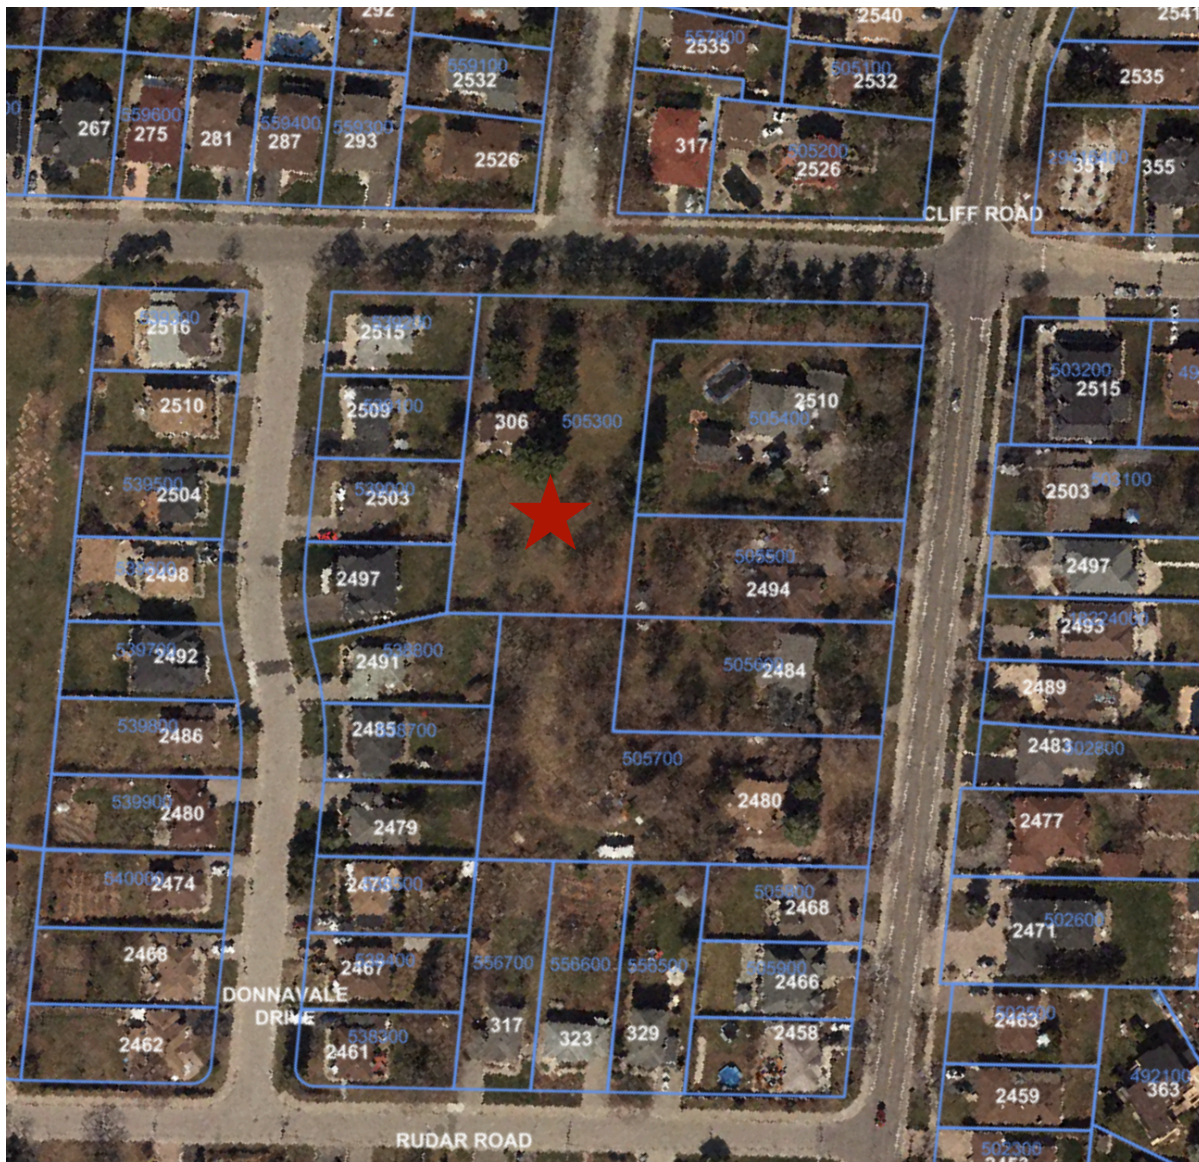
Figure 10: 2020 Aerial Photo

The area is totally developed.

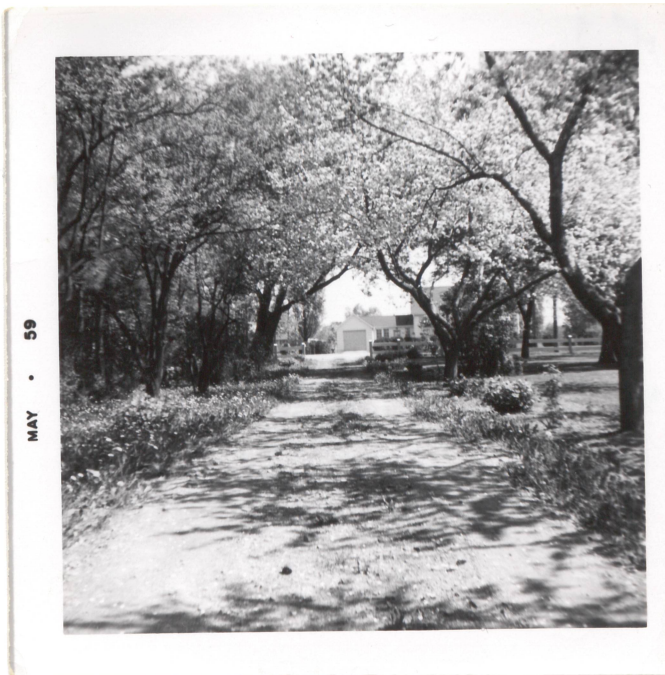
Photo 7: The laneway extending to Cliff Road. (1959)

The laneway was bordered on both sides by flower beds and fruit bearing trees. When King Street was extended, the address changed from 2510A Cliff Road to 306 King Street East. When the laneway was no longer required for access, it became neglected. As Peter and Katherine aged, the maintenance of the laneway was abandoned.

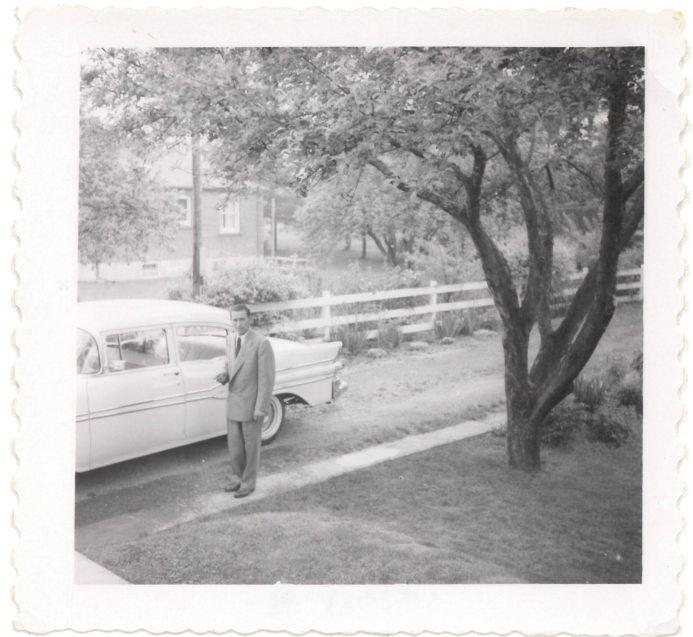
Photo 8: Driveway on the west side of the house.

The picket fence was removed and a privacy fence erected by the neighbours. The driveway was resurfaced from gravel and concrete slabs to asphalt.

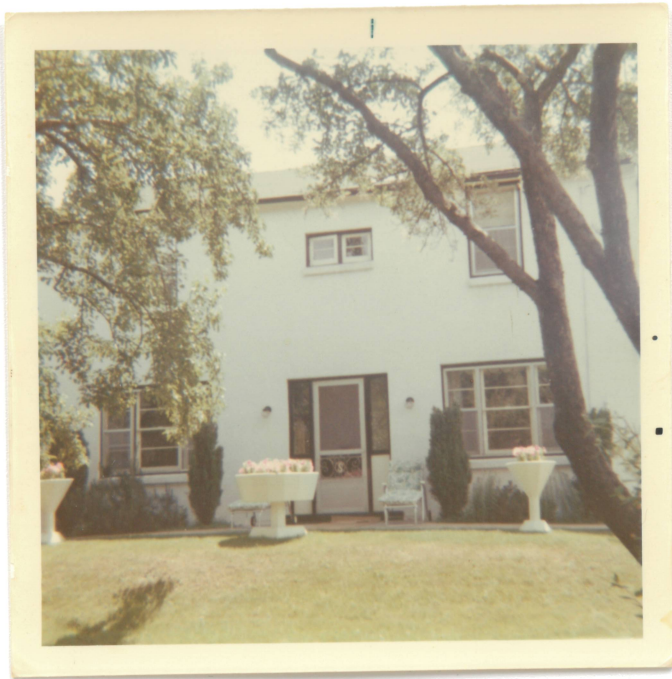
Photo 9: Front Elevation.

The wooden window over the door is all that remains of the original windows. All windows were replaced with vinyl windows prior to Peter's death in 2002. As the fruit trees died, Peter replaced them with coniferous trees.

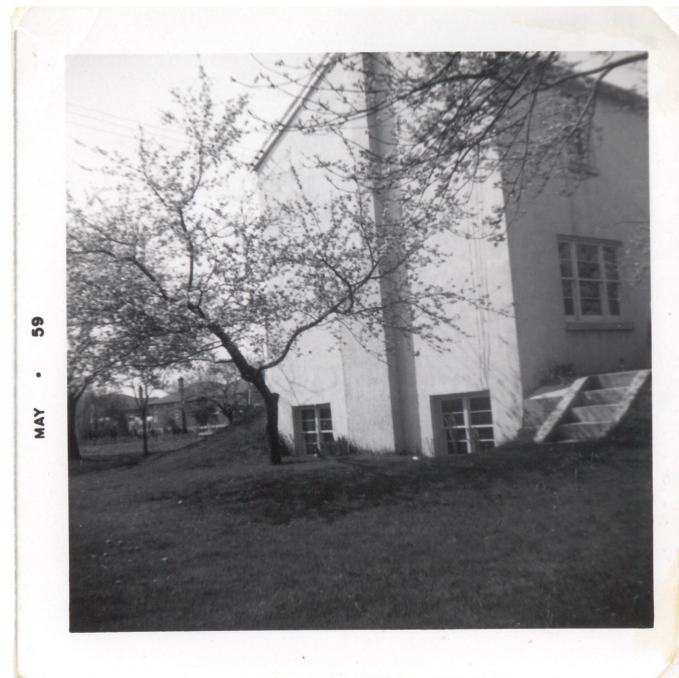
Photo 10: East Elevation (1959)

The house was stucco prior to the aluminum siding which was done in the 1990's. The only recent maintenance to the house was a new roof in 2009. The garage door was also painted at this time as well.

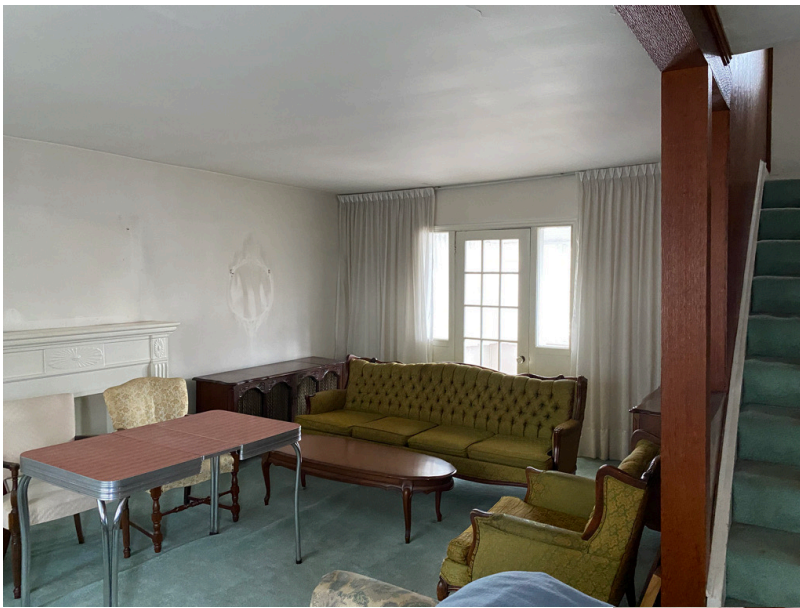
Photo 11: Living room

The door enters to one of the small additions at the rear.

The main entryway and living room access are trimmed with molding whereas the dining room is simply an arched opening.

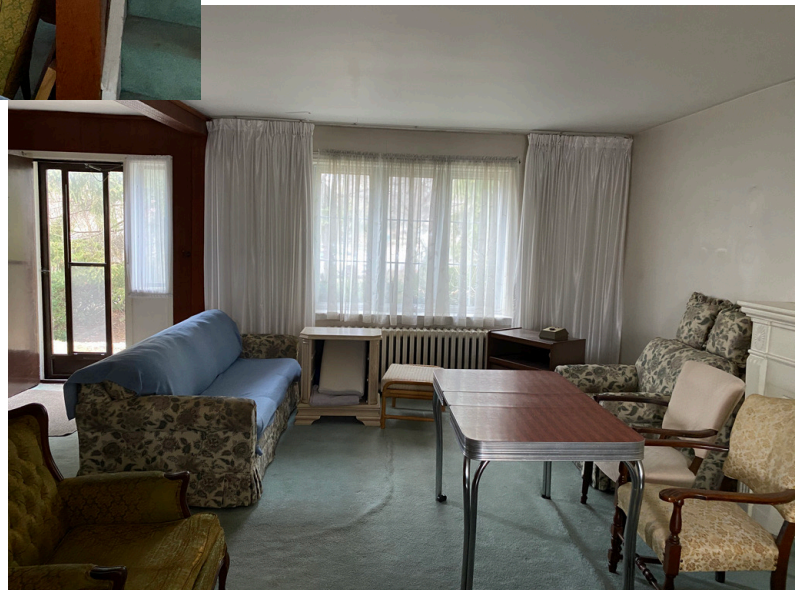
Photo 12: Living Room

The front door is visible to the left.

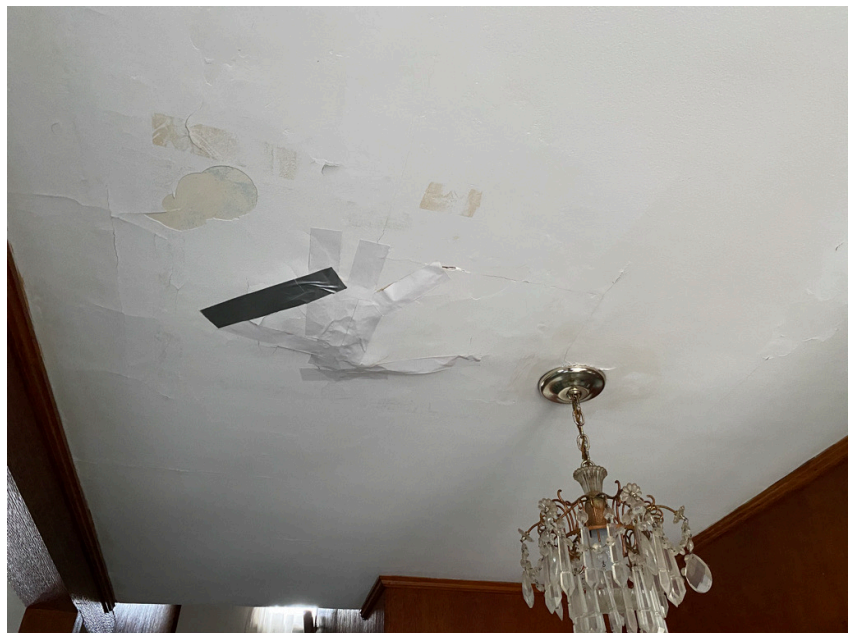
Photo 14: Front foyer ceiling

Water damage is evident from the bathroom above.

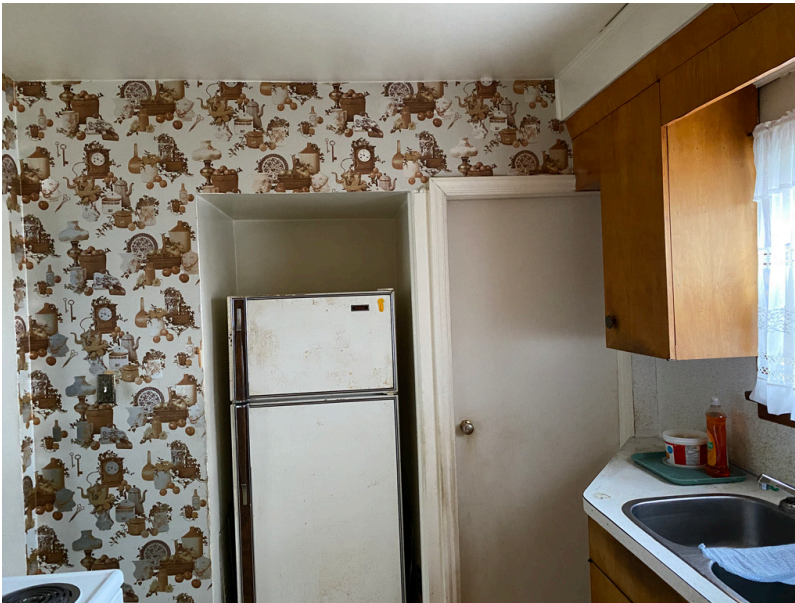
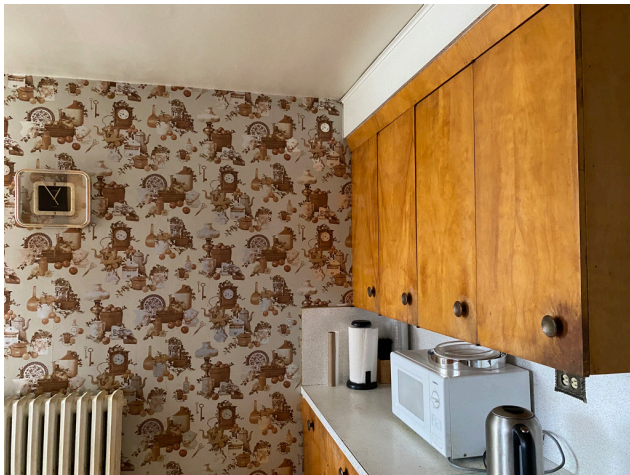
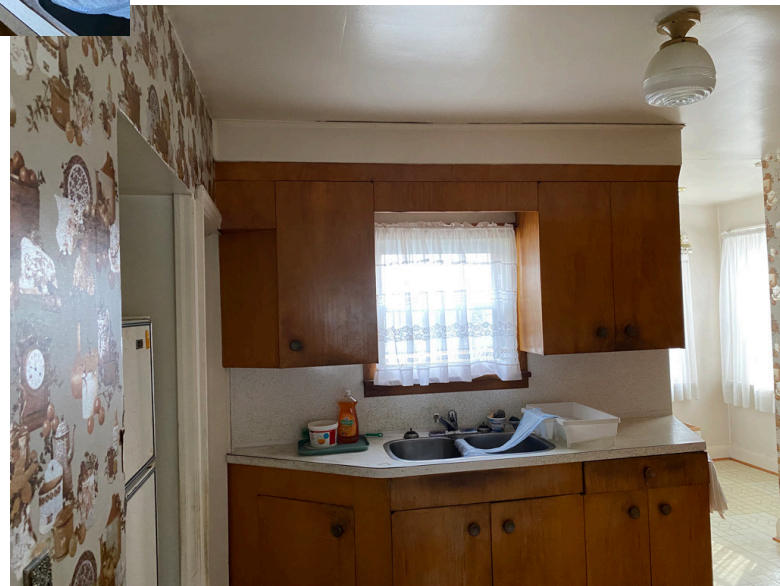
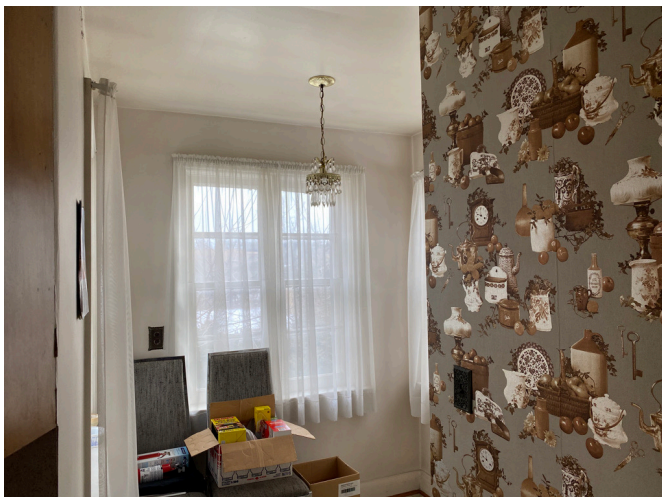
Photos 15, 16, 17 & 18: Kitchen

The doorway on the right leads to the basement.

The small room off the kitchen. (Visible in the photo above to the right, and the room in the photo at left) Most likely this held a dining table for informal eating. Kitchen cupboards and countertops are original.

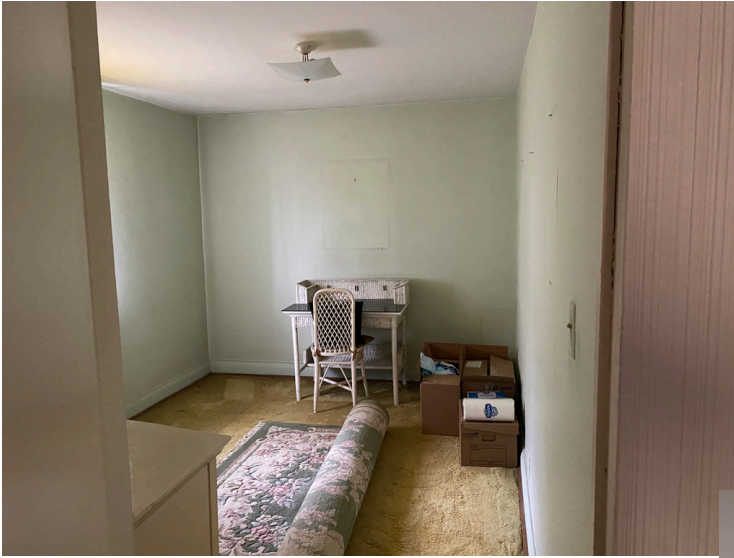
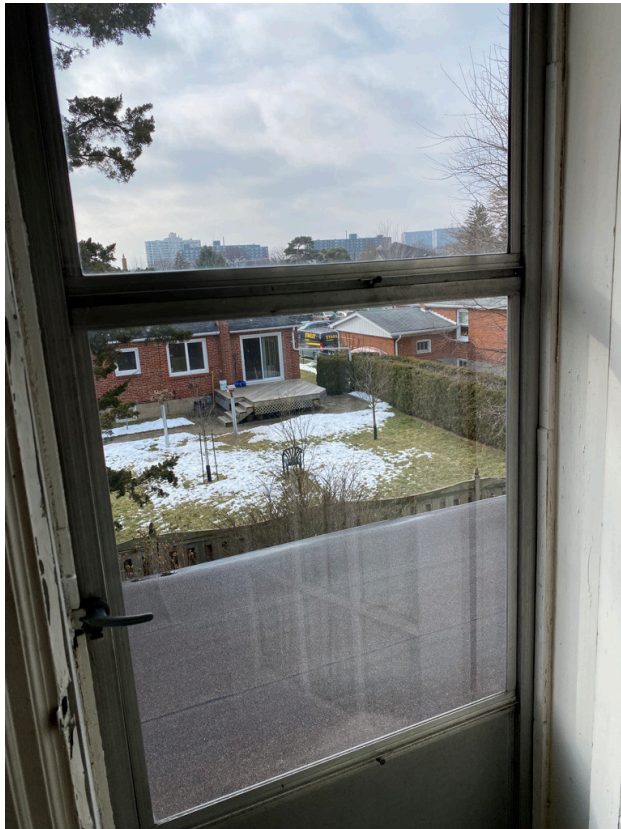
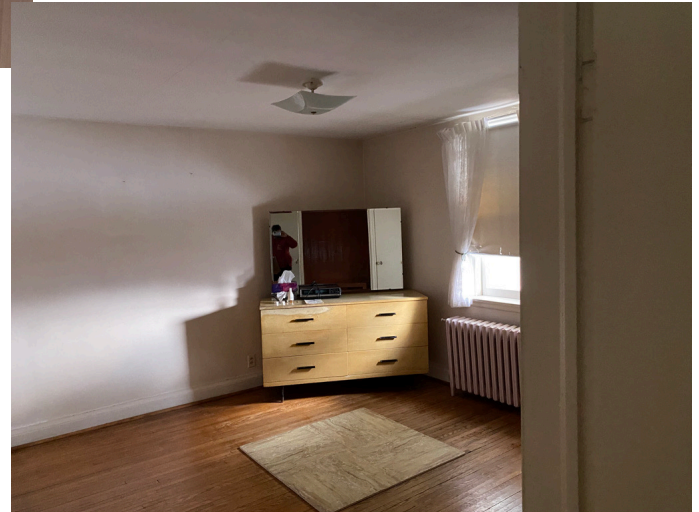
Photos 22, 23 & 24: Bedrooms

There is a master bedroom the south side and two smaller bedrooms on the north side. The photos left and bottom right are of the smaller bedrooms.

The exterior door is located in the master bedroom and accessed the roof of the garage.

The state of the dwelling would suggest that the owners were aware of the fact that it would be purchased as a 'demolition-rebuild'.

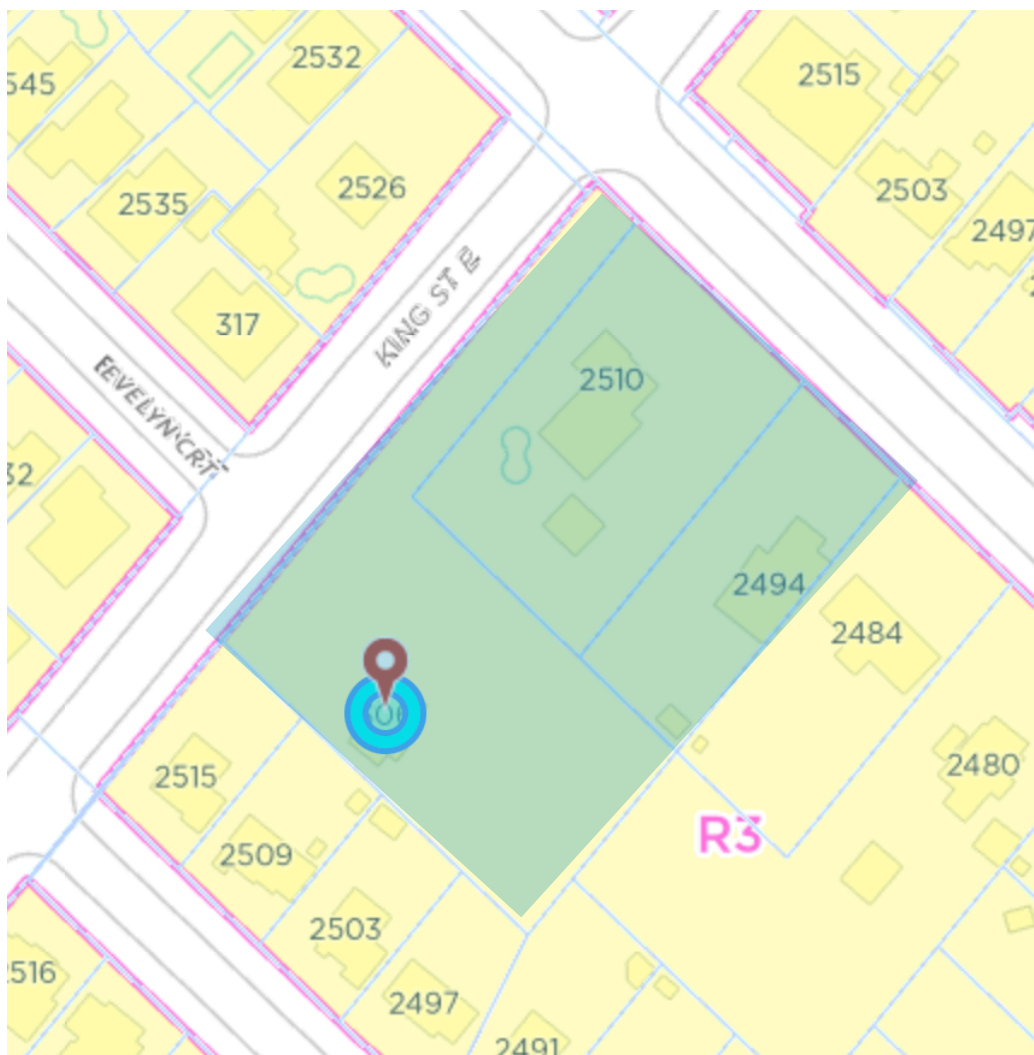
Figure 9: Lot Amalgamation Plan

The subject property is part of a lot amalgamation with 2510 and 2494 Cliff Road. The proposed property block is highlighted in the figure below. The subject property (King Street) has a lot frontage of 47.42m (155 feet) and a depth of 76.22m (250 feet). Amalgamating it with the properties on Cliff Road, the property will have a frontage of 106.64 m (350 feet) on King Street and a frontage on Cliff Road of 76.22m (250 feet).
