2439 Mississauga Road

Heritage Impact Assessment

March 2021

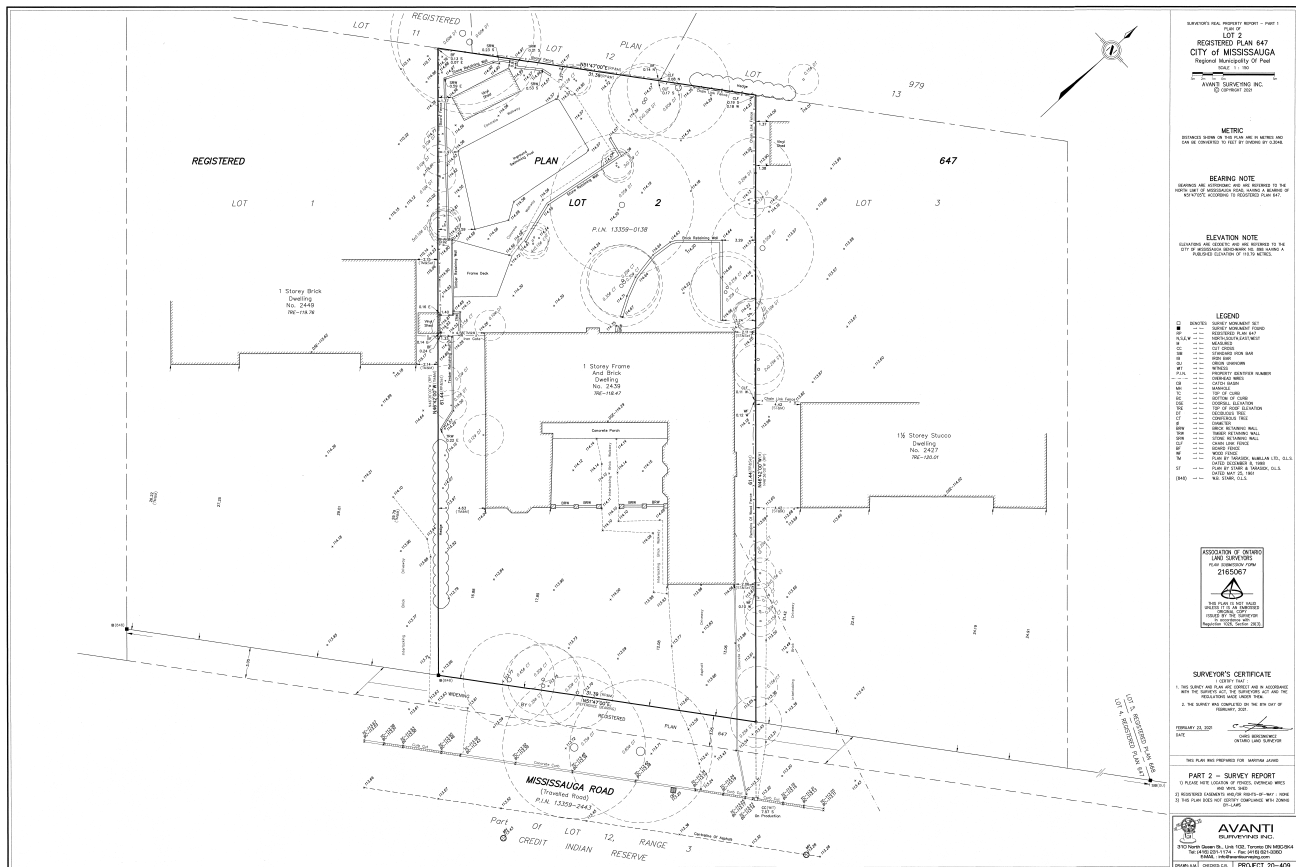
Figure 2: Topographic Survey

The lot has an area of 1906.11 m², a street frontage of 31.39m and a depth of 61.44m. The property contains many mature trees, both coniferous and deciduous. The home is situated midway back on the lot with a generous front yard setback. The property is accessed by a single driveway access point from Mississauga Road. The subject property contains a one-storey bungalow built after 1954. The home is red brick with the front elevation being sided. The windows and the interior finishes are original to the home. The home is currently vacant.

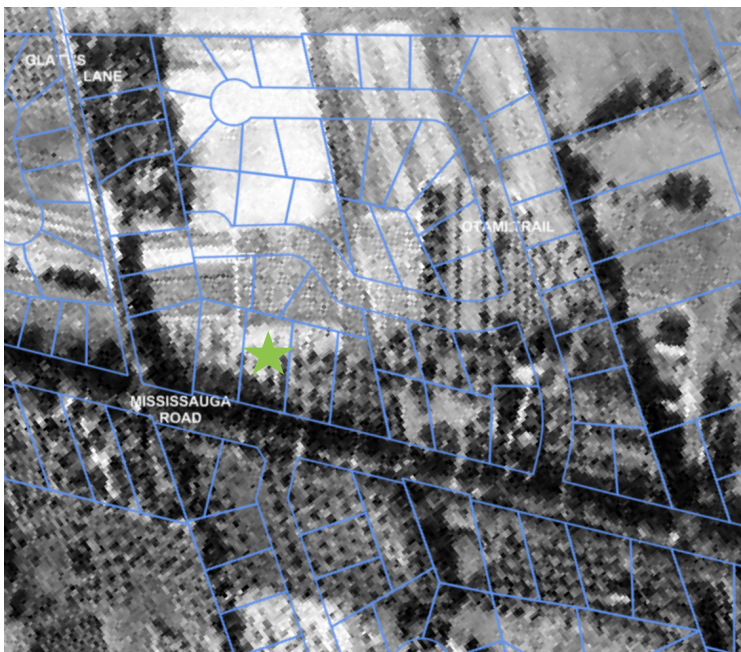
Figure 5: 1944 Aerial Photo

The subject property is identified by the green star. The photo demonstrates that the area was dominated by fruit orchards at this time.

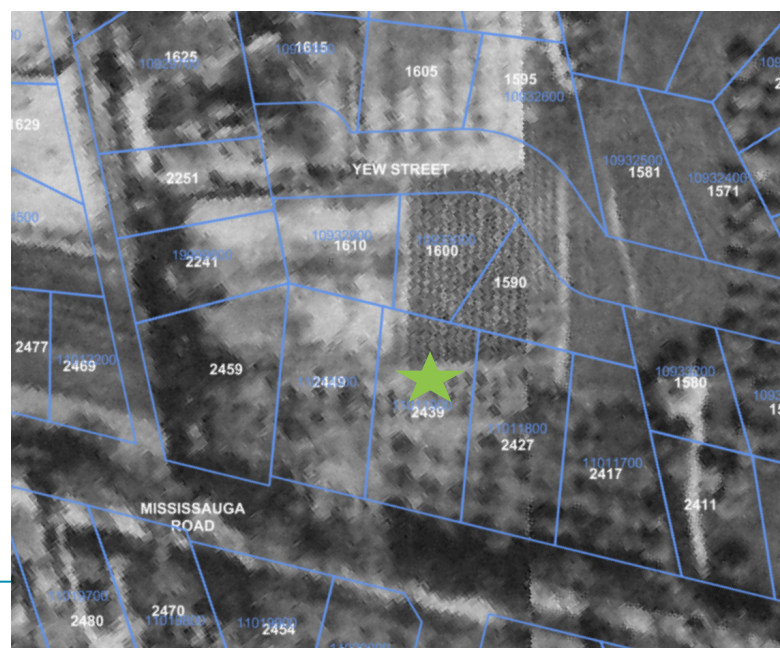
Figure 6: 1954 Aerial Photo

The property remains

undeveloped.

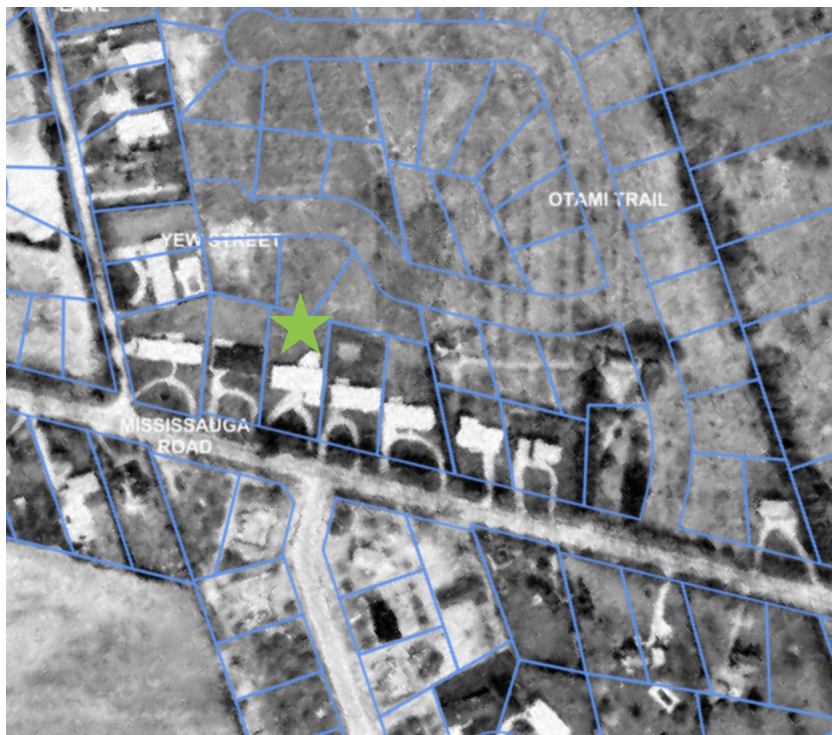
Figure 7: 1966 Aerial Photo

Prior to construction of the dwelling, it was part of the fruit orchards and farmland bisected by Mississauga Road. The aerial photo from 1966 (above) demonstrates that development was occurring rapidly along Mississauga Road. The five lots south of Glatts Lane were all built at the same time by Salem Construction Limited.

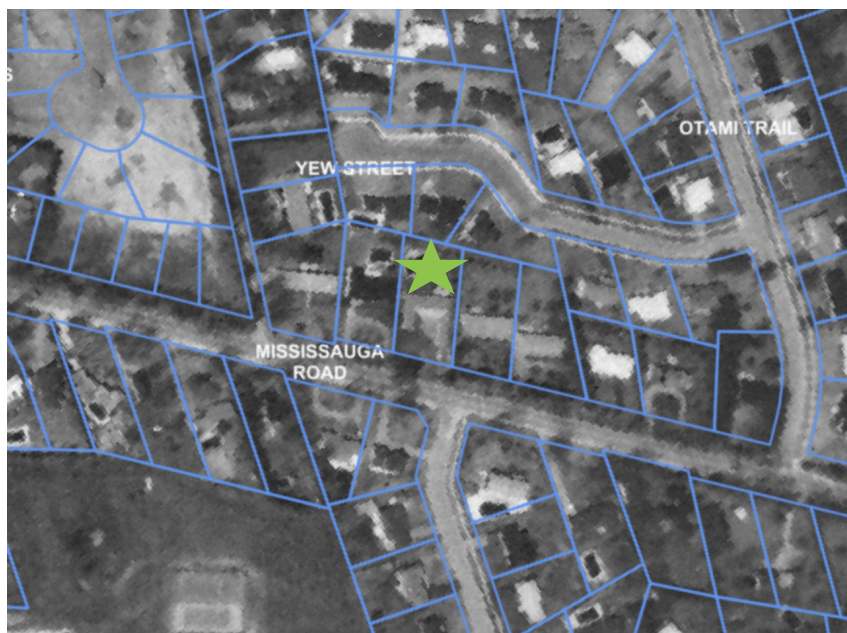
Figure 8: Aerial Photo 1975

This photo provides evidence that the addition was done after 1966 and before 1975. In speaking with the owners of the time during this period, they confirmed that the additions were completed in

1974.

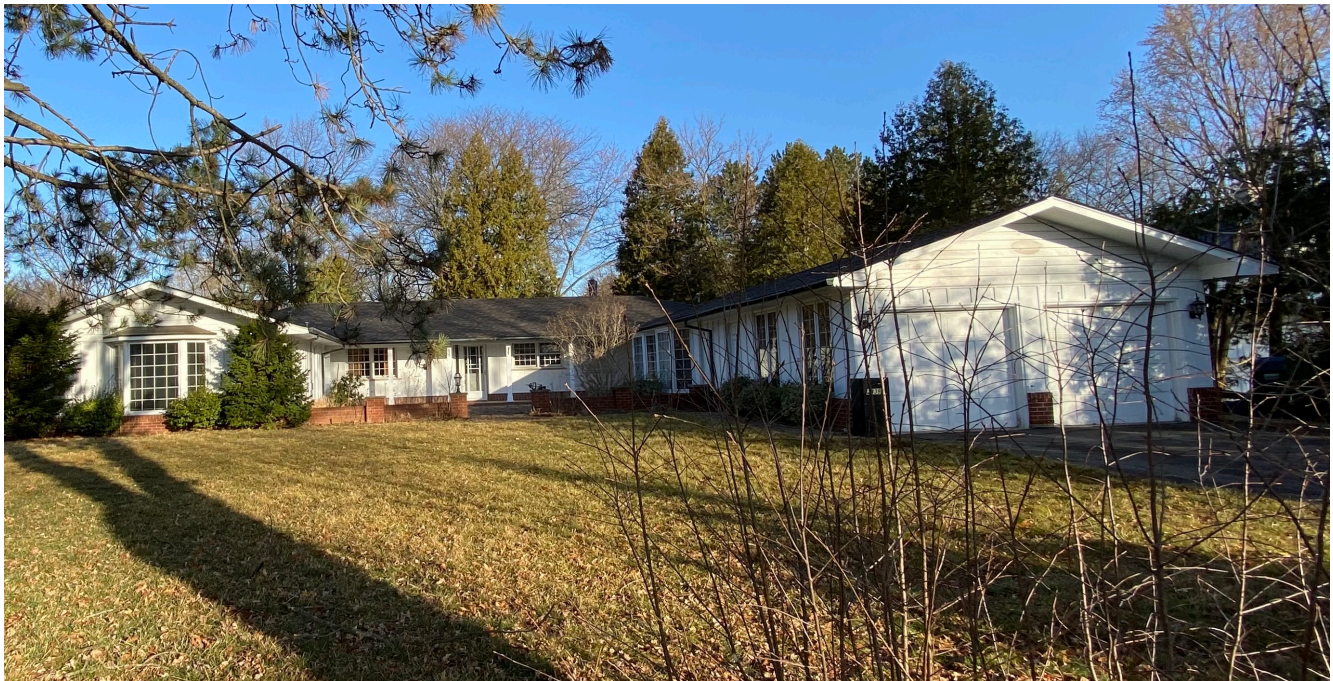
Photo 1: Front Elevation

The single family detached dwelling situated on the property is a one storey home. The dwelling has a brick and siding exterior. The roof is asphalt shingles (the original roof was cedar shake - as confirmed by the previous homeowner) The windows and doors appear to be original to the home.

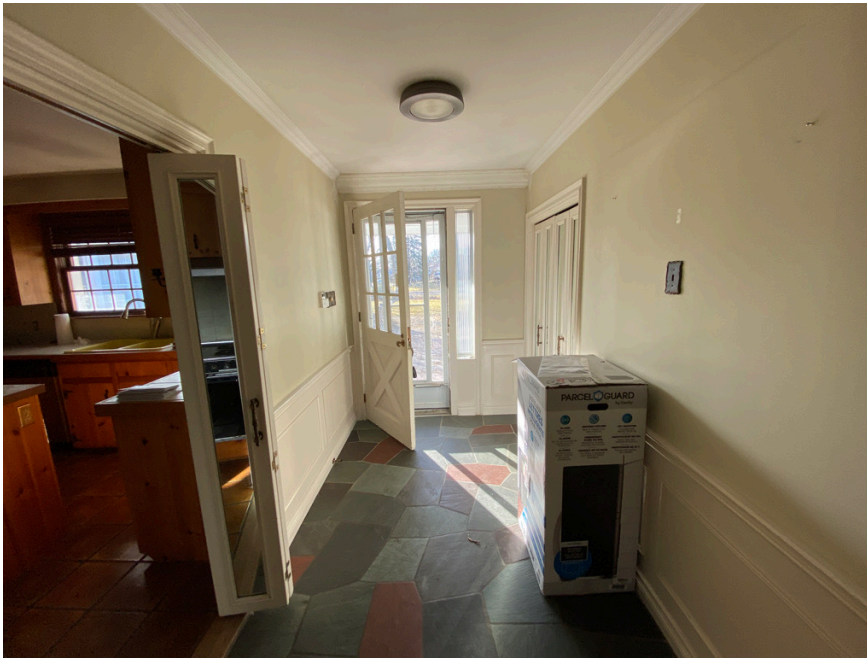
Photo 8: Front Foyer

Note the original flagstone flooring.

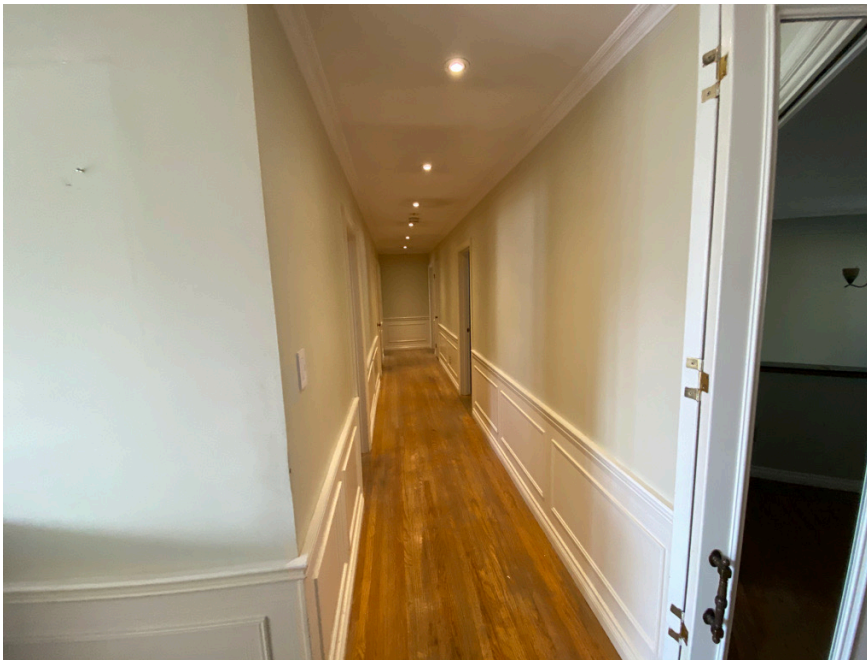
Photo 9: Hallway leading to bedrooms

The 1974 renovations added a games room and relocated the garage on the east side of the dwelling. On the west side a bedroom was expanded to create a master suite that included a his and hers bathroom (the his bathroom was a sink, shower and toilet, whereas the hers bathroom included a soaker tub and sink - no toilet). Mary indicated that

the lack of storage (ie no basement was a concern, but that quickly dissipated with they heard of basements flooding and property damaged). The renovations created a U-shaped dwelling, with sleeping areas on the west side and living and cooking areas on the east side.

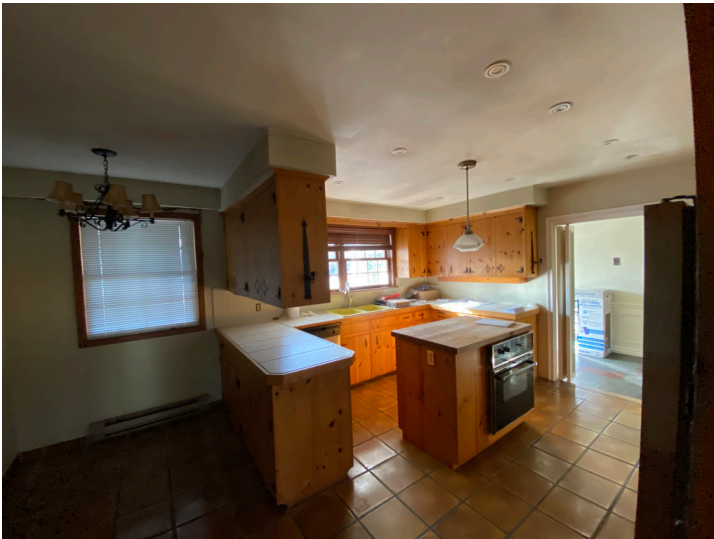
Photo 11: Kitchen

The eat in dining area is visible in the left of the photo.

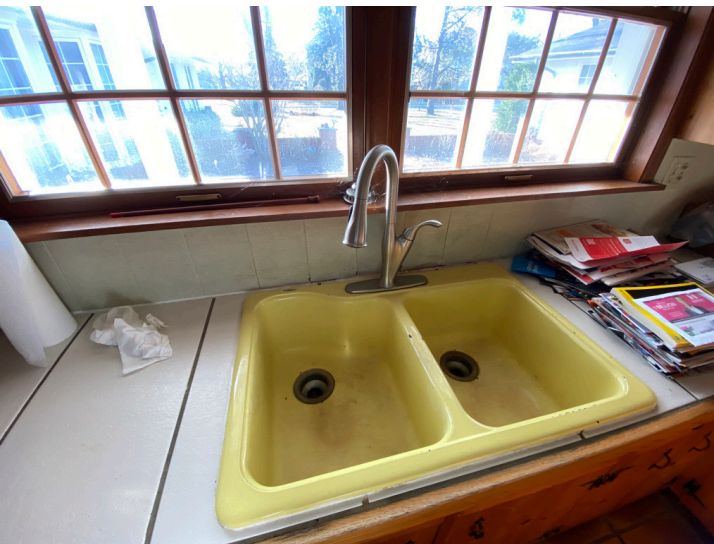
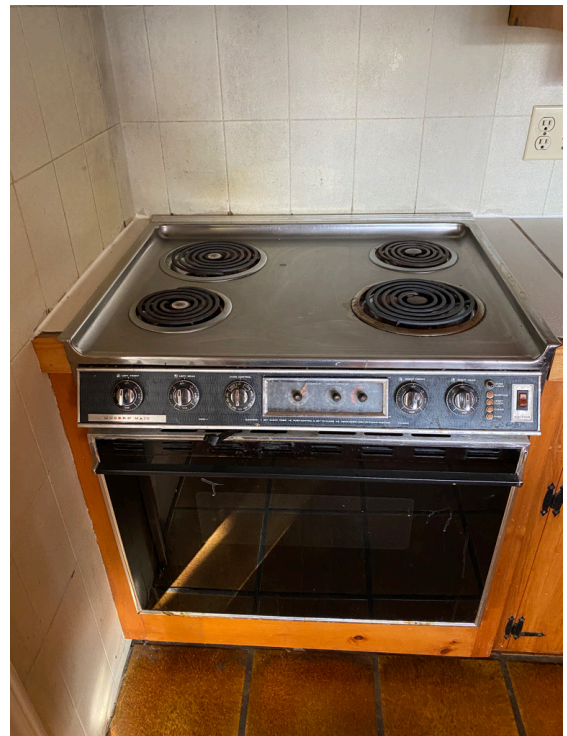
Photo 12 & 13: Kitchen sink and stove

The fixtures are original from time of build in 1961.

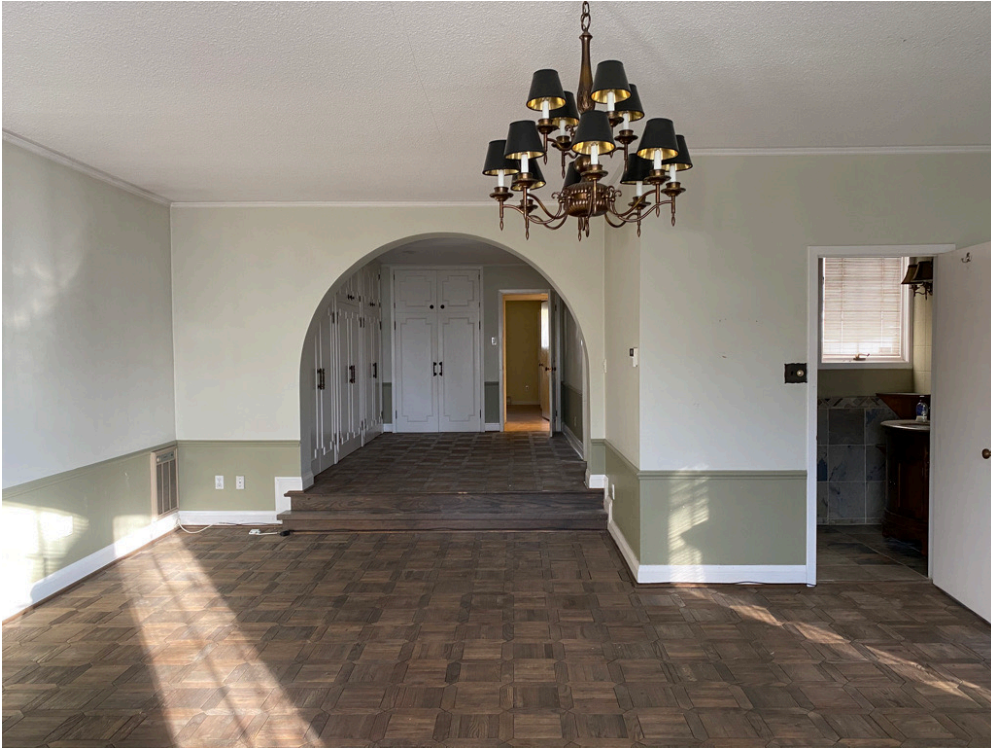
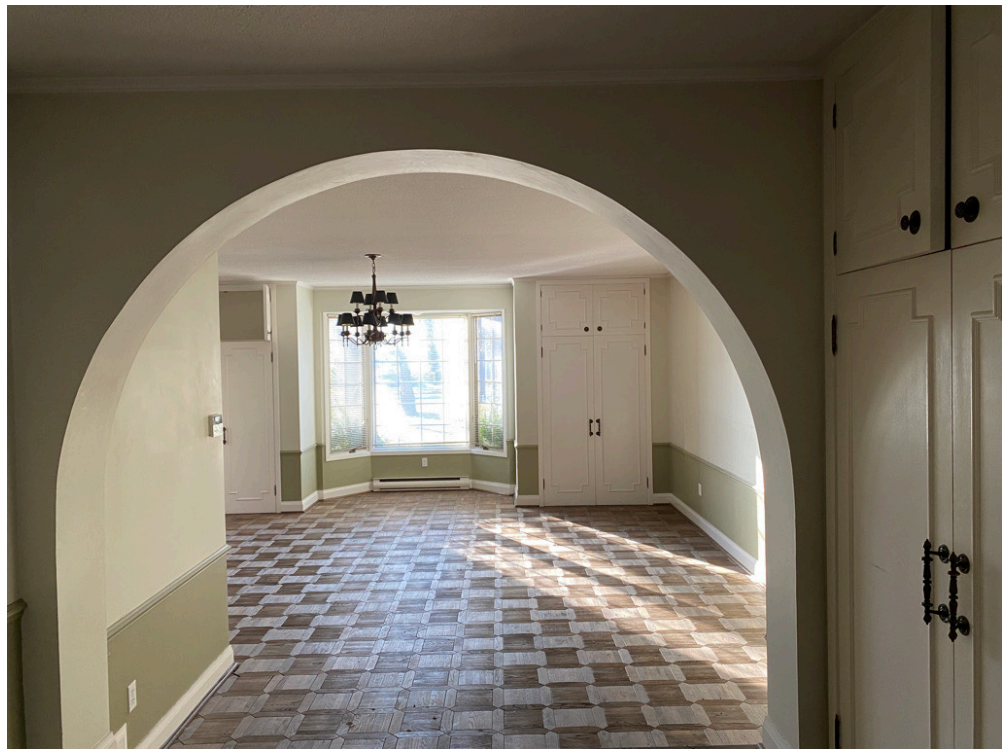
Photo 14 & 15: Master Bedroom

The master bedroom addition was completed in 1974 with the garage addition. This addition added a his and hers bathroom to this area as well.

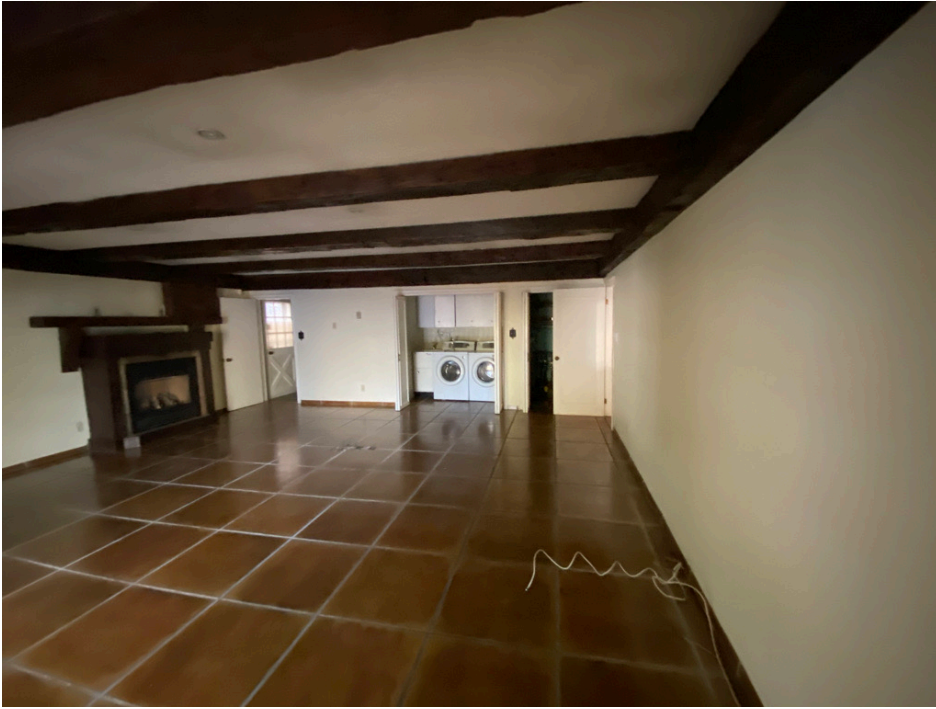
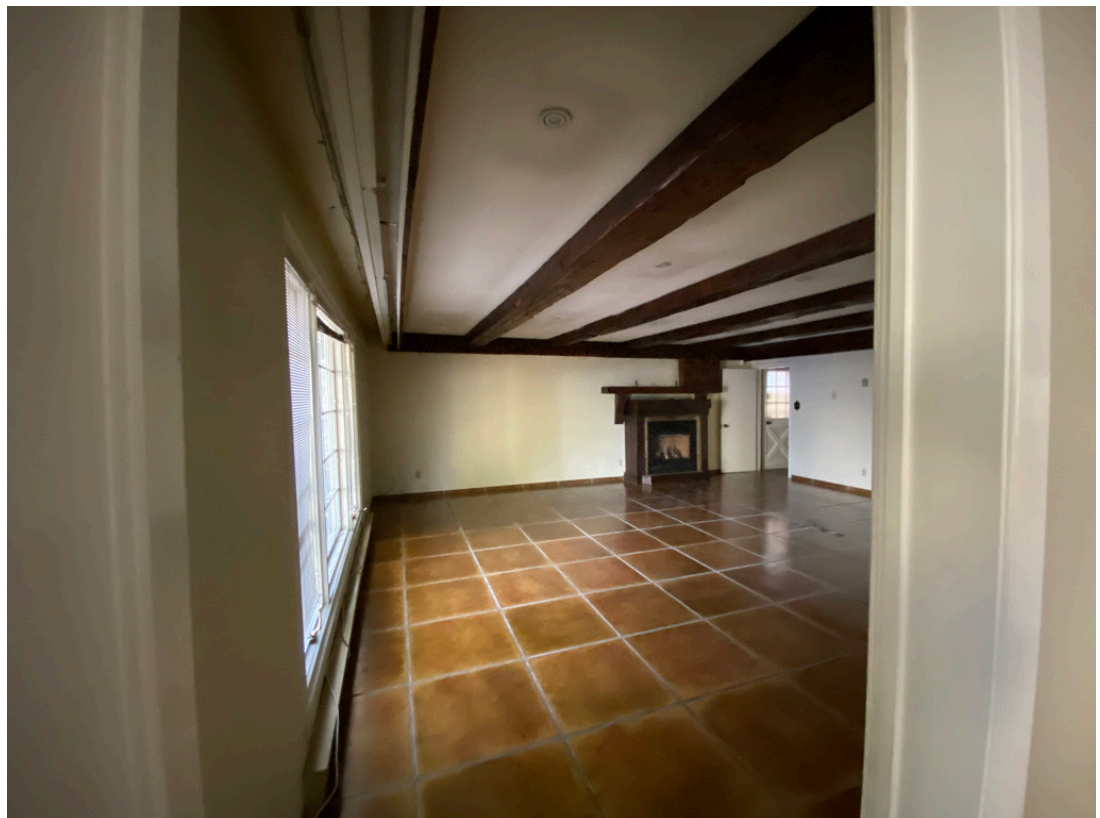
Photo 18 & 19: Family Room

The owner for whom the home was built indicated that these floor tiles were imported from Germany. The kitchen flooring tiles were as well.

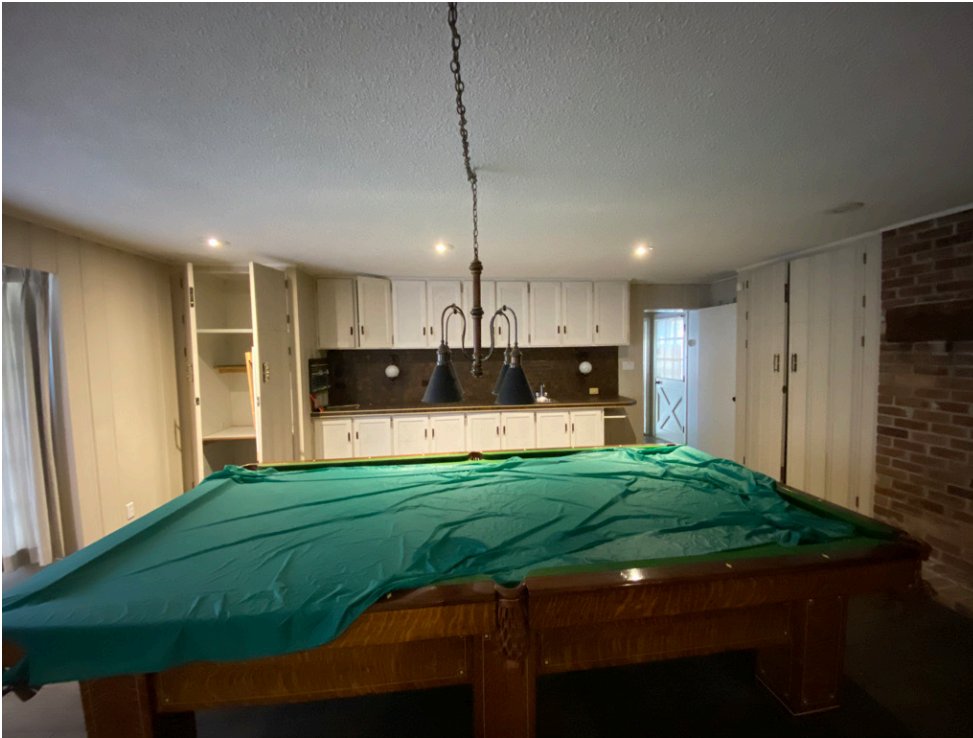
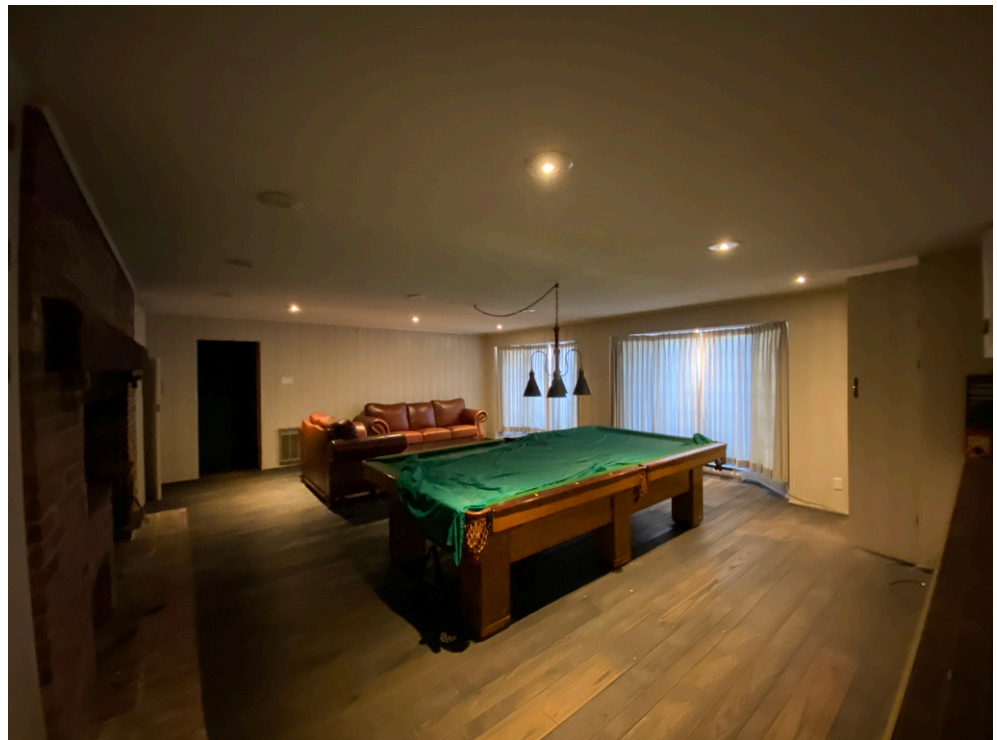
Photo 20 & 21: Games Room

This space was originally the garage, converted in 1974 to a games room.

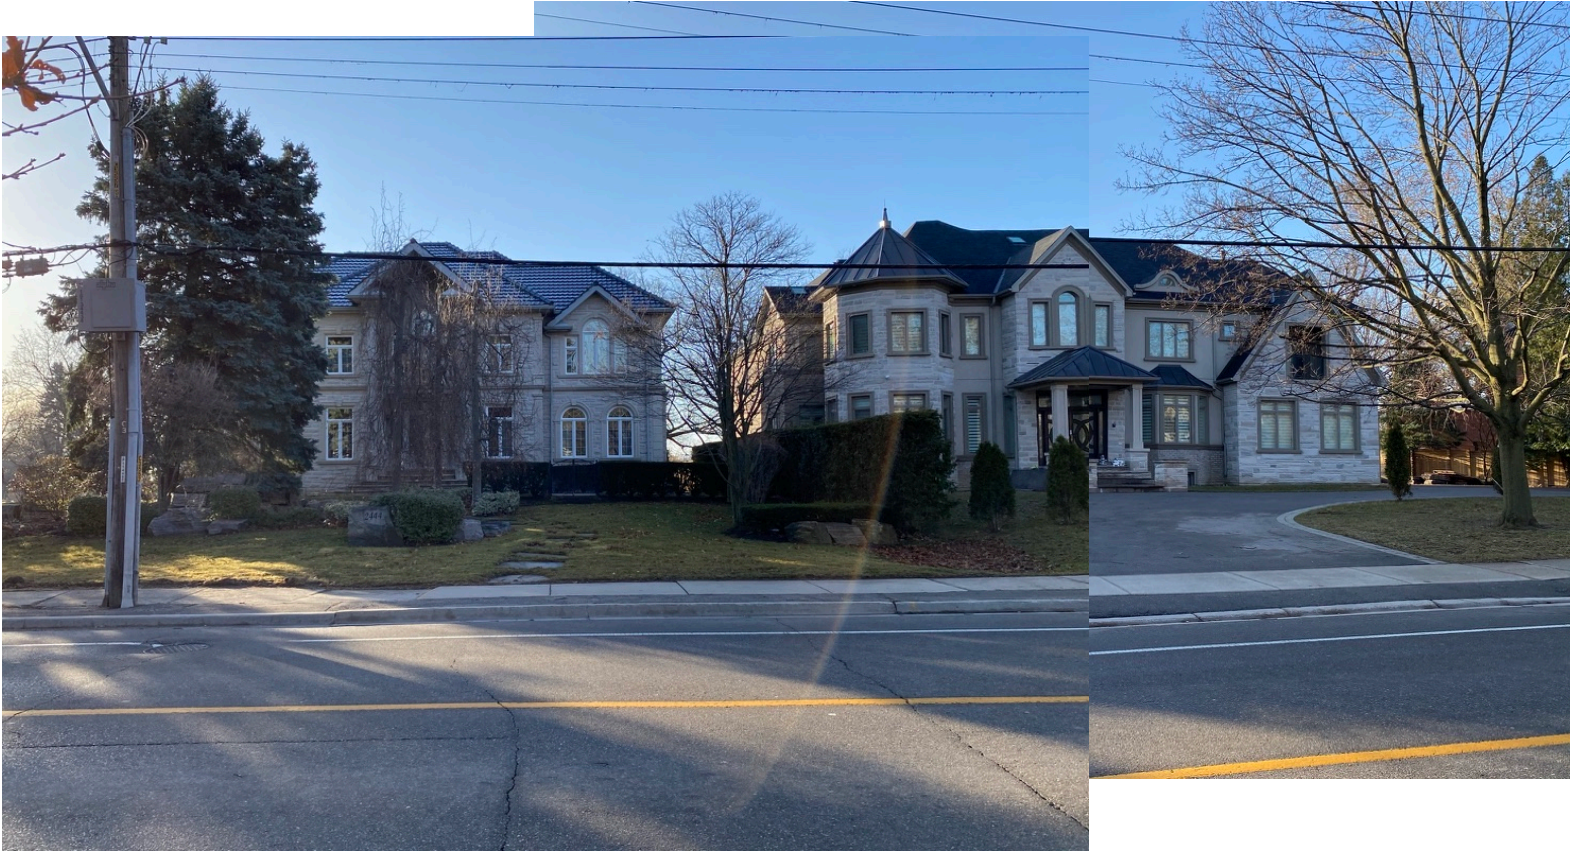
Photo 22: Streetscape, west side of Mississauga Road.

The image demonstrates the variety of housing stock in the immediate area.
