# Living Arts Center

Entry Doors Replacement

# Project Reference: Civic Center doors replacement

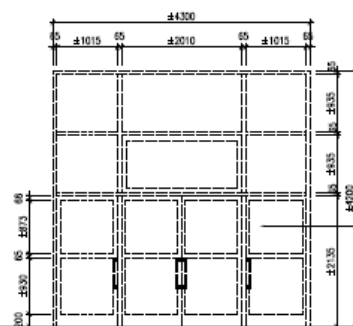
EXISTING ELEVATION  
DOOR 1105A, 1105B, 1105C

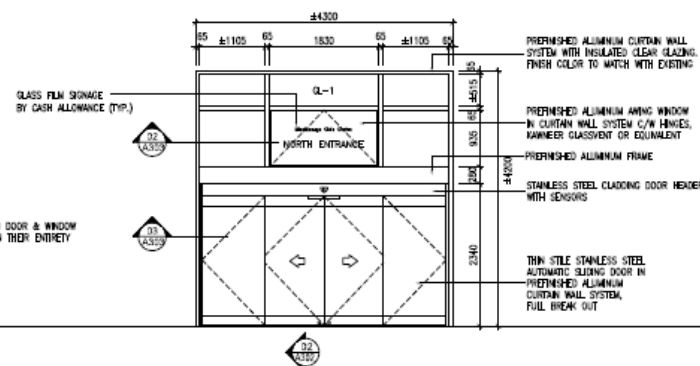
NEW ELEVATION  
DOOR 1105A

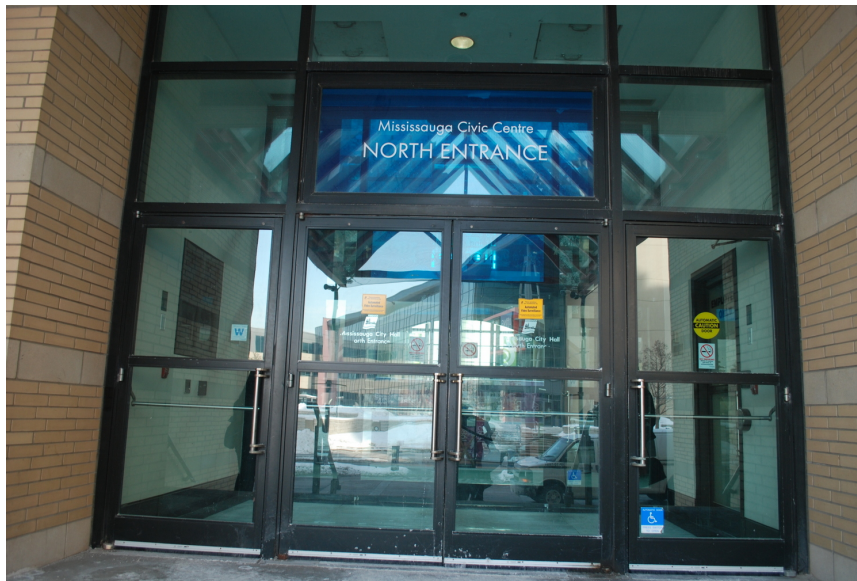
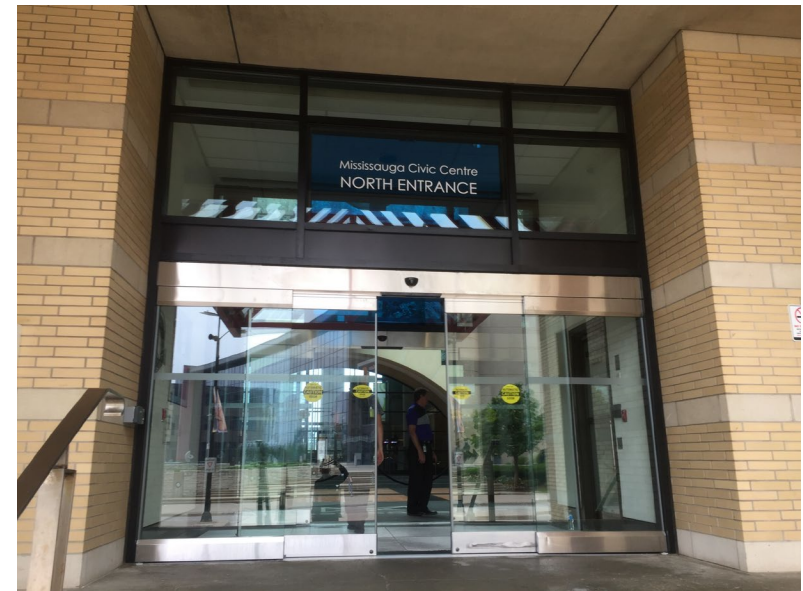
Reference : North Entrance doors

Before & After

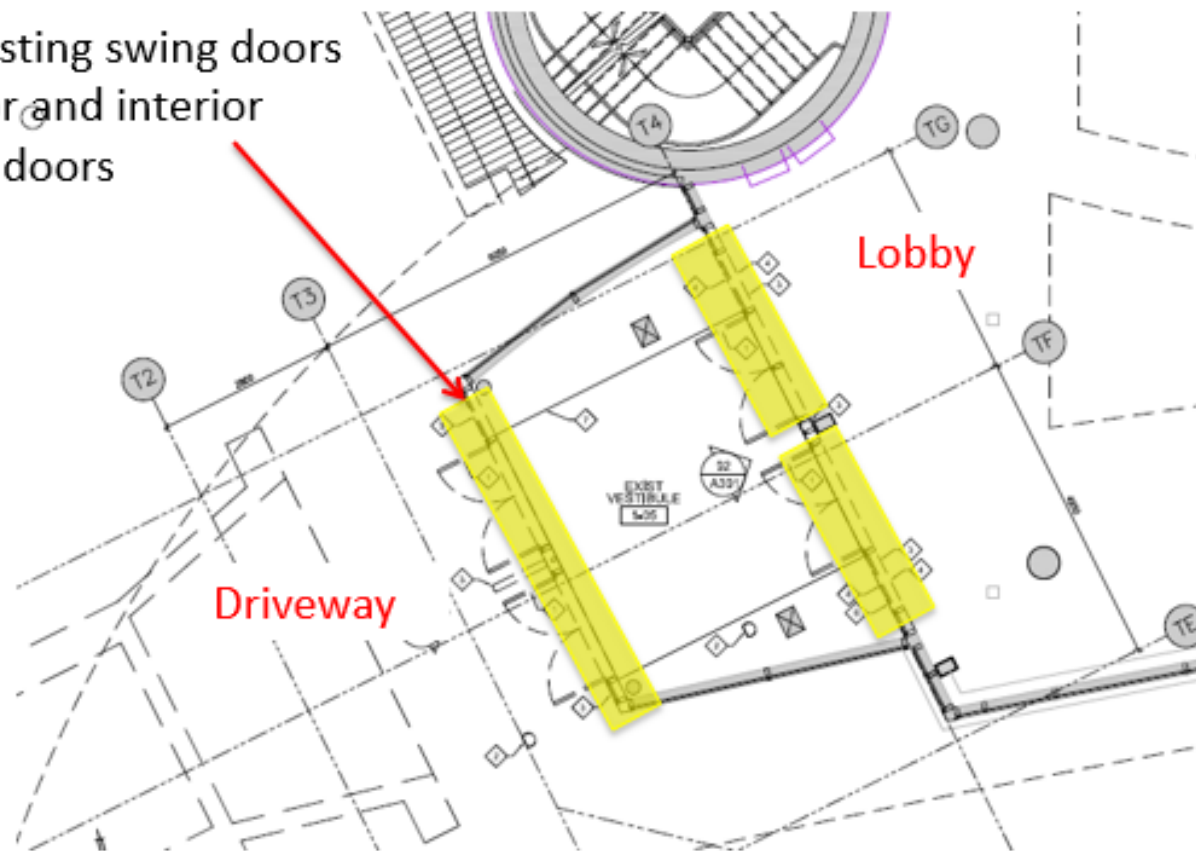
Existing plan view:

Demo existing swing doors  
at exterior and interior  
vestibule doors

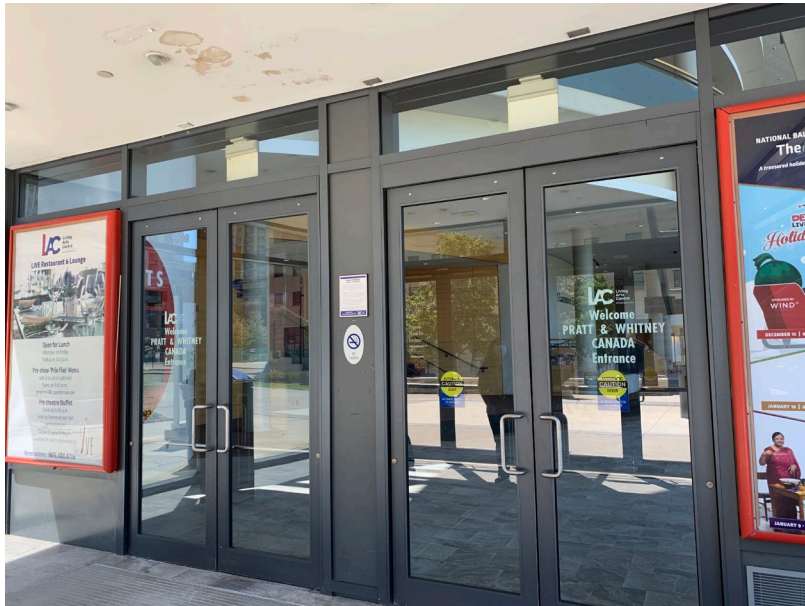
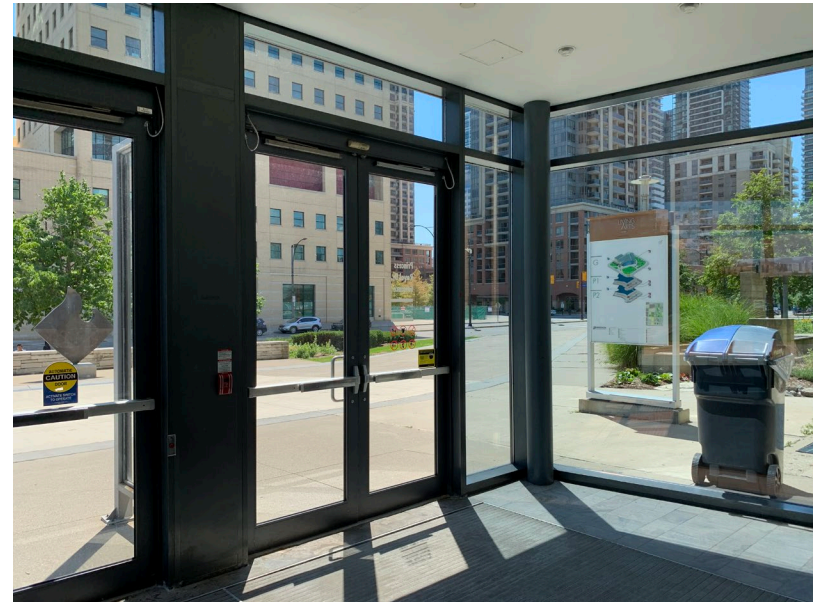
## Existing: Main entry door views

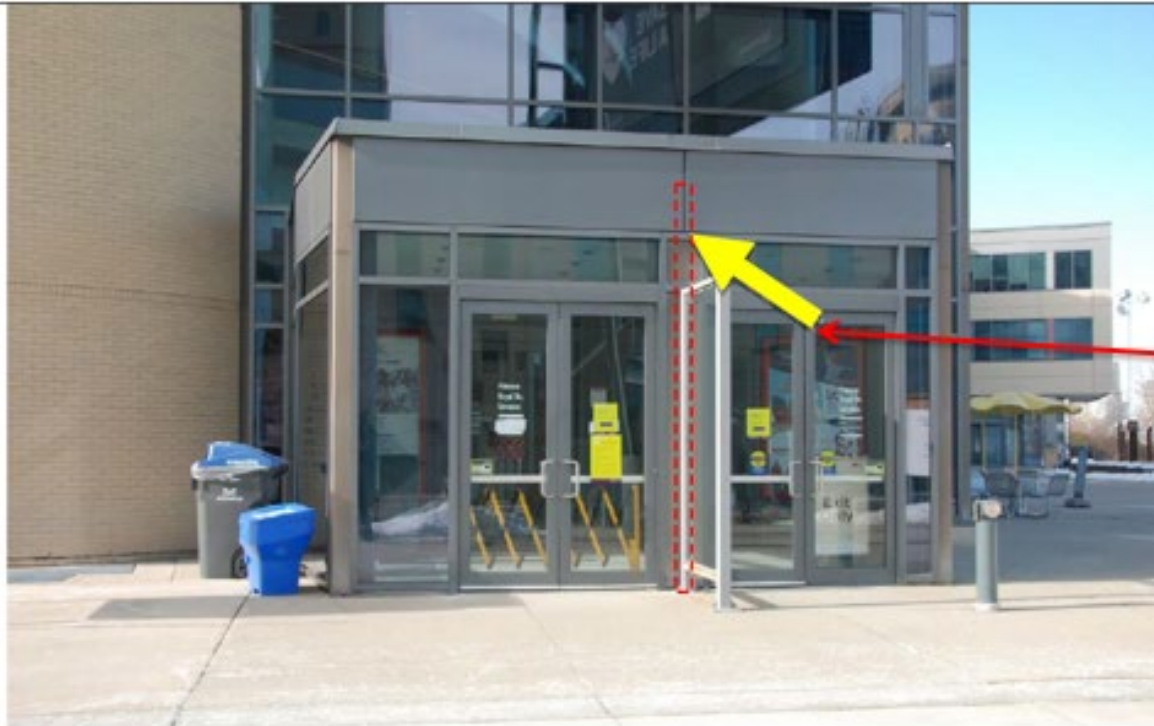
Existing rain water leader pipe between the entry doors.

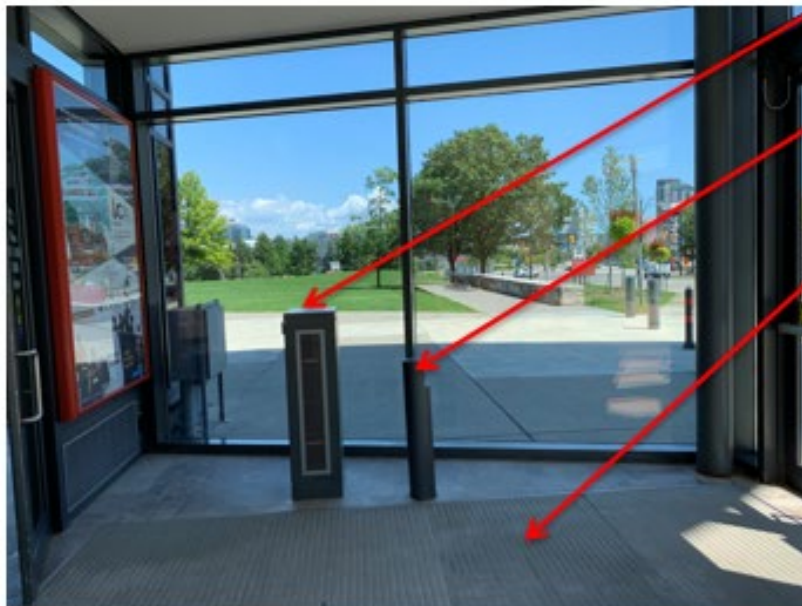
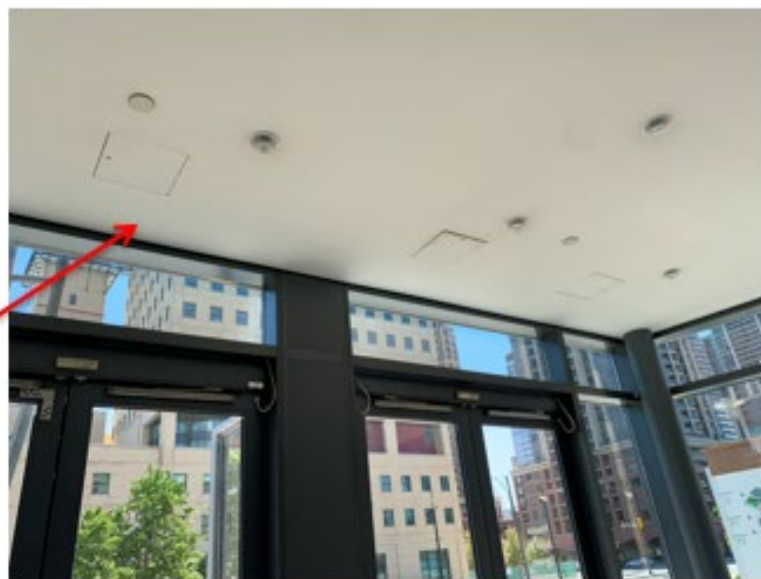
### Existing vestibule view:

Demo existing ceiling, reroute rain water leader pipe and install new drywall ceiling and new lights.

Existing supply duct and grille to remain.

Existing door operator push button to be removed.

Existing Pedimat and flooring to be replaced.

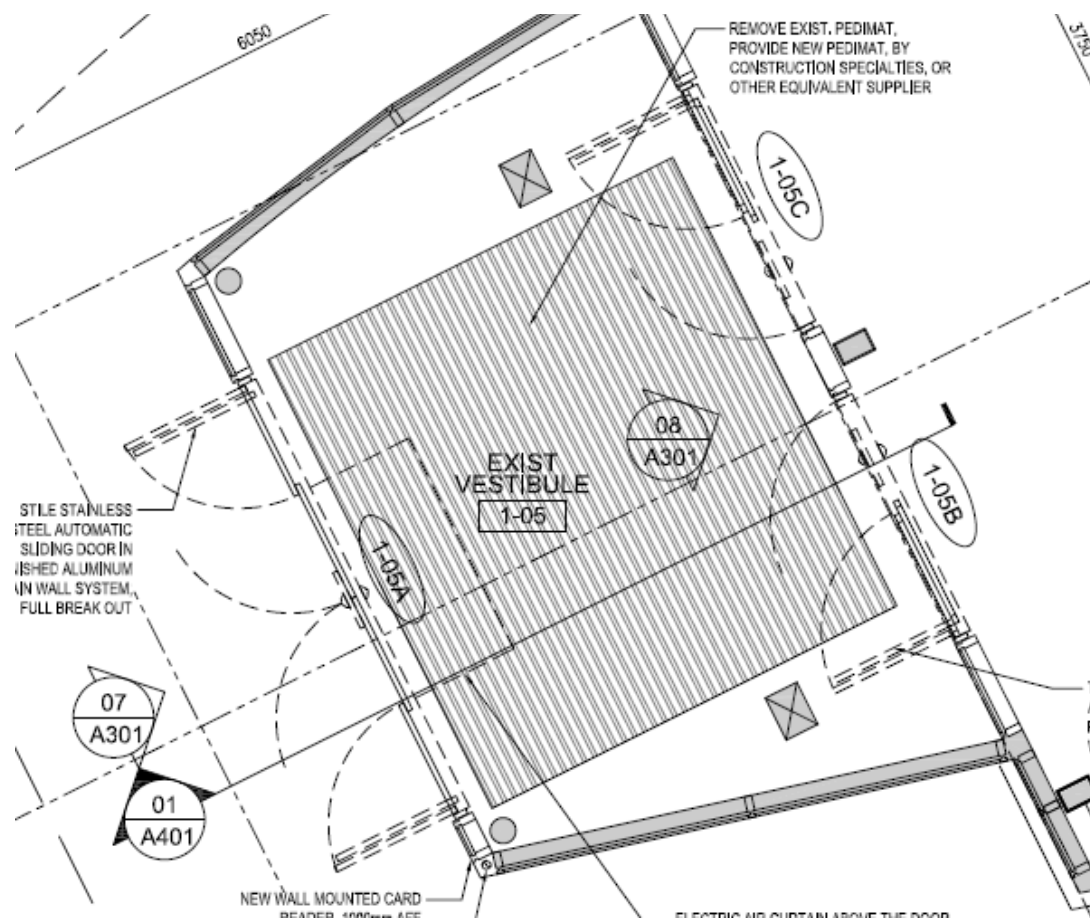
New sliding doors: Main entry doors (exterior doors)

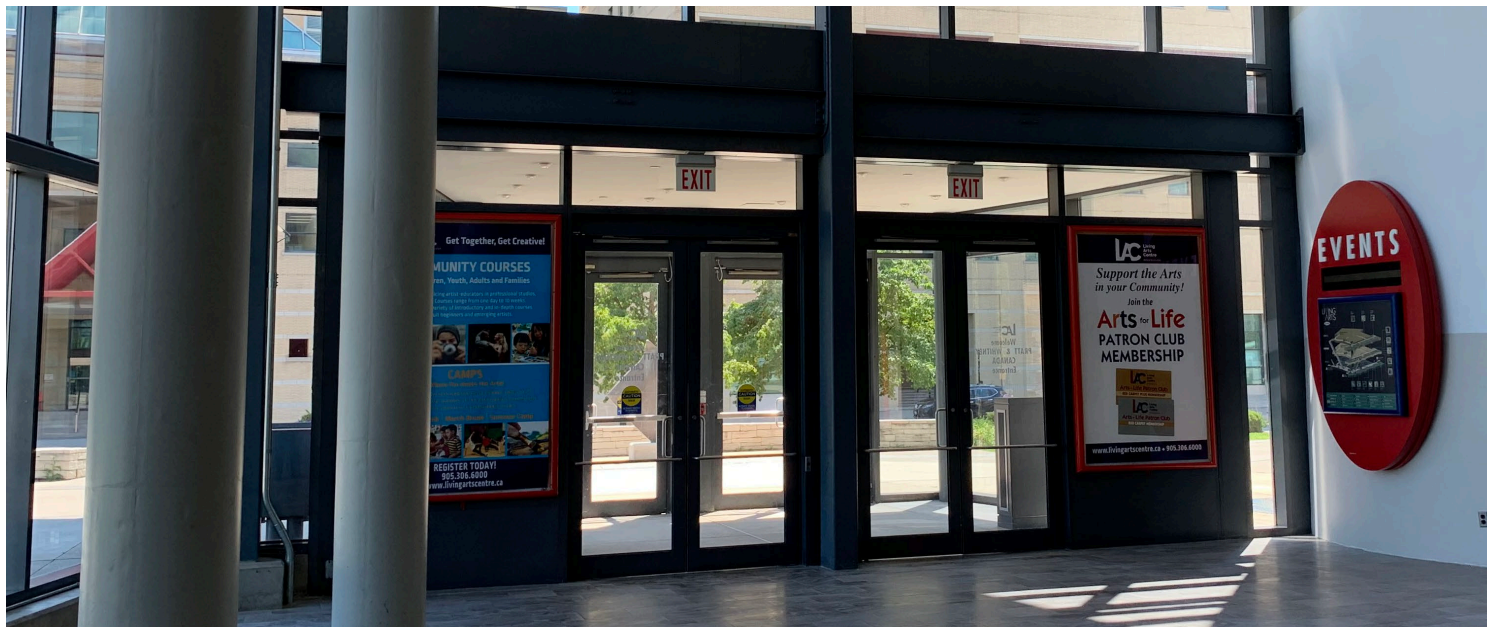
Existing: Vestibule doors

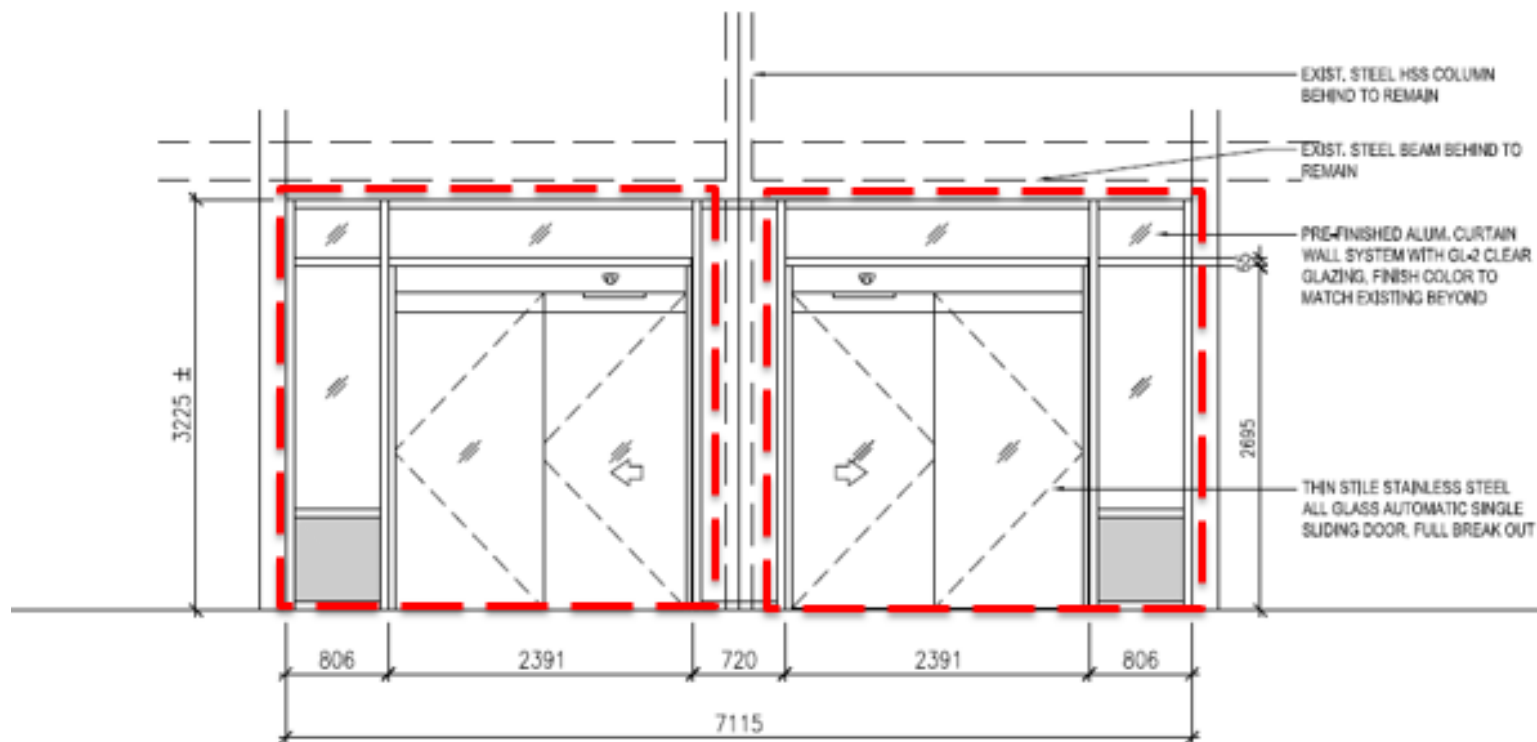
**Recommended option: New vestibule sliding doors; retain existing structural column**

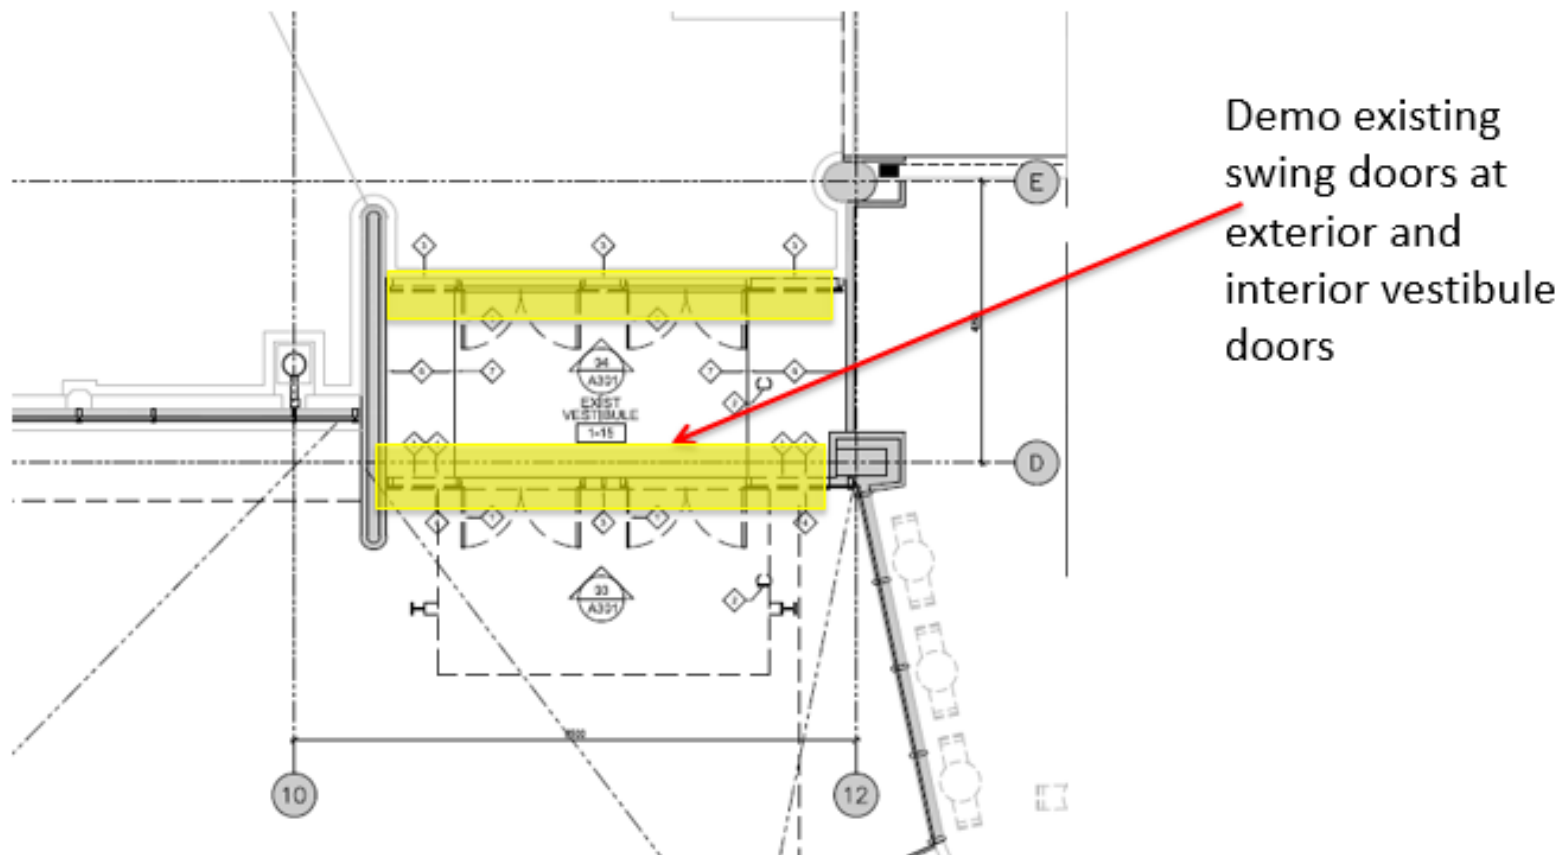
Existing plan view:

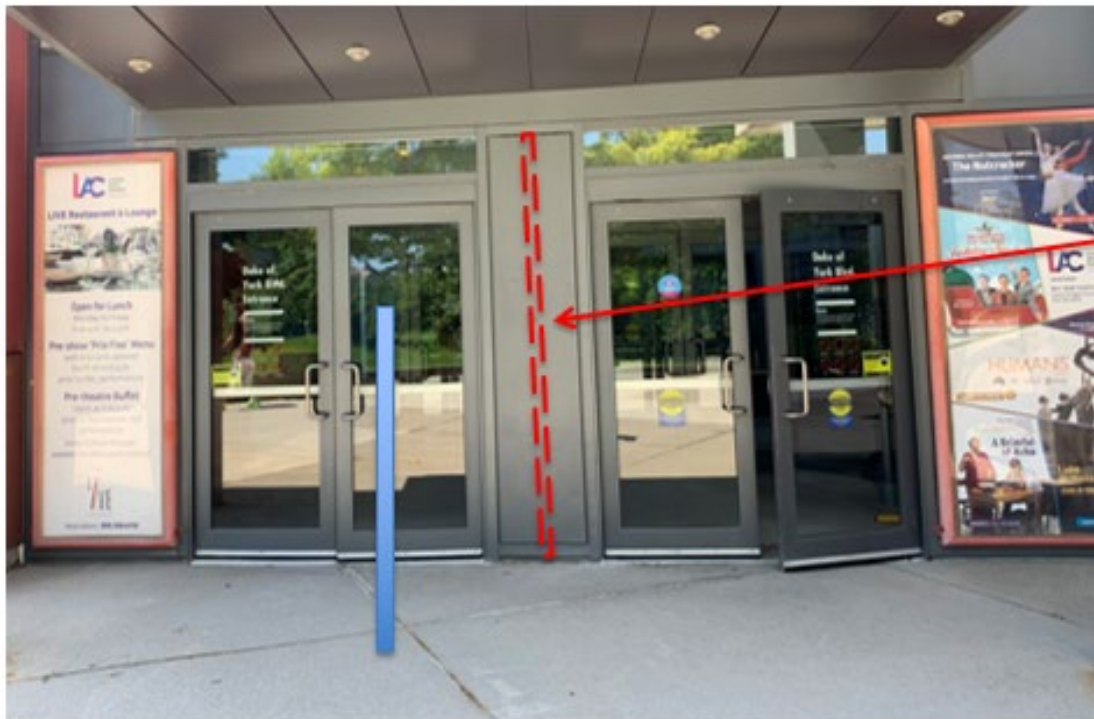
### Existing entry doors

Existing rain water leader pipe inside the aluminum panel.

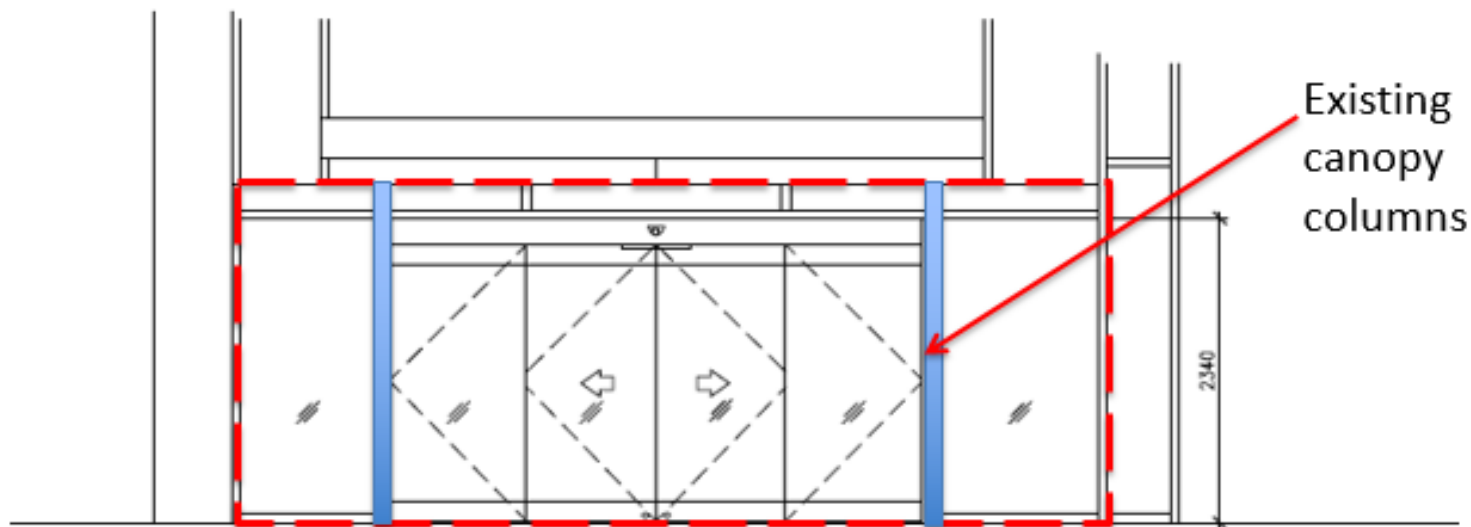
New bi-part sliding doors: Entry Doors

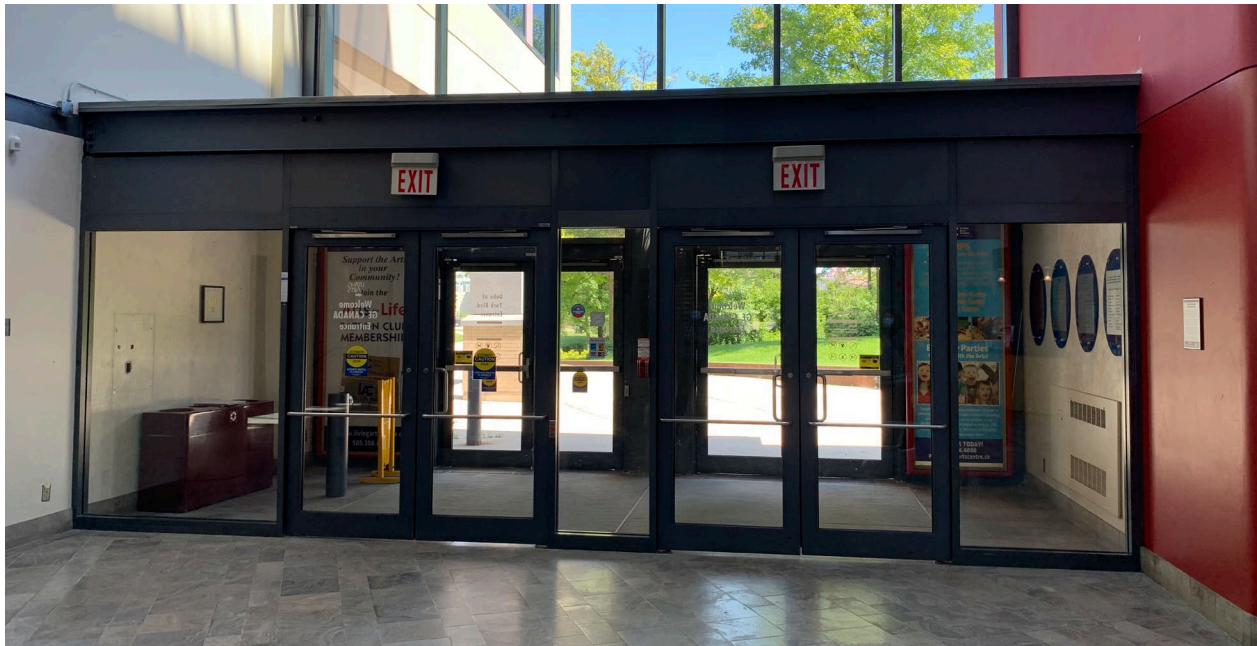
Existing: vestibule doors and vestibule view

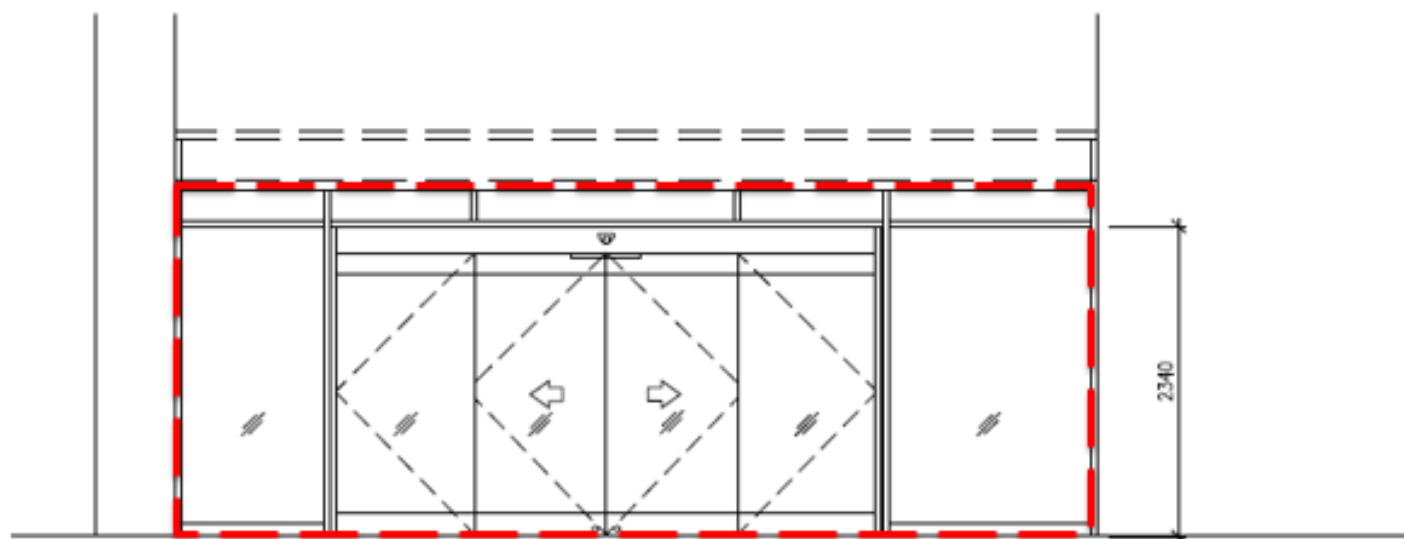
New bi-part sliding doors: Vestibule doors

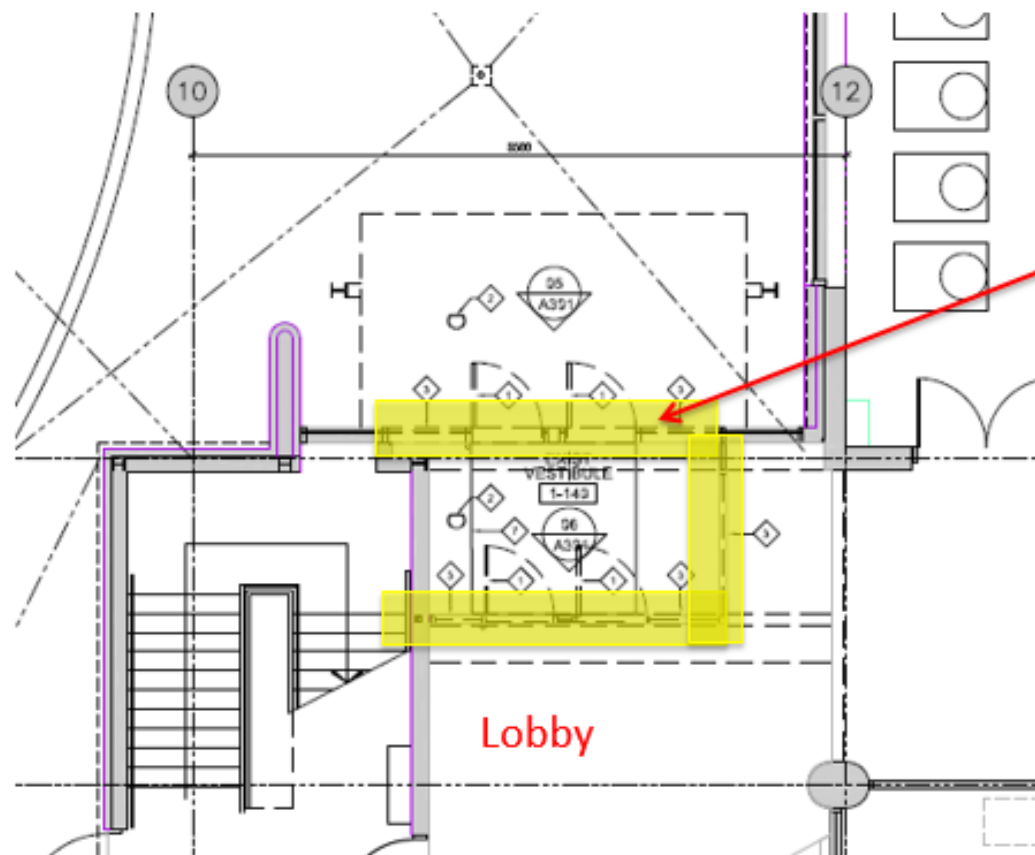
Existing entry storefront system to be removed in its entirety & replaced with new automatic sliding doors with full breakout curtain wall system.

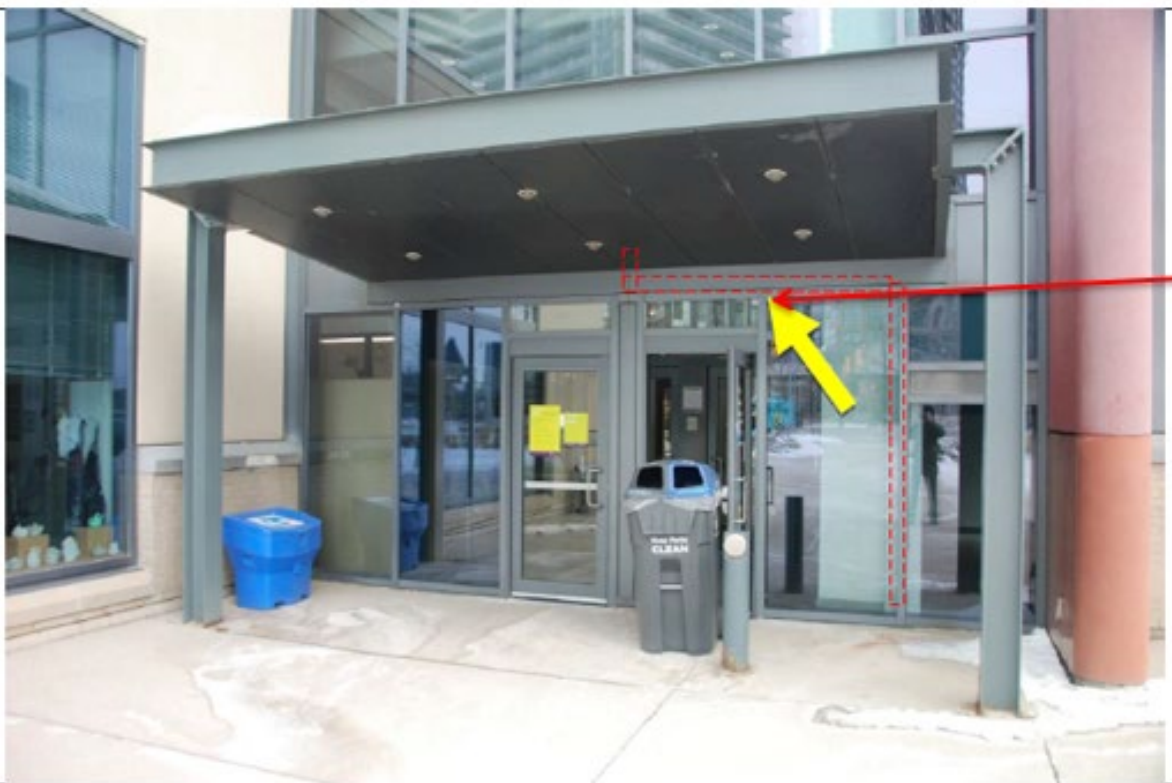
Existing: Entry doors view

Existing rain water  
leader pipe to be  
rerouted for new  
sliding doors

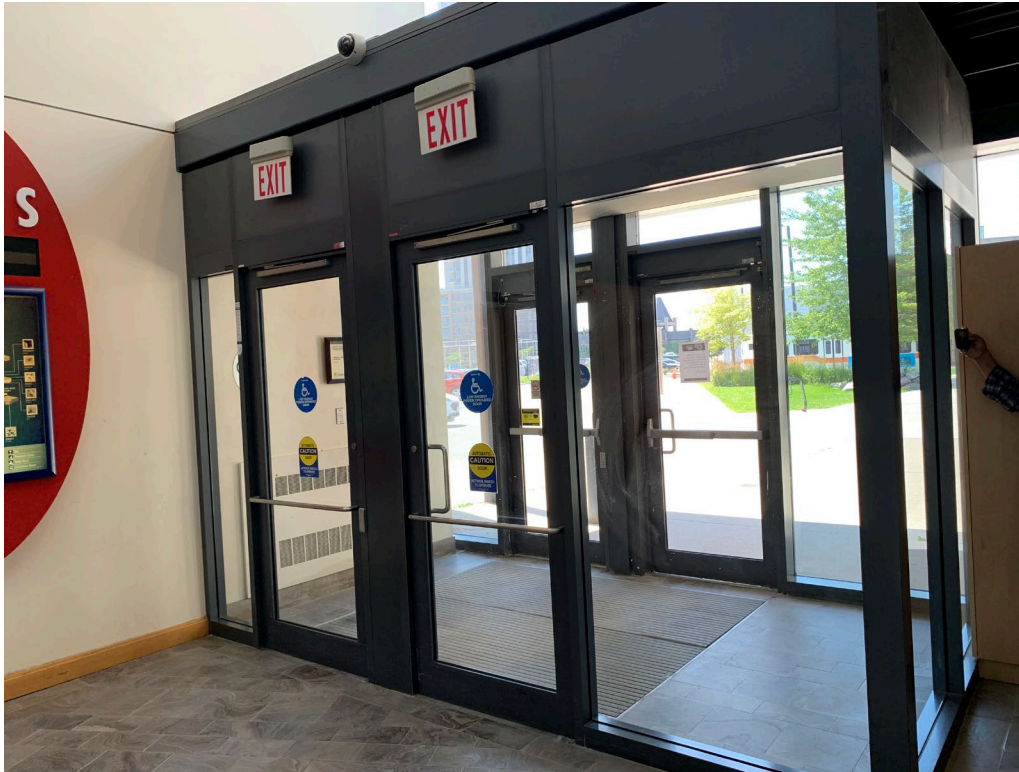
Existing: Vestibule view

- Replace or paint existing HVAC grille. Remove any existing door operating push buttons

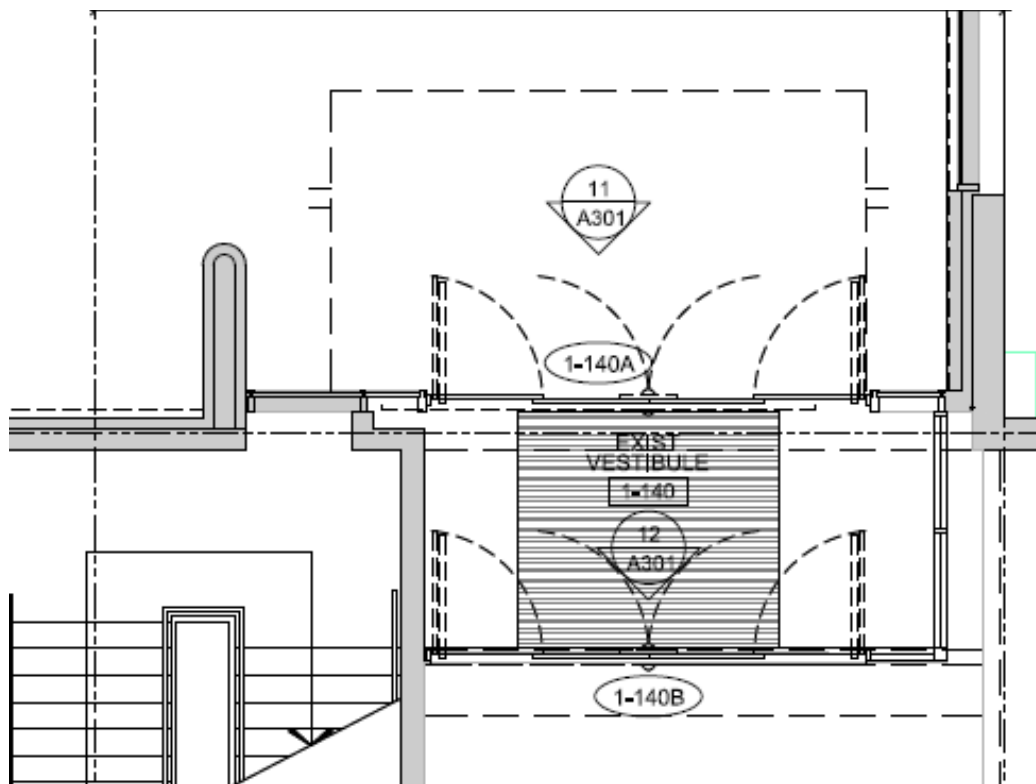
New bi-part sliding doors: Entry doors aligned with canopy column

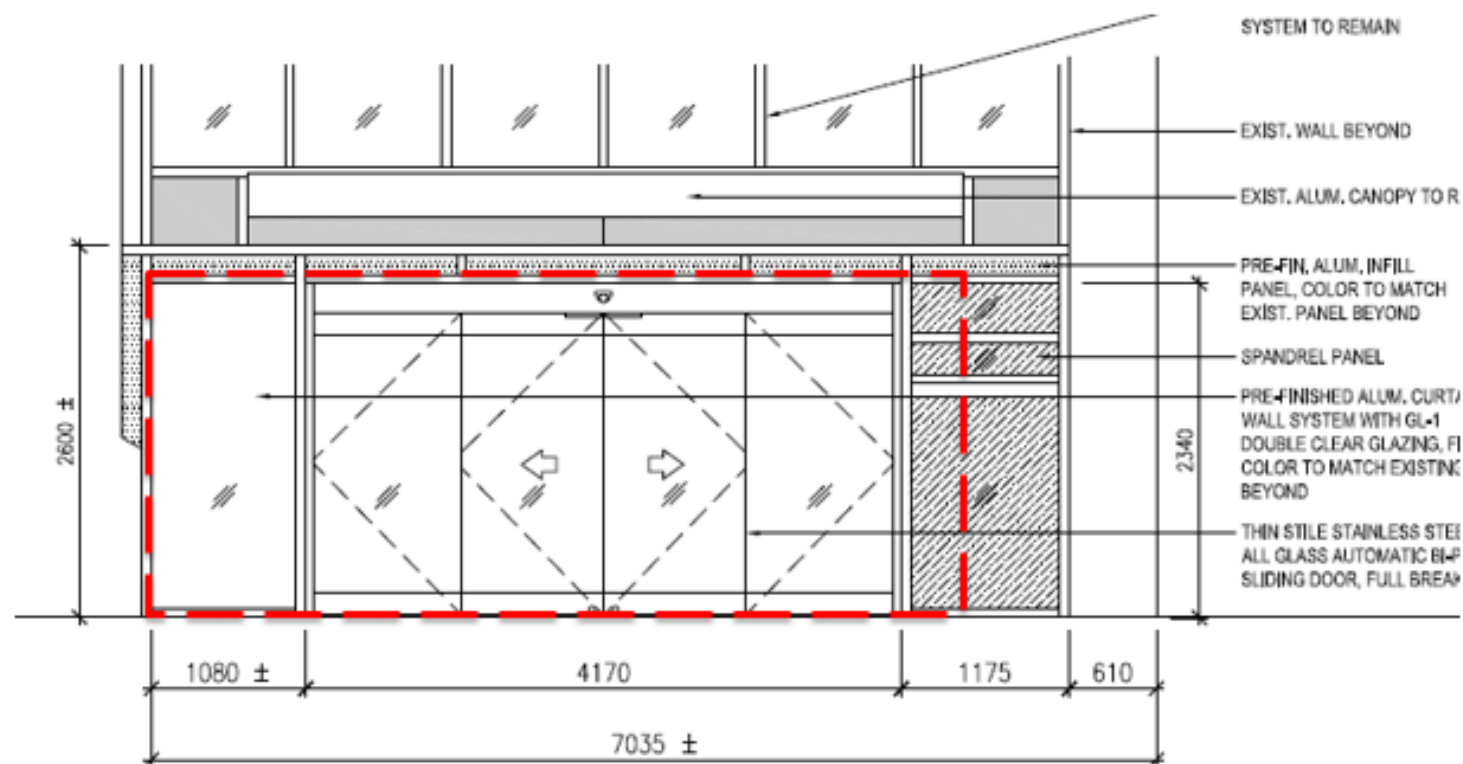
### New bi-part sliding doors: Entry doors
