**Heritage Impact Assessment
1220 Stavebank Road
Part of Lot 6, Range 1, Credit Indian Reserve
Port Credit, City of Mississauga
Region of Peel**

HR- 0330-2021
Project # 2021-0132

**REVISED
07/10/2021**

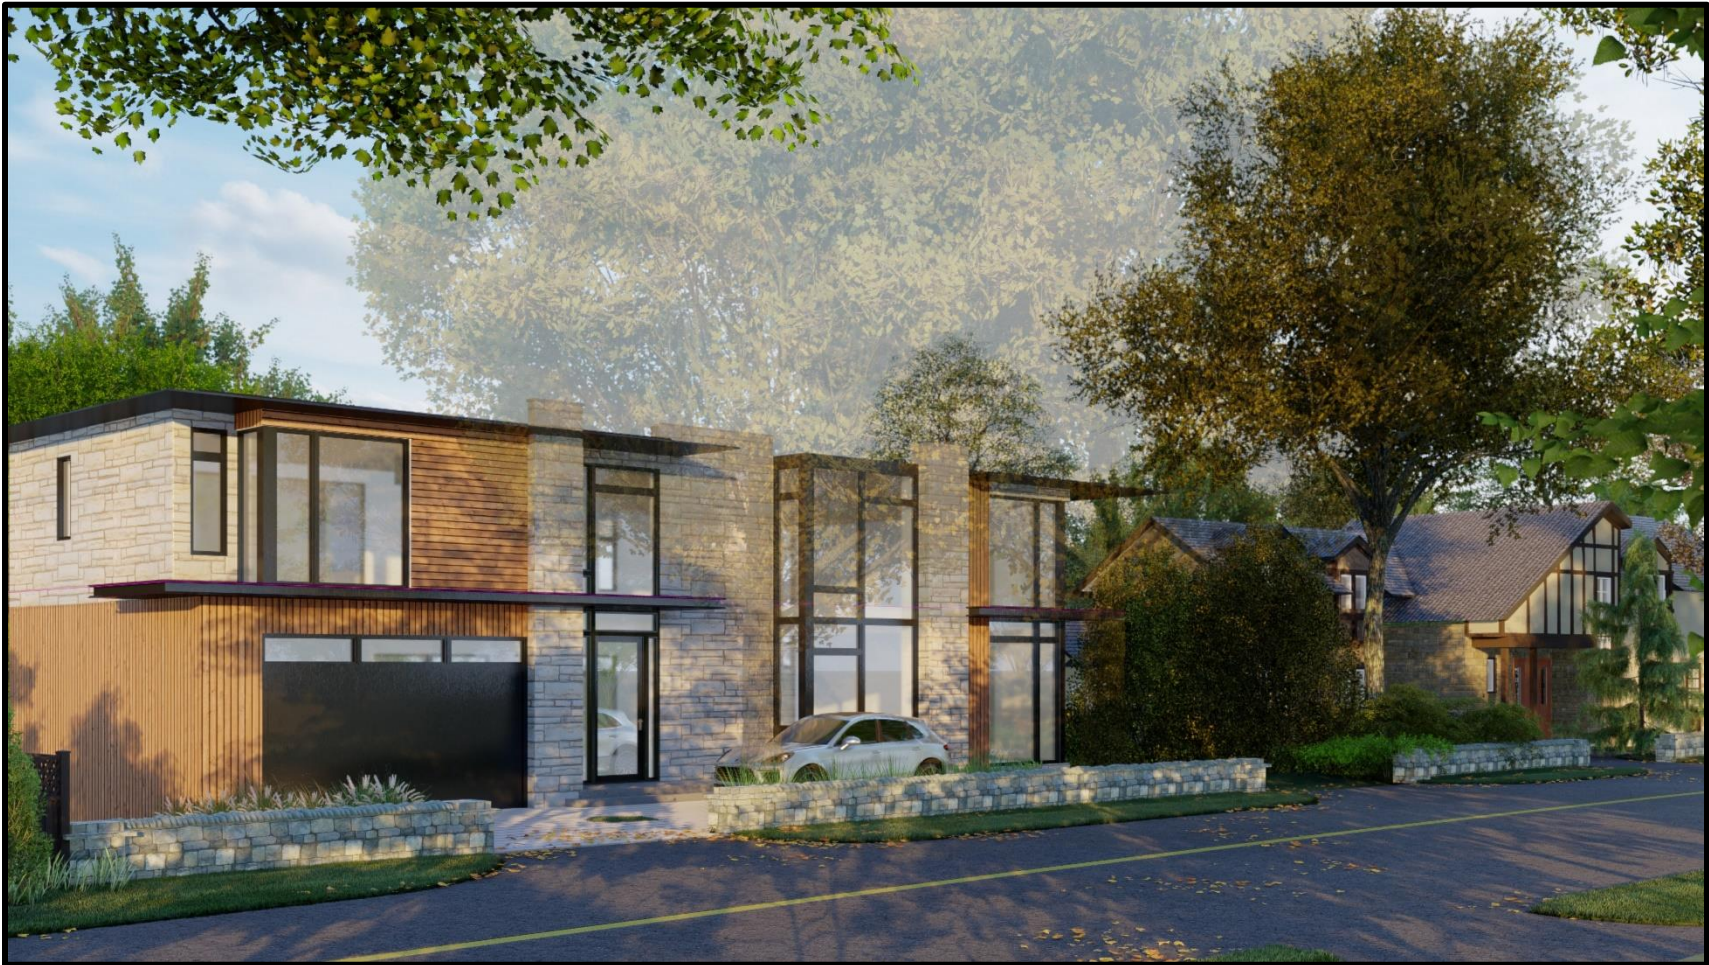
Figure 13: 3D Rendering of Alternative Option 3 – Looking West (trees on 1220 Stavebank Transparent to show House)
(Contempo Studio 2021)

In order to mitigate the noted impacts of the proposed development, **the preferred development from a heritage perspective is Alternative Option 3**. Rendering of the Alternative Option 3 have been included to provide an understanding of how this option would appear along the streetscape and in relation to the neighbouring properties (see Figure 13 -Figure 20).

Alternative Option 3, the preferred alternative, does not result in any changes to the original proposed building design as outlined in Section 11.0. Alternative Option 3, as described in 13.1.3 is considered the final proposed development that will be implemented by the property owner. The following renderings reflect the final proposed development and design.

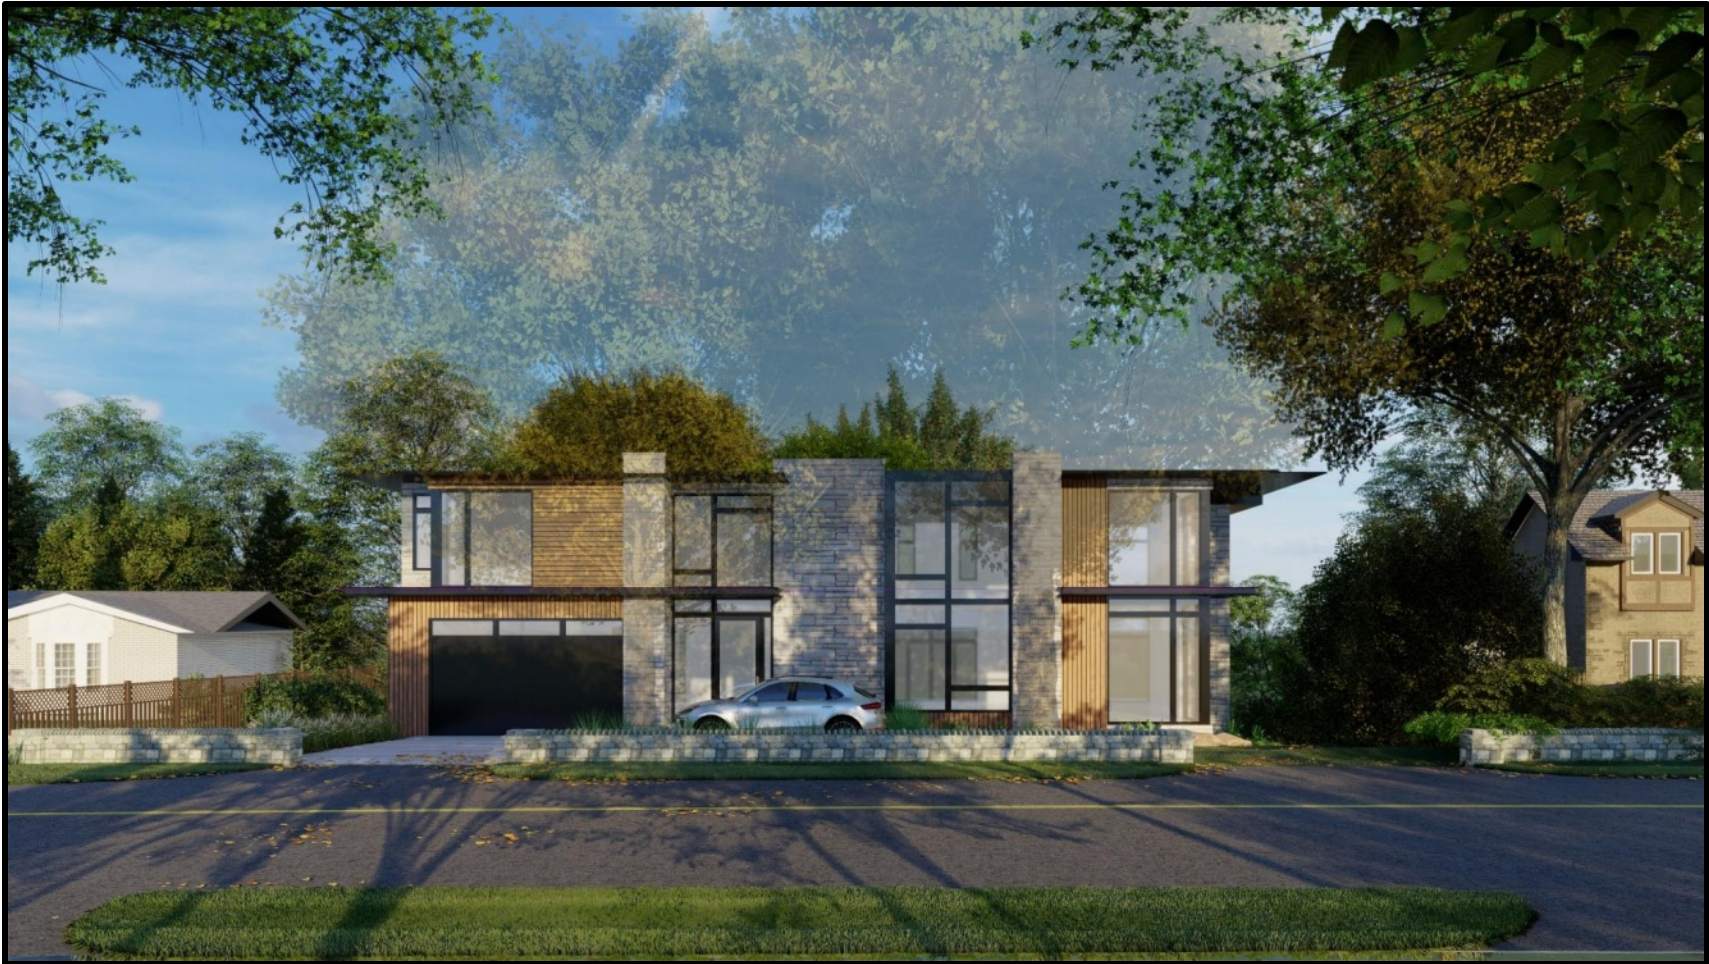
**Figure 20: 3D Rendering of Alternative Option 3 – Façade (Trees on 1220 Stavebank Transparent to Show House
(Contempo Studio 2021)**

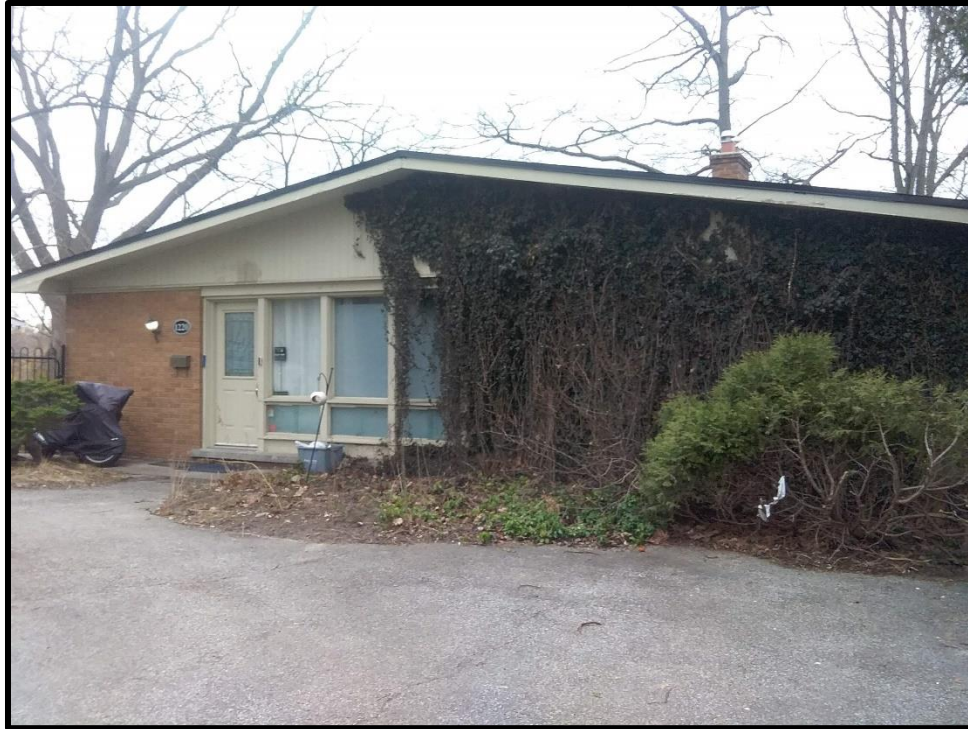
Image 1: Façade – 1220 Stavebank Road
(Photo taken April 1, 2021; Facing South)

There is little indication that the building has been altered from its original form and materials. Except for the bay window on the east face of the building all window and door openings appear to have their original form, and, in most cases, the original doors and windows are still in place. There are multiple windows which appear to be failing and have visible rot.

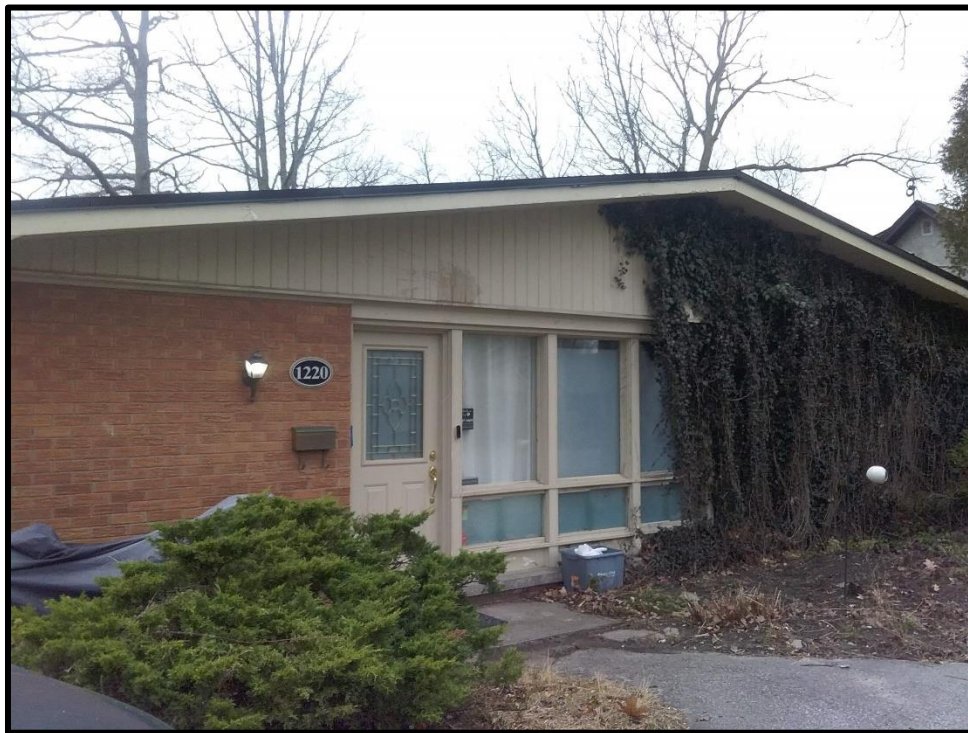
Image 3: Detail of East Elevation Roofline – 1220 Stavebank Road
(Photo taken April 1, 2021; Facing Southwest)

The north and south elevations are two-storeys in height, given that the full basement is visible. The east and west elevation have multiple windows openings (see Image 4 and Image 7). The rear of the building has substantial window openings and features central sliding glass doors that are flanked by large full-height transom windows (see Image 5). The building has a shallow gable roof with overhanging eaves that emphasize the wide, horizontal orientation of the building (see Image 3). A secondary entrance is located on the east elevation.

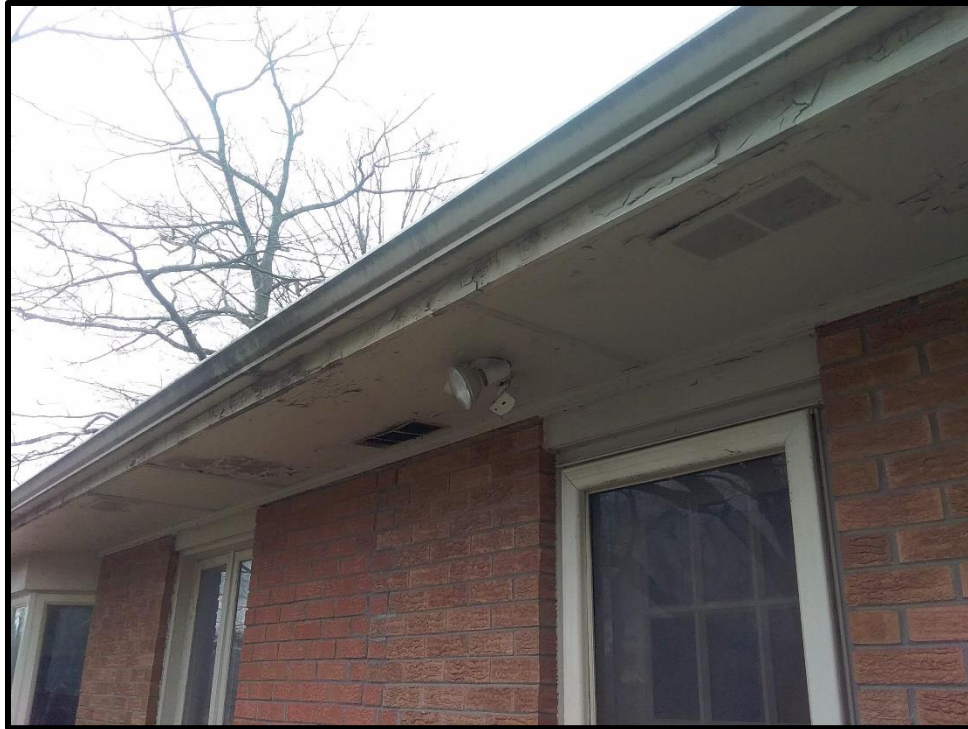
Image 4: East Elevation – 1220 Stavebank Road
(Photo taken April 1, 2021; Facing Southwest)

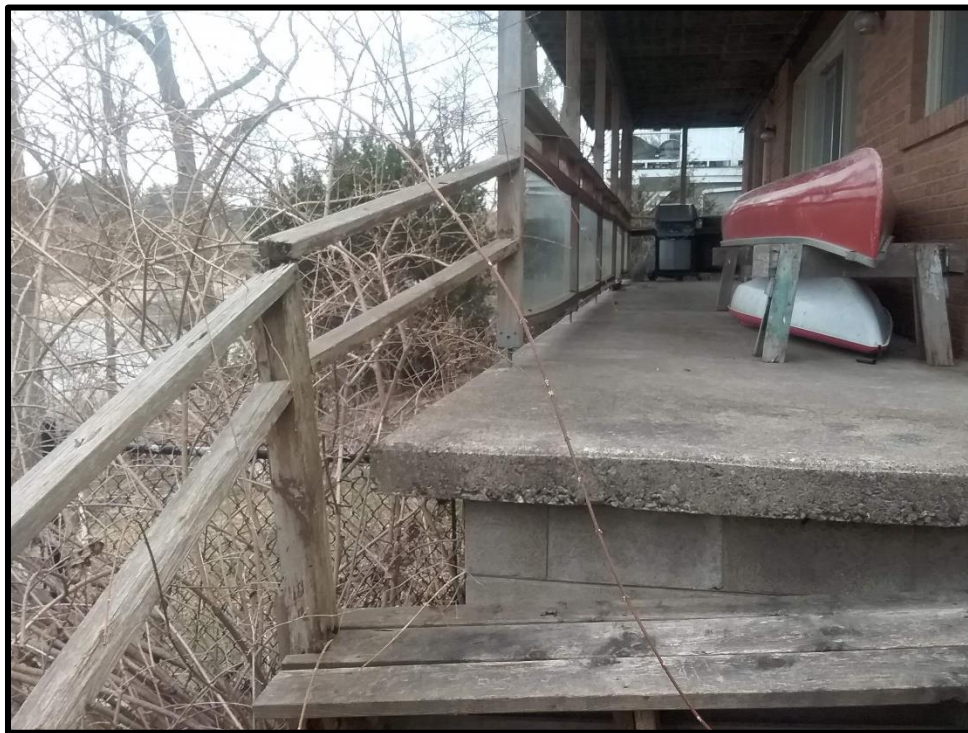
Image 6: Rear Elevation Basement Level Porch – 1220 Stavebank Road
(Photo taken April 1, 2021; Facing West)

A large open wooden porch is located along the rear on both levels. Various sliding doors provide interior access. The porch is supported by wooden posts and cinderblock with large cement flooring (Image 6 and Image 8). A set of wooden stairs provides access to the lower level of the porch; however, the stairs have visible rot. A set of wooden stairs are also located along the eastern elevation, which provides exterior access between levels and to the yard.

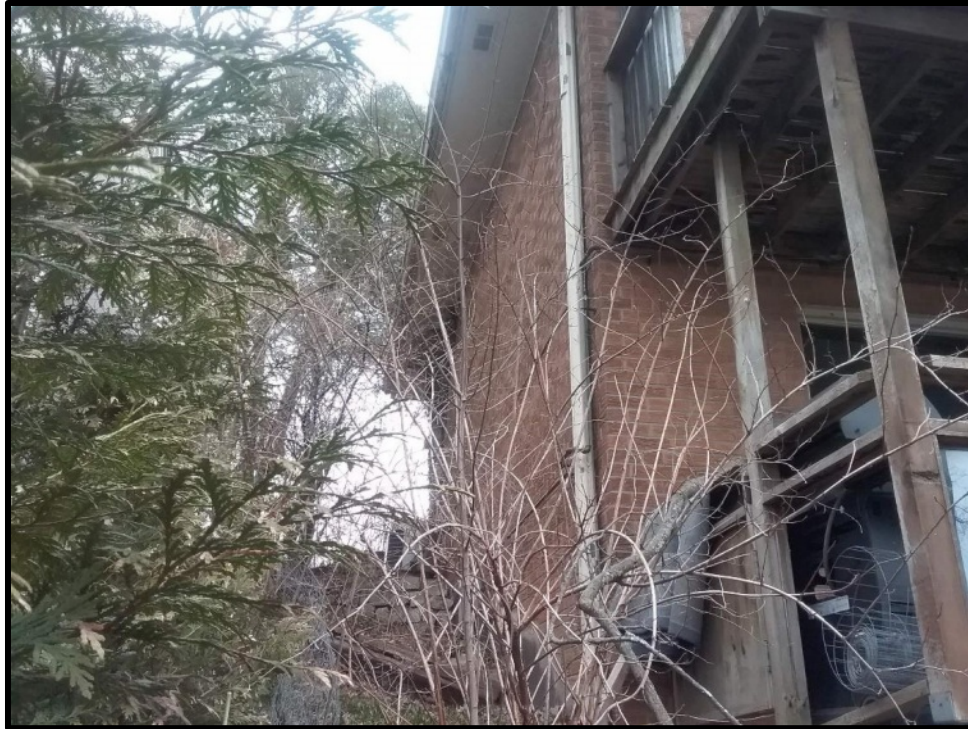
Image 7: West Elevation – 1220 Stavebank Road
(Photo taken April 1, 2021; Facing North)

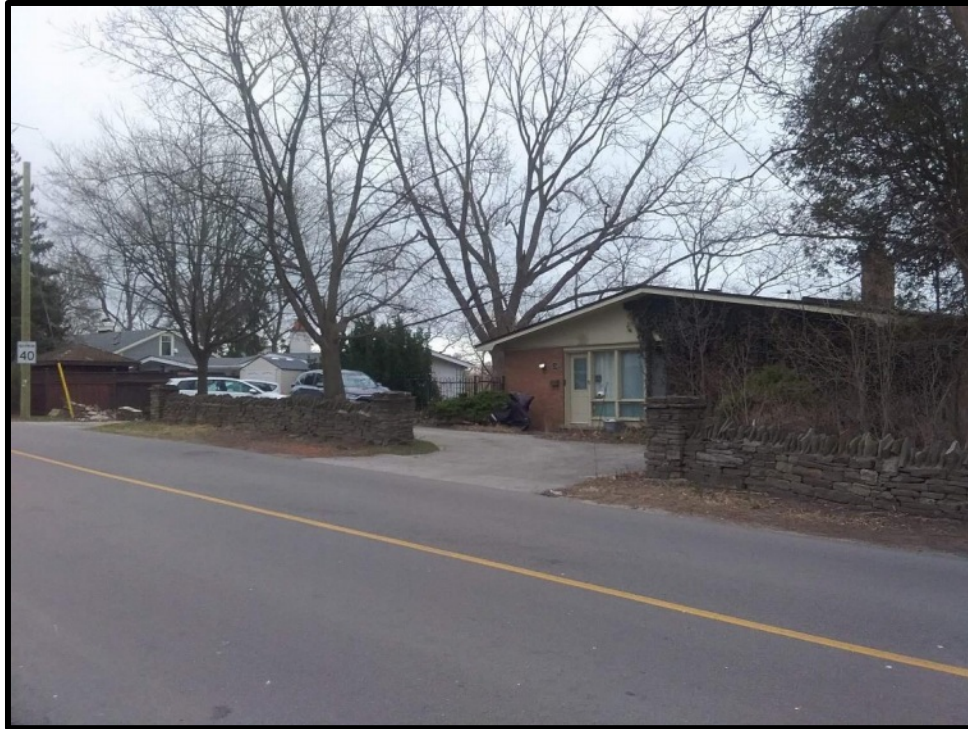
Image 9: Front Yard – 1220 Stavebank Road
(Photo taken April 1, 2021; Facing Southeast)

The property is separated from the street by a low, dry-stone wall that continues northward as far as 1232 Stavebank Road (see Image 21). Two maple trees sit immediately south of the stone wall and are likely contemporary with the house (see Image 11 and Image 12). Access to the house is gained via a u-shaped driveway that comes quite close to the front wall of the building (see Image 9). It is likely that the approach to the building has been graded and levelled.

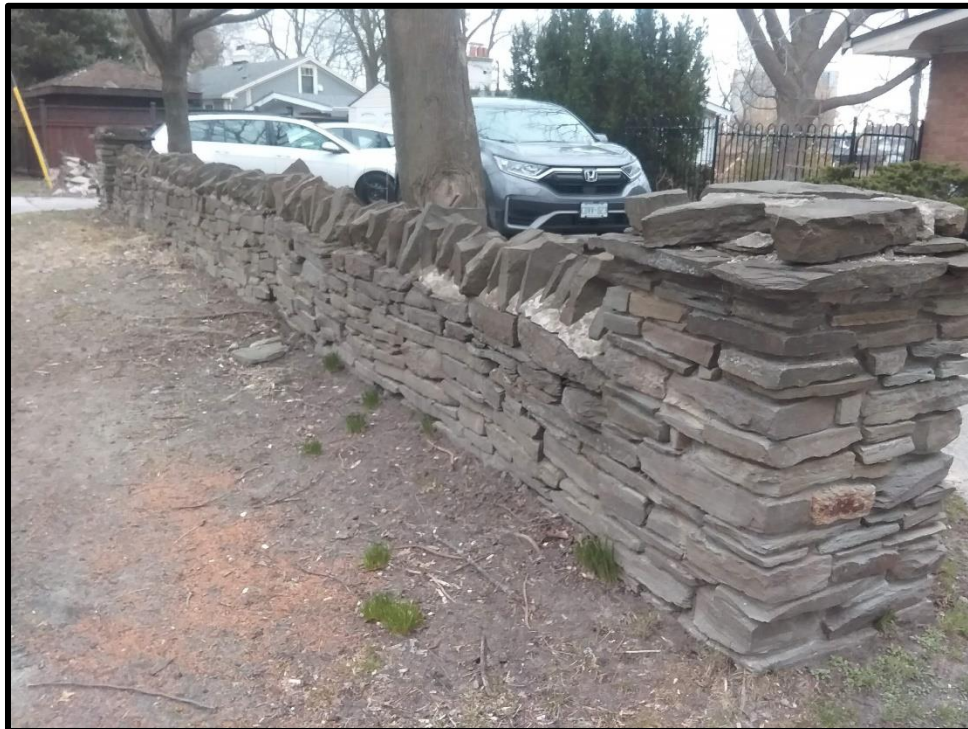
Image 10: Stone Wall- 1220 Stavebank Road
(Photo taken April 1, 2021; Facing Southeast)

1220 Stavebank Road contains a low stone wall which is a significant cultural landscape feature found throughout the neighbourhood. The low stone wall runs along the northern edge of the property, parallel to Stavebank Road. The low stone wall is a dry-stone construction with vertical stone detailing and framed within square end pillars. It is possible that the stone is shale from the Credit River.

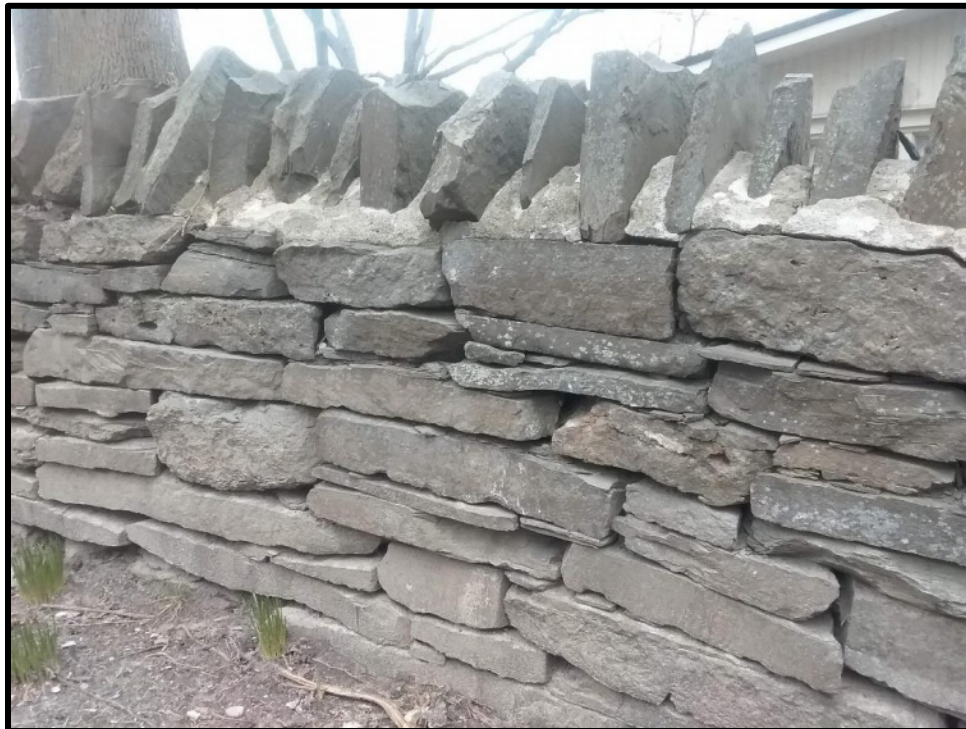
Image 12: Detail of Stone Wall – 1220 Stavebank Road
(Photo taken April 1, 2021; Facing East)

The wall section associated with 1220 Stavebank is of dry-stone construction and appears to be of local material, likely shale. It is capped with vertical oriented stones set in concrete (see Image 12). There are two openings for driveway access and each wall section terminates in a robust square post with loose stones laid horizontally on top. There are three sections to the wall. Two shorter sections on the northern and southern ends of the property and a longer main section. The gaps between sections are created by the driveway openings. The eastern section of wall has collapsed, apparently after it was struck by a car (Image 13).

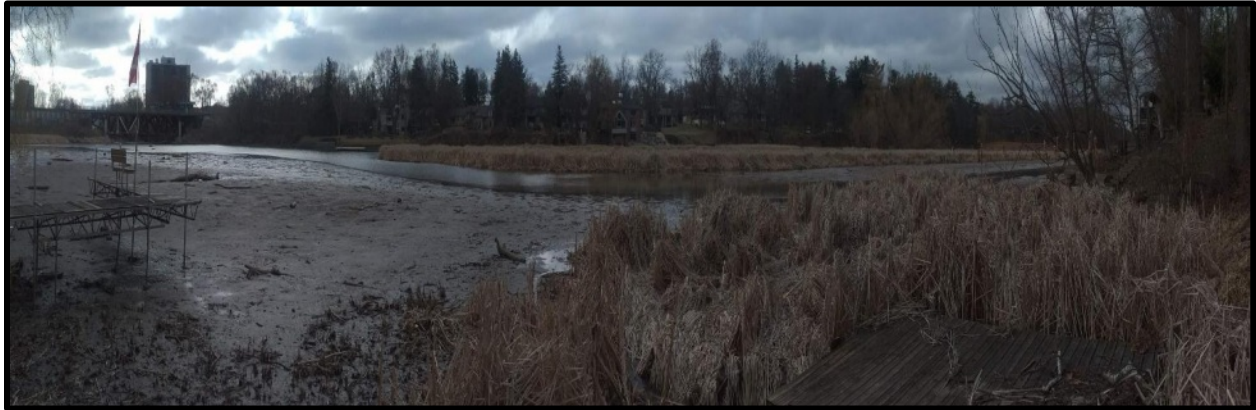
Image 19: Rear Yard and Credit River – 1220 Stavebank Road
(Photo taken April 1, 2021; Facing East to West)

Credit River. The slope of the property from east to west is quite substantial and the property has been terraced to provide level ground for gardens, lawn areas and pathways leading from the house to the CRCA lands (see Image 18, Image 19 and Image 20).

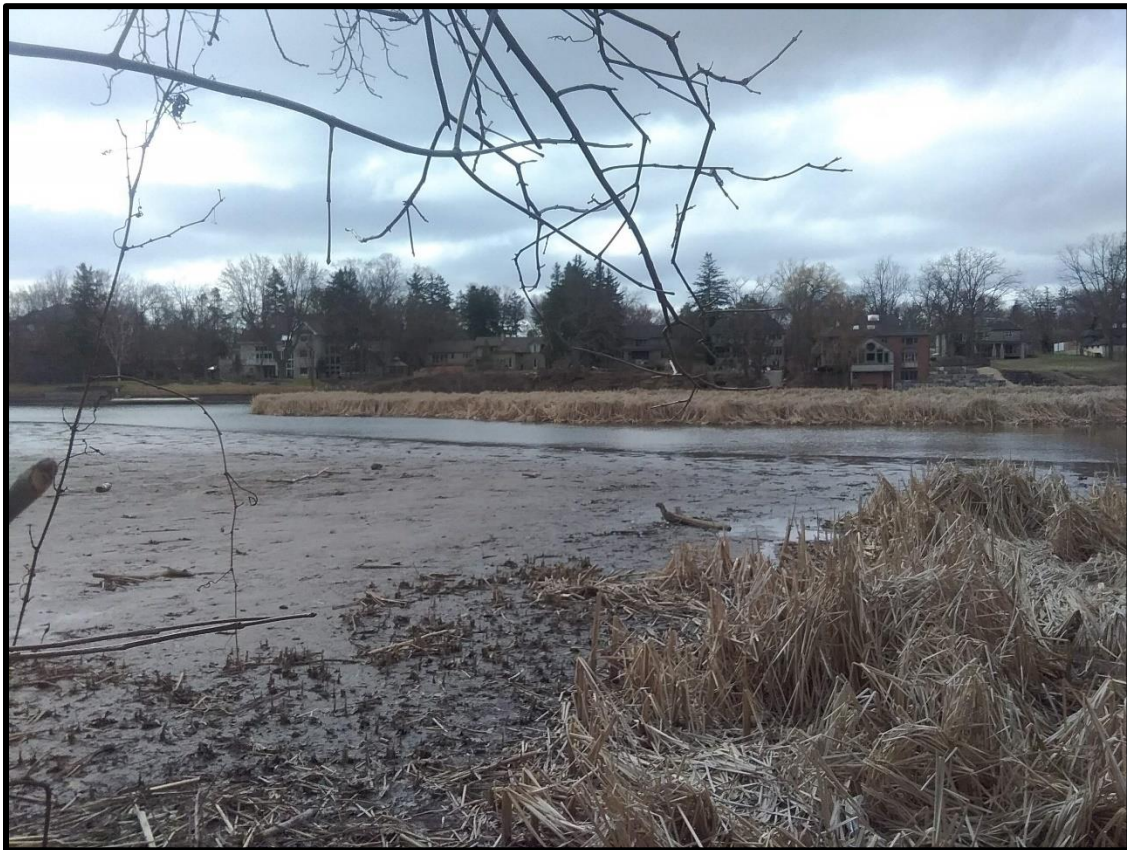
Image 20: Detail of Credit River from Property Edge – 1220 Stavebank Road
(Photo taken April 1, 2021; Facing South)

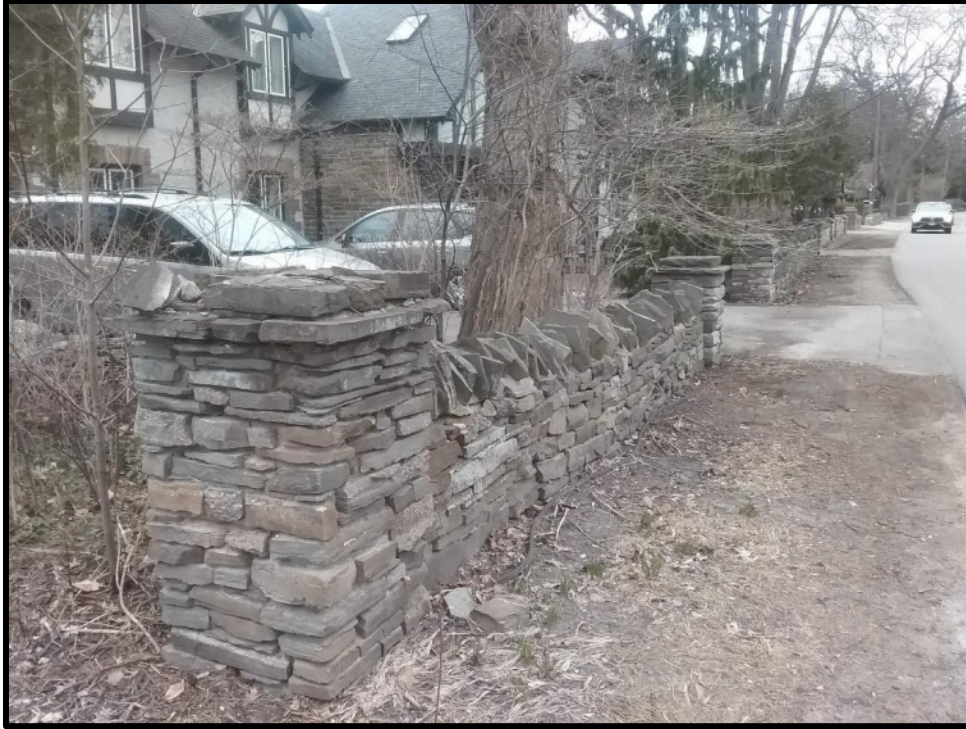
Image 21: Context- Shared Stonewall – 1220 Stavebank Road and 1232 Stavebank Road
(Photo taken April 1, 2021; Facing West)

As noted, the frontage of the property is bounded by a low stone wall that continues across a series of properties along the south side of Stavebank Road (see Image 21). It also occurs intermittently on the east side of the road. The wall is a Special Landscape Feature associated with the Mineola Neighbourhood Cultural Heritage Landscape, as well as other CHLs in Mississauga:

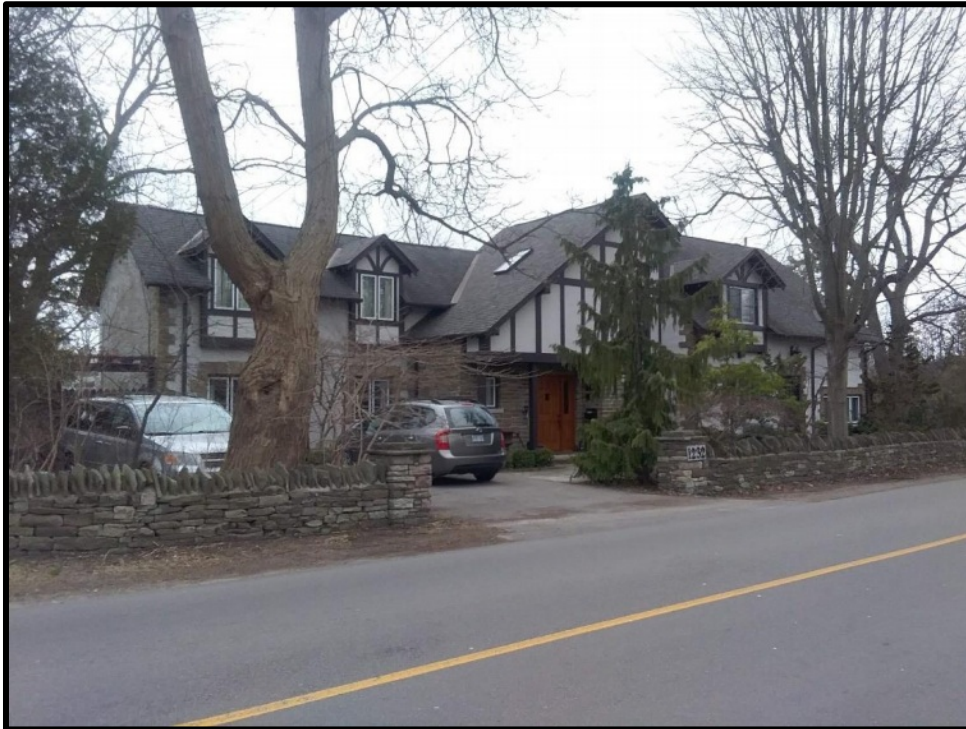
Image 22: Façade- 1232 Stavebank Road
(Photo taken April 1, 2021; Facing Southwest)

The section of stone wall further west along Stavebank Road are not of uniform construction but they do create an overall cohesive appearance along the street. The differences in construction and stone suggest that they were not all constructed at the same time or to the same standard. For example, although superficially similar the wall sections that cross 1232 Stavebank Road, immediately west of the subject property shows more variation in stone colour but greater uniformity in stone size and shape (see Image 22).
