**CULTURAL HERITAGE EVALUATION REPORT  
7044 NINTH LINE**

**HIGHWAY 407 TRANSITWAY TRANSIT PROJECT ASSESSMENT PROCESS  
FROM WEST OF BRANT STREET TO WEST OF HURONTARIO STREET G.W.P. 16-20003**

**CITY OF MISSISSAUGA  
REGION OF PEEL, ONTARIO**

**FINAL REPORT**

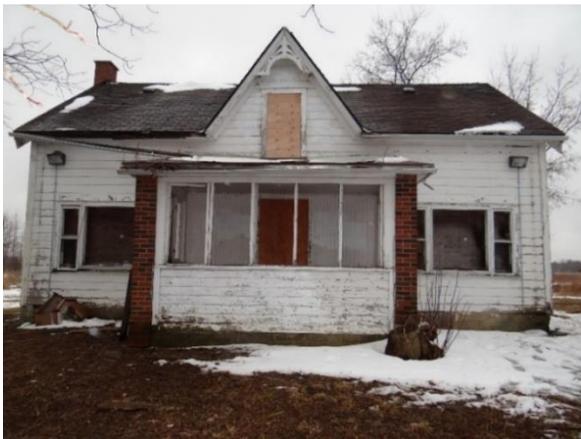
Plate 6: Farmhouse, south elevation.

The front façade (southern elevation) features a covered front porch with square brick pillars, a centre gable with remnants of vergeboarding, a window below the gable and symmetrical windows on either side of the porch. The west elevation of the original structure features two windows on the second floor, a single window on the main floor, and a centrally-located brick chimney. The northern window on the second floor and the main floor window have both been boarded over. The west elevation of the addition has a small window on the second storey and a door on the main floor to cement steps. The door has been boarded over. The north elevation of the original farmhouse features a window on the main floor. The north elevation of the addition features a central window on the second storey and a central window on the main floor. The main floor window and much of that level has been boarded over. The foundation on the northeast corner of the addition was crumbling at the time of field inspection, causing concern regarding the structural integrity of the residence. ASI staff were advised to avoid this area in the interior of the residence. The east elevation of the frame house features two windows on the second floor, a door on the main floor, and a covered window on the main floor. The east elevation of the addition features a central gable with dormer on the second floor. The main floor features a door and two windows which have all been boarded over. The door leads to a patio with cement patio stones.

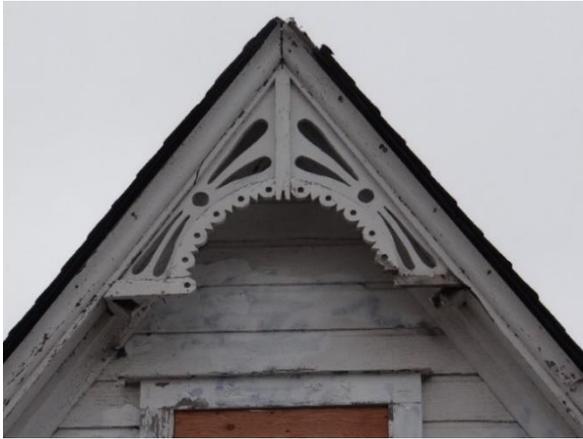
Plate 10: Vergeboarding on the south elevation.

Some elevations feature remnants of a vergeboarding along the eaves. The roof of the structure has been covered in asphalt shingles. The original structure has slightly pedimented surrounds on doors and windows that are not featured on the addition. There are original window frames in the original structure and some in the addition. Storm windows have been added throughout. There is wood siding over larger wood planks and the siding is slightly different between original building and the addition.

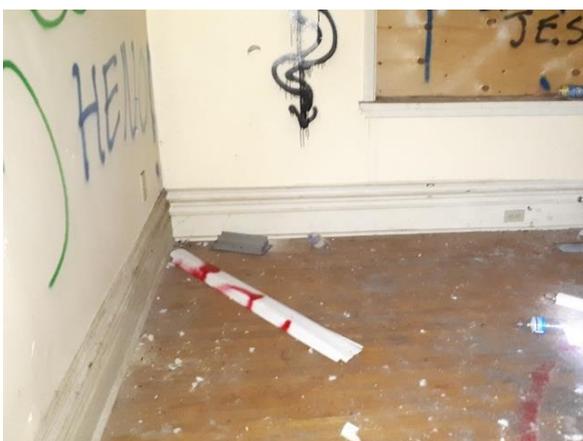
Plate 22: Detail of tall baseboard and wood flooring.

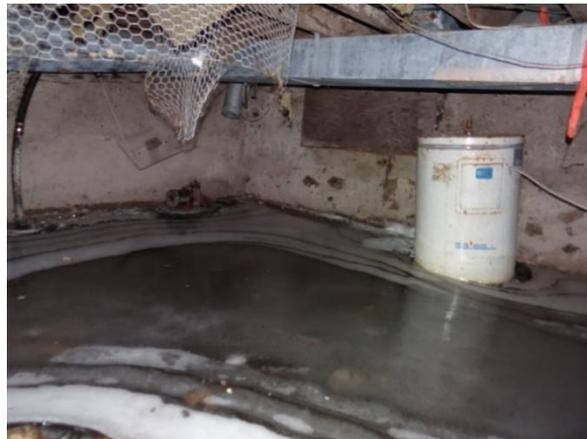
Plate 29: Detail of flooded basement.

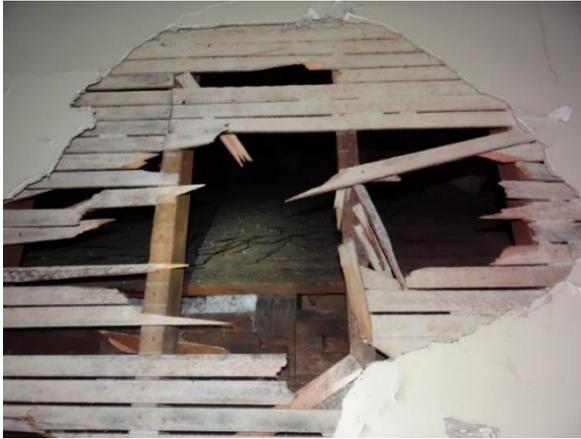
Plate 32: Detail of the original structure's roof with cedar shingles.

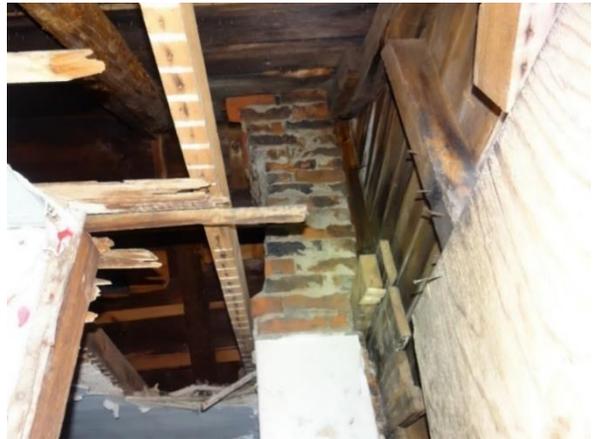
Plate 39: Detail of the chimney from the second floor to the exposed ceiling.

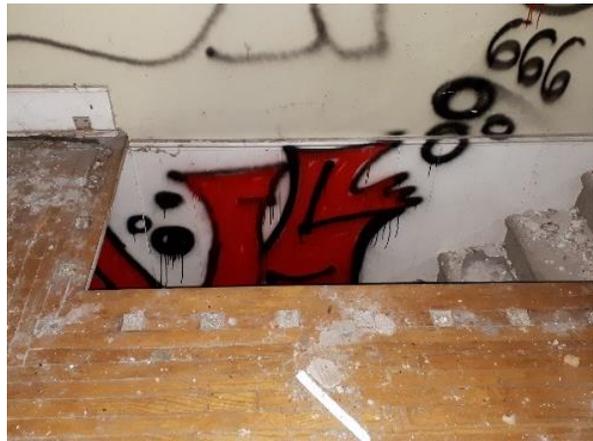
Original or early baseboards remain in some of the second floor bedrooms in the original structure. In the rooms that are not carpeted, there is wood flooring, but these are not likely original. The newel posts are either damaged or removed from both staircases leading to the second floor (Plate 43).

Plate 43: Detail of staircase and remnants of newel posts in the original portion of the house.

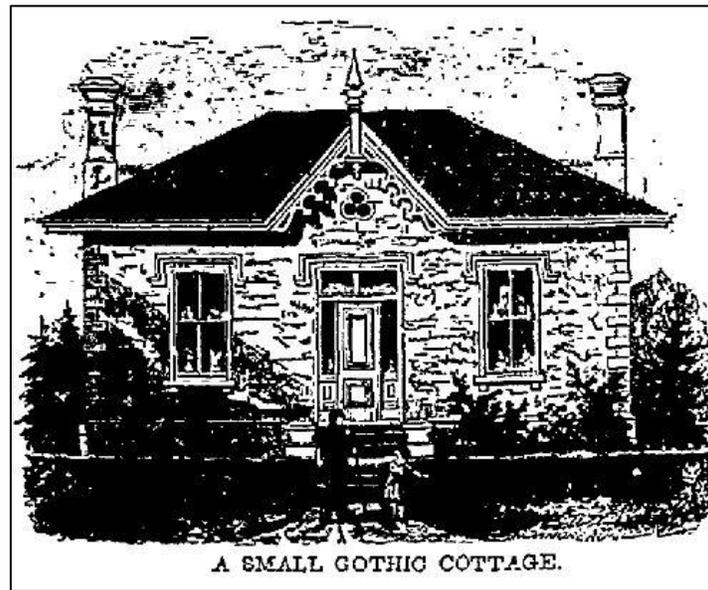
Gothic Revival residences are notable for their centre gables and use of Gothic detailing, including Gothic arched windows, vergeboarding and finials. This style was one of the most common styles in Ontario amongst European settlers, often taking the form of a vernacular cottage. This largely stemmed from a depiction of a Gothic Revival cottage in an 1864 issue of the *Canada Farmer* (Figure 10). While architect-designed Gothic Revival buildings are found throughout Ontario, the prevalence of the Gothic Revival style is owed more to the availability of plans and forms set in pattern books that were popular with the middle-class, farmers and other rural settlers (Mikel 2004). These houses were one-and-a-half storeys, would have a gable-end, symmetrically balanced with a central door flanked by a window on either side. The houses would be individualized with available details and finishes (Mikel 2004). Another feature was the use of two tones of brick, usually a red brick with buff or yellow brick to highlight. This is known as dichromatic brickwork, which was a vernacular attempt at producing the polychromatic effect (Blumenson 1990).

Figure 10: A drawing of a Gothic farmhouse from the 1864 Canada Farmer (N.A. 1864)
