## HERITAGE IMPACT STATEMENT

### DEMOLITION OF EXISTING GARAGE AT HARDING WATERFRONT ESTATE

This report is prepared to address the proposed demolition of an existing garage and loft located on the Harding Waterfront Estate, 2700 Lakeshore Rd. W., Mississauga ON.

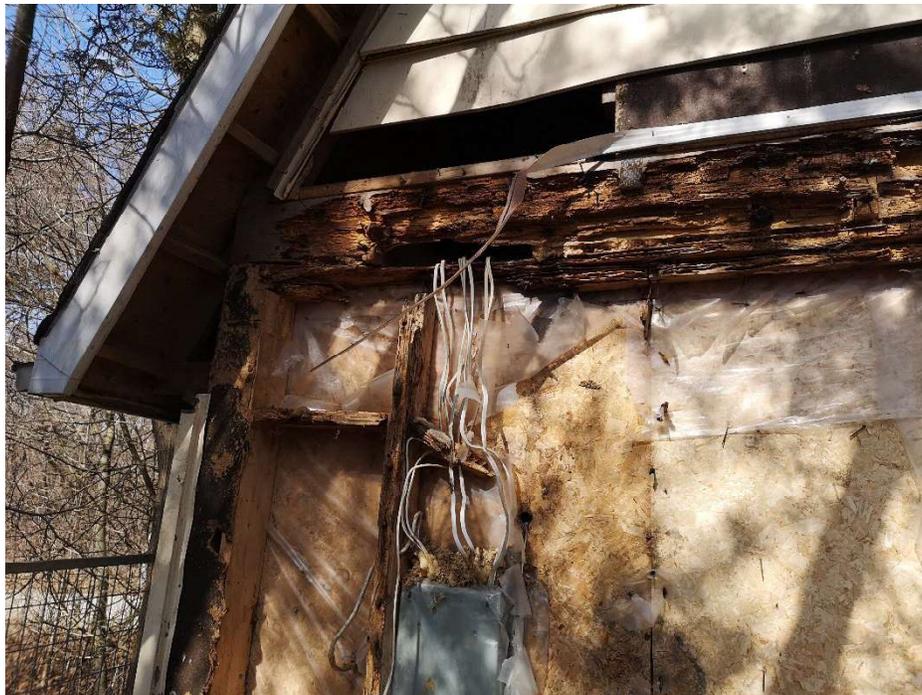
**SIGNIFICANT ROT OF FRAMING MEMBERS ON REAR ELEVATION**

The overall condition of the front and side elevations is fair, with some aging apparent but no obvious issues. The building appears straight and square. The rear elevation is in very poor condition, with the majority of the siding and sheathing missing, exposed framing, obvious rotted members and missing members.

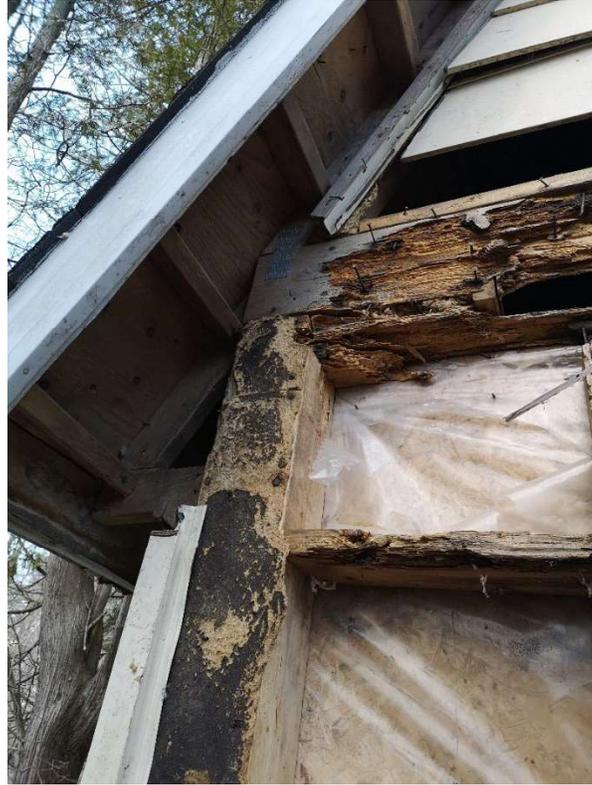
**DETAIL SHOWING ROTTED MEMBERS, NEWER ROOF FRAMING, ALUMINUM SIDING AND FASCIA**

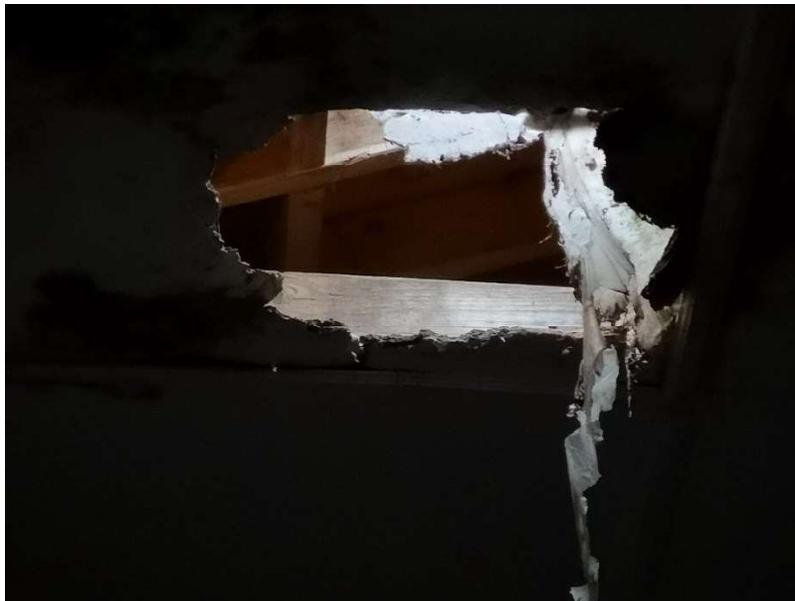
The interior is in fair condition although full of refuse. There is a hole in the roof approximately 0.5m x 0.5m. There is a newer electrical panel and service on the rear wall of the building, although the power appeared to be disconnected.

**HOLE IN CEILING**

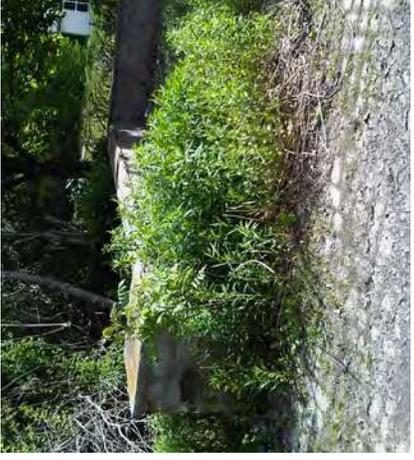
4. LOW STONE WALLS

4. Low credit valley stone walls enclose the roundabout in front of the house. The overgrowth needs to be cleared away and some minor repairs made.

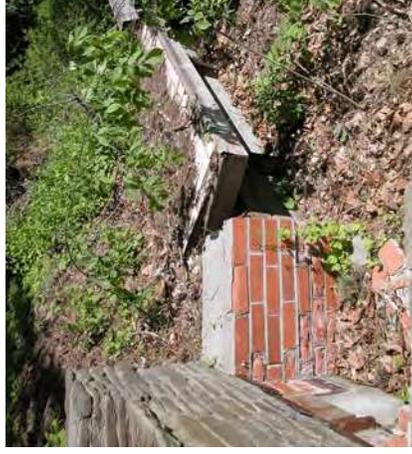
11. SITTING

11. Walls require some repair work, cleaning and clearing to make this area usable.

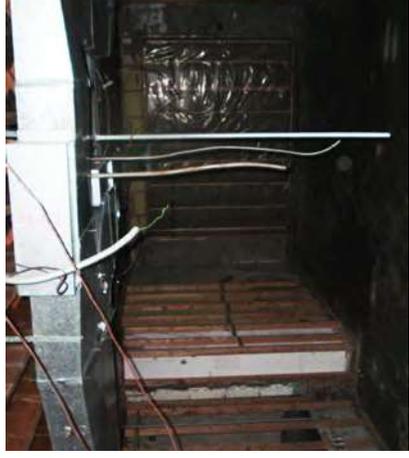
16. FORMER LIBRARY/GAMES ROOM

16. The large doors at the south side of this room were damaged by vandals and the openings are currently protected by plywood and insulation.

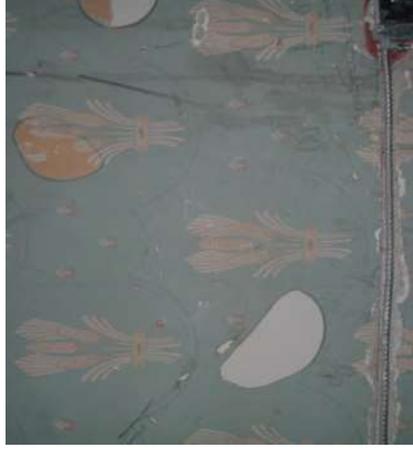
31. WALLPAPER

31. During the last renovation much of the original detailing was damaged or completely lost. This sample of the original wallpaper was found behind the drywall.

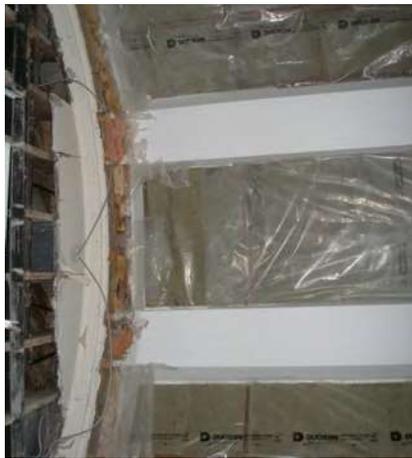
32. OFFICES

32. All of the windows have been damaged by vandals.

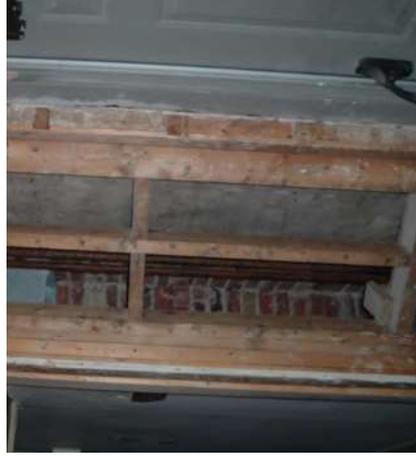
36. MAIN ENTRANCE

36. As can be seen in this photo and the previous photo the drywall has been removed from this space during the remediation work.

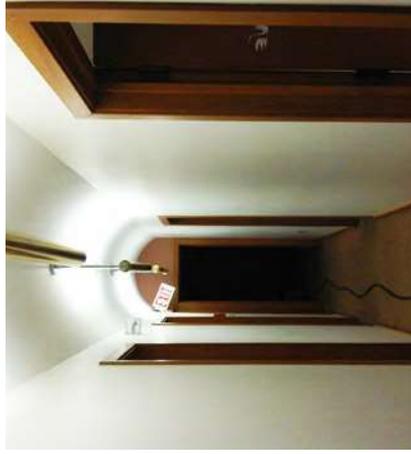
41. HALLWAY

41. No original finishes have been found on the second floor. Since this photo was taken the ceiling has been removed under a previous heritage permit.

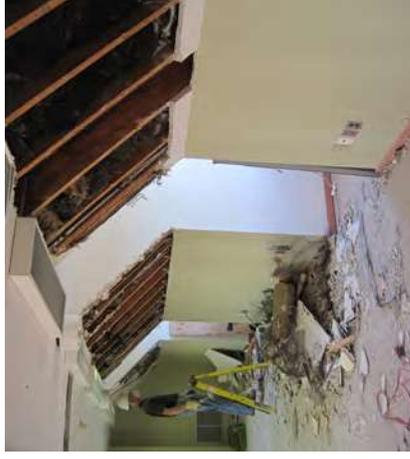
57. THIRD FLOOR CORRIDOR

57. Dormers provide natural light to the third floor. They were damaged by vandals.

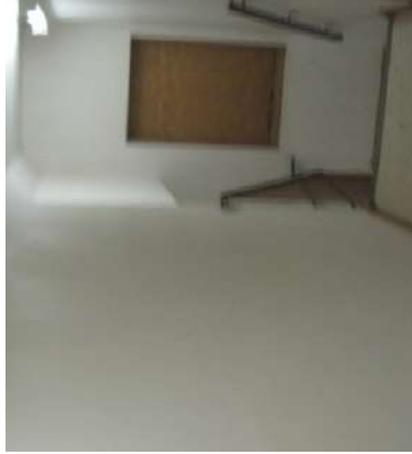
61. EMERGENCY STAIRS

61. These stairs were added in 1984 to provide egress from the third floor to the exterior at grade.

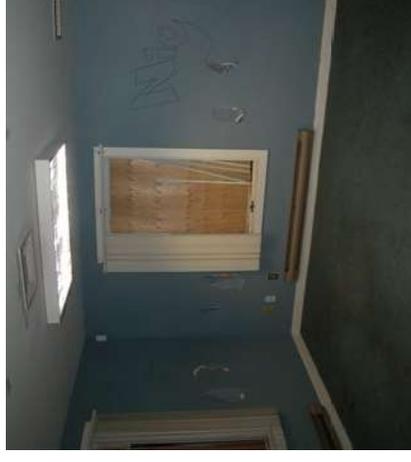
79. CONFERENCE ROOM (FIRST FLOOR)

79. Visible signs of vandalism in the form of graffiti and damaged drywall.

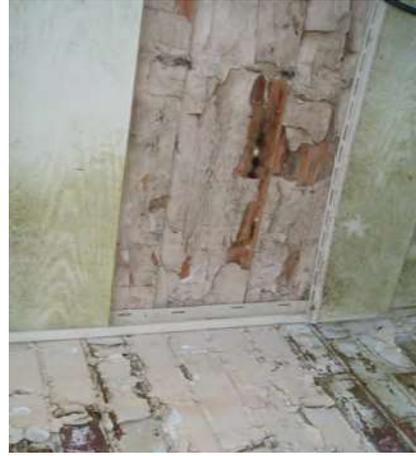
88. SIDING

88. Wood siding was found beneath the vinyl siding.
