**To: City of Mississauga  
Community Services – Culture Division**

**Re: Structural Assessment of the Existing Detached Garage**

**Subject Property: 7025 Pond Street, Mississauga, Ontario**

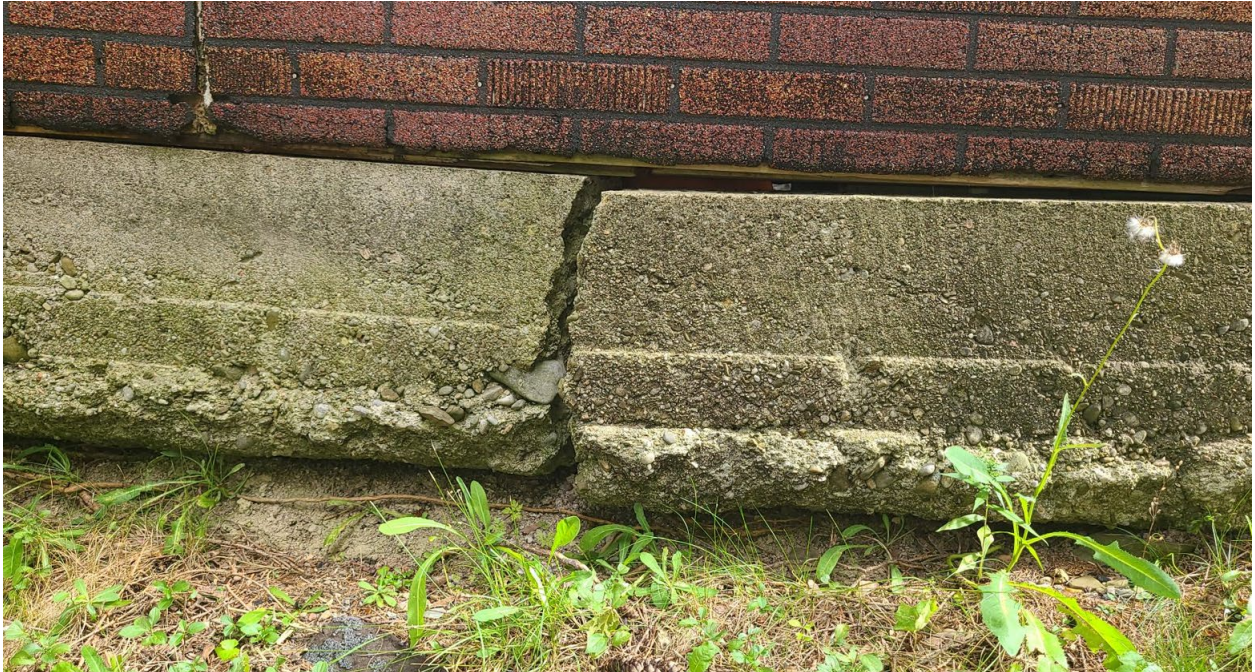
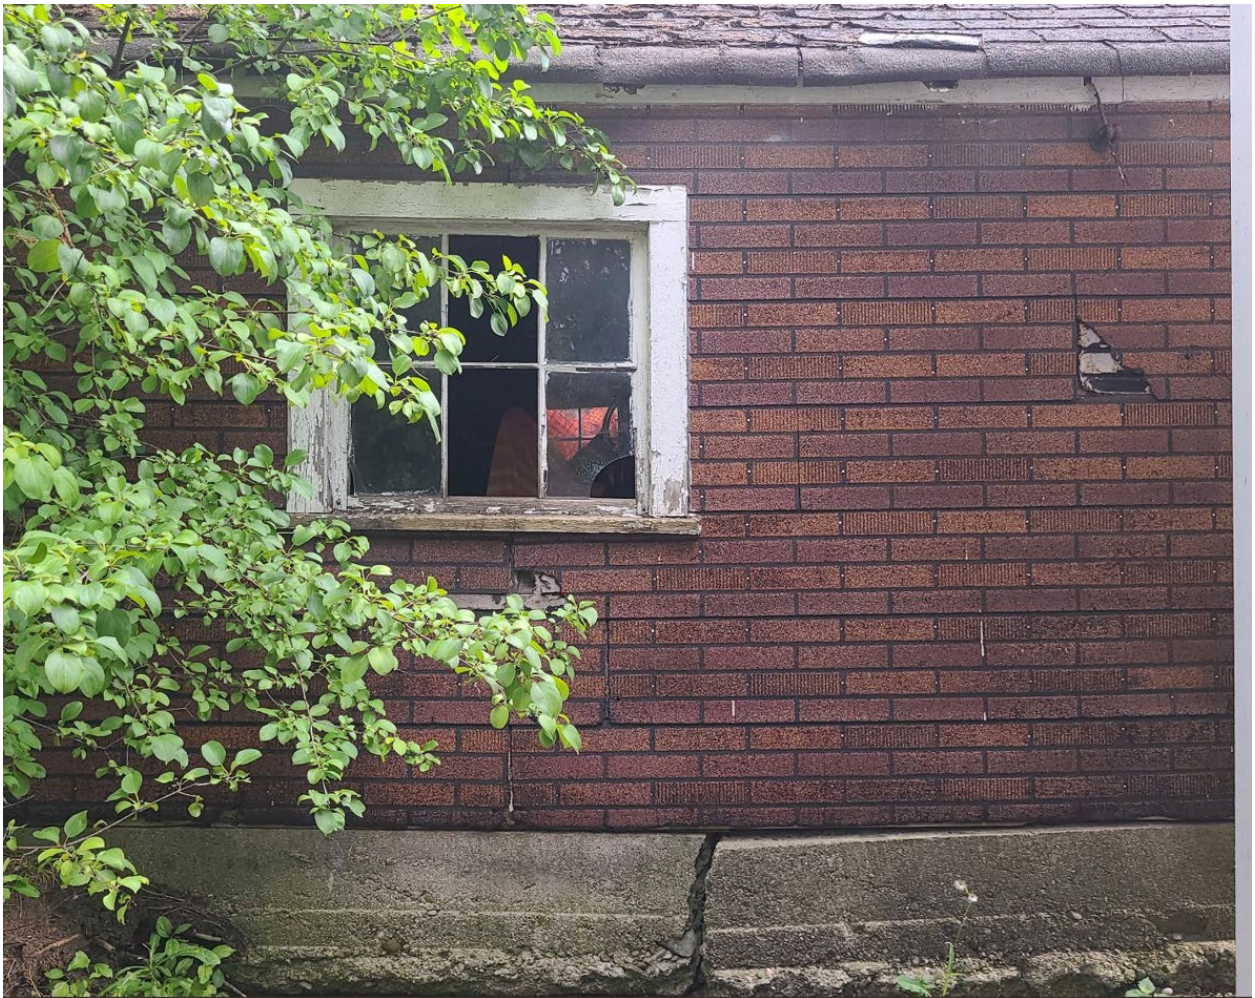
Per our observations and with reference to the photos presented in this report, the subject detached garage is constructed on a concrete slab. There is no footing extended below the frost depth of 4' on the perimeter of the slab, nor there is any evidence of rigid insulation presence. As shown on the photos, wide cracks due to settlement had occurred on the exterior face of the concrete slab. In addition, erosion under the slab is verified. Knowing that the framing of garage is supported on the settled concrete slab, there are evidence of movement and misalignment along the framing caused by movements to the slab.

Our conclusion based on above discussed observations is that the structural integrity of the existing detached garage has been adversely compromised and is considered a cause for safety hazard.

Due to extent of the damages to the concrete slab, remedial solutions are not feasible. Thus, we strongly recommend the detached garage to be demolished and a new garage in compliance with the current Ontario Building Code requirements and applicable by-laws to be built.
