**Re: Structural Assessment of the Existing Detached Garage**

**Subject Property: 7025 Pond Street, Mississauga, Ontario**

March 14, 2023

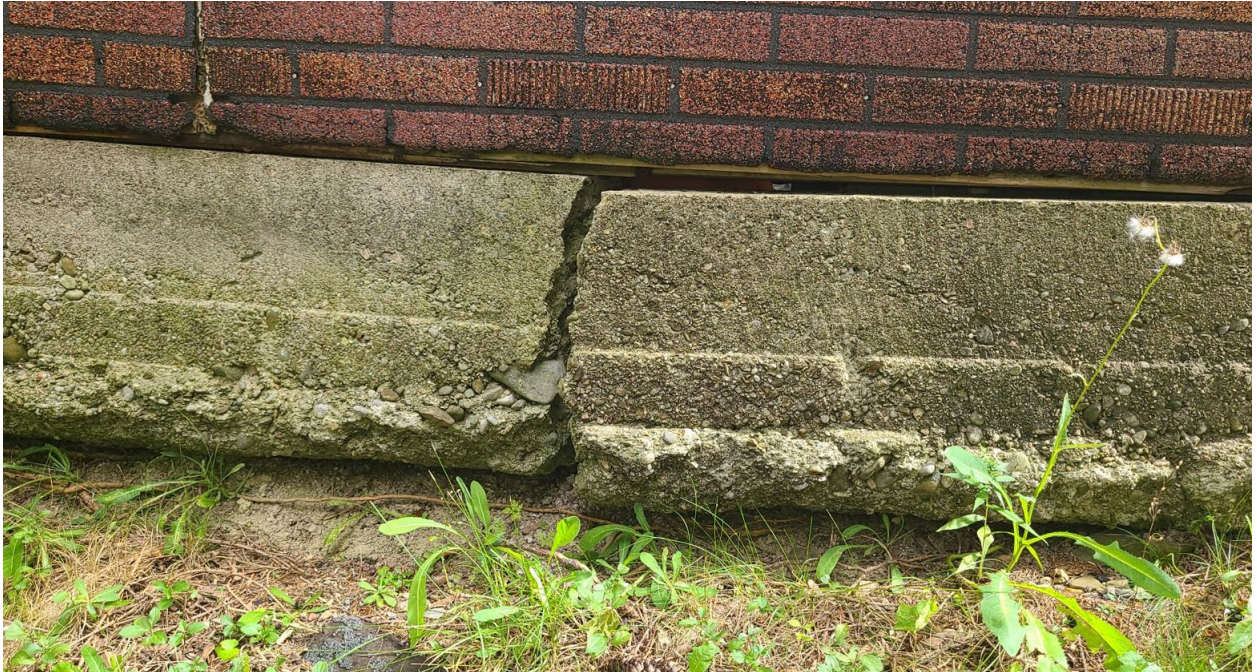
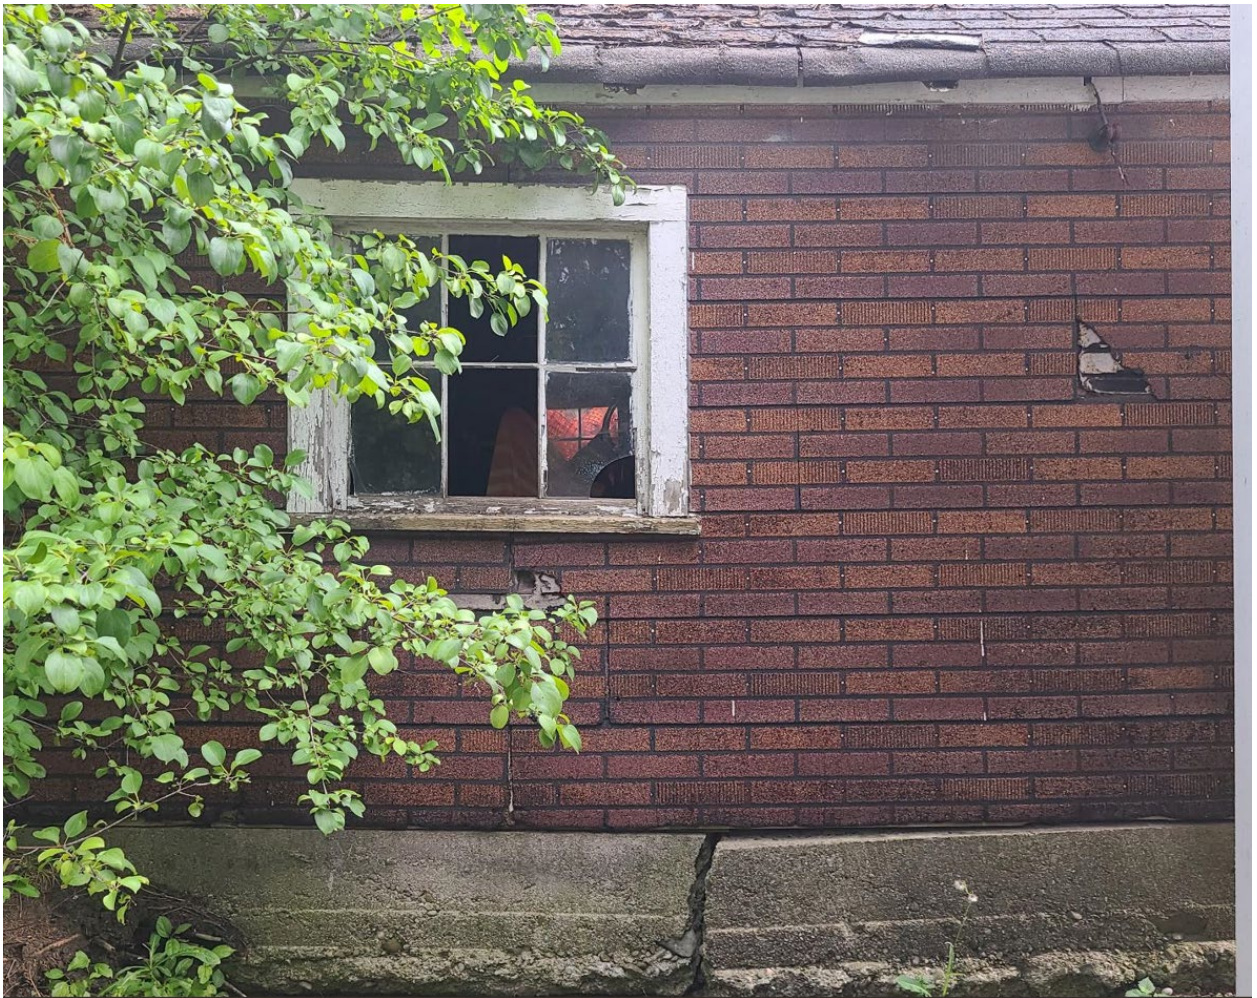
Per our observations and with reference to the photos presented in this report, the subject detached garage is constructed on a concrete slab. There is no footing extended below the frost depth of 4' on the perimeter of the slab, nor there is any evidence of rigid insulation presence. As shown on the photos, wide cracks due to settlement had occurred on the exterior face of the concrete slab. In addition, erosion under the slab is verified. Knowing that the framing of garage is supported on the settled concrete slab, there are evidence of movement and misalignment along the framing caused by movements to the slab.

Our conclusion based on above discussed observations is that the structural integrity of the existing detached garage has been adversely compromised and is considered a cause for safety hazard.

Due to extent of the damages to the concrete slab, remedial solutions are not feasible. Thus, we strongly recommend the detached garage to be demolished and a new garage in compliance with the current Ontario Building Code requirements and applicable by-laws to be built.
