HERITAGE IMPACT ASSESSMENT

2465 SHEPARD AVENUE
COOKSVILLE, MISSISSAUGA

27 APR 2020_FINAL REPORT

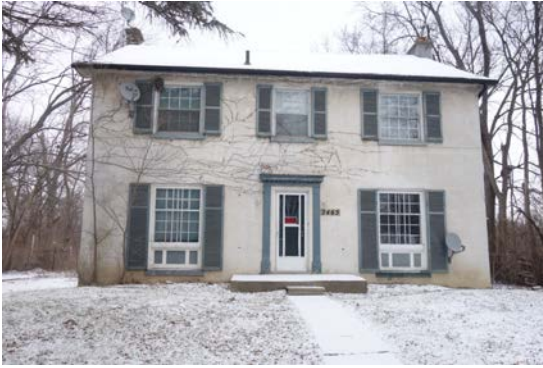
Left: Front elevation

The subject dwelling is currently vacant and boarded up. The house appears to be constructed of brick with stucco applied directly on top of the brick. Some minor condition issues were noted with the stucco as a result of improper maintenance including uncontrolled ivy, missing downspouts, improper installation of satellite discs. Other issues were more serious including the loss of stucco on the chimneys and settlement cracks below windows sills.

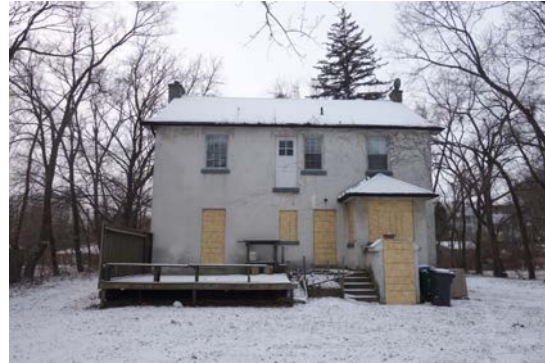
Right: Rear elevation

The roof was not inspected but there were indications on the interior of leaks including damaged plaster and water staining in bedrooms on the 2nd floor. There was significant evidence of flooding in the basement and the conditions in that area were damp.

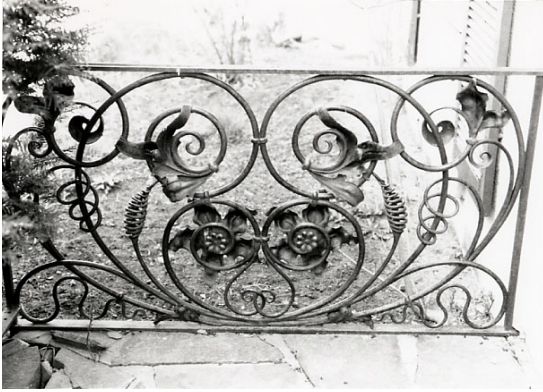
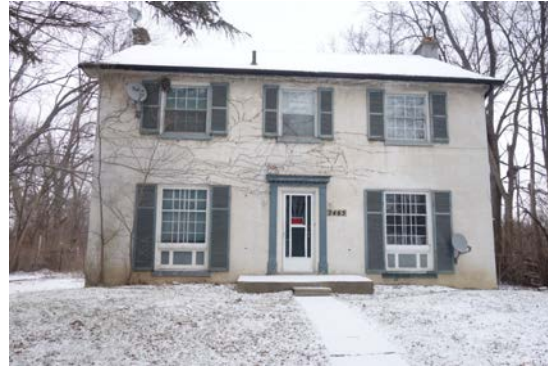
It was noted during site investigation that the 'decorative ironwork' described in the listing has been removed. It was also noted that other heritage elements are in poor condition. The stucco has failed on the chimneys and is cracking in several other locations. The wood components including the Neo-classical door surround, the windows, window panels and window shutters are intact but have not been well maintained.

Original ironwork on the front porch shown in historic photos is missing

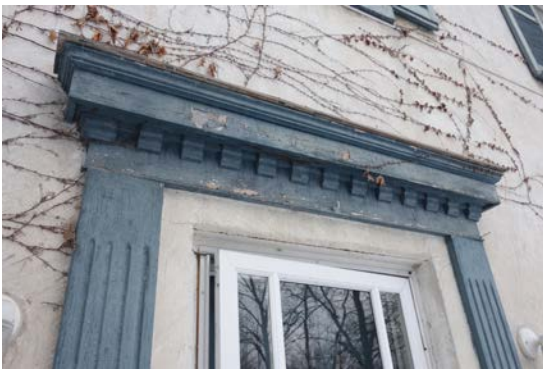
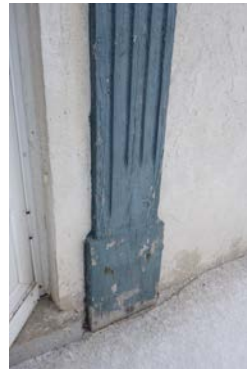
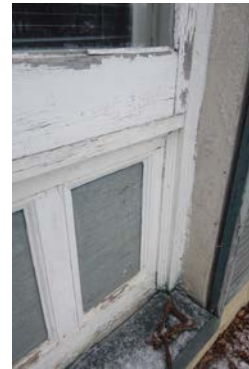
Architectural woodwork on the exterior has not been well maintained and is not properly protected with paint and caulking. Therefore, in general, the exterior woodwork including the door surrounds, wood windows, wood shutters, wood soffits and fascia boards are in poor condition.

Original wood components are intact but have not been well maintained

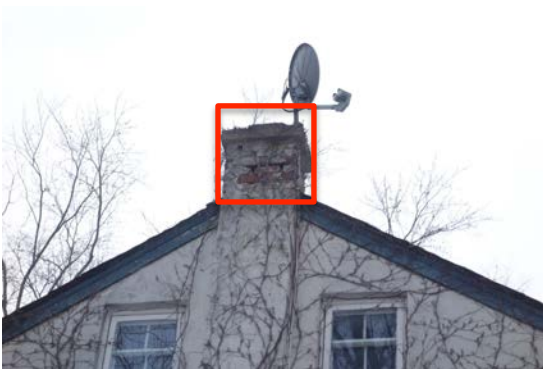
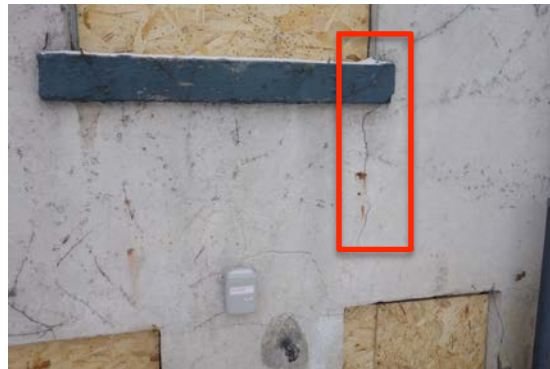
Original lime stucco has failed on the chimneys and is cracking in other areas

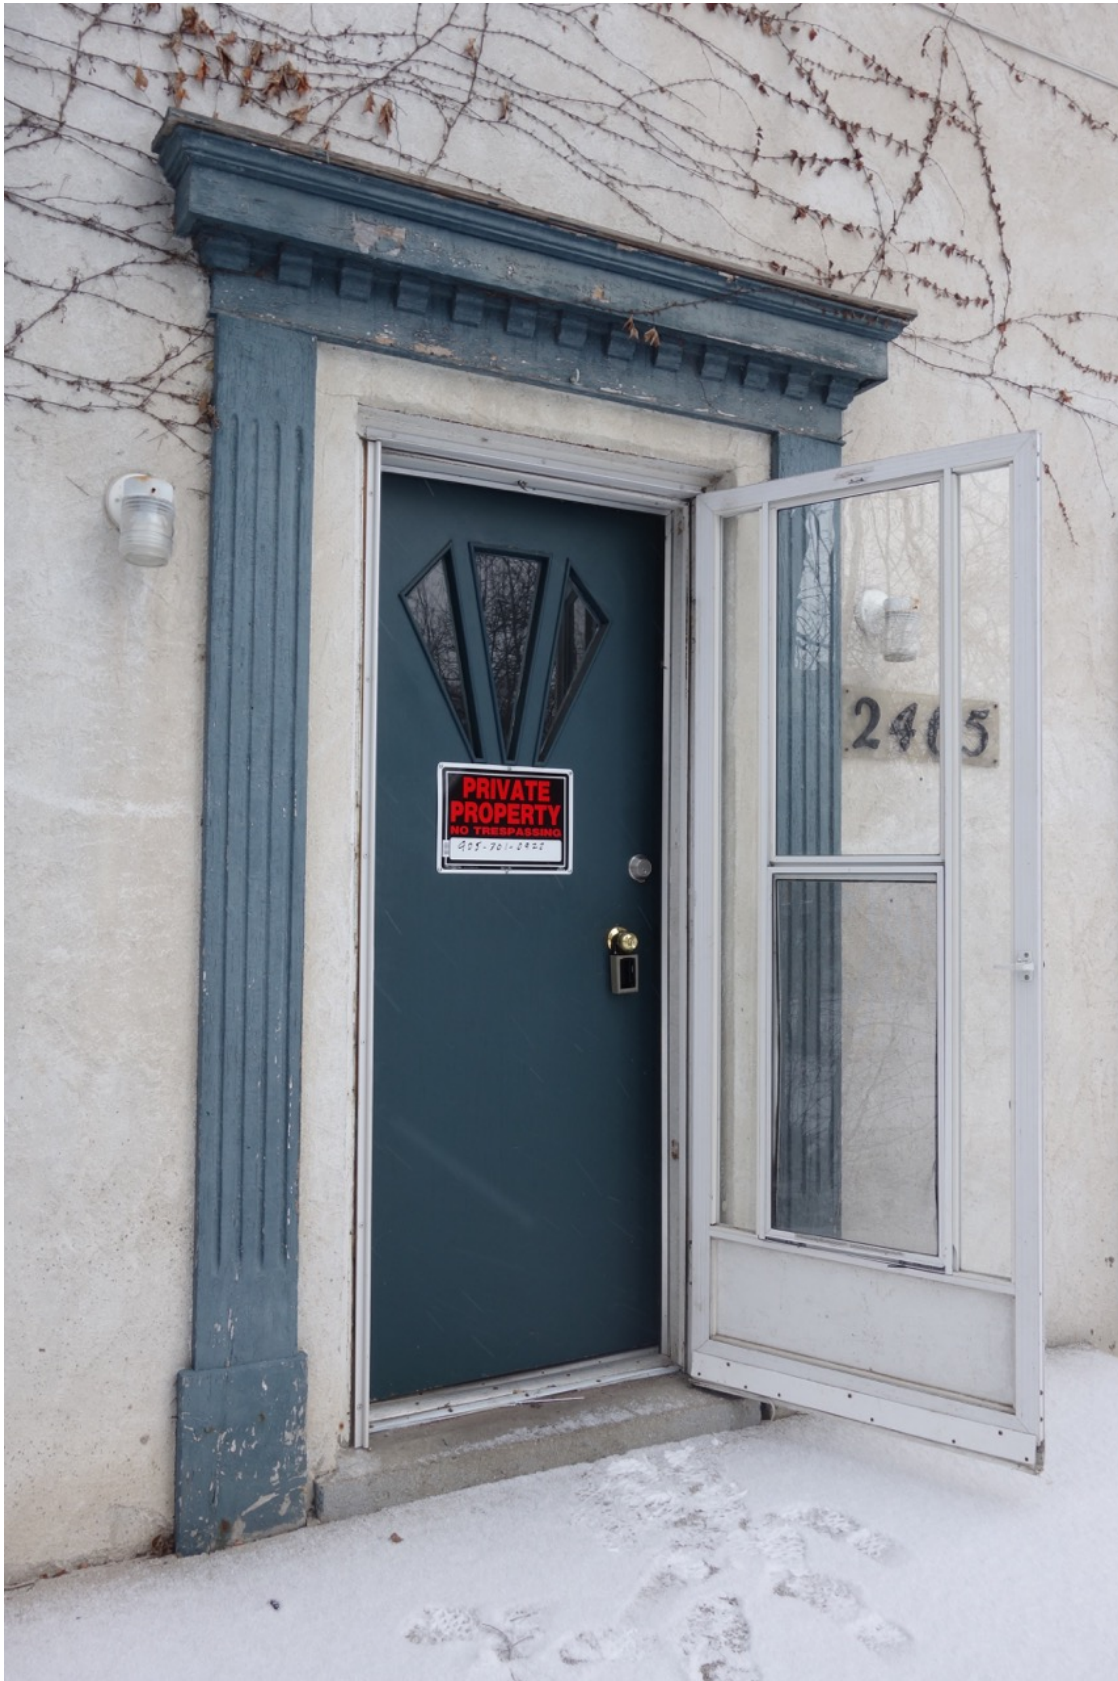
MAIN ENTRANCE – replacement door – exposed wood where paint finish has failed

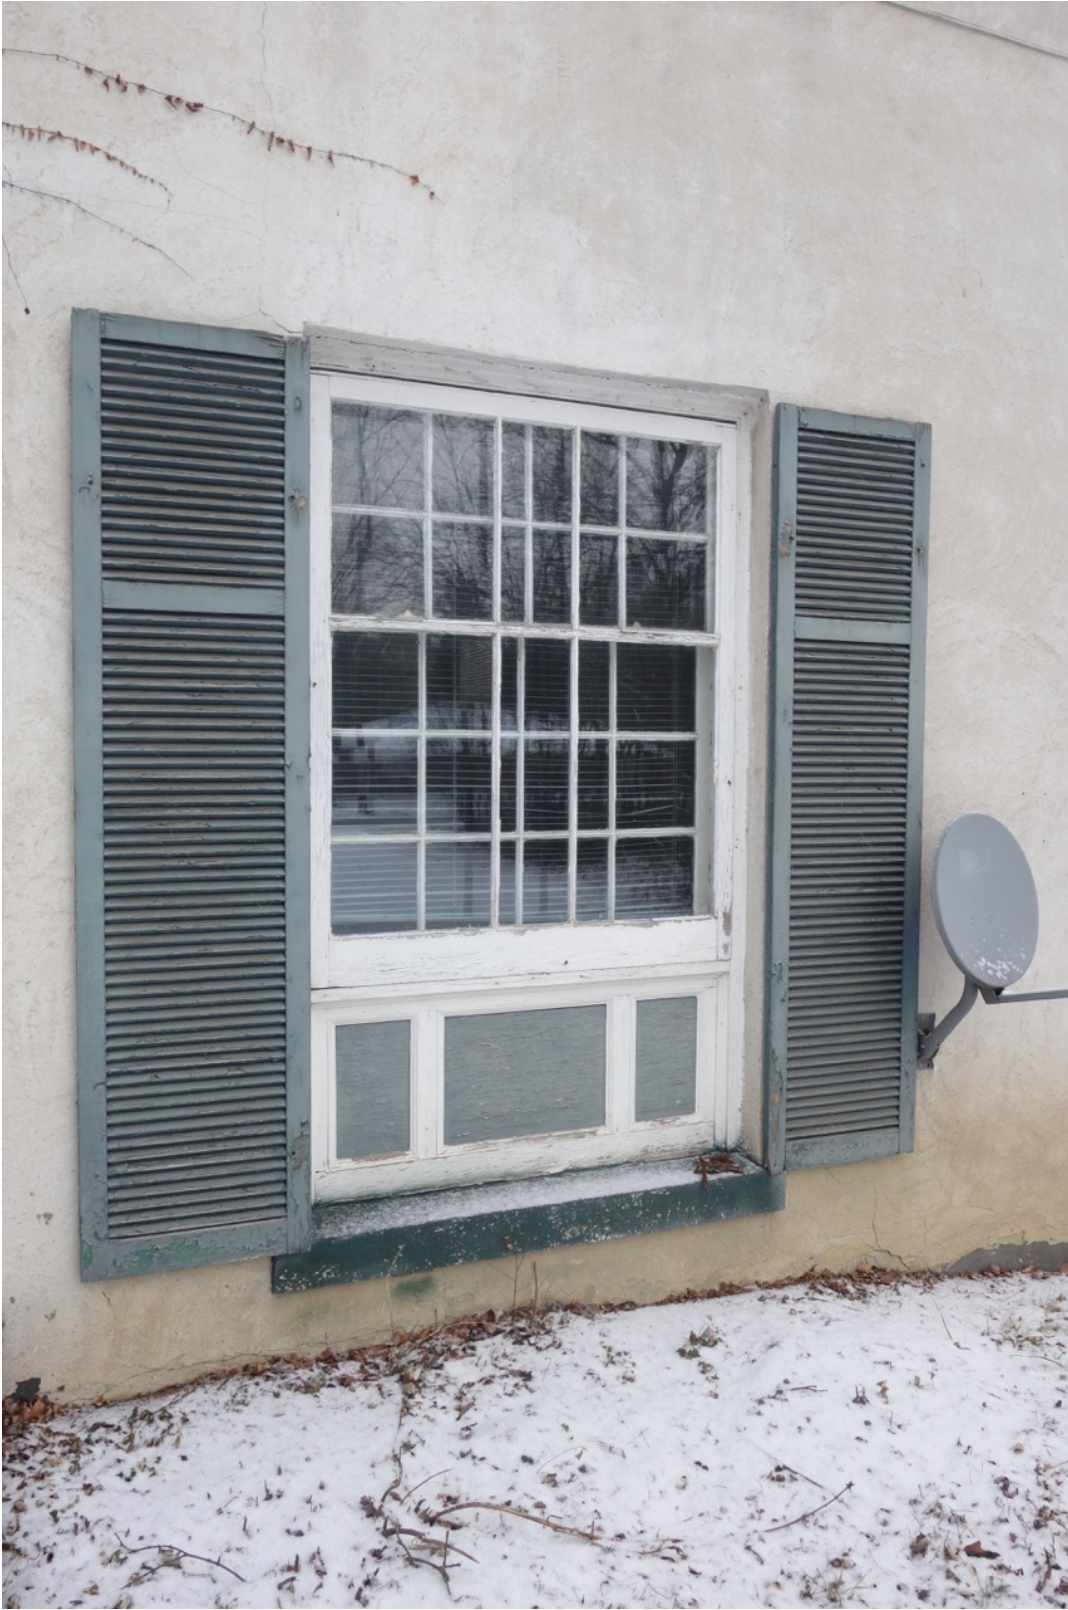
GROUND FLOOR WINDOW ON MAIN ELEVATION – 8 over 12 configuration - new putty, paint and some repairs needed on wood windows, shutters and paneling

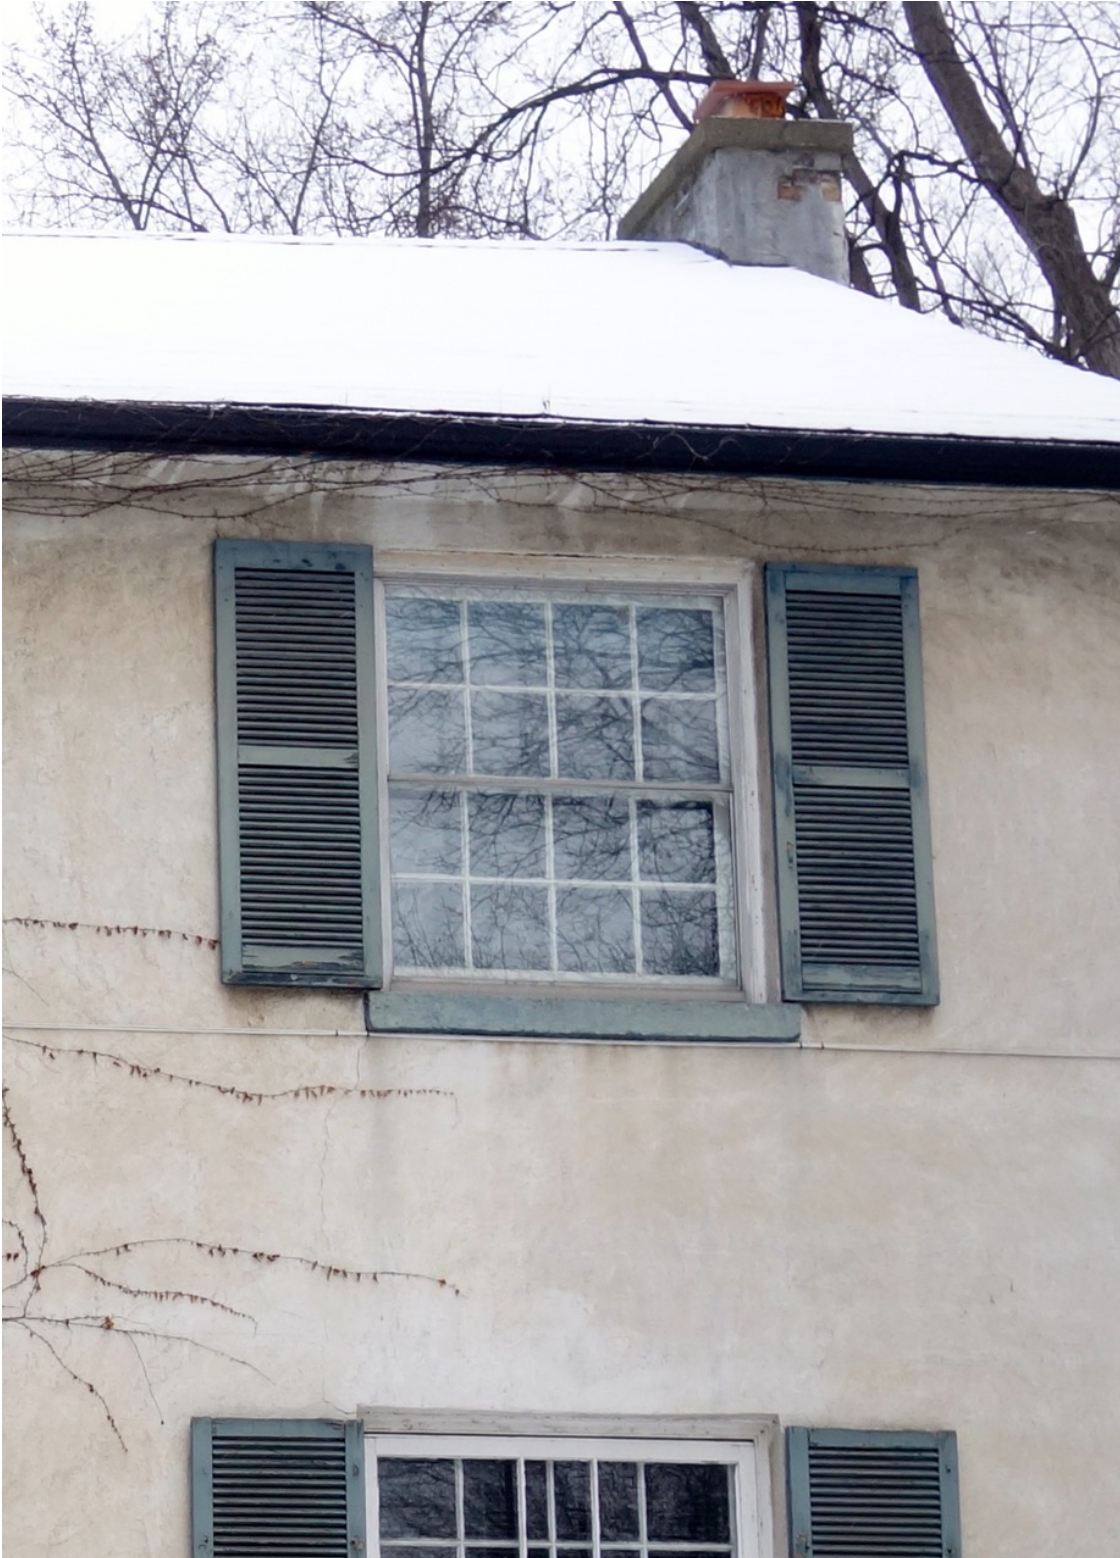
2nd FLOOR WINDOW ON MAIN ELEVATION – 8 over 8 configuration - new putty, paint and some repairs needed on wood windows and shutters

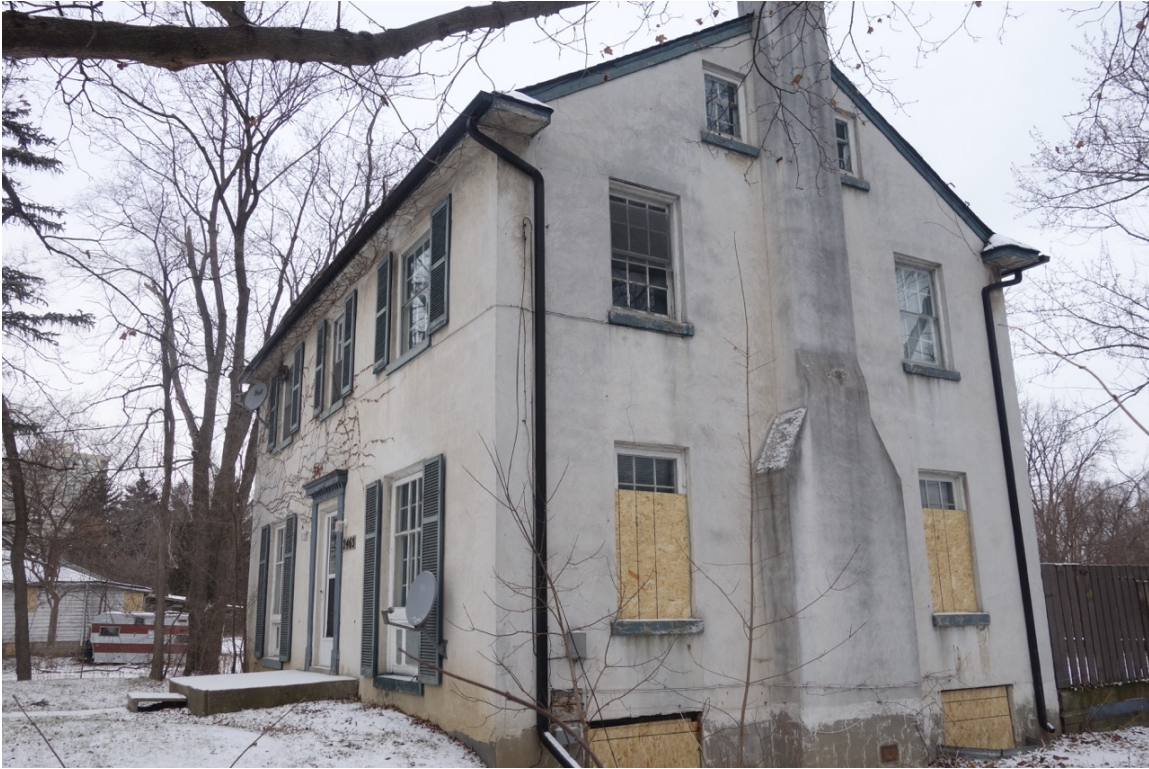
FRONT & SIDE ELEVATIONS – carbon deposits on wet area of the stucco

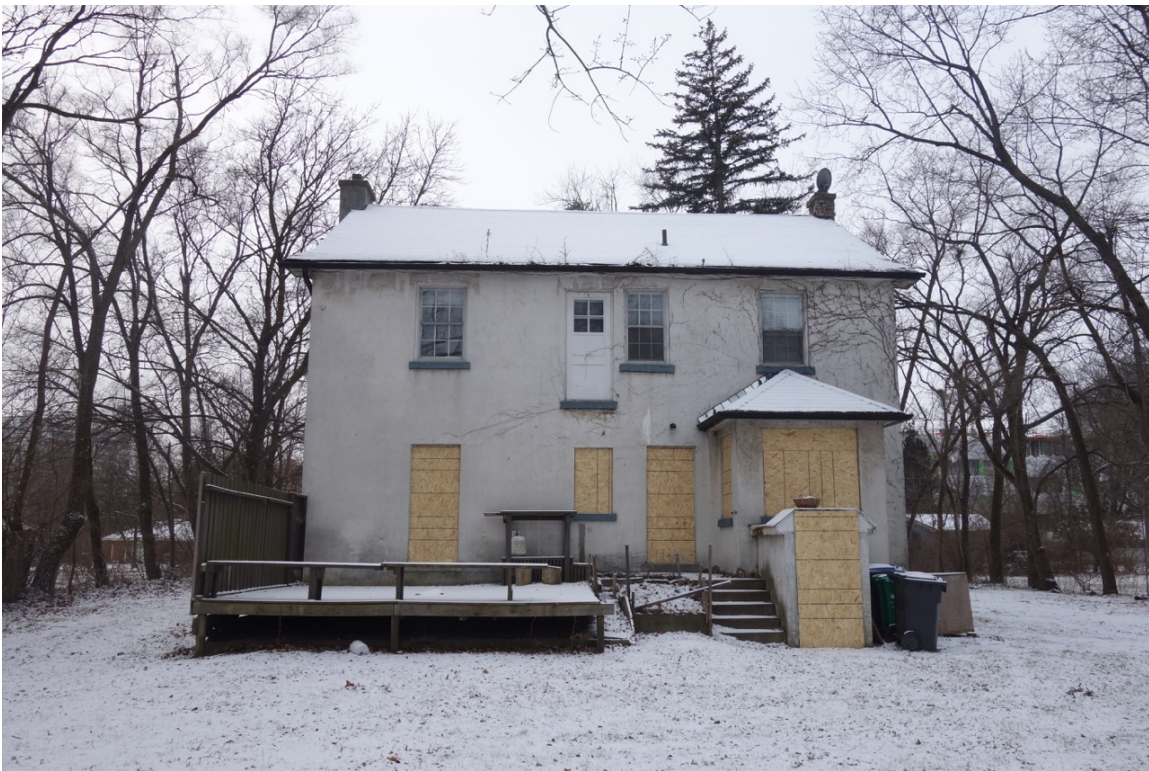
REAR ELEVATION – vegetation has grown up into the soffit and roof gutter

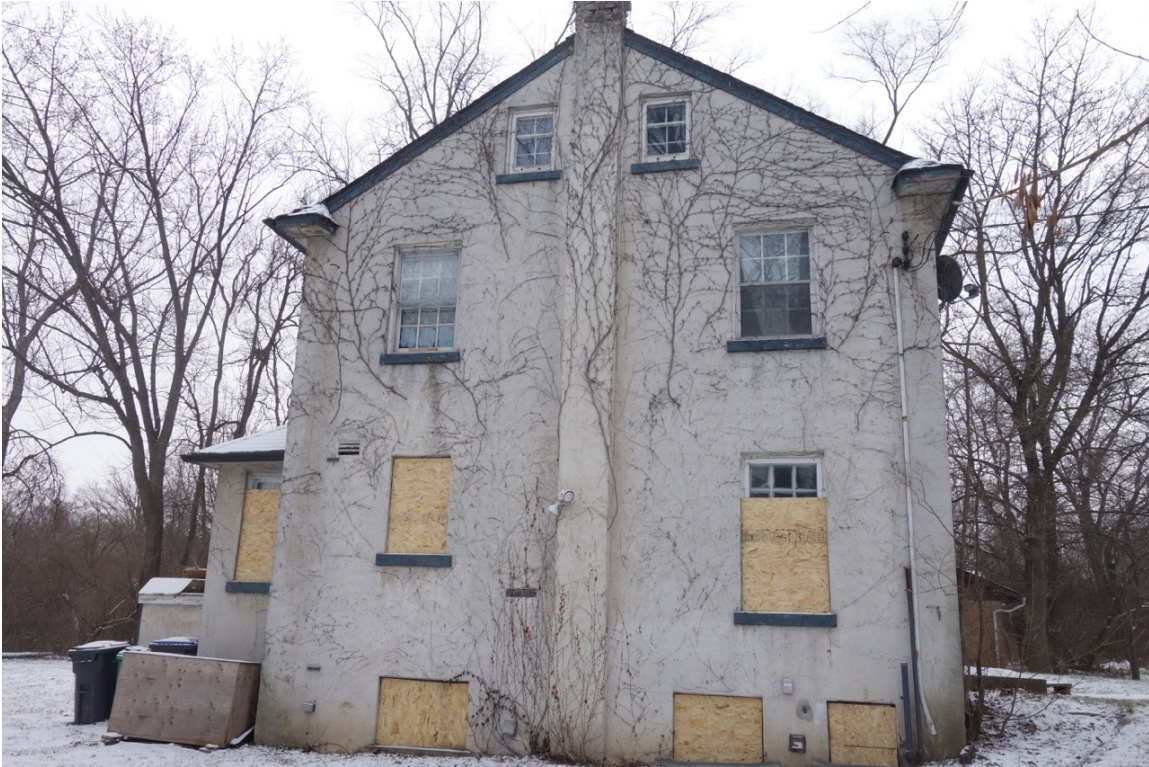
SIDE ELEVATION – ivy may have damaged stucco – missing downspout on left side - water staining below eaves and at grade level

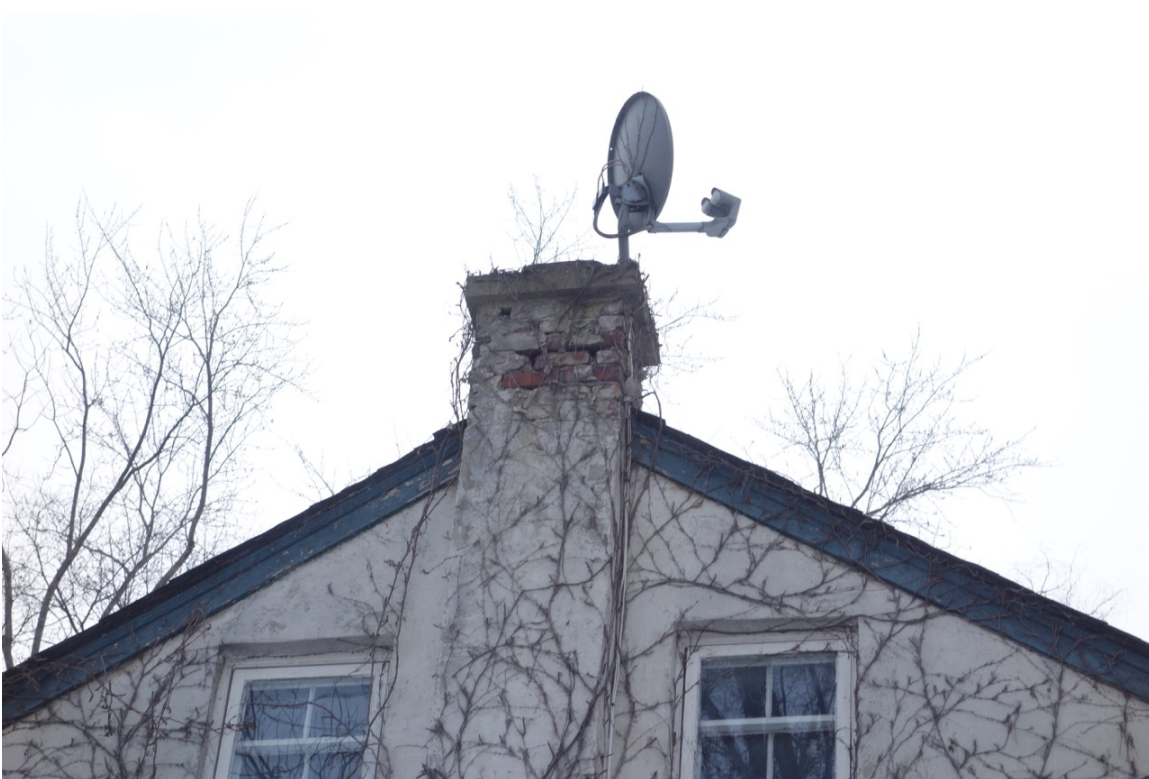
BRICK WITH STUCCO - chimney needs re-building and stucco repair

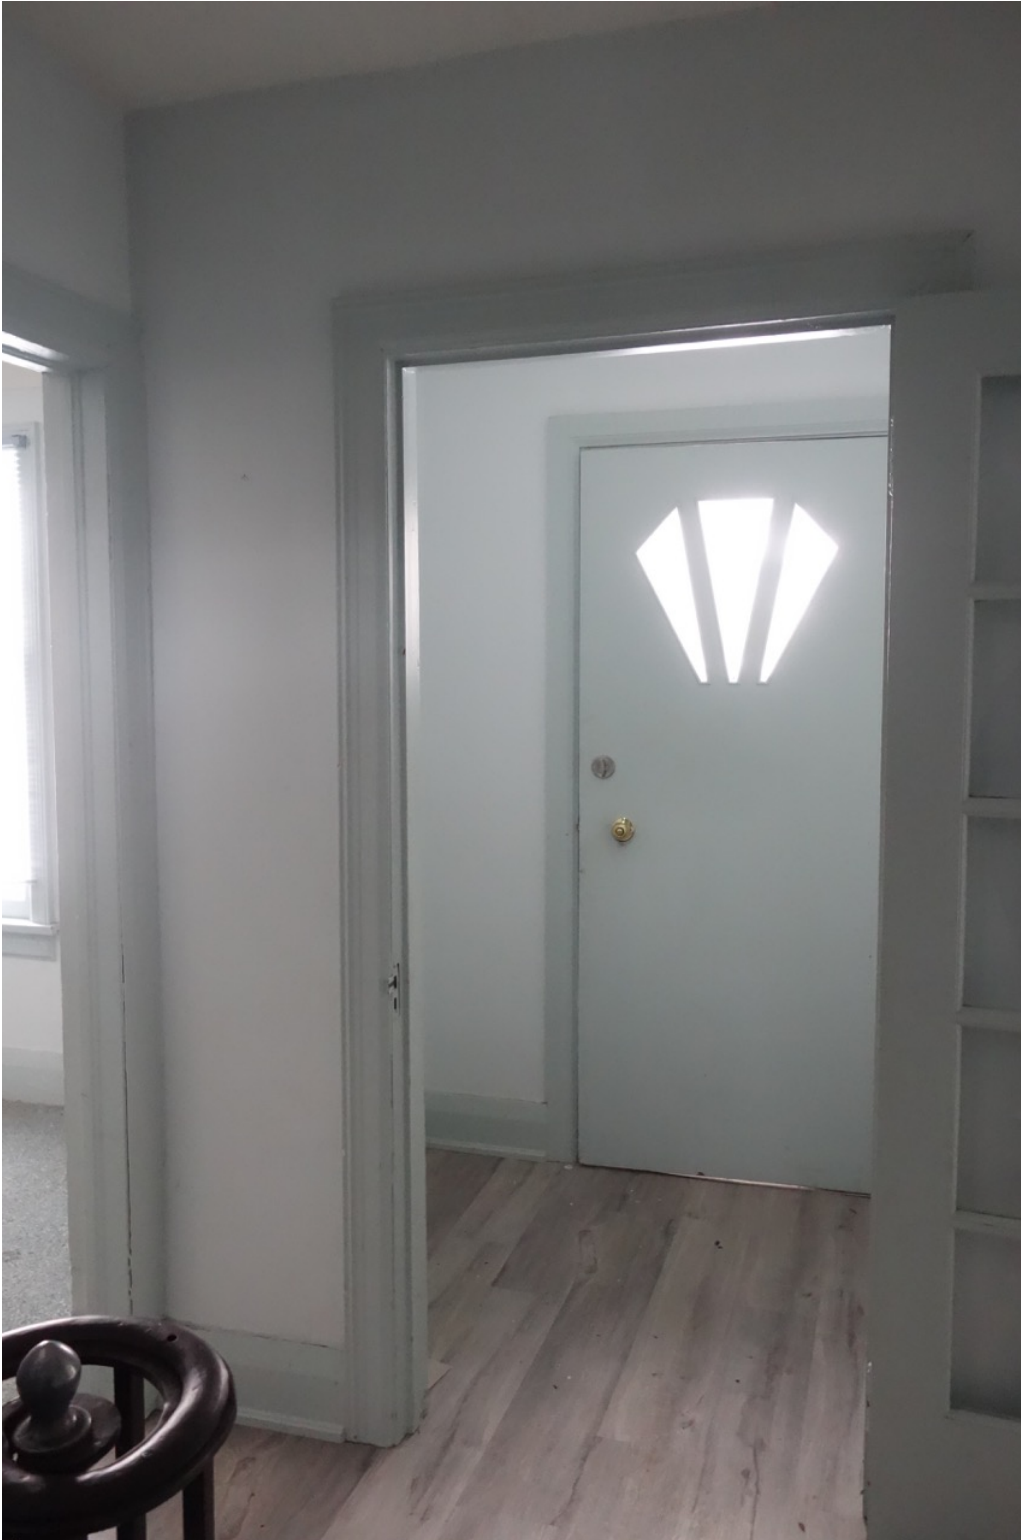
FRONT HALL & VESTIBULE – replacement flooring and front door is not original

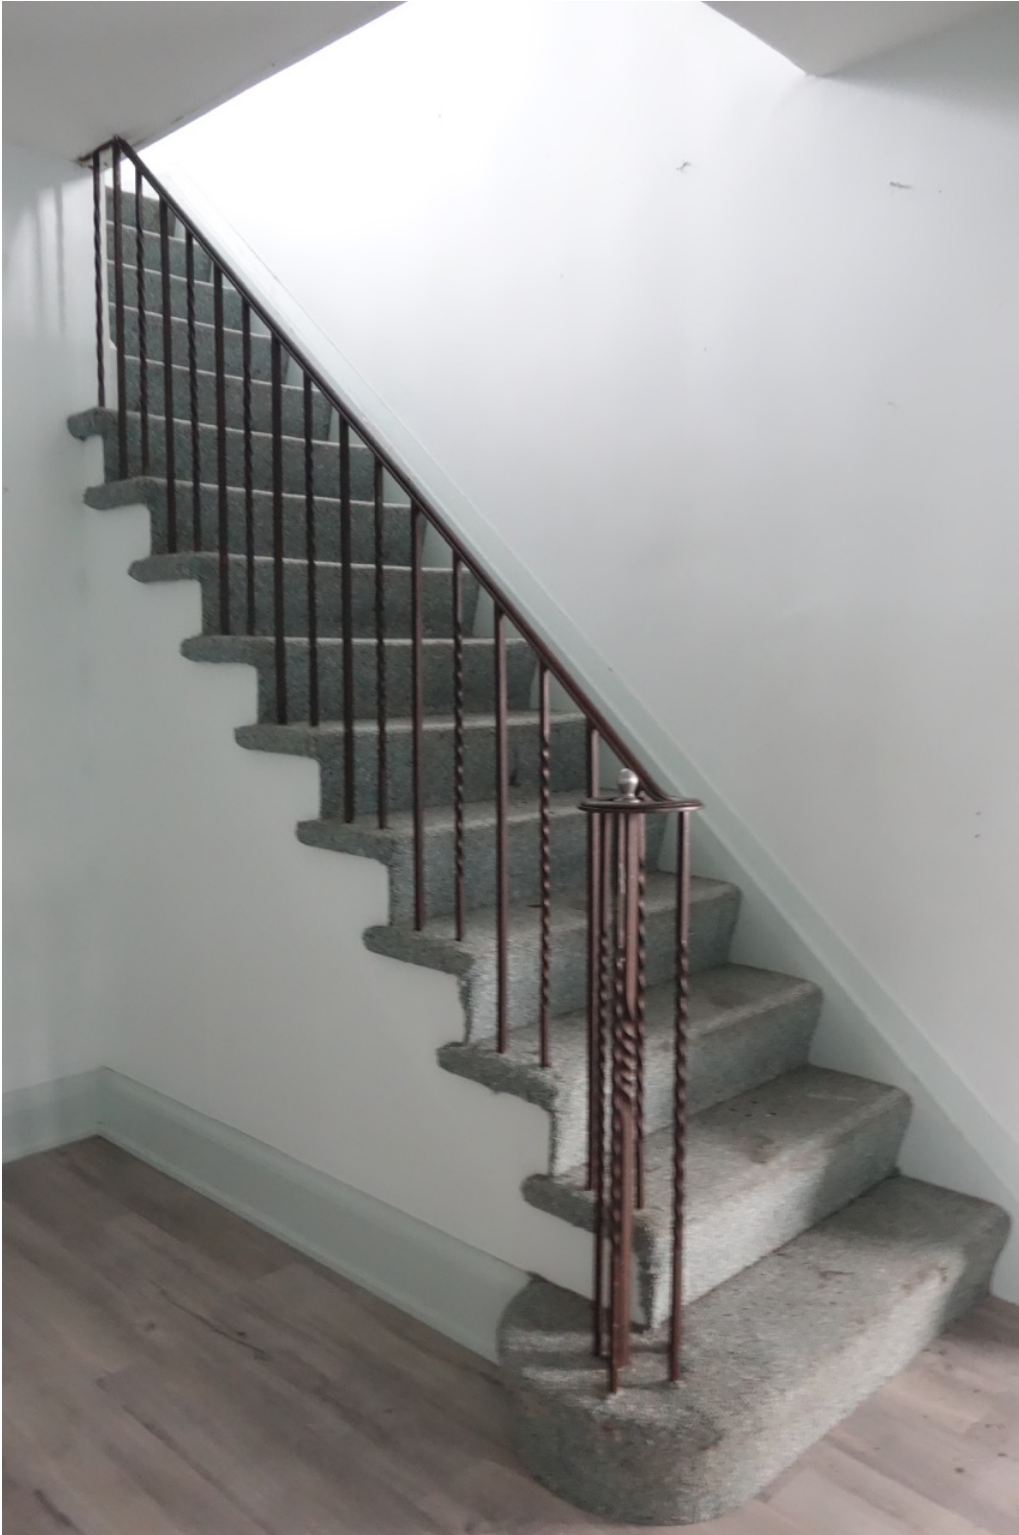
The house has a centre hall plan. The iron stair railing does not appear to be original and is very utilitarian in character. It is possible that a more decorative iron railing was removed when the decorative ironwork on the front porch was removed. The laminate flooring installed on the main floor is not original. There appears to be hardwood flooring on the second floor underneath wall-to-wall carpeting. A corner of the carpet in the upstairs hallway was lifted revealing oak flooring that was in very good condition. The walls are plaster and lathe and original millwork is generally intact and in good condition, including baseboards and wood trim around doors and windows. The millwork is well executed and has a very common profile.

MAIN STAIRS – replacement railing

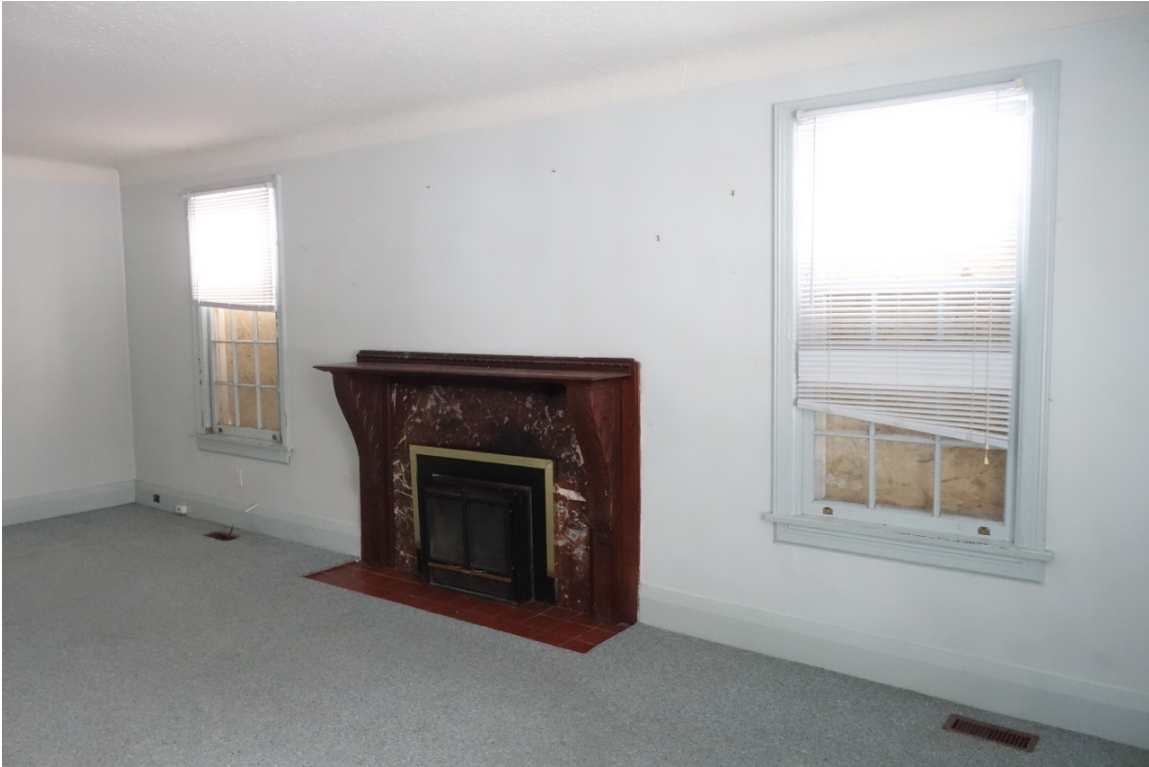
On the main floor there is a large double parlour, a smaller parlour and a kitchen. The fireplace in the large parlour has an ornate carved mantle and marble surround. It does not appear to be original based on the style. The kitchen has been renovated and has 20th century cabinetry that does not have a high level of design or craftsmanship and is not complimentary to the Georgian interior.

LIVING ROOM – this ornate fireplace may not be original but is of a high quality

- wood windows and storms
- oak flooring
- living room fireplace
- basement fireplace

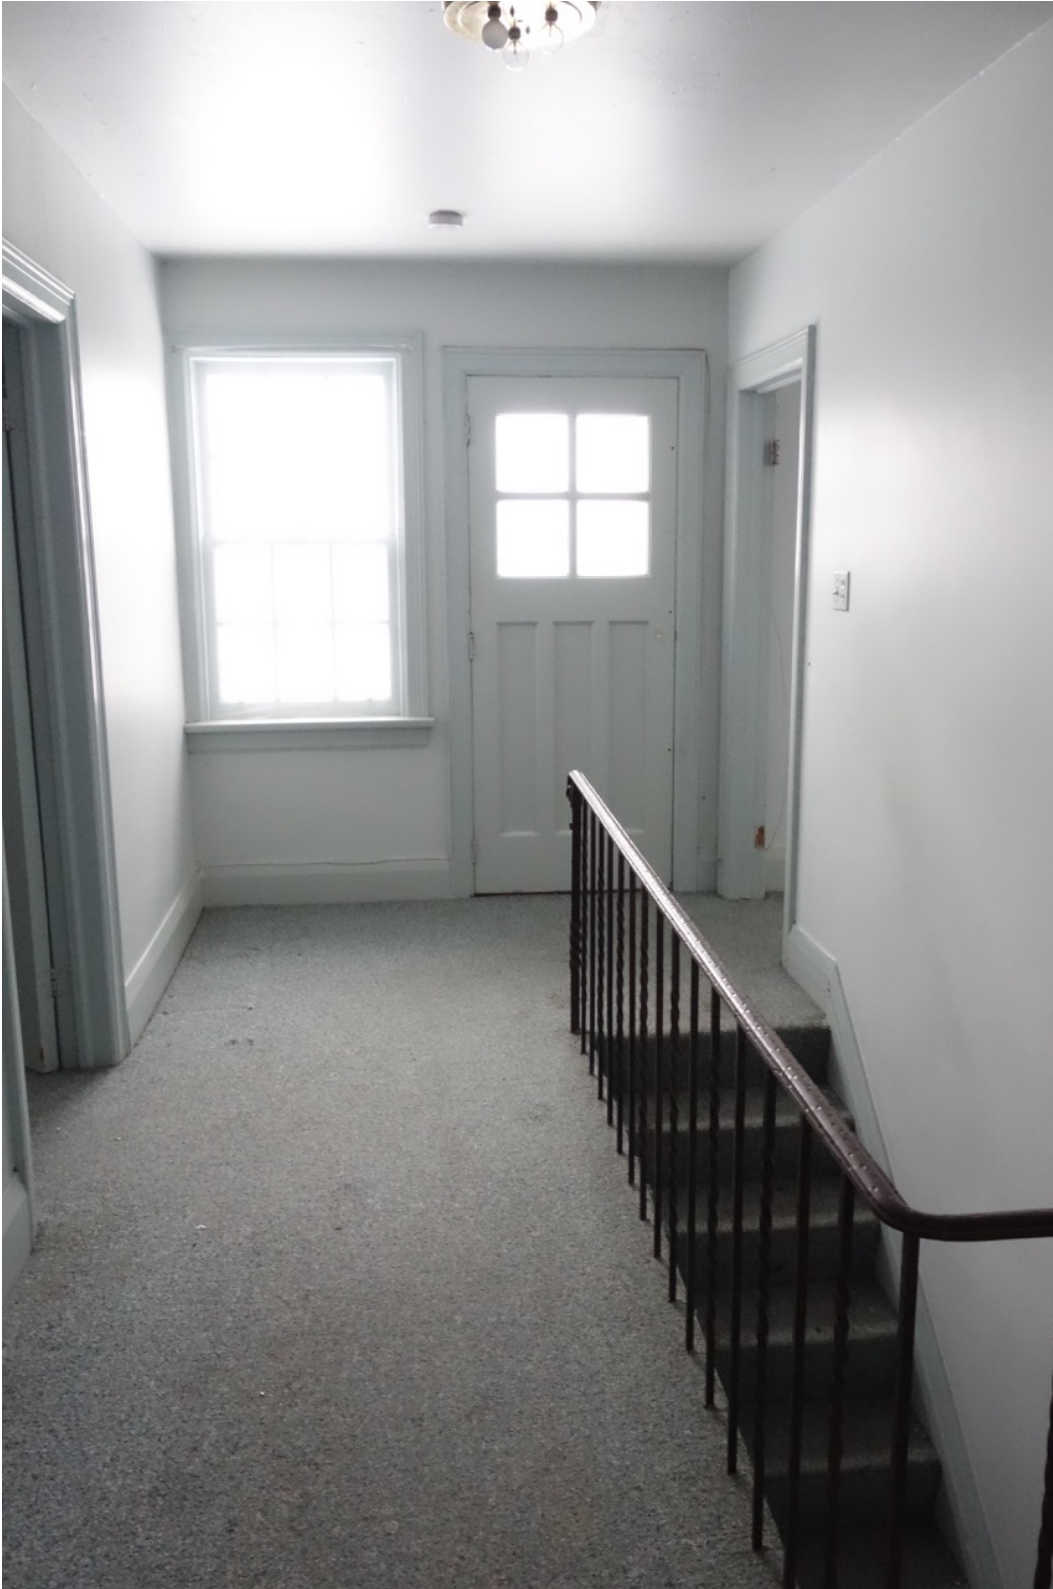
2ND FLOOR HALL – replacement iron railing – original wood doors, baseboard and trim – modern wall-to-wall carpeting

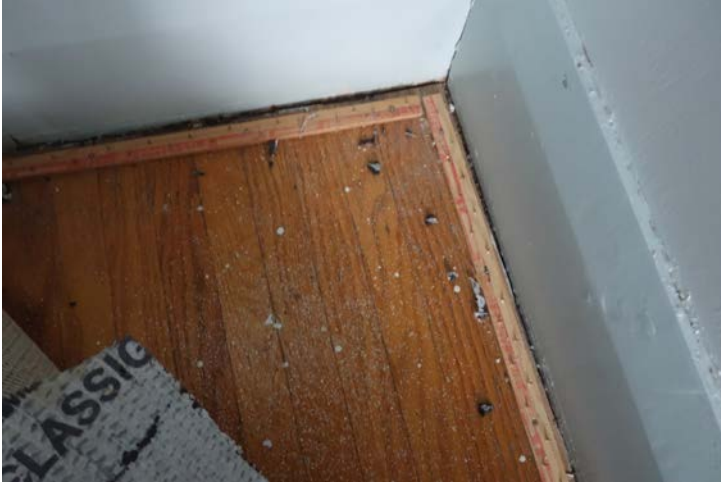
2ND FLOOR HALL – original oak flooring well preserved beneath the wall-to-wall carpeting

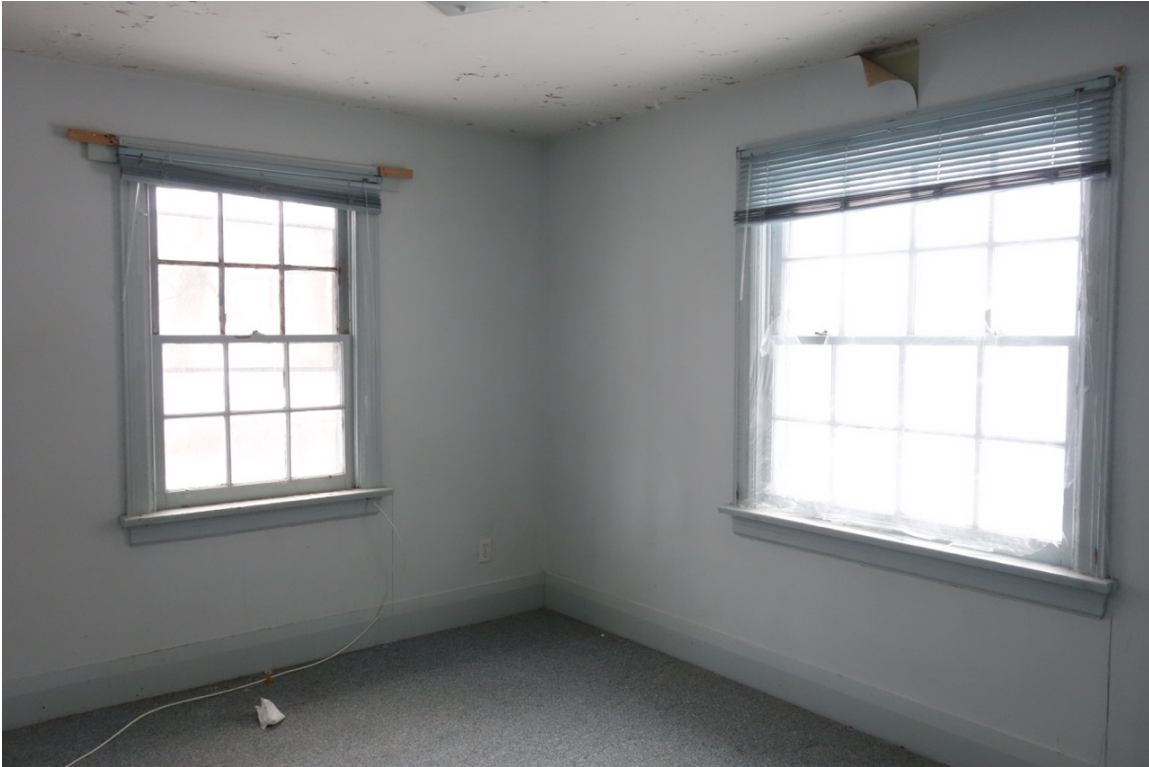
2ND FLOOR - BEDROOM 2 – original windows – modern wall-to-wall carpeting – ceiling damage due to roof leaks

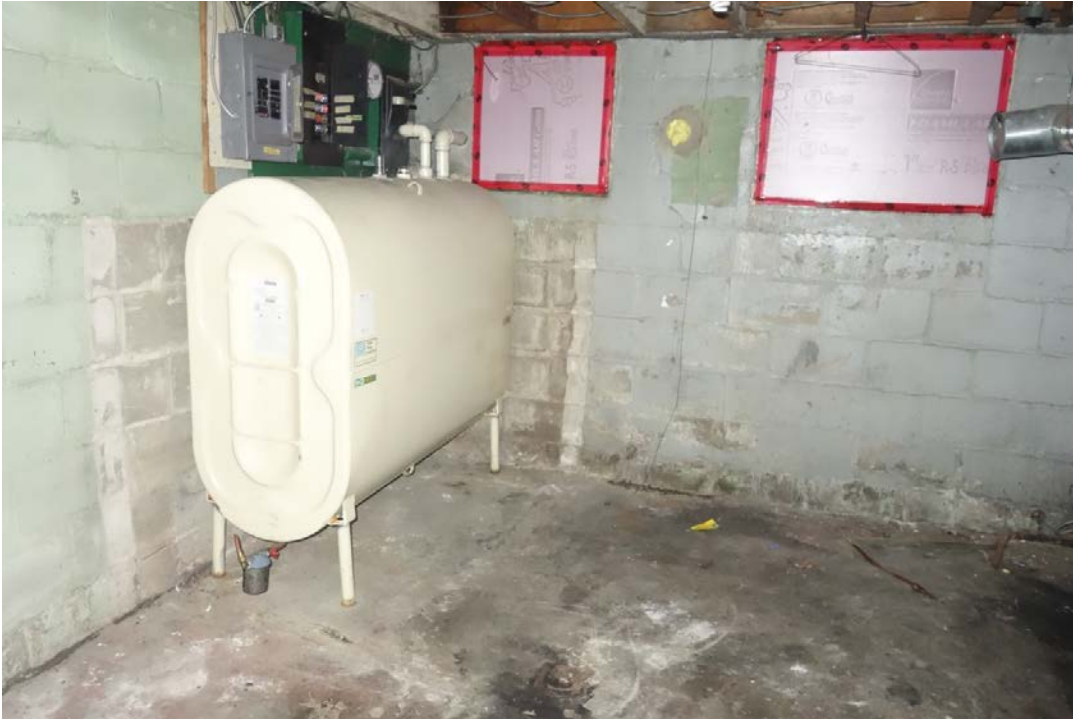
The house has a full basement with concrete block walls. The conditions are very damp but no standing water was observed. The basement contains the furnace room, laundry room and storage areas. One area has been partially finished as a living room and contains a metal fireplace insert with decorative tiles. This fireplace may be original or may have been relocated here when the more ornate fireplace was installed in the living room on the main floor.

BASEMENT – electrical panel & water heater – concrete block foundation

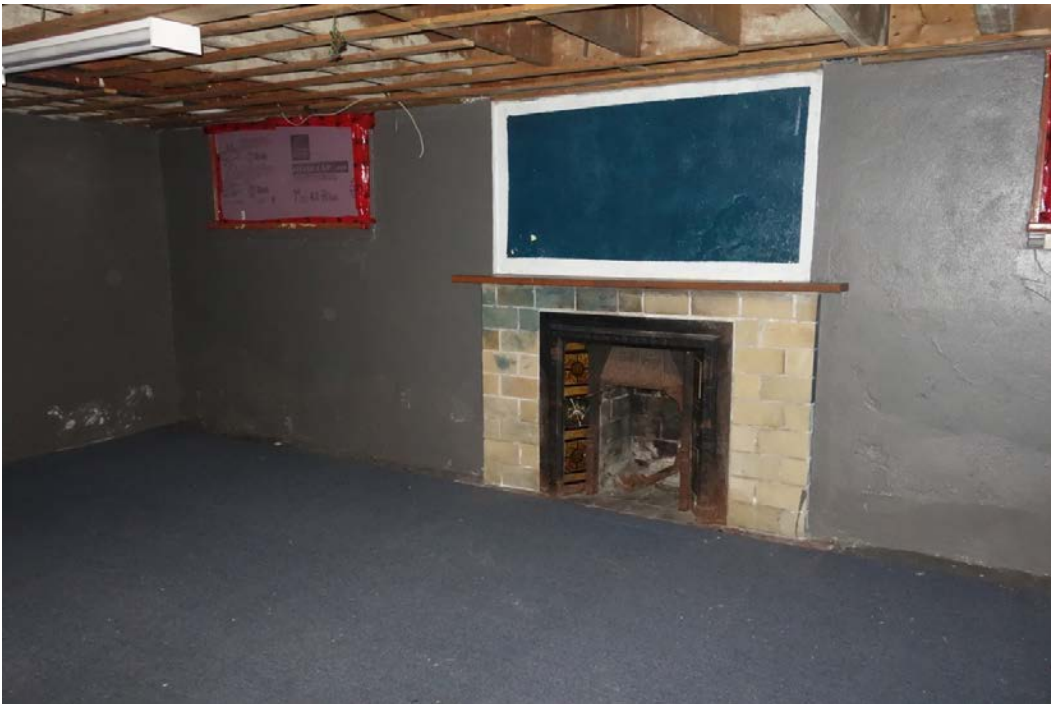
BASEMENT – partially finished living room – original fireplace? (perhaps relocated here when the more ornate fireplace in the living room was installed)
