HERITAGE IMPACT STATEMENT

EFFECT OF DEVELOPMENT AT SMALL ARMS INSPECTION BUILDING, 1352 LAKESHORE RD. E.

PROPOSED DEMOLITION OF STORAGE BUILDING

August 28, 2023 (revised Nov 28, 2023)

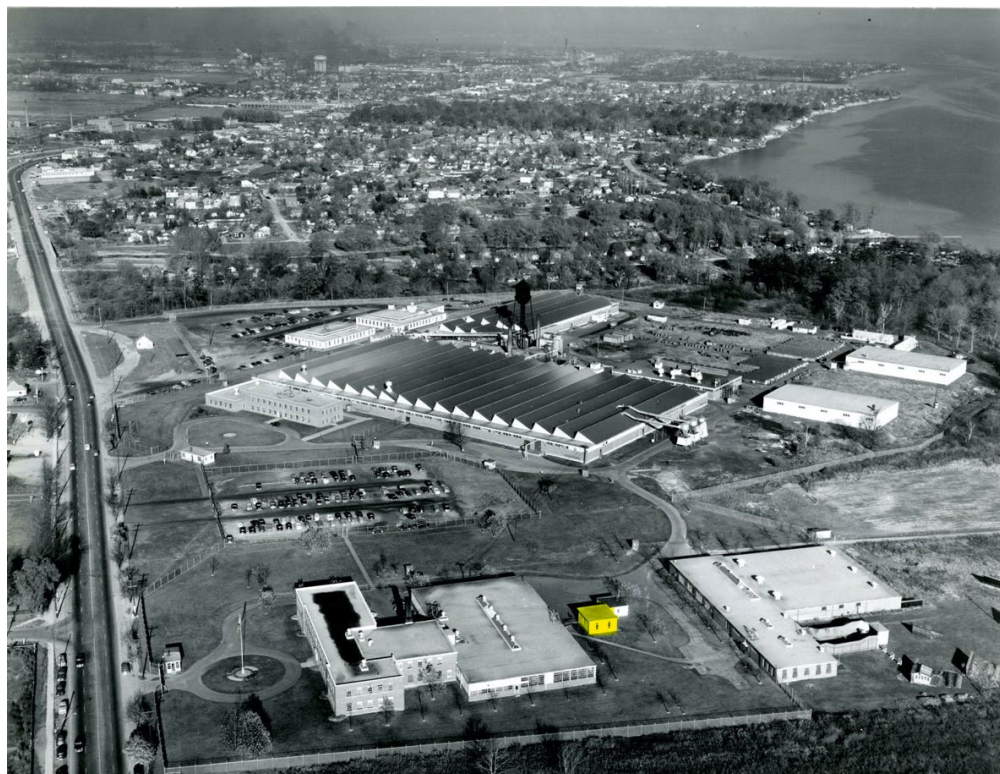
1940'S AERIAL VIEW OF FORMER SAIB COMPLEX. STORAGE BUILDING IN QUESTION IS HIGHLIGHTED IN YELLOW, BOTTOM CENTER⁴. SAIB AT BOTTOM CENTER LEFT REMAINS. ALL OTHER BUILDINGS ON THE SITE EXCEPT THE WATER TOWER HAVE BEEN DEMOLISHED.

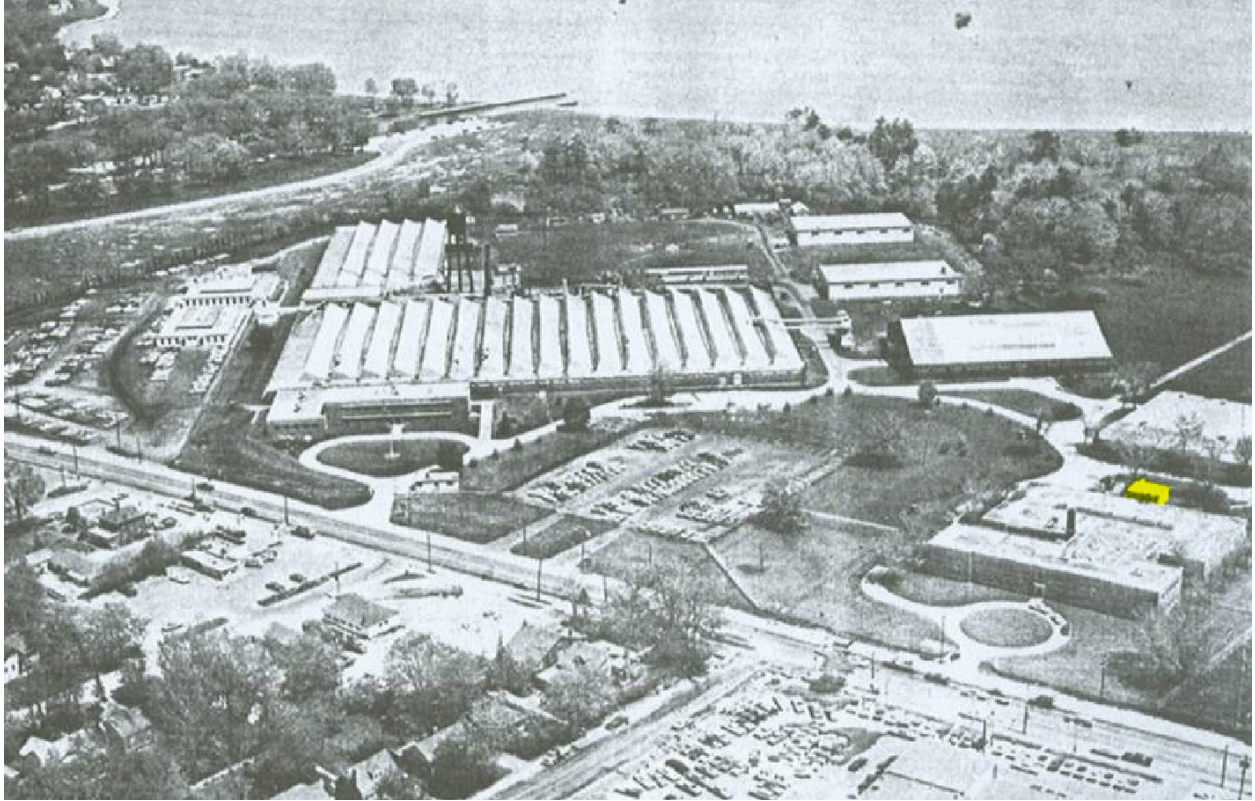
1952 AERIAL VIEW OF FORMER SAIB COMPLEX. STORAGE BUILDING IN QUESTION IS HIGHLIGHTED IN YELLOW, RIGHT CENTER. SAIB IS AT LOWER RIGHT. ALL OTHER BUILDINGS ON THE SITE EXCEPT THE WATER TOWER HAVE BEEN DEMOLISHED.⁵

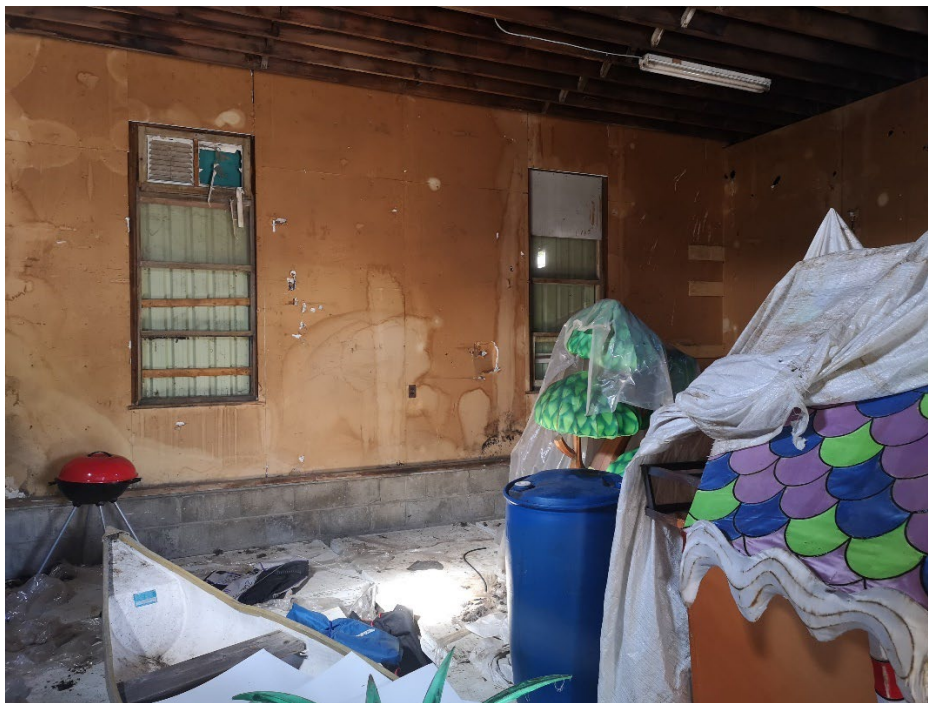
STORAGE BUILDING INTERIOR FACING WEST. NOTE ORIGINAL WINDOW OPENINGS EXTANT WITH REMNANT OF DOUBLE HUNG SASH VISIBLE. BACK OF METAL SIDING PANELS ARE VISIBLE THROUGH THE WINDOWS

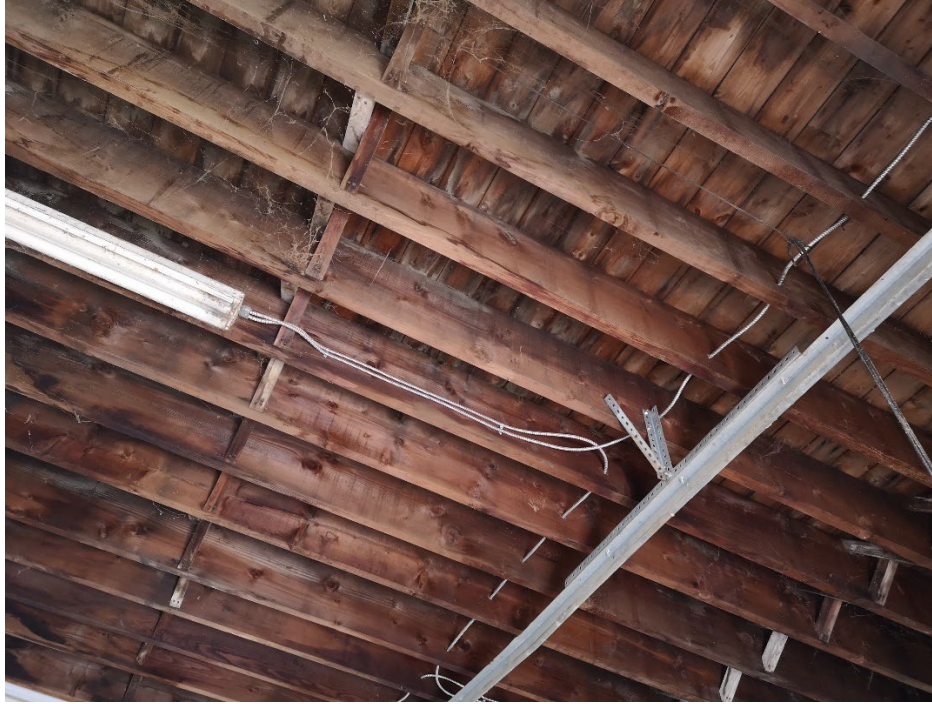
STORAGE BUILDING ROOF STRUCTURE SHOWING ORIGINAL JOISTS AND SHEATHING, NEWER LIGHT FIXTURES, ELECTRIC WIRING AND OVERHEAD DOOR TRACK

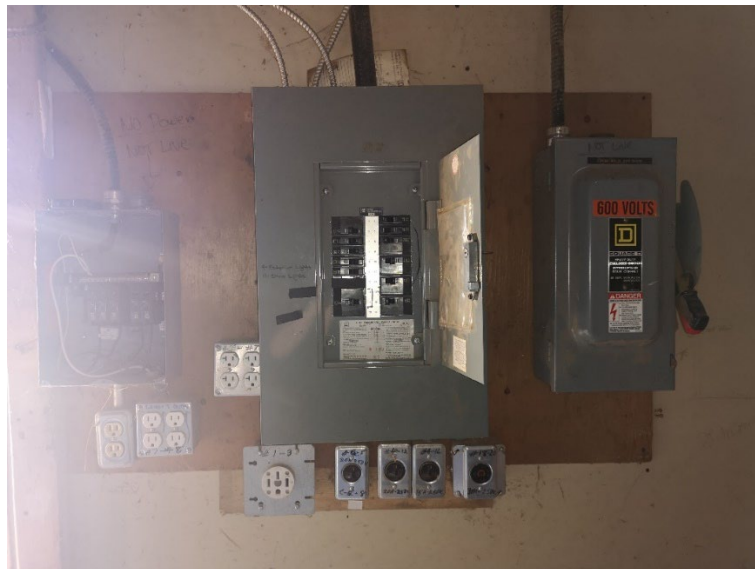
STORAGE BUILDING ELECTRICAL PANEL AND DISTRIBUTION. THIS IS NOT ORIGINAL TO THE BUILDING.

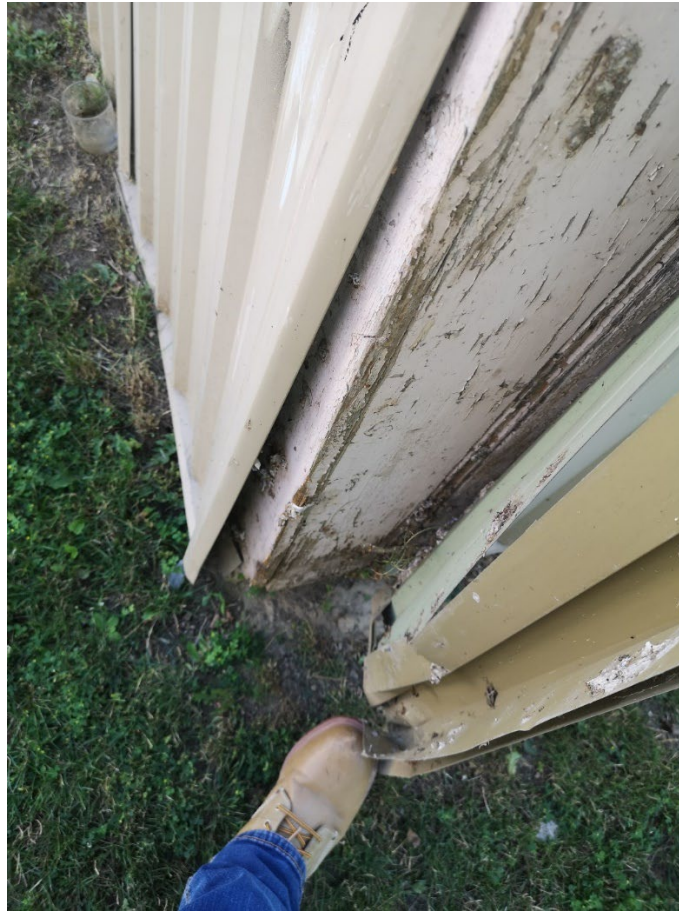
STORAGE BUILDING ORIGINAL WOOD SIDING VISIBLE BENEATH METAL CLADDING
