Heritage Impact Assessment

1341 Stavebank Road, Mississauga, ON

Heritage Resources Consulting

March 2020

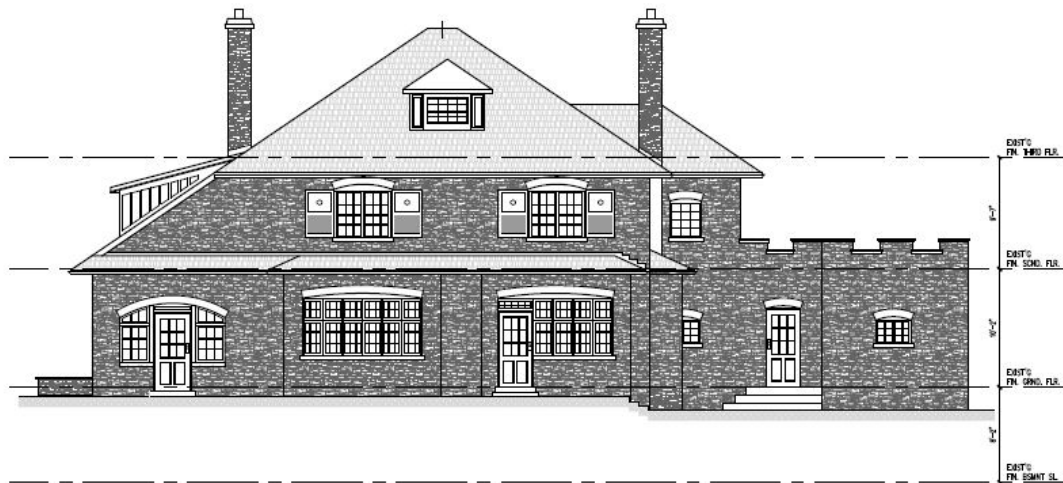
EXISTING FRONT (EAST) ELEVATION

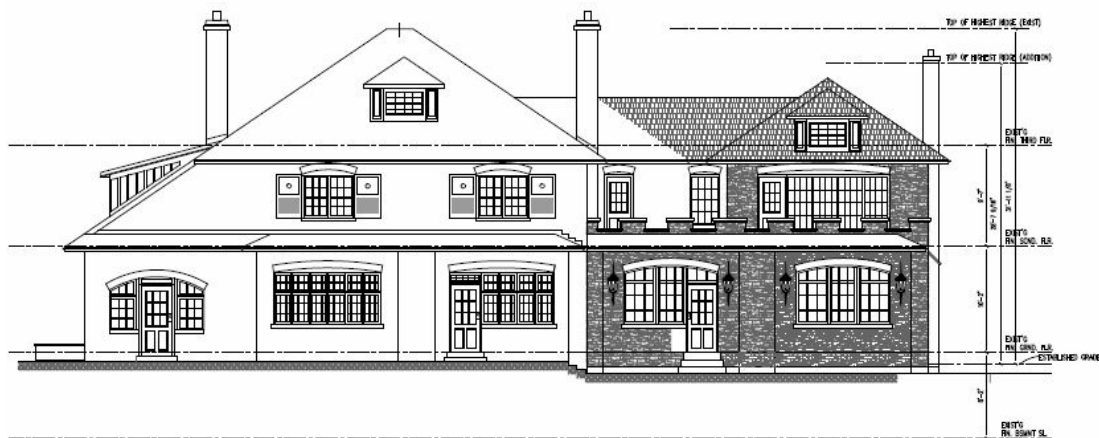
PROPOSED FRONT (EAST) ELEVATION

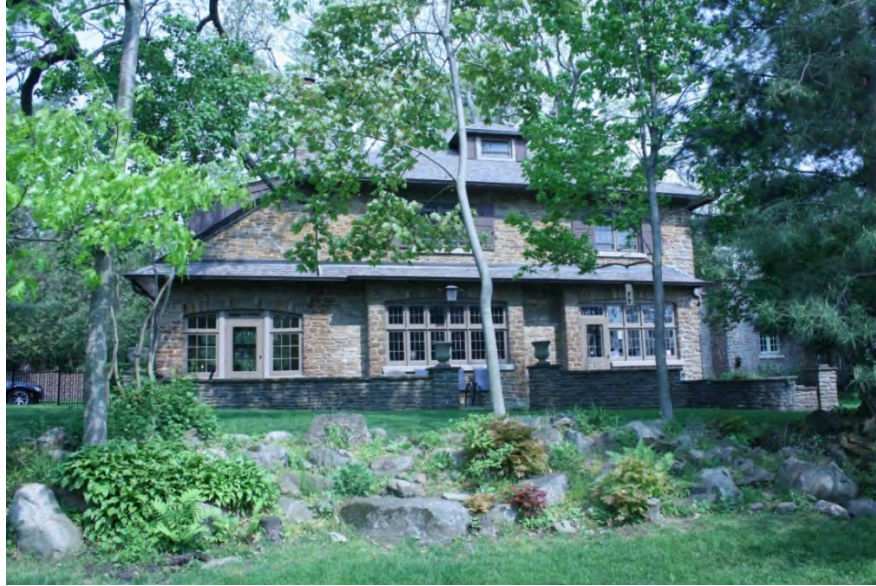
Figure 3 *1341 Stavebank Road, front or east façade. (Photo by author.)*

a large two storey structure built of Credit Valley stone. It is a well-crafted building featuring a hip roof and gently sloping eaves (Figure 3). It is located on a large lot graced with a number of mature trees (Figures 4 and 5). Its main entrance is from Stavebank Road and its Stavebank boundary is delineated with a low stone wall which adds to the property's charm (Figure 6).

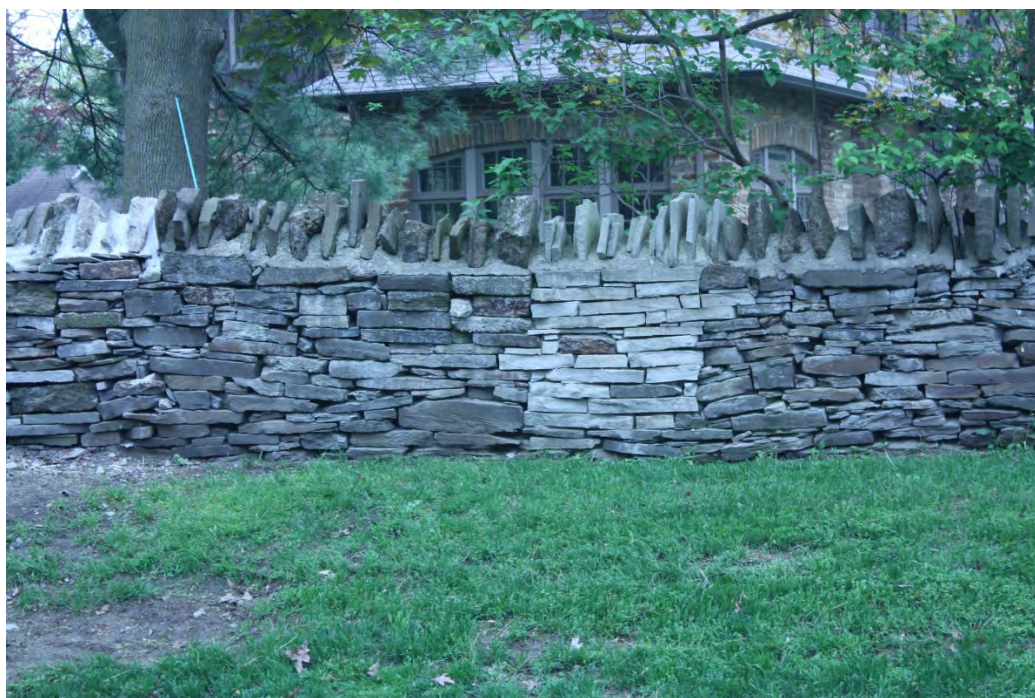
Figure 6 *A portion of the low stone wall bordering Stavebank Road. (Photo by author.)*

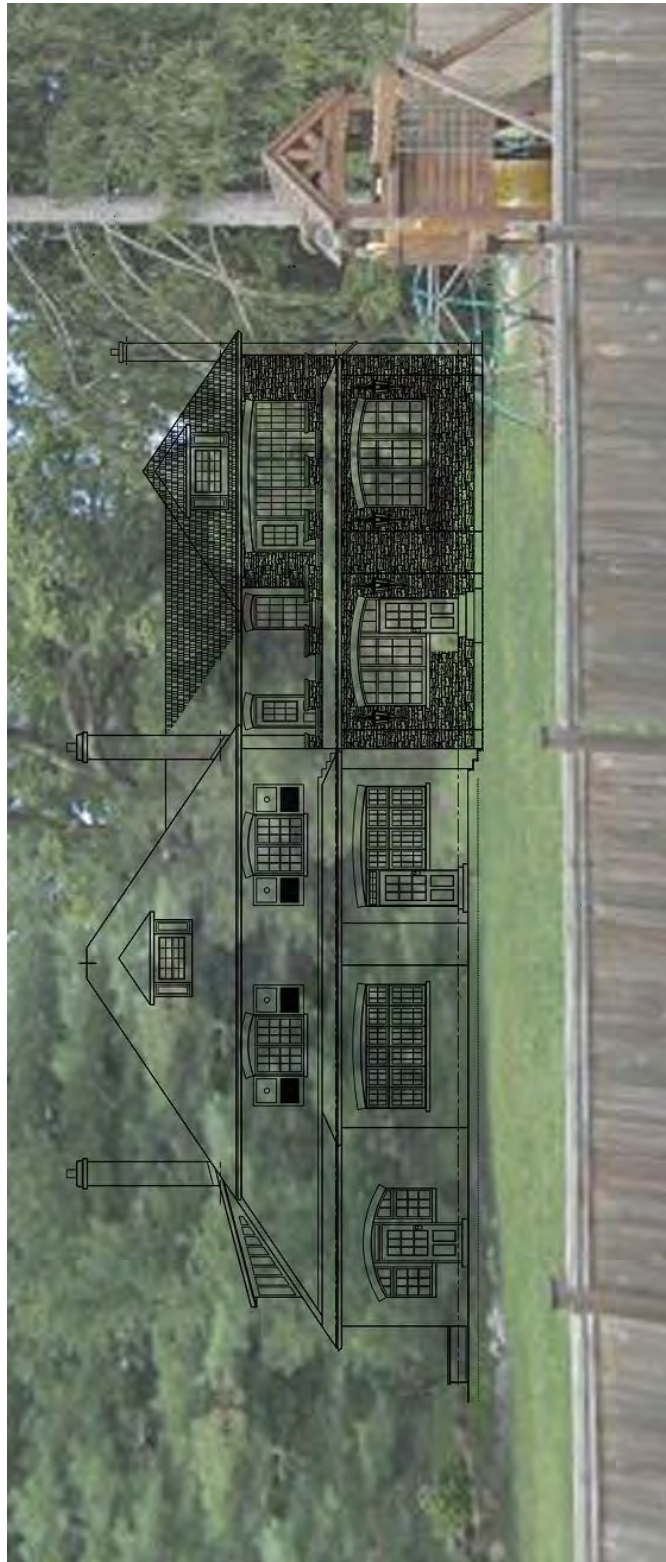
Figure 44 *Proposed development set in current landscape. The property is too large to incorporate adjacent structures into a single image. (Image from owners.)*

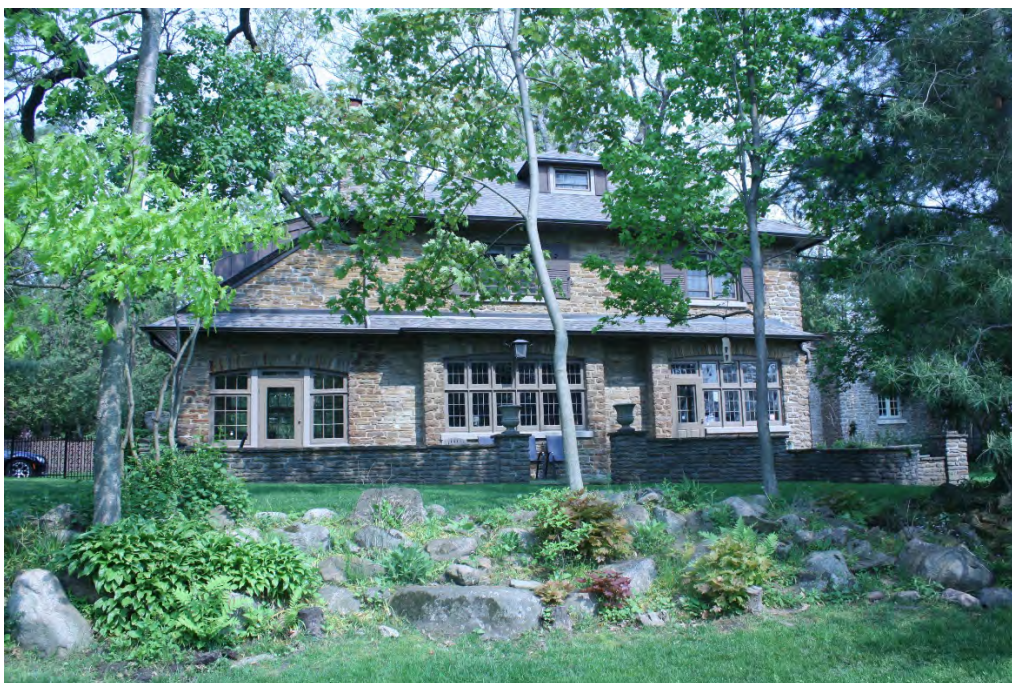
Figure 57 *Windows and roof lines on the east or front façade. (Photo by author.)*

The residence at 1341 Stavebank Road has been listed on the City of Mississauga’s Inventory of Properties of Historical Interest or Value but it is not currently designated under part IV of the Ontario Heritage Act. It is listed because of its architectural values which include a pleasing Tudor style complete with multi-paned windows, gently sloping roof lines and tall chimneys. Figure 58 shows both the window detailing and the double roof lines. The excellent quality of

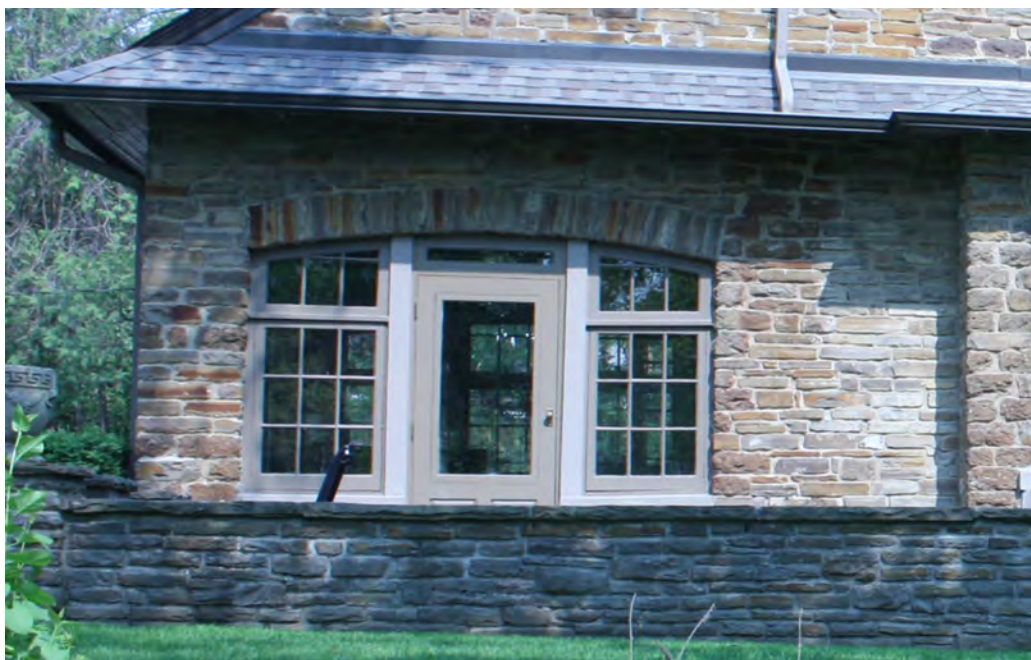
Figure 58 *Detail of the stonework on the front façade. (Photo by author.)*

the stonework and the interior woodwork are testament to the craftsmanship displayed in this building's construction.

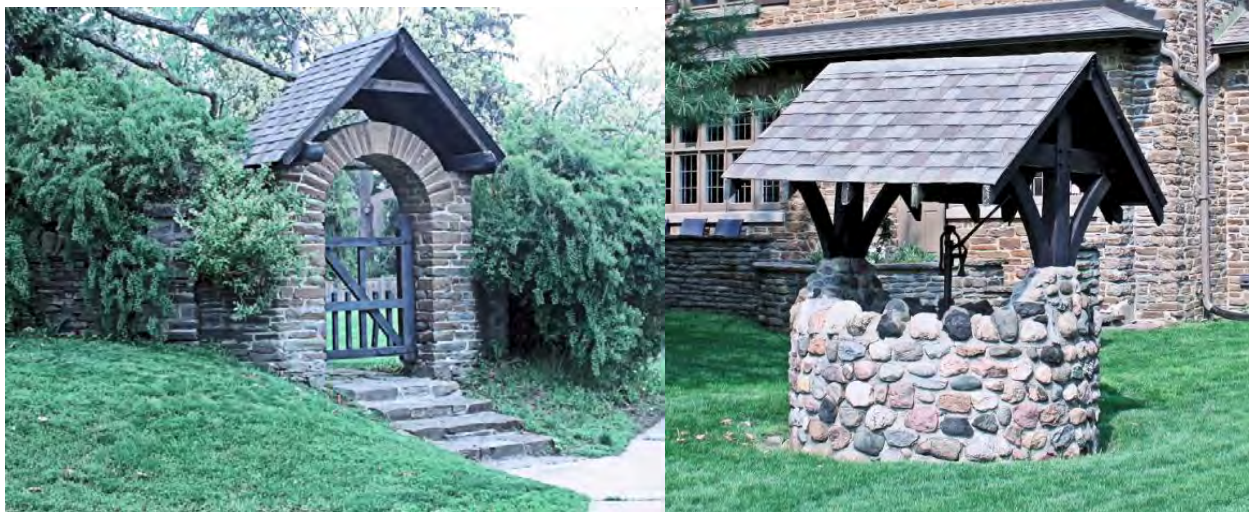
Figure 60 *The arched stone entrance and the wishing well at 1341 Stavebank Road. (Photos by author.)*

The decorative arched stone entrance to the grounds and the stone wishing well both reinforce the whimsical picturesque setting for the property.
