General – executive summary

Our firm was engaged by Stephenson Engineering to assist with heritage requirements related to its consultant contract regarding the repair/replacement of a deteriorated late 20th century pseudo-industrial style mild steel 'bridgeway' that forms part of added 2006 east ground floor entrance to the c.1950's extension of the c.1914 vernacular stone cottage. Recent photographs and a few excerpts of detail drawings, prepared by dTAH, were provided by the City, unfortunately with no access to full record drawings or archival photography of the house.

On 22 April 2020 we conducted a visual condition review and photo-documentation of the bridge/entrance structure, the exterior of the stone cottage (MacEwan House), and its context including immediately adjacent buildings, landscape, and vistas. The bridge/entrance elements are necessary for the current use and context, as a public park and visual arts centre, but do not contribute to the character-defining elements. Our review photos are available upon request with selected images in **Appendix B**.

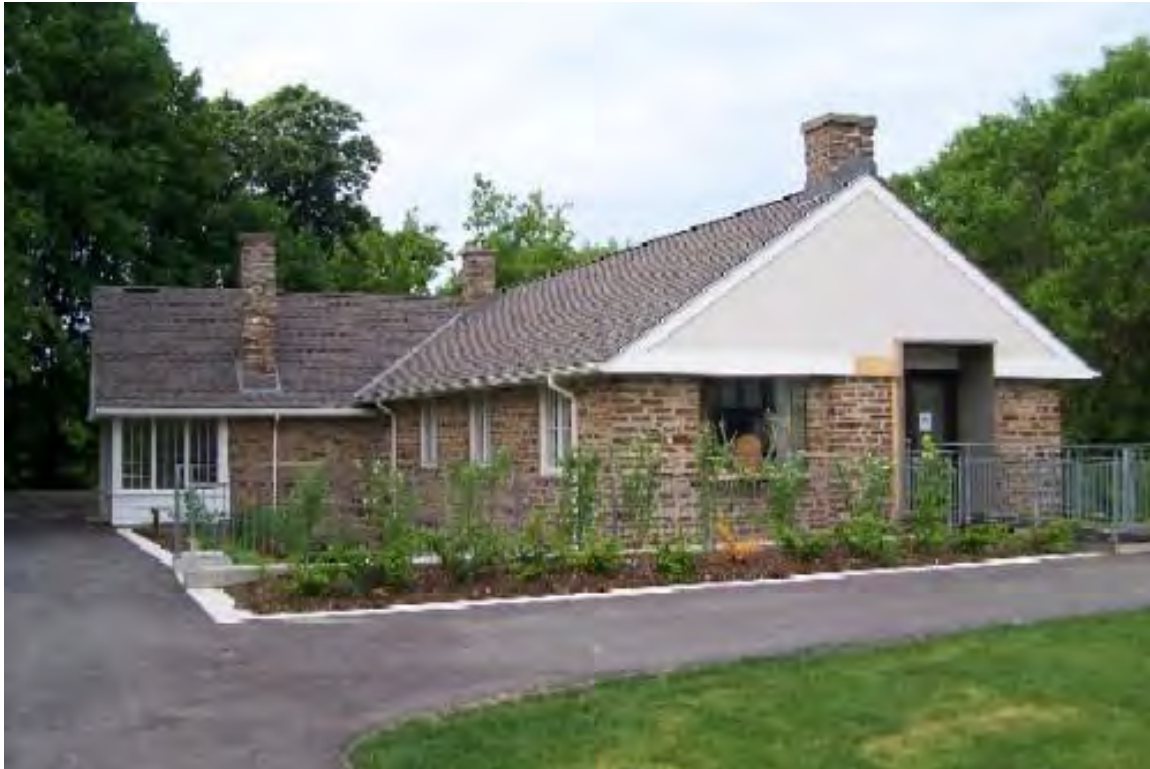
Image 1: 2006 photo from Historic Places.ca, image 2 of 130, City of Mississauga; location given as 1465 Burnhamthorpe Road West; unpainted woodwork visible here, along with aerial photos, confirm construction year of new entrance/bridgeway.

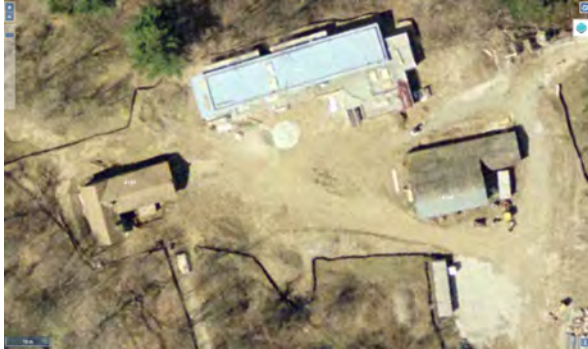
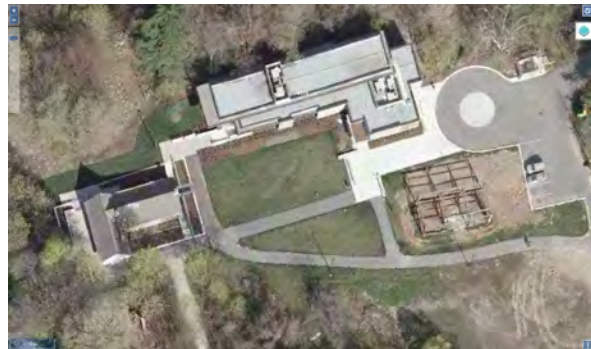
Aerial photography from Maps – selected details from 2005(left) and 2006 (right)

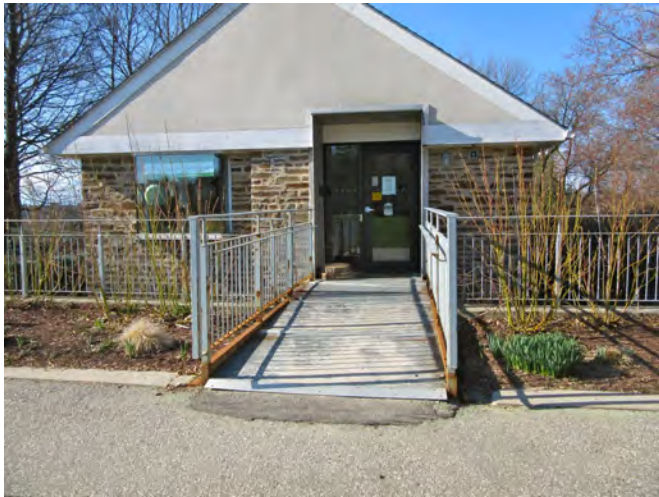
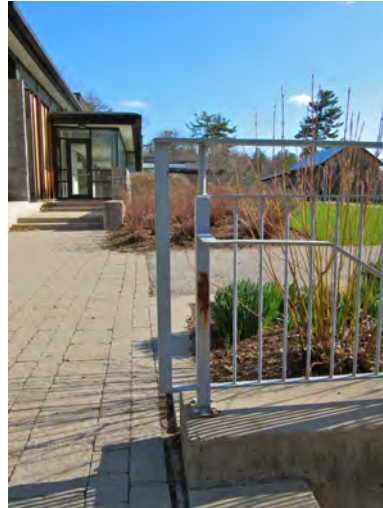
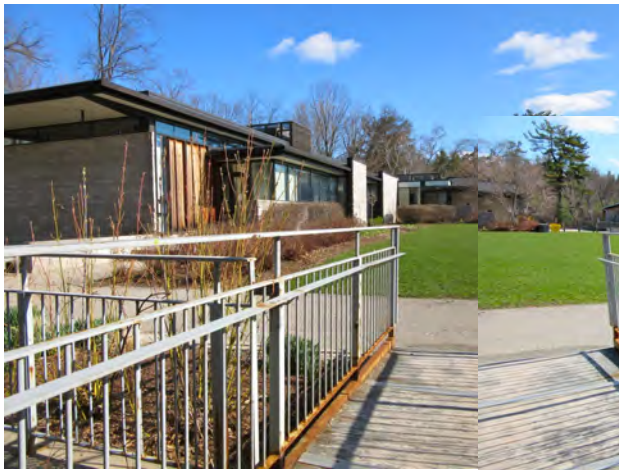
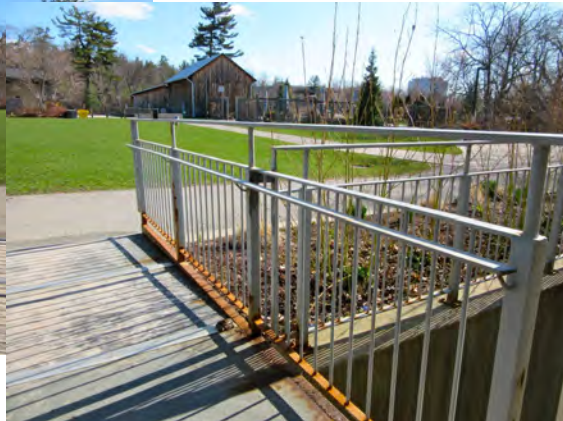
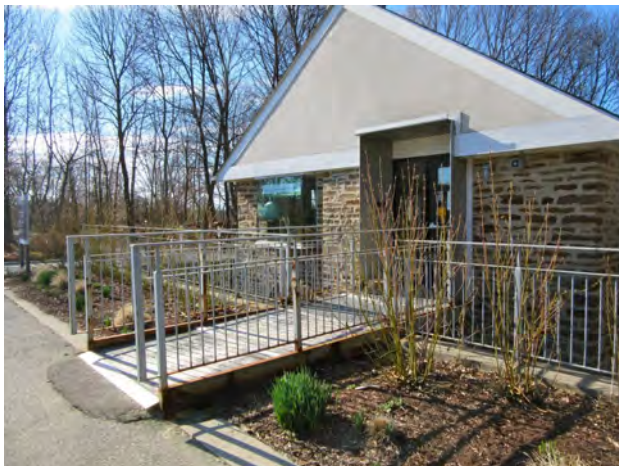
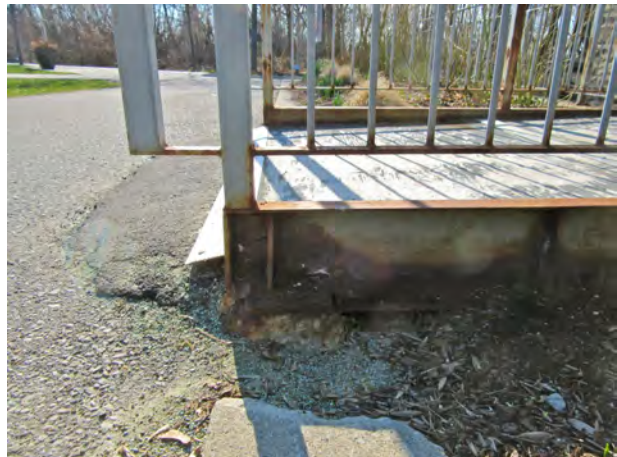
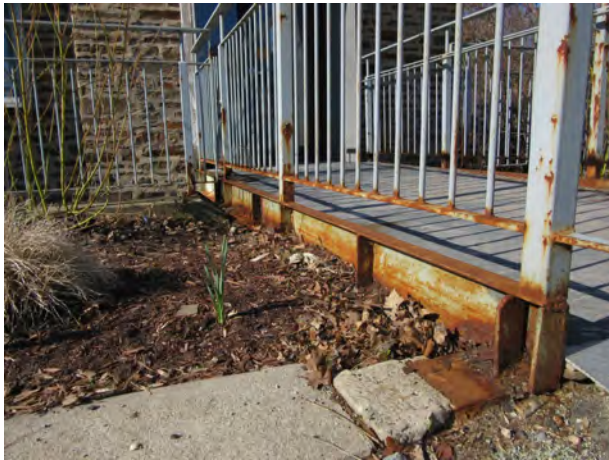
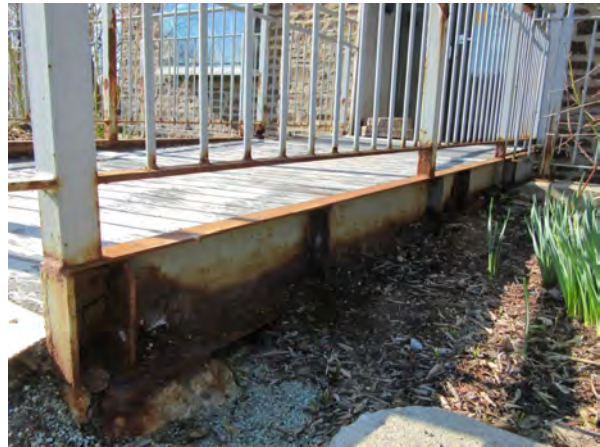
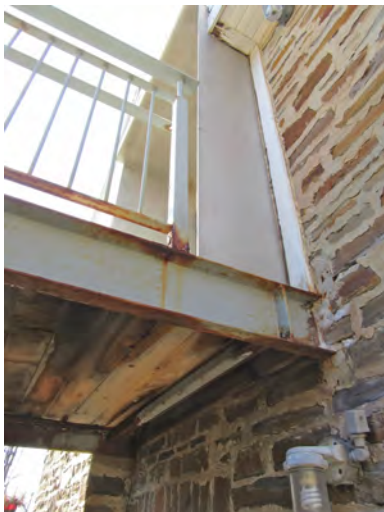
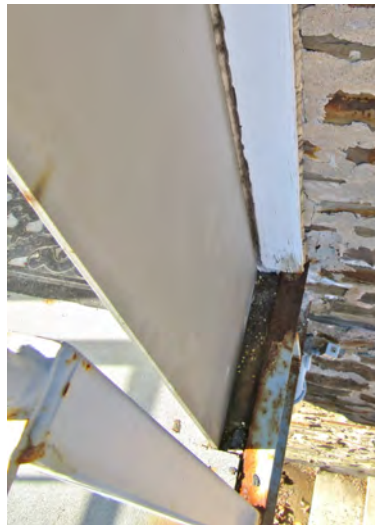
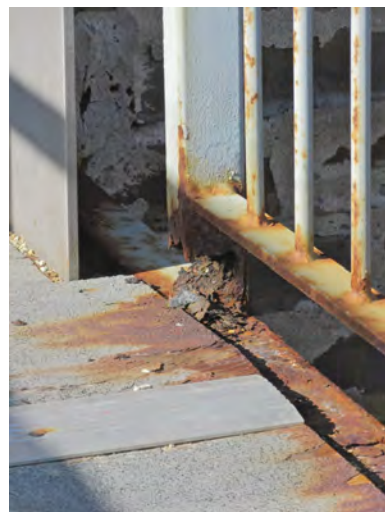
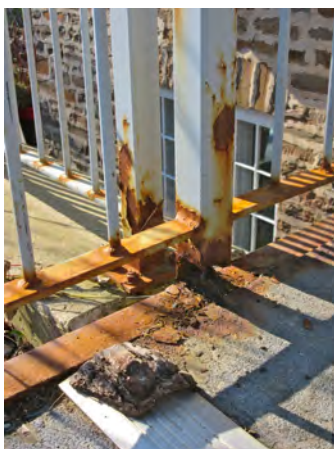
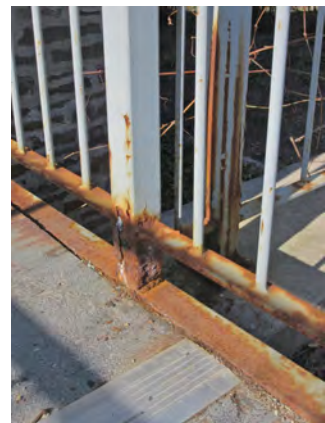
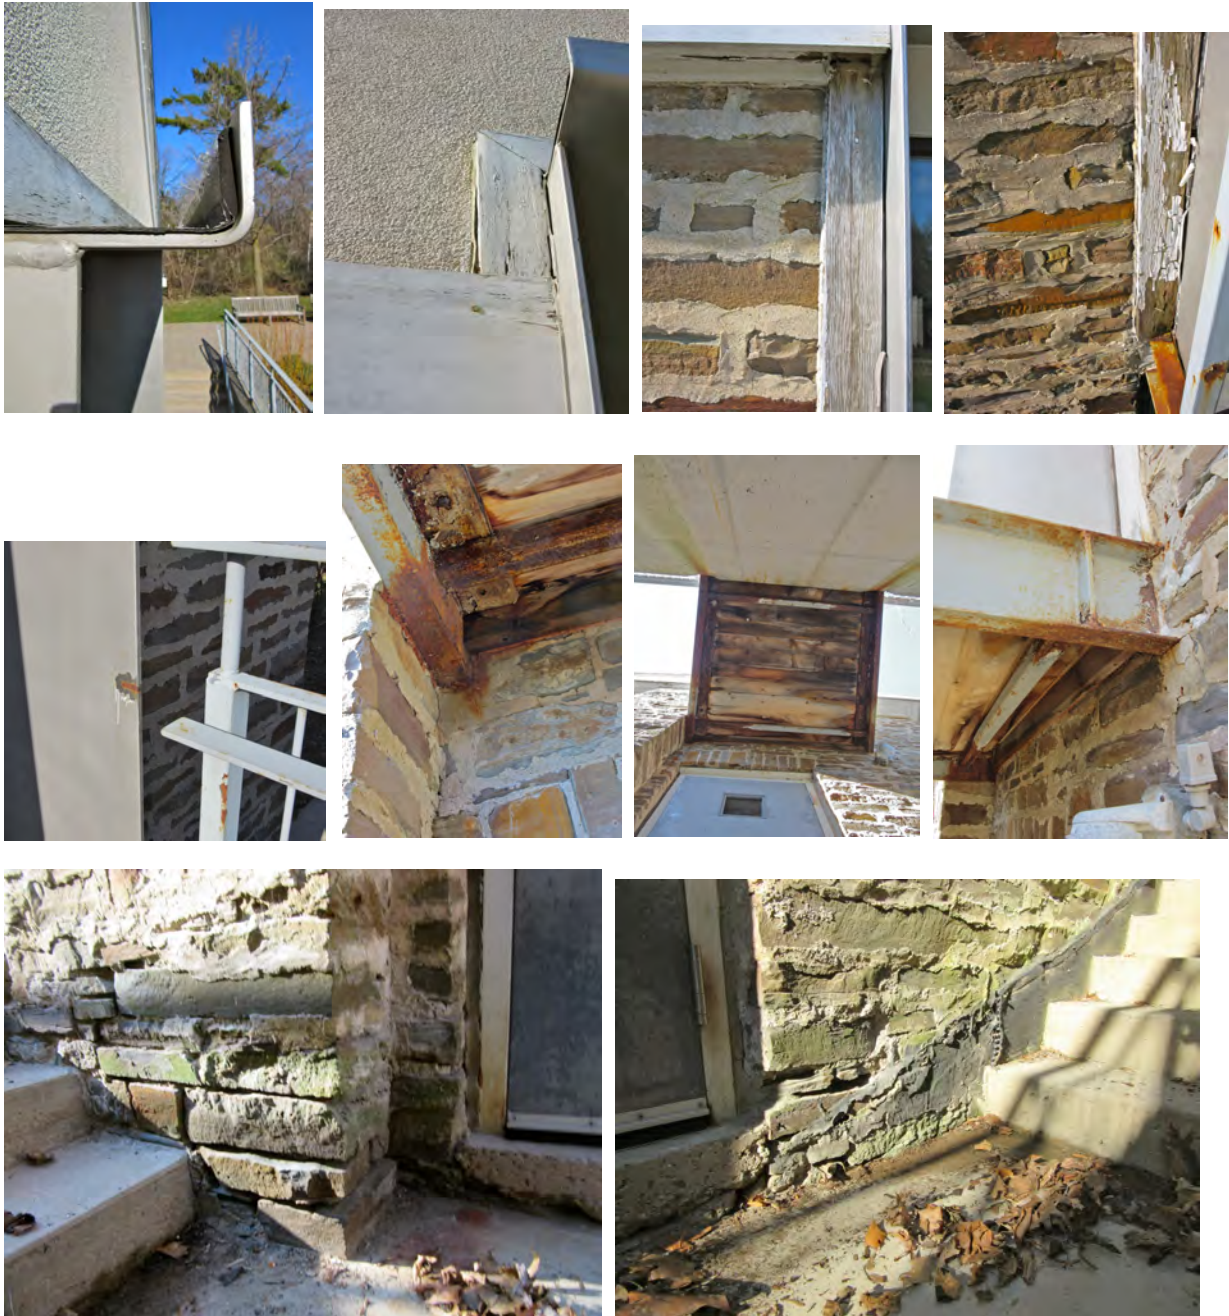
Appendix B – selected condition review photographs by Allan Killin, MRAIC, OAA, CAHP

The bridge/wall connection points exhibited localized masonry efflorescence and rust stain, darker grey mortar, rotted wood trim, and more intensely corroded steel elements. Rust staining also marked the concrete retaining wall and basement landing below. Wood, steel, and concrete elements appear to be in direct contact with stone masonry without normal isolation membrane, mastic, or bitumen-impregnated joint filler. Such observations suggest potential hard mortar, masonry rust-jacking, cracking, and water infiltration into surrounding stone masonry resulting in premature deterioration of bridge and heritage fabric.

Existing bridge abutment connections and transitions, at both the old masonry wall and new bearing plates on concrete pads at grade, appear to be designed without due consideration of thermal or differential movement of the long structural steel channels and rigid steel guard railings, nor mitigation of corrosion of these painted steel components, infiltration at masonry embedment of rust-jacking of ferrous metal, nor drainage/drying of adjacent wood trim

Open mortar joints were observed in historic masonry adjacent to basement level concrete steps and landing with no isolation/sealant joint to protect masonry from migrating moisture and de-icing salts.

The bridge spans a planter[planting appears designed to screen the basement walk-out] in which the top of soil and mulch has been permitted to rise above the under-side of the bridge and covered most of the bottom flange. The poorly vented concealed space beneath the deck above the planter may trap moisture and be attractive to small rodents.

Repair, or remove and replace, deteriorated portions of existing metal bridgeway, and related wood decking and vertical wood trim, generally to match existing, except refine design to improve durability and accessibility as follows (item 1 requires a heritage permit):

- 1) a) revise bridge connection & beam pockets at masonry wall and b) repoint open joints at walk way with salt resistant hydraulic mortar c) using CAHP-accredited heritage contractor;
- 2) upgrade painted steel to H.D. galvanized steel;
- 3) provide more durable replacement decking & trim;
- 4) lower grade in planter below bridge beams;
- 5) raise level of asphalt path at bridge landing.
