HERITAGE IMPACT ASSESSMENT

1390 Conliffe Court

June 2024, Revised August 2024

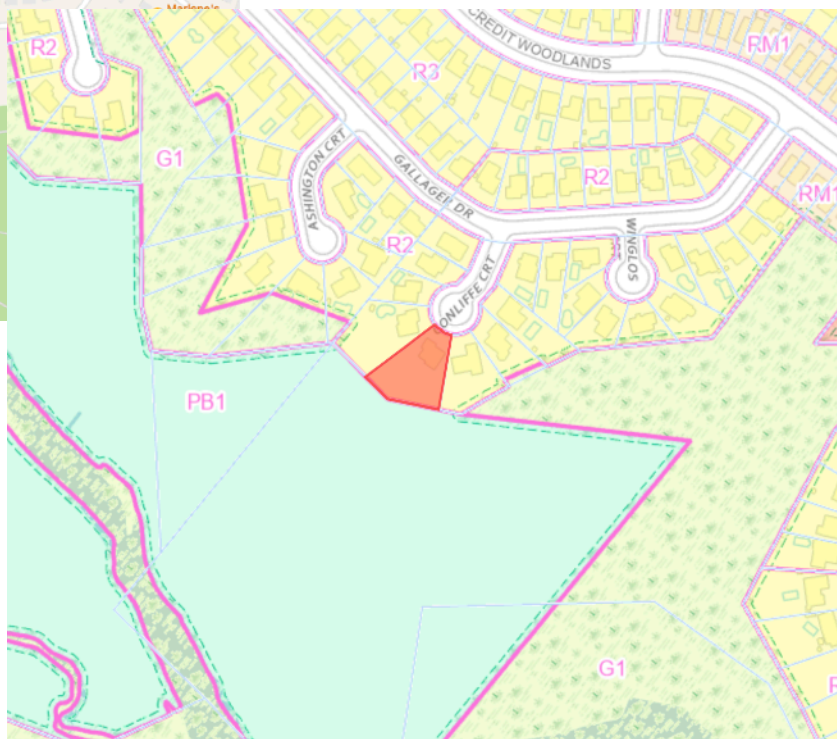
Figure 2: Zoning (right)
The property is a pie shaped lot.

It has a frontage of approximately 12.89m on Conliffe Court. The property abuts directly onto the park. The subject property contains a single family detached dwelling. It is zoned R2, Residential

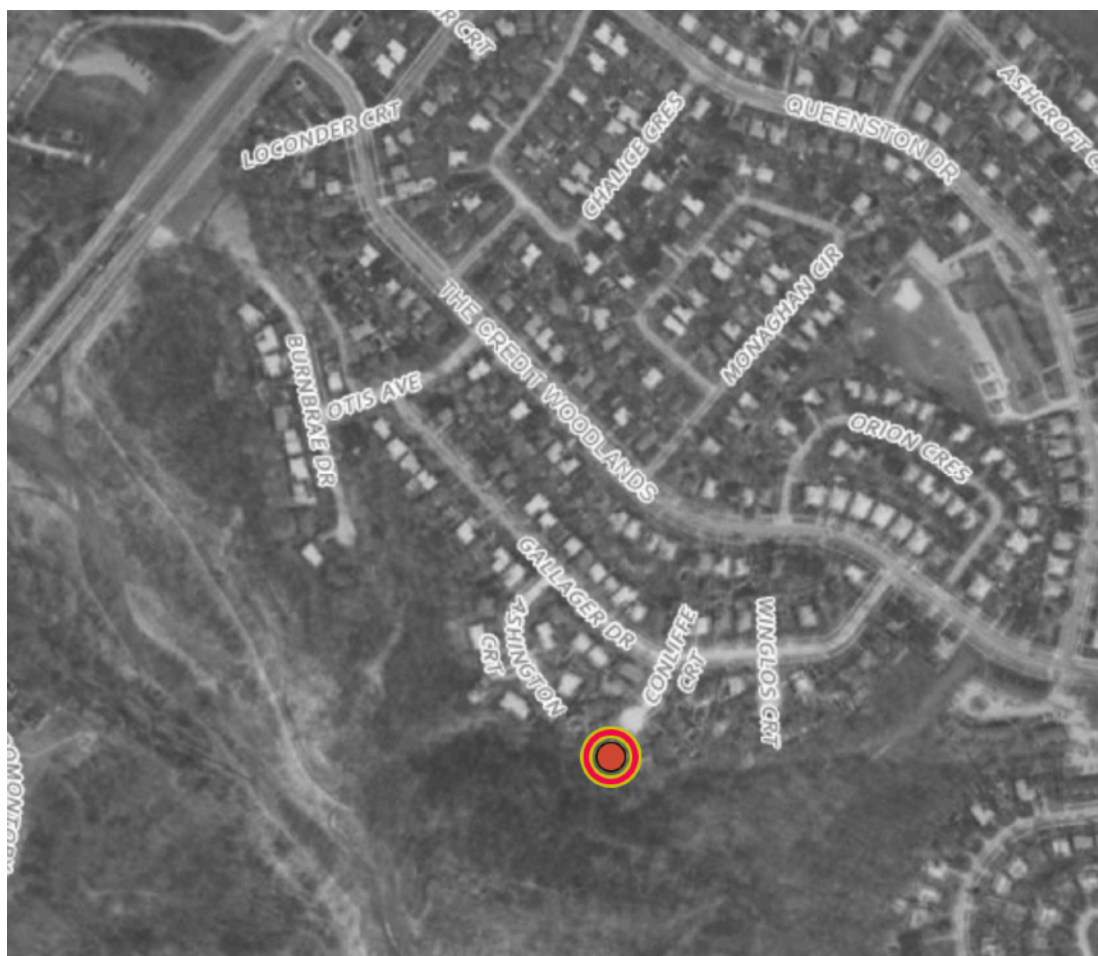
Image 1:
1966
Aerial
Photo

The aerial photo from 1966 depicts the development of the Credit Woodlands. The subject property is identified by a yellow star. HWY 403 has yet to be constructed, and Burnhamthorpe Road does not extend over the Credit River.

The subject
property
has not yet
been
developed

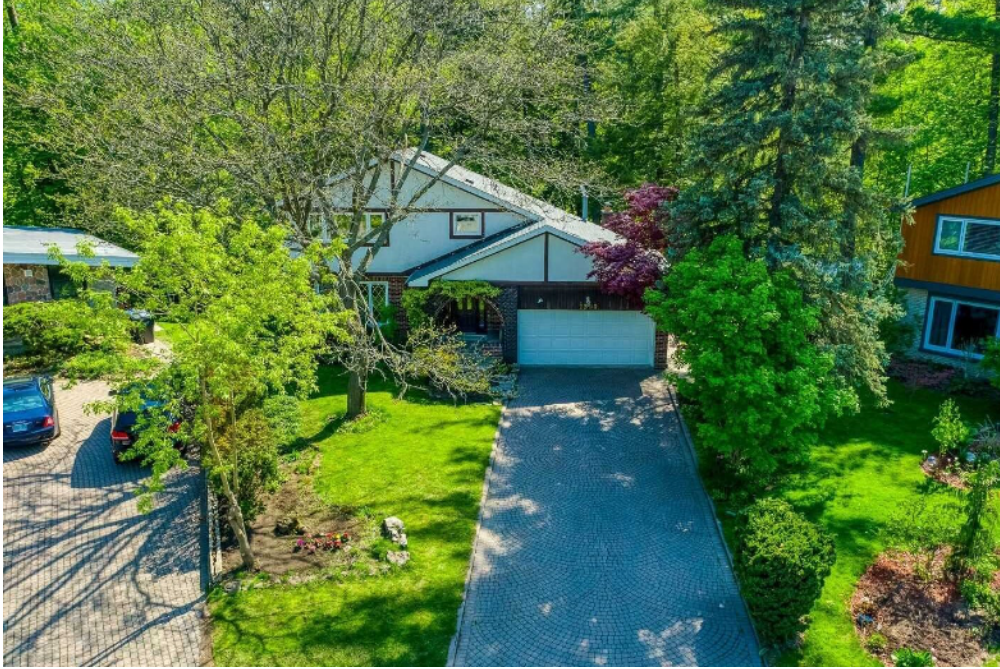
Photo 1: Front Elevation

The house would be considered a side split, where the multiple levels are visible from the street. In this house, you enter on the main floor and the lower and upper levels are on the south side. The garage is situated in front on the north side.

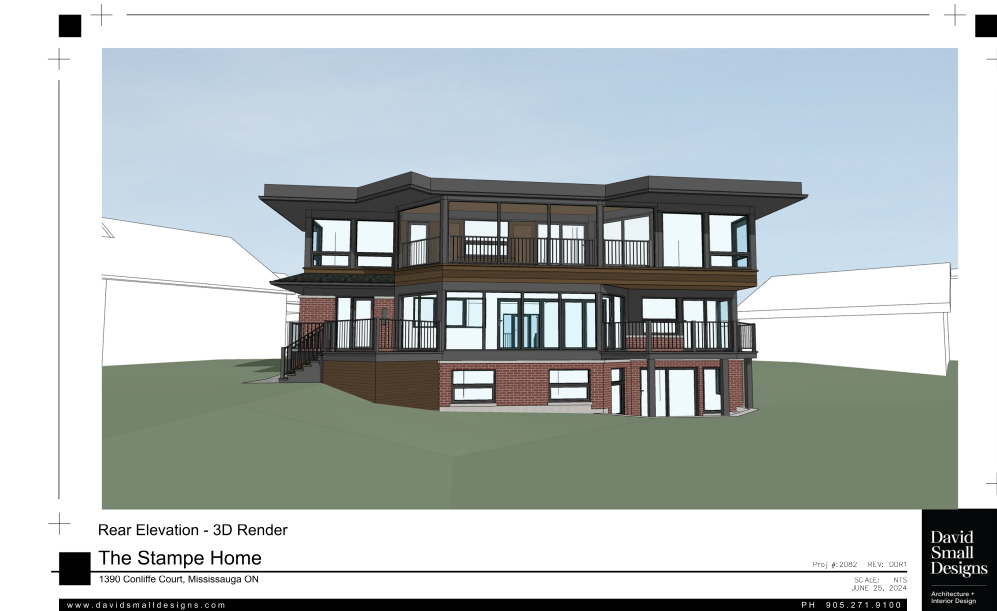
Figure 8:
Proposed rear elevation

Muted and natural colours have been chosen so that the home will maintain its 'blended' appearance.

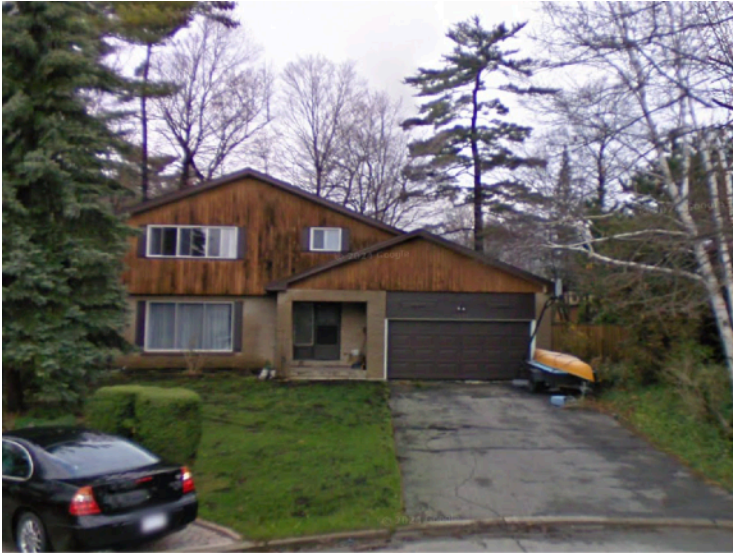
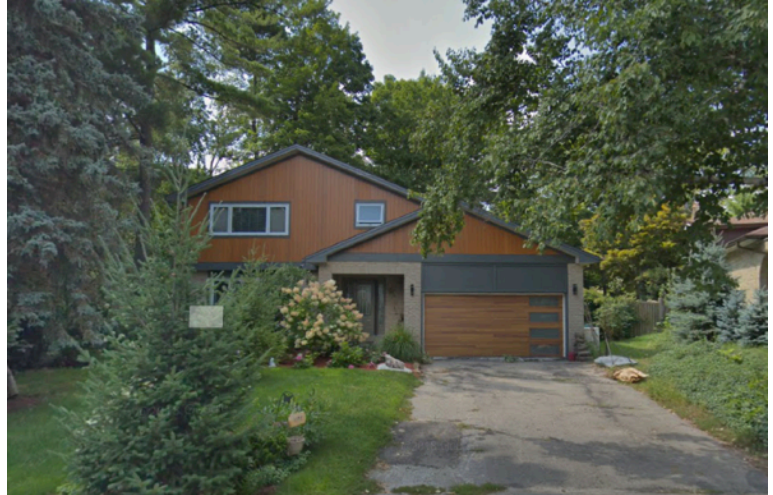
Image 4: 2009 Google street image (1387) (left)

All of the homes on Conliffe Court appear to be original builds. However, the adjacent home at 1387 Conliffe appears to have had a 'facelift' between 2014 and 2018, giving it a more modern, clean look
