# HERITAGE IMPACT ASSESSMENT

**3610 Burnbrae Drive**  
**May 2024**

This Heritage Impact Assessment (HIA) has been prepared by W.E. Oughtred & Associates Inc. as a requirement for obtaining a heritage permit for the demolition of the existing dwelling and the construction of a new home on the subject property. 3610 Burnbrae Drive is a part of the Credit River Corridor Cultural Landscape within the City of Mississauga Cultural Landscape Inventory.

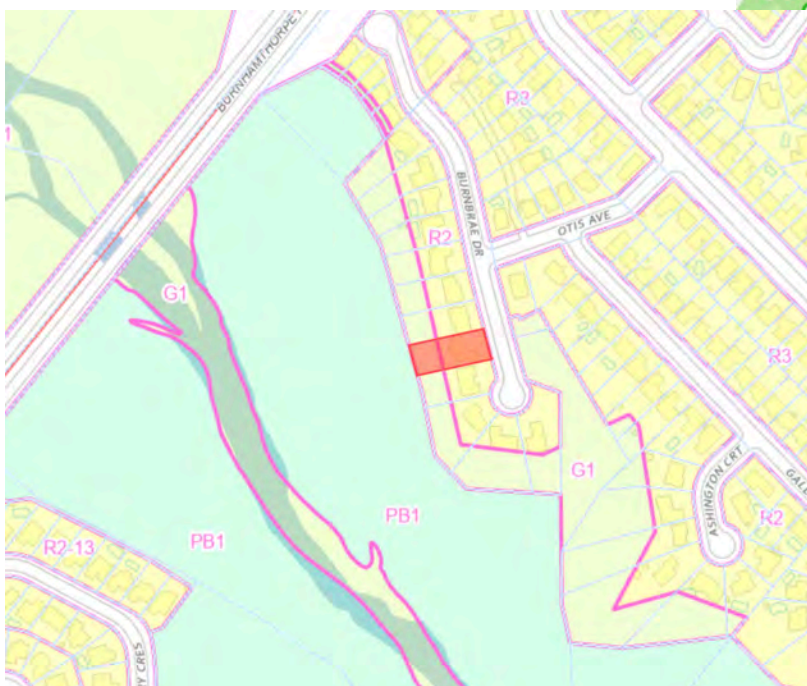
Figure 2: Zoning (below)

The property is rectangular shaped lot. It has a frontage of 22.4m on Burnbrae Drive. The property is separated from the Credit River by a parkway belt. The subject property contains a single family detached dwelling. It is zoned both R2, Residential and G1, Greenbelt. See figure 2 for zoning delineation.

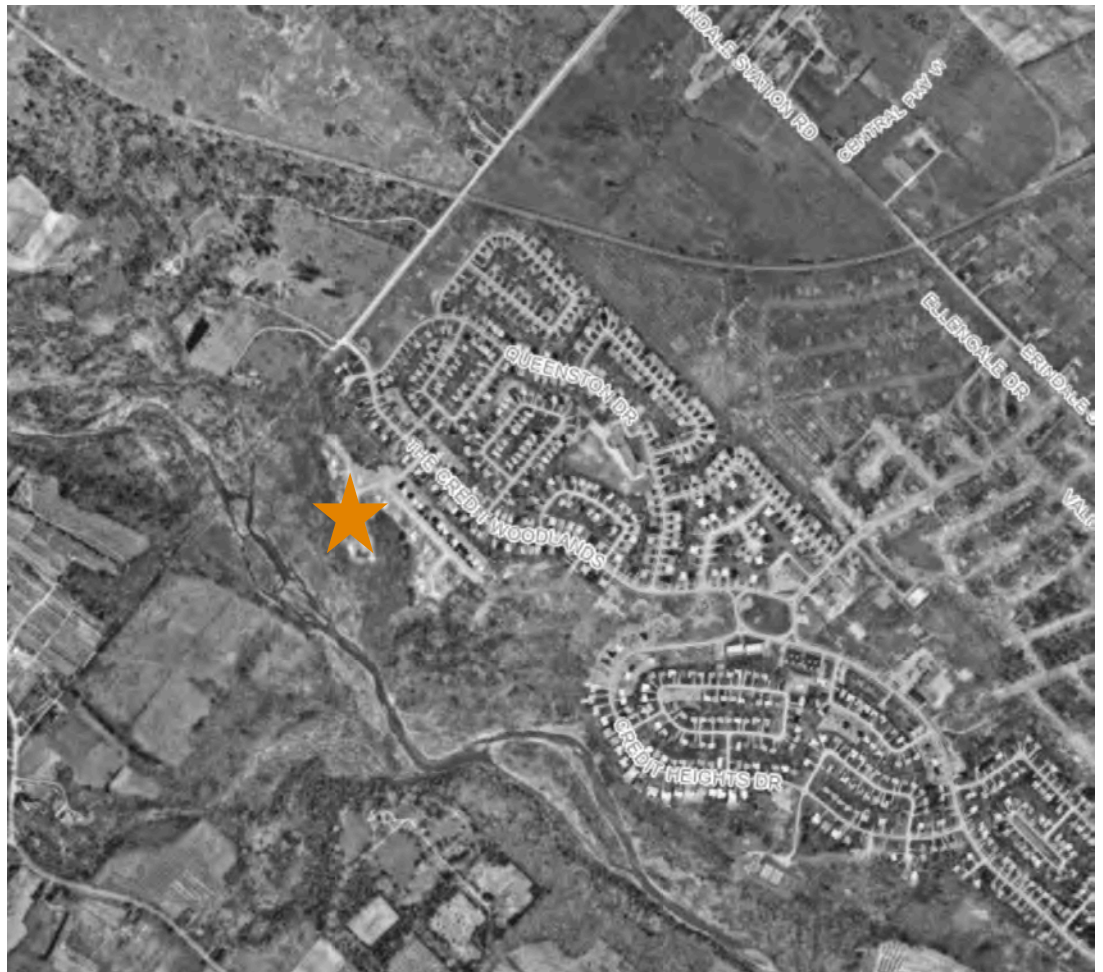
Image 1: 1966 Aerial Photo

The arial photo  
from 1966 depicts  
the development of  
the Credit  
Woodlands. The  
subject property is  
identified by an  
orange star. HWY  
403 has yet to be  
constructed, and  
Burnhamthorpe  
Road does not  
extend over the  
Credit River.

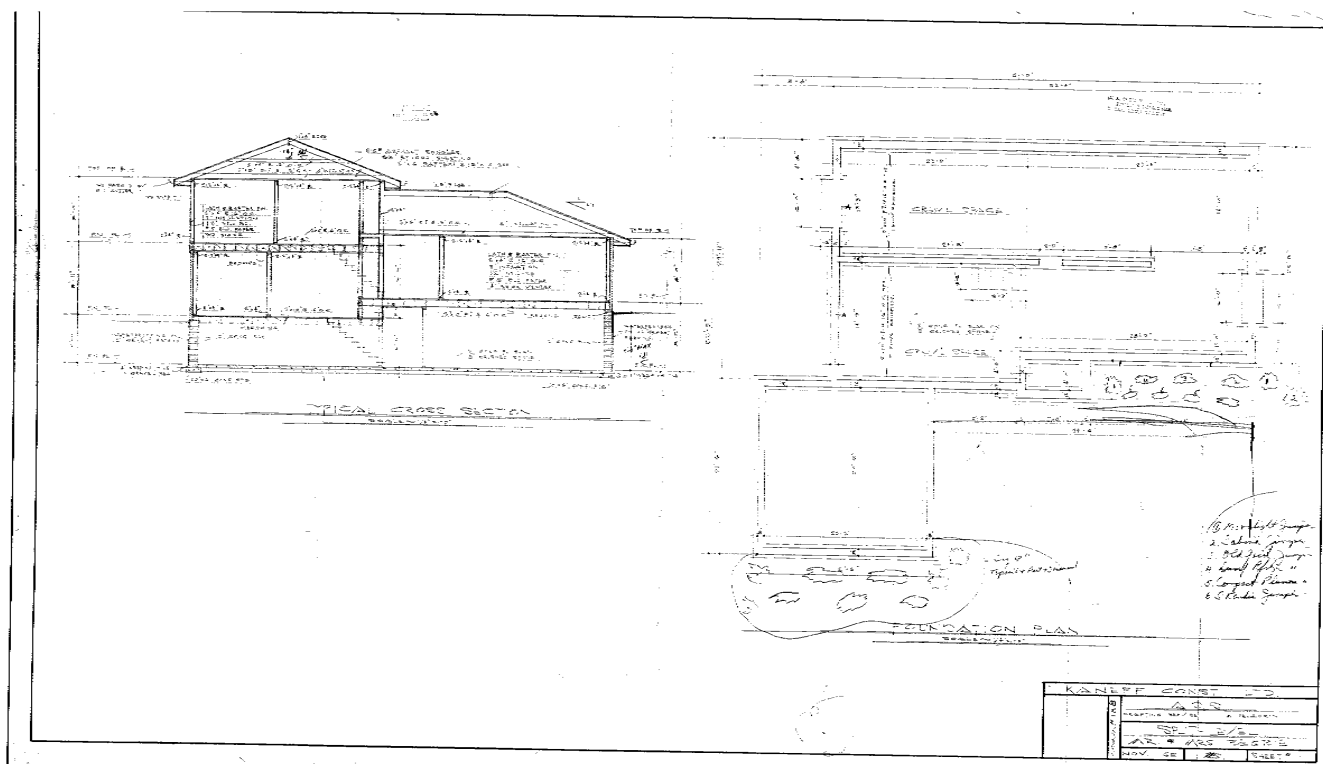
Figure 7: Cross section and Foundation

The home was built on a foundation of 10" concrete block with lath and plaster walls. Homes of this era were on the such of integrating construction and housing innovations. "Equally important demonstrations of new approaches and materials were made with respect to interior finishings, traditionally time consuming and highly skilled work. In the 20 years after World War 2, major changes took place in this phase of construction. Use of component parts, such as prefabricated bathroom and kitchen cabinets made from plywood or various kinds of waferboard, was beginning to appear by the late 1960's and significantly lessened the need for skilled on-site labour. Of equal significance was the replacement of plaster with gypsum drywall. Drywall was installed once the interior partitions were in place, and the joints between the sheets were taped and plastered to provide a smooth surface. This demand skilled labour, although much less so than for lath and plaster. In 1955 plasters had made up about 7 percent of total cost of on-site labour, but by 1969 this had dropped to less than 1 percent.<sup>7</sup>

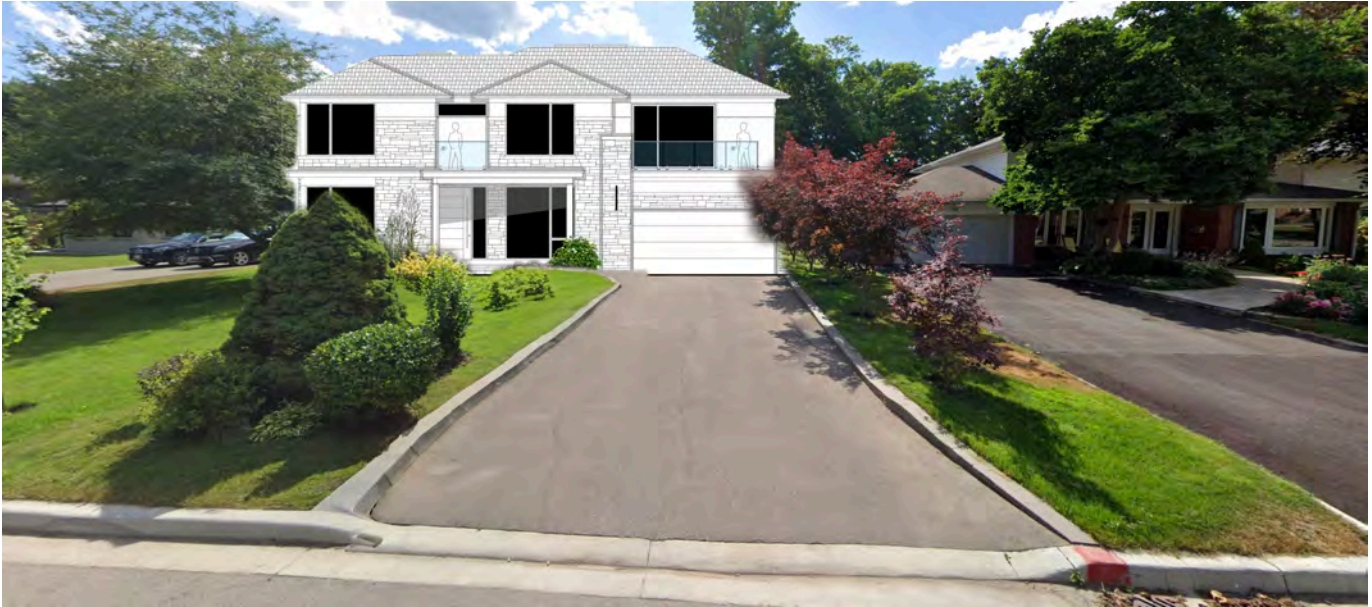
**Figure 14: Proposed Streetscape**

The proposed dwelling will maintain the residential quality of the neighbourhood. Although it is a new dwelling, many homes in the area have been renovated and or replaced. It is an area that is experiencing redevelopment due to its desirable location.
