# 33 Beverley Street

## Heritage Impact Assessment

May, 2025

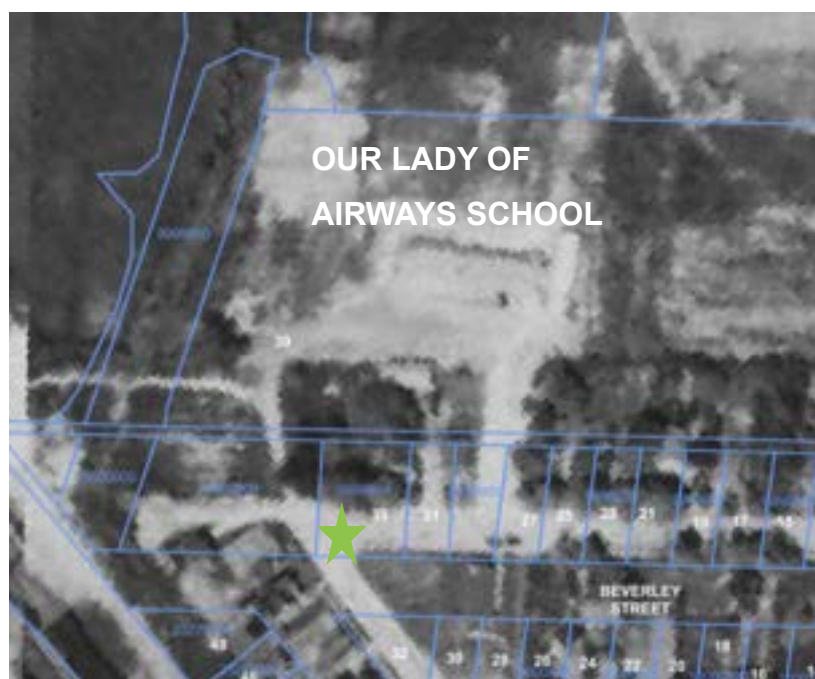
Figure 5: 1952 Aerial photo

Subject property defined by green star. The property does not appear to be associated with a farming operation. Our Lady of the Airways Catholic School was situated behind the property and opened in 1954.

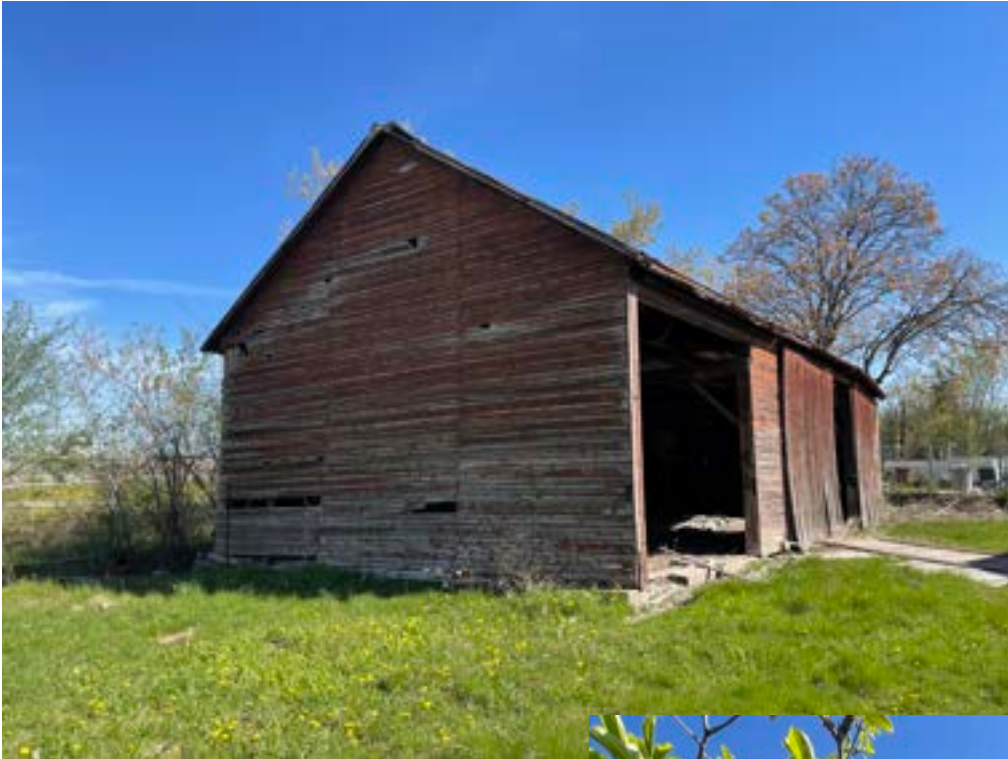
Photo 8: Barn,  
Side Elevation

**Construction:** Wood, with corrugated metal roof, no foundation evident.

**Condition:** poor, structurally unsafe

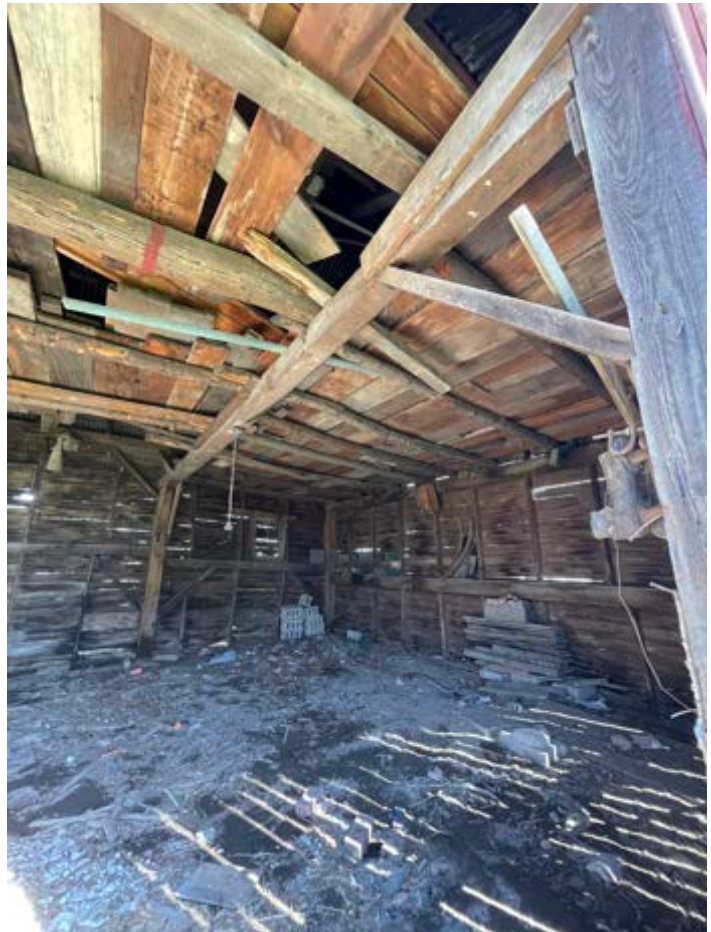
Photo 11: Barn, Interior

There is a central beam (as evidenced in Photo #11) dissecting the barn. Sway braces are also prominent.

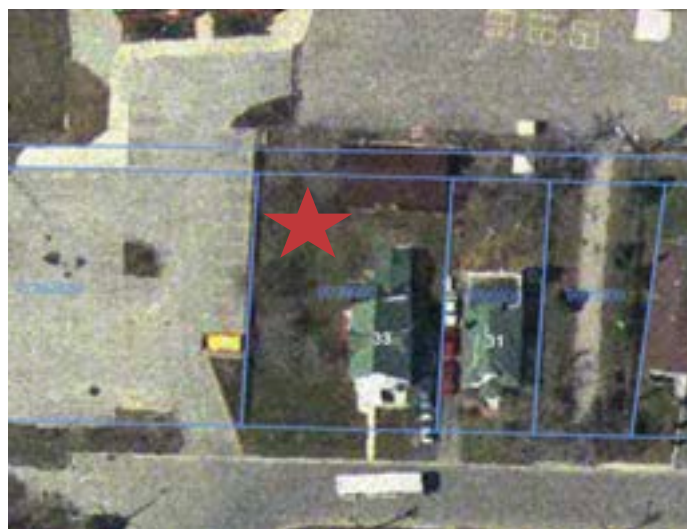
Figure 7: 2002 Aerial Photo

Aerial photos are not legible prior to 2002 and thus the date of the additions cannot be determined.

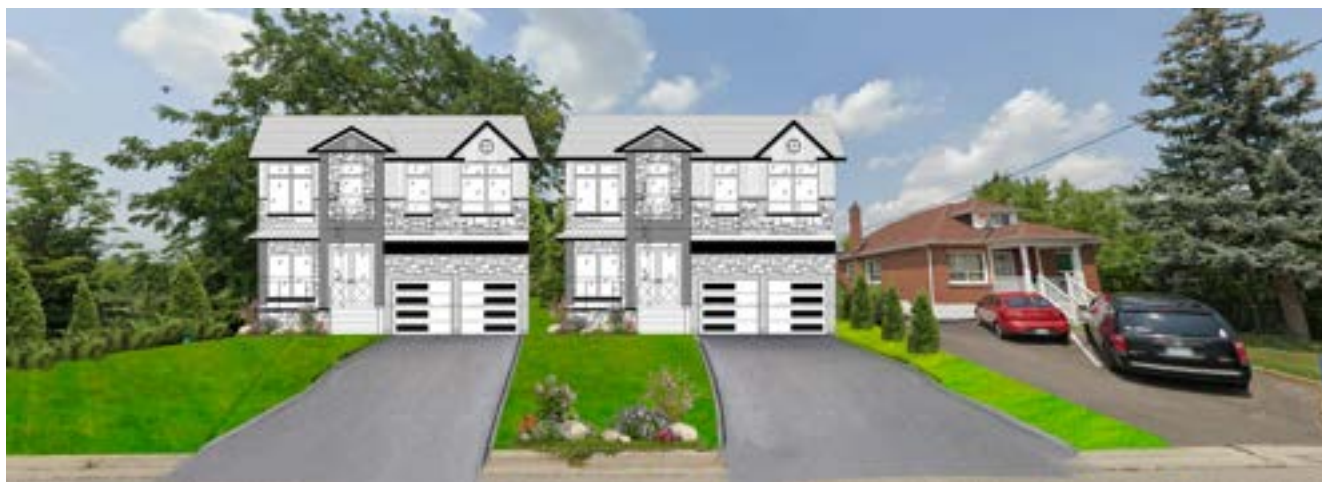
## Proposed Streetscape

The new by-law permits a maximum dwelling height of 10.7m. The proposed height is 9.14m and complies with the by-law. The houses are in keeping with the new builds around the corner shown in the previous image.
